# L'AUBERGE CARMEL

1 Monte Verde Street at Seventh Ave.

Photos by Jenna Tyndall from Wald, Ruhnke and Dost Architects (June 28, 2021)

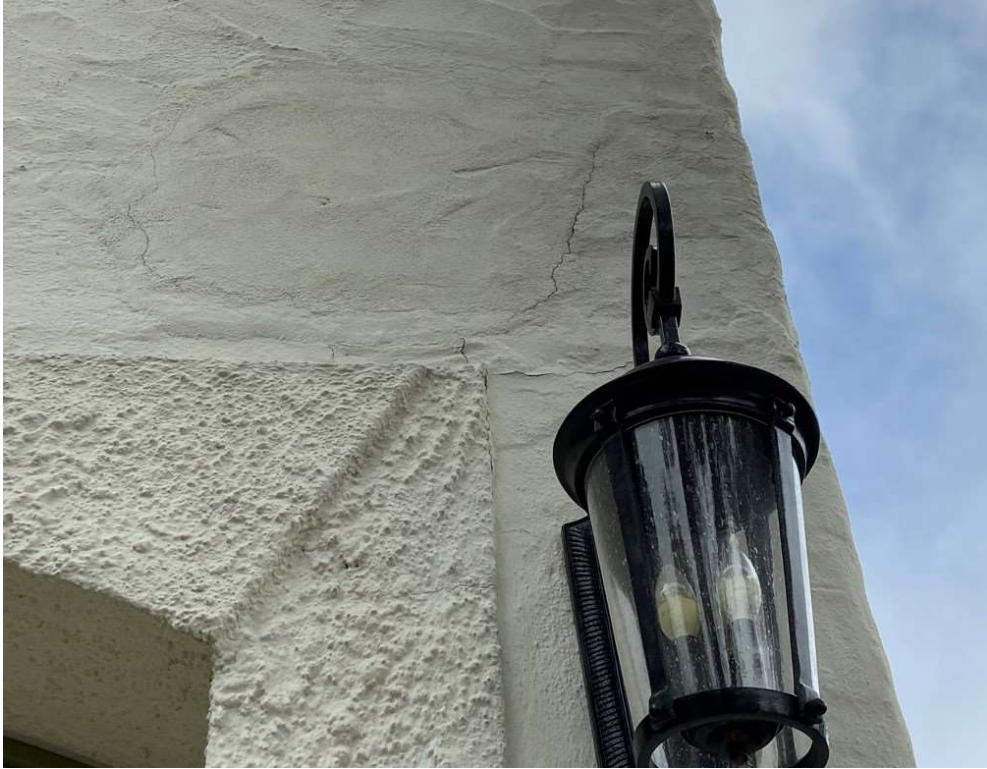
Photo #5, radial plaster cracking at Southwest building corner

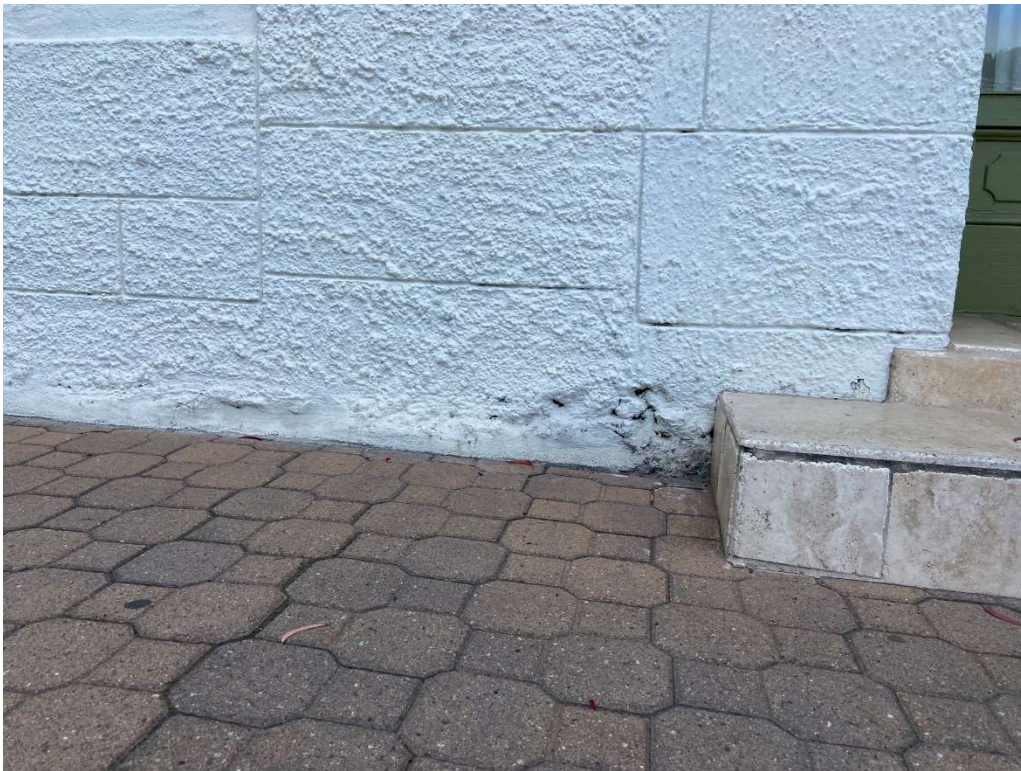
Photo #6, holes in foundation, plaster and tile at Southwest corner

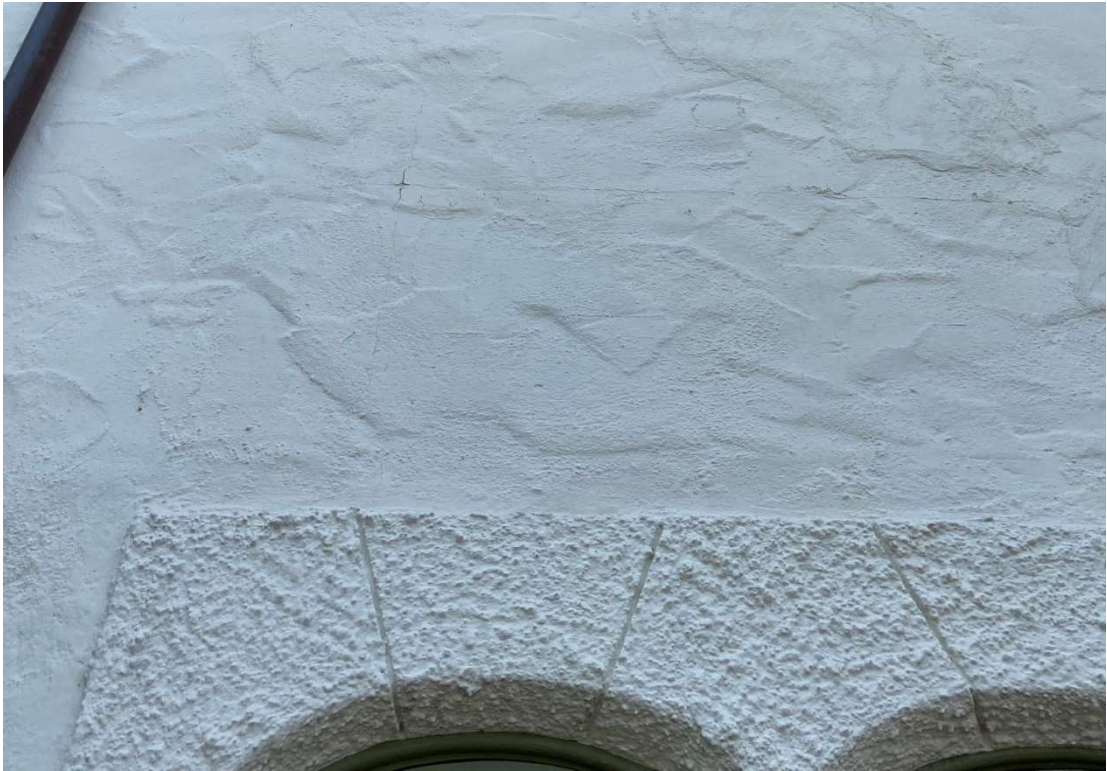
Photo #7, hairline cracking in plaster above double windows by main entry

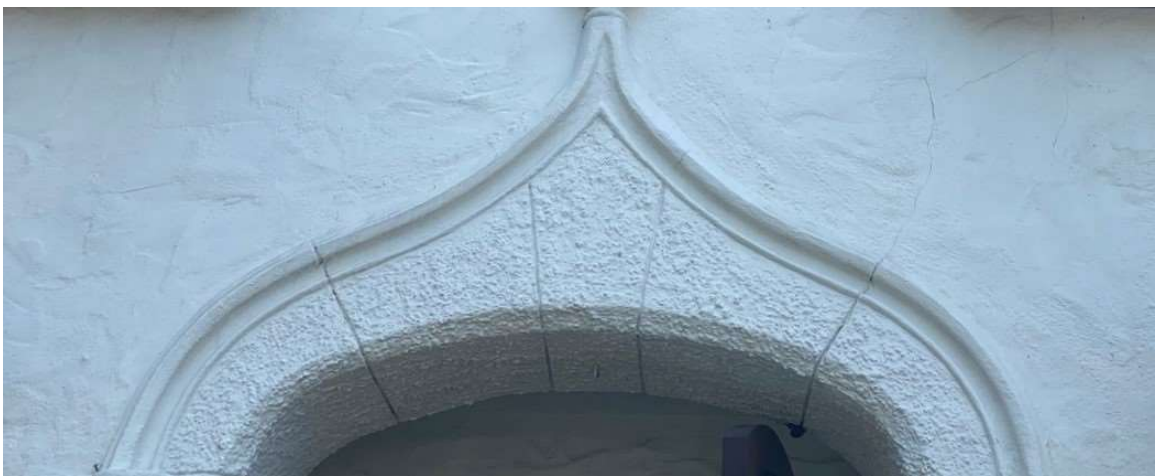
Photo #8, radial cracking in plaster above main entry doors.

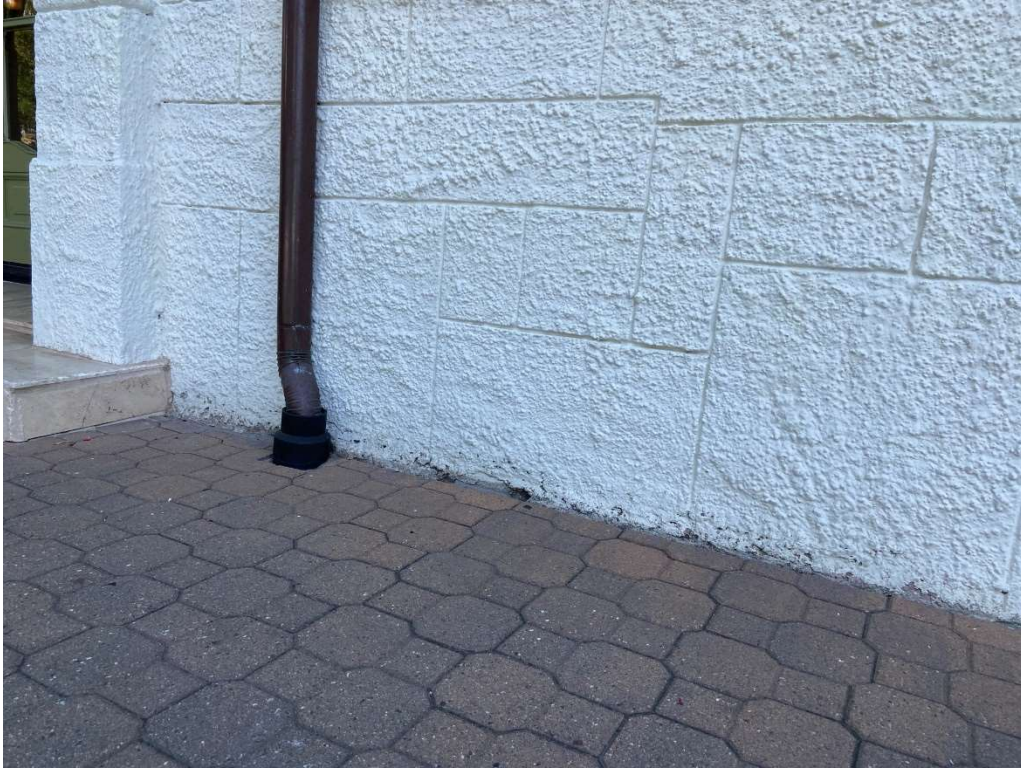
Photo #9, holes in foundation near Northwest building corner

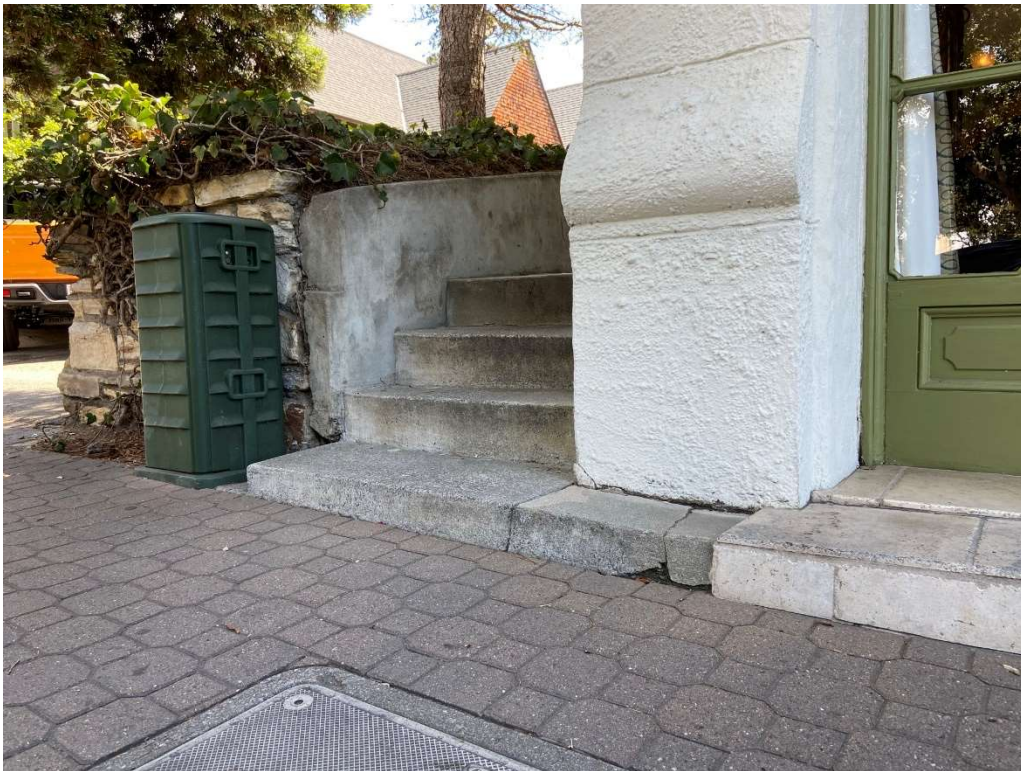
Photo #10, cracked step/foundation at Northwest building corner

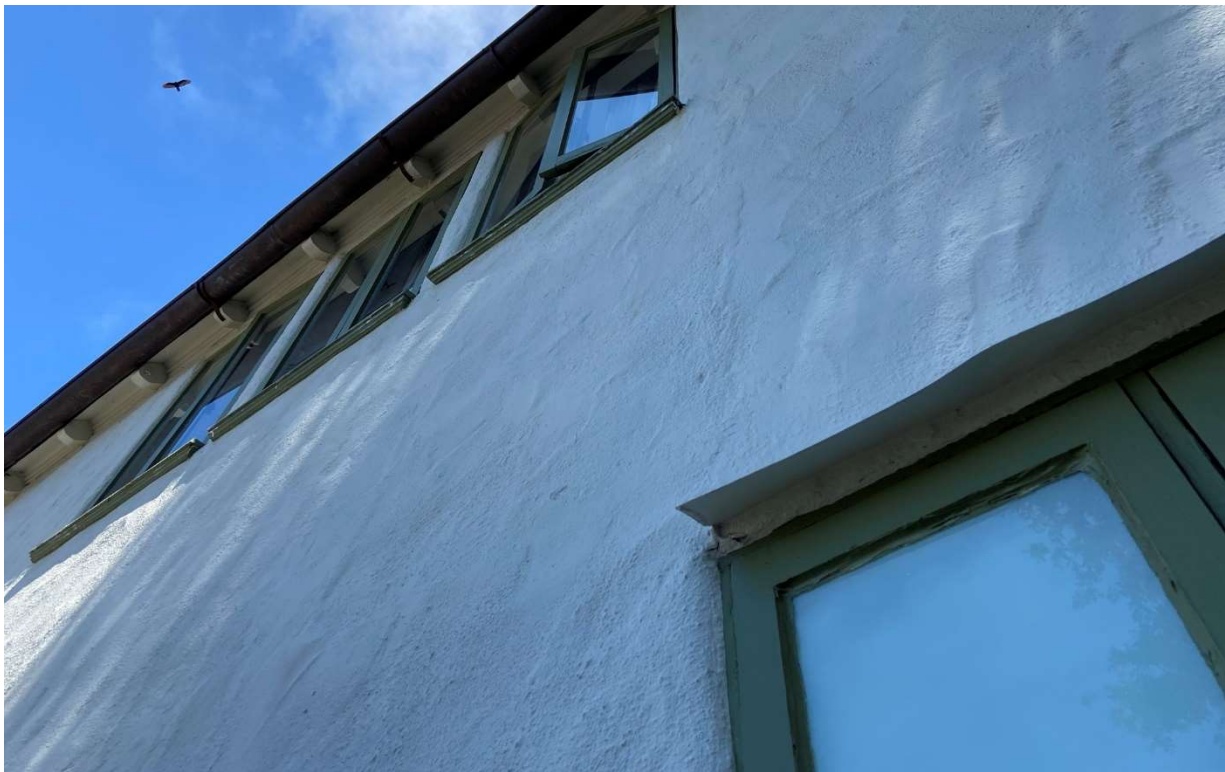
Photo #12, bent/damaged flashing at second level opening

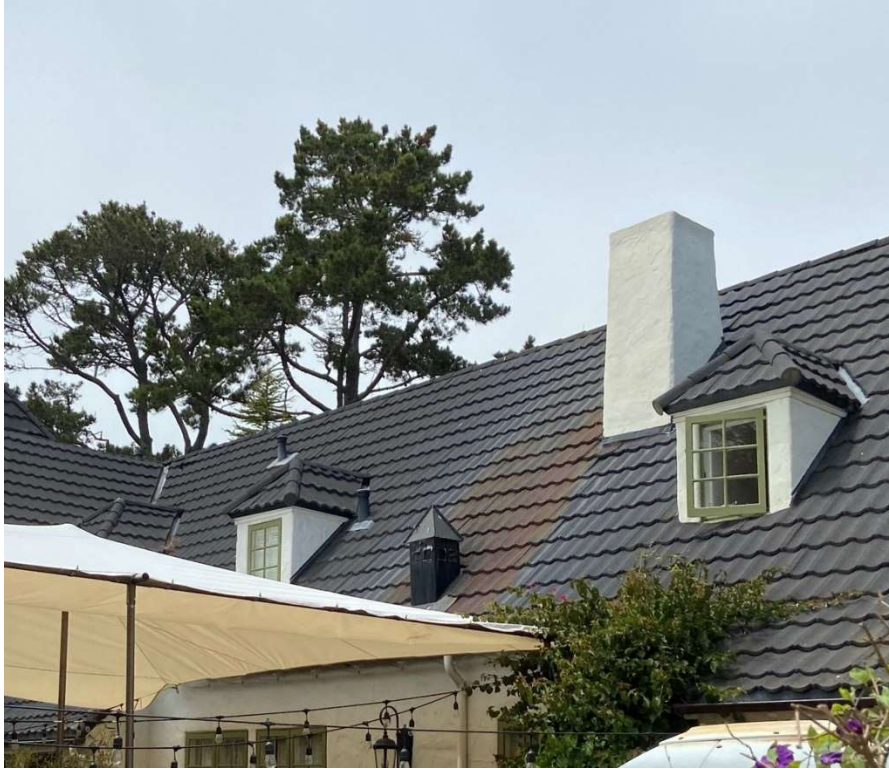
Photo #10, weathered/oxidized roofing at central courtyard

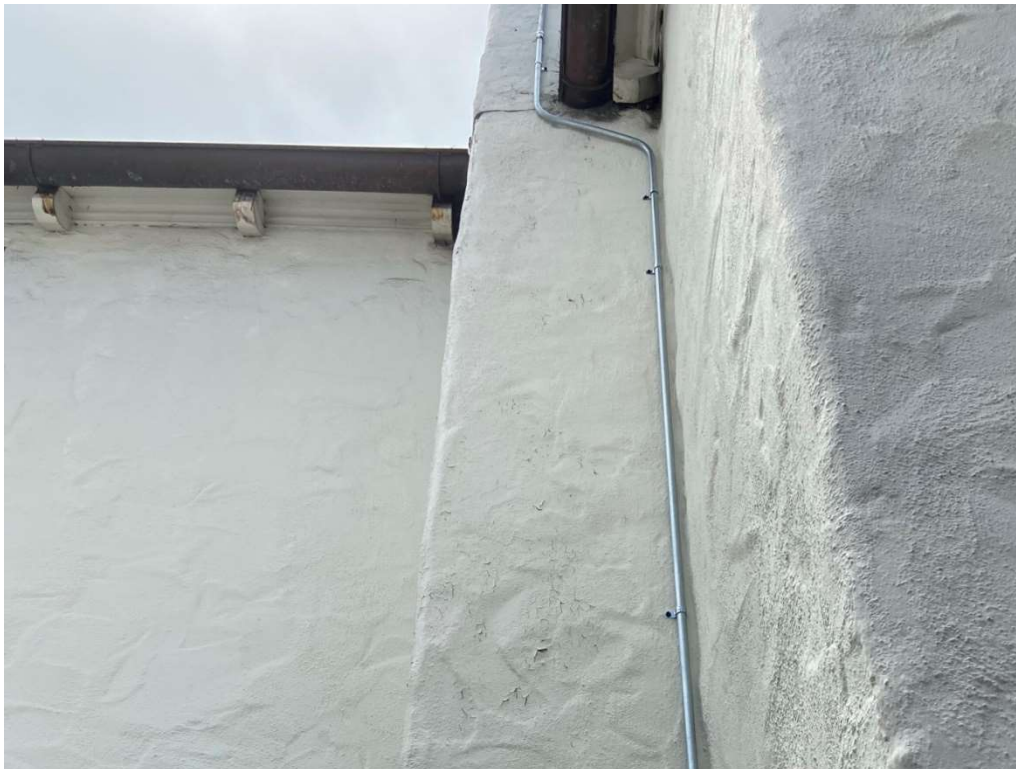
Photo #11, damaged rafter tails at roof as seen from courtyard

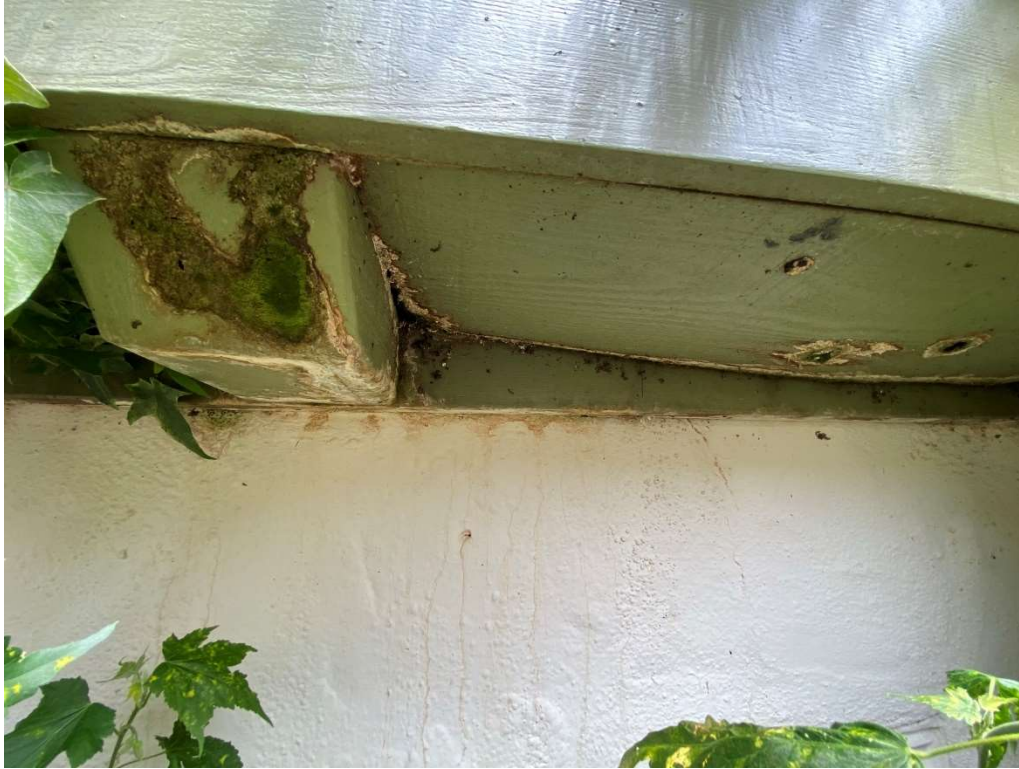
Photo #12, rotted supports at exterior planter box

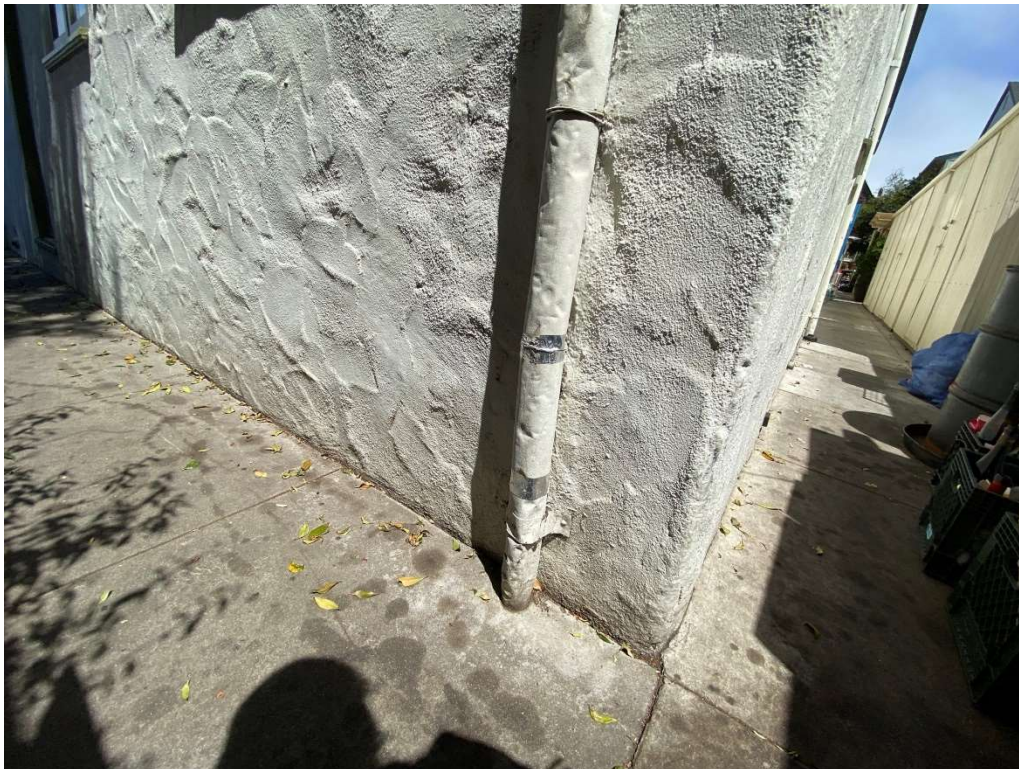
Photo #13, damaged downspout (typical condition at perimeter)

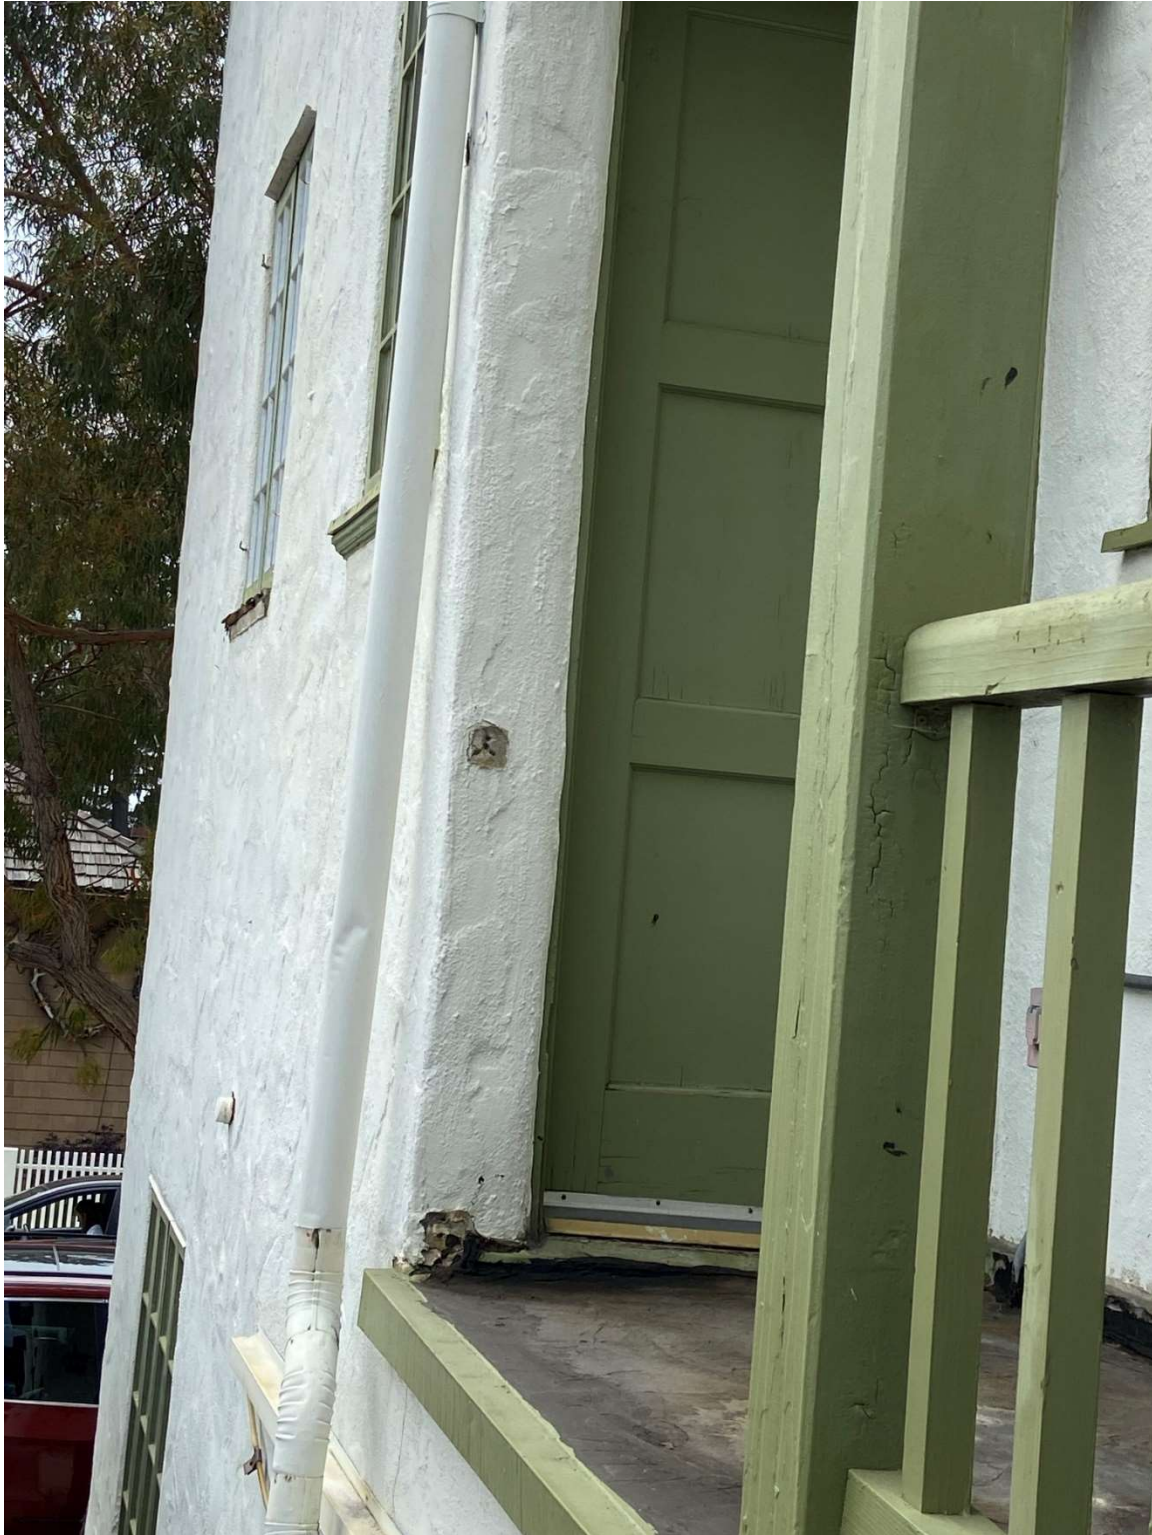
Photo 14, Water damage at upper-level balcony

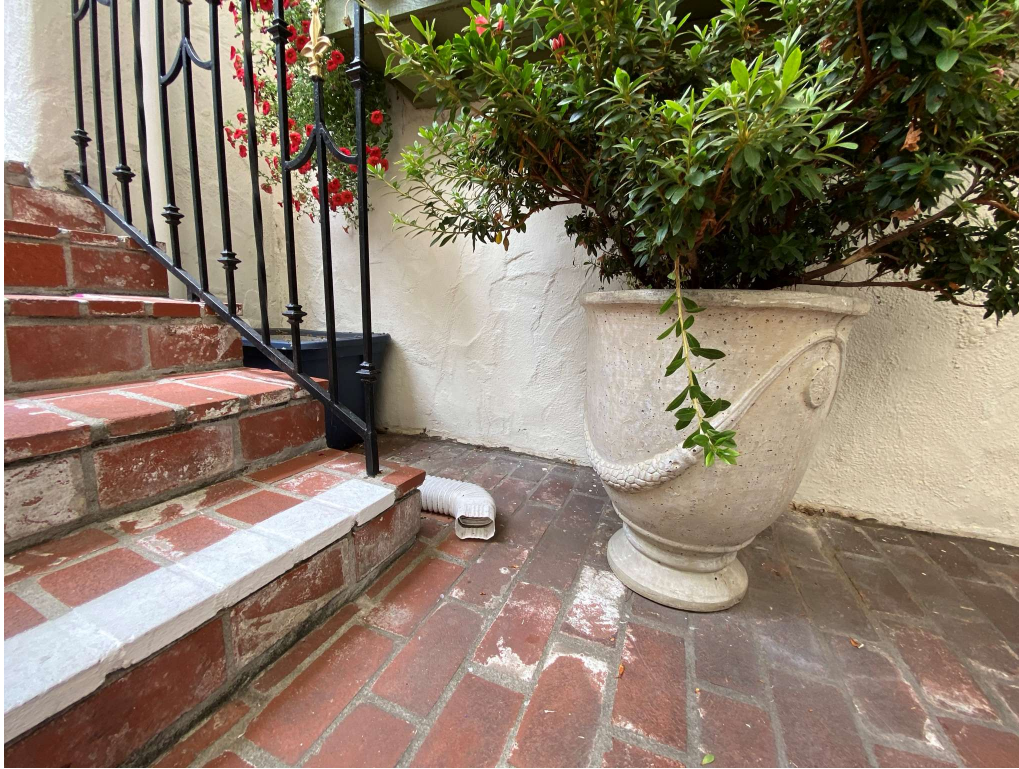
Photo 16, temporary surfact drainage at courtyard
