Carmel Legacy Hotel Response to Appeal to the City Council and Recommended Evidence for a Class 32 Categorical Exemption

This report presents the findings of the visual assessment and evaluation of the Hofsas House Hotel, located in Carmel, California. The objective of this study was to perform a visual conditions assessment, noting deficiencies encountered, and a qualitative structural review of the buildings along with a civil assessment of the site.

SITE & STRUCTURAL SCREENING and EVALUATION

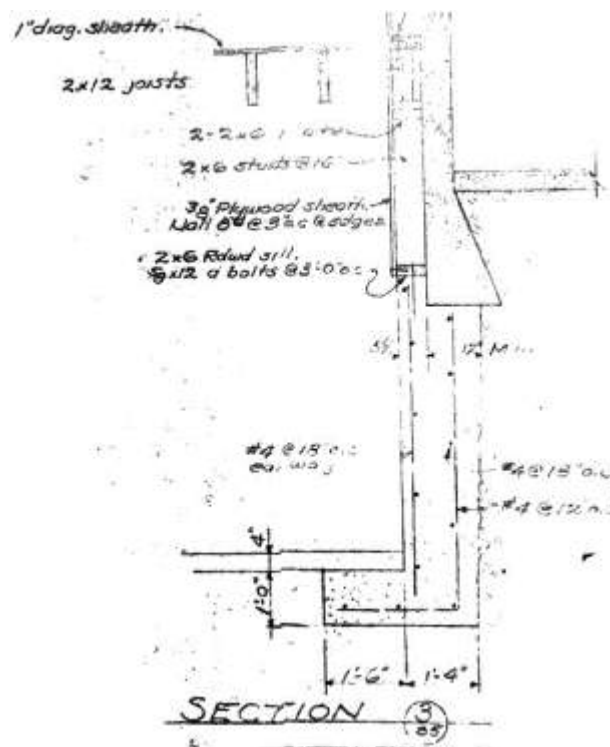
Figure 3- Interface Between 1957 Structure and Pre-1957 Structure

- 4.3 Interface with pre-1957 building: The 1957 structure was built over one of the original structures located on the site. The drawing sheet with the east wall section was not available for review; however, Figure 3 below shows the interface between the original structure with the flared foundation and the 1957 structure. The 1957 structure was excavated below the original foundation, so underpinning was shown in the section. No positive attachment between the structures is shown, and without is the 1957 structure is likely to shift on the original structure in the event of a major earthquake. Such a shift will cause substantial damage and may be irreparable.

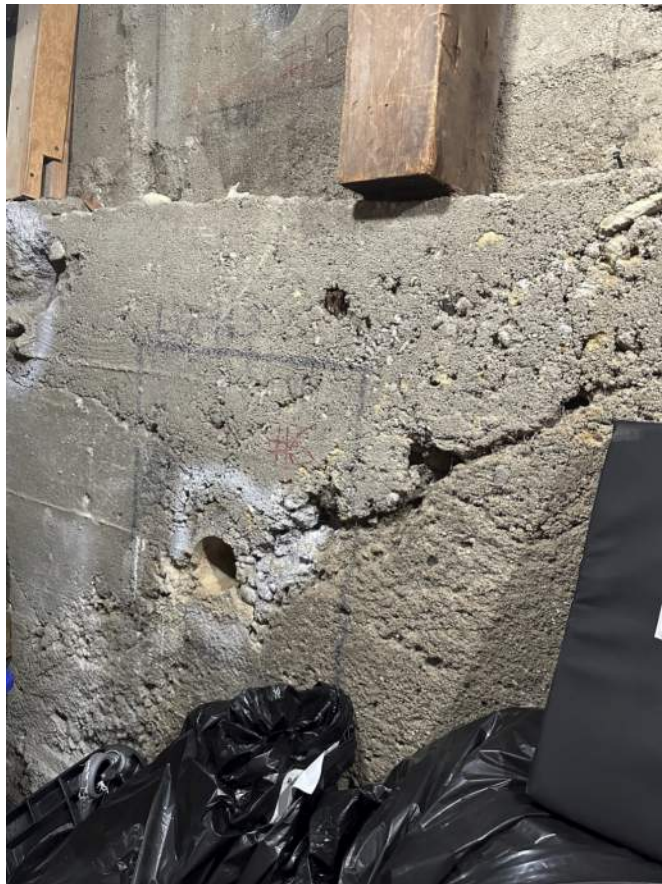
Figure 4- Void Vein in East Wall of Pre-1957 Structure

- 4.4 Condition of the pre 1957 retaining wall: The pre-1957 structure that was incorporated into the 1957 structure has an 8' tall concrete retaining wall within 8' of San Carlos Street. The wall is in poor condition and has a large void vein running through it (See Figure 4). Beach sand and Carmel stone appear to have been used as aggregate in the wall concrete. Because of this, and because water

appears to have been leaking through the wall for some time, the average concrete core compressive strength was tested to be 1290 psi, with a low value of 790 psi tested where shown in Figure 4. Two other samples were taken away from the void vein, and the compressive strengths were 1050 psi and 2020 psi, as seen in the materials testing report in Appendix A. The tested concrete is quite weak, and the weakened wall is critical for the support of both the 1957 structure above and the adjacent San Carlos Street. Replacement is recommended, though it may prove cost prohibitive as it will require shoring both the roadway and the entire building, plus reattachment. The work will also likely trigger a full seismic retrofit. Due to the potential impact on the adjacent street, further detailed study is warranted, including a geotechnical investigation. Traffic, including truck traffic, is potentially surcharging a weak and decaying retaining wall in its current configuration.

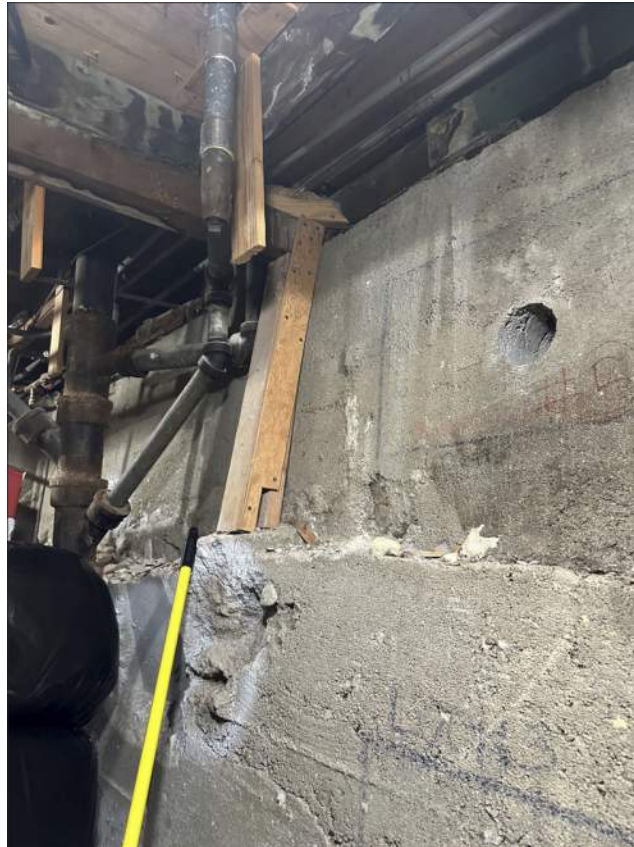
Figure 5- Resupport of 1957 Structure at East Wall of Original Structure

- 4.5 Attachment to Pre-1957 Structure At East Wall: Although the structural drawing showing the attachment between the 1957 structure and the east wall of the original structure was not available, the connection appears tenuous in the field and appears to have been repaired at one location in the past. The repair also does not appear to be rugged. Failure of this connection will lead to substantial damage.

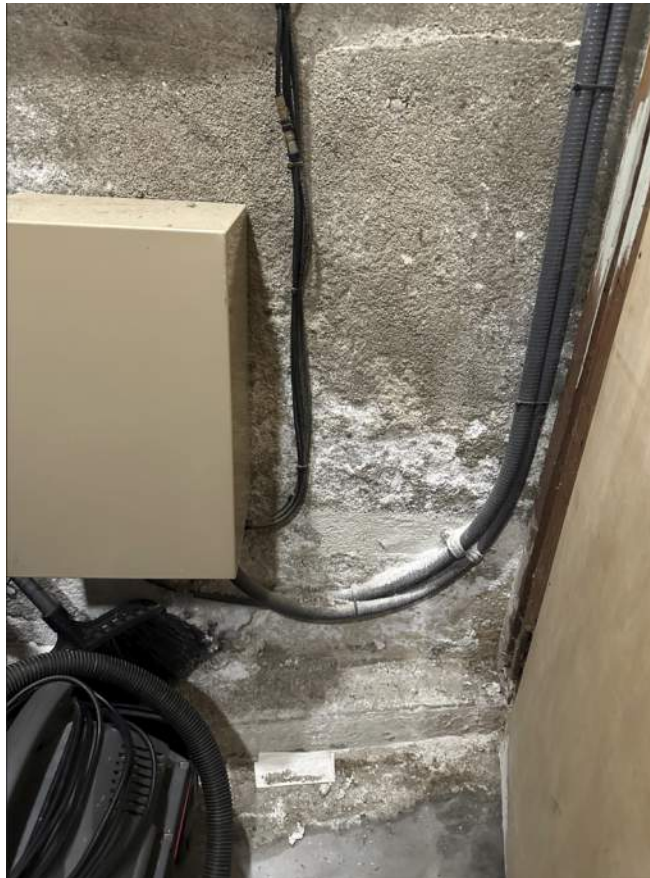
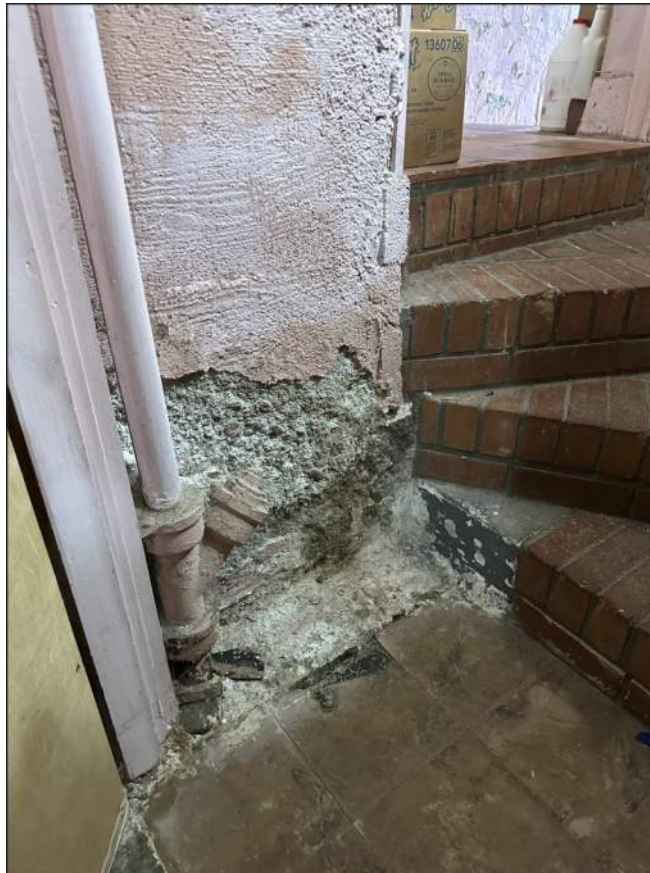
4.6 Efflorescence and Weak Concrete in South Wall of Pre-1957 Structure: As shown in Figures 6 and 7, there is visible efflorescence on the surface of the south wall of the pre-1957 structure, indicating that water has been migrating through the wall. Additionally, the surface concrete at the efflorescence crumbled easily by hand. The concrete condition is likely similar to the tested concrete of the east wall.

Figure 6- Efflorescence and Weak Concrete in South Wall of Pre-1957 Structure

Figure 7- Additional Efflorescence and Weak Concrete in South Wall of Pre-1957 Structure

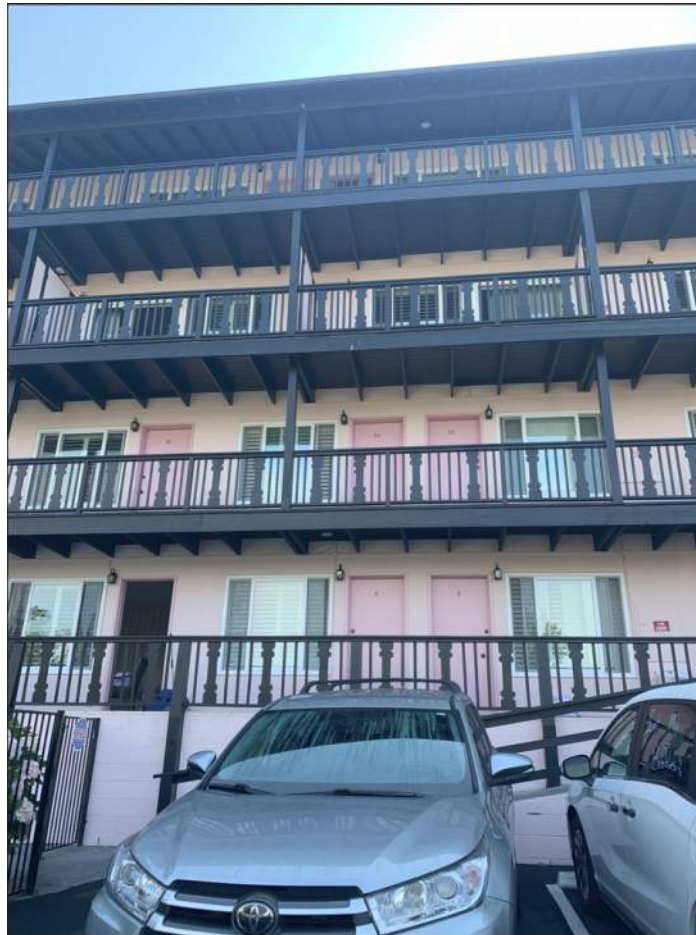
Figure 8- Typical Exposed Framing at Walkway

4.7 Exposed Deck Joists: Figure 8 shows a typical condition of cantilevered 2x12 joists on the west and south sides of the hotel buildings. The 2x12 joists at 32" on center specified on the historic structural drawings do not have the capacity to carry 100 psf corridor loading required by the building code. Although they don't extend to the ground, the intermittent posts will help share load between floors; however, corridor framing is typically designed to carry load at the level it is applied. In addition, the cantilevered joists are prone to dry rot, and we noted locations in the exposed walkway framing where the original members have been replaced with pressure treated lumber, presumably because the original elements rotted. We also noted signs of weathering on some exposed timber elements, plus some rot in in the exposed framing in the northmost building.. All rotted elements should be removed and replace. Additionally, the joists are a conduit for moisture to enter the building if not flashed properly. No finishes were removed to examine the supporting west wall framing, but there may be rot in some locations due to water intrusion. The cantilevered joist condition has been singled out as the cause of the infamous balcony collapse in Berkeley.

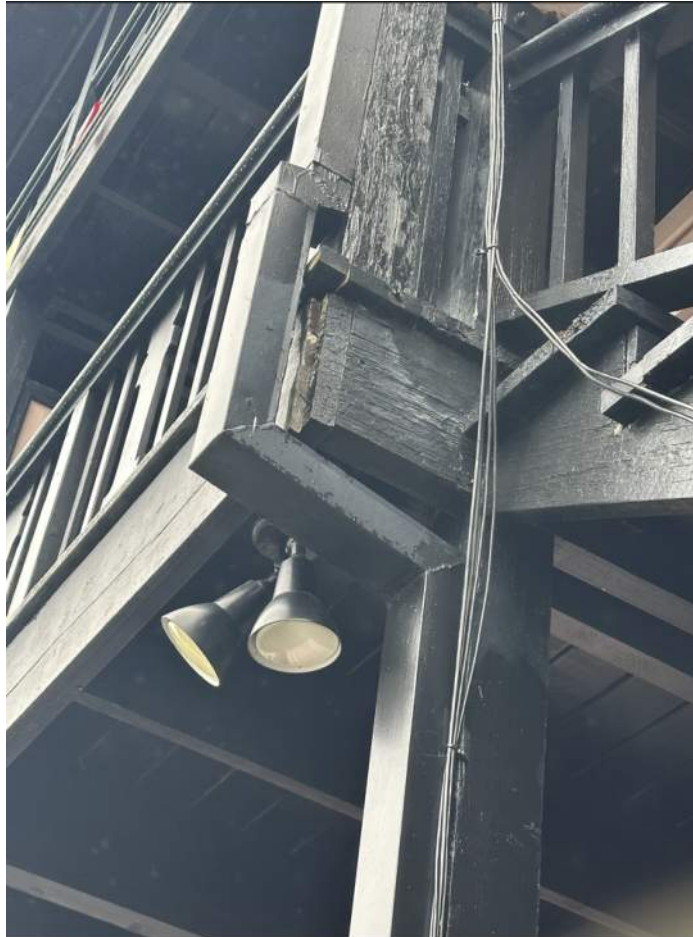
Figure 9- Example of Weathering in Exposed Framing

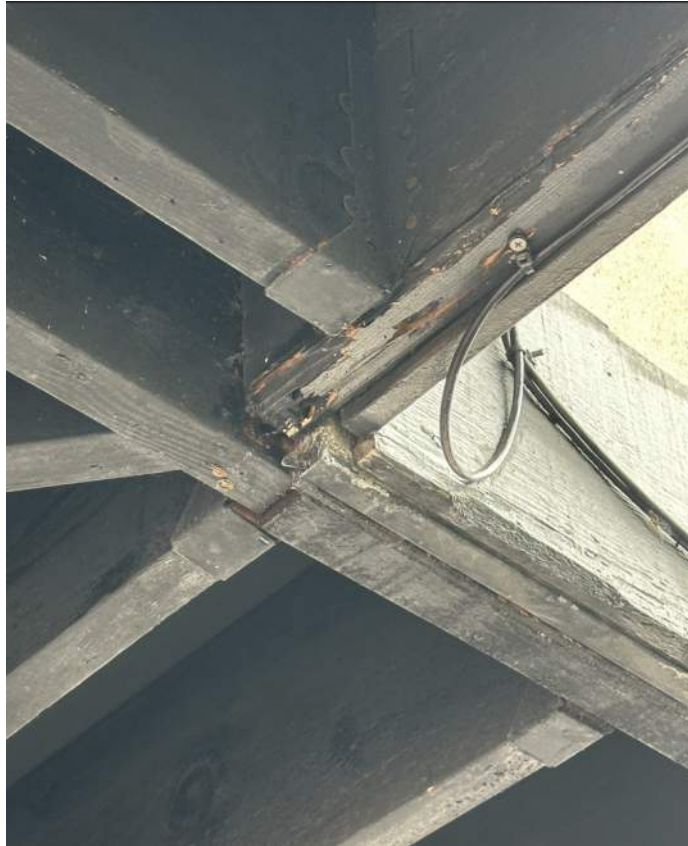
Figure 10- Dry Rot in Exposed Framing at Northmost Building

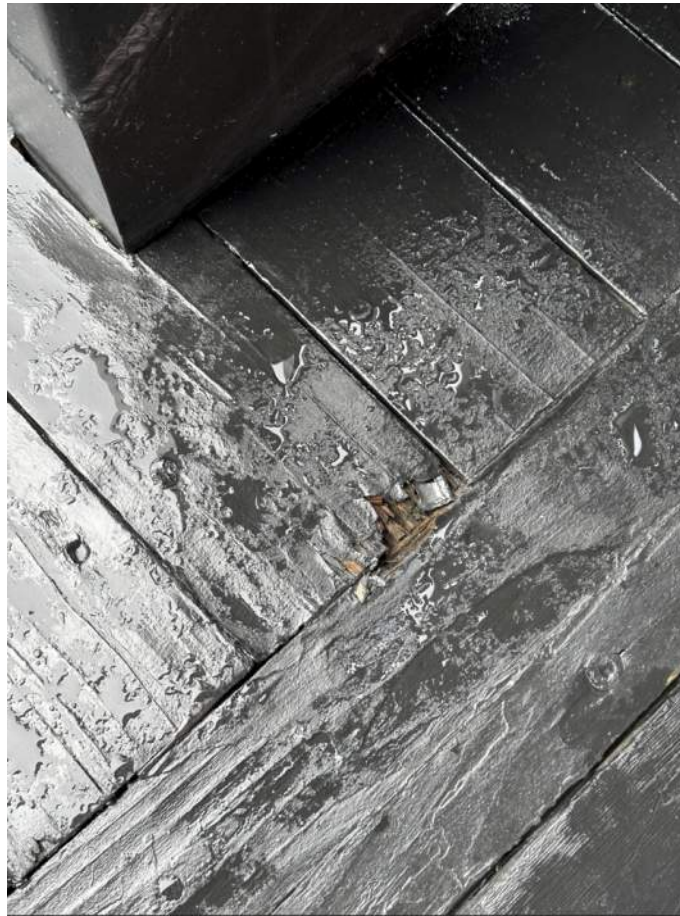
Figure 11- Dry Rot in Exposed Landing Framing at Northmost Building

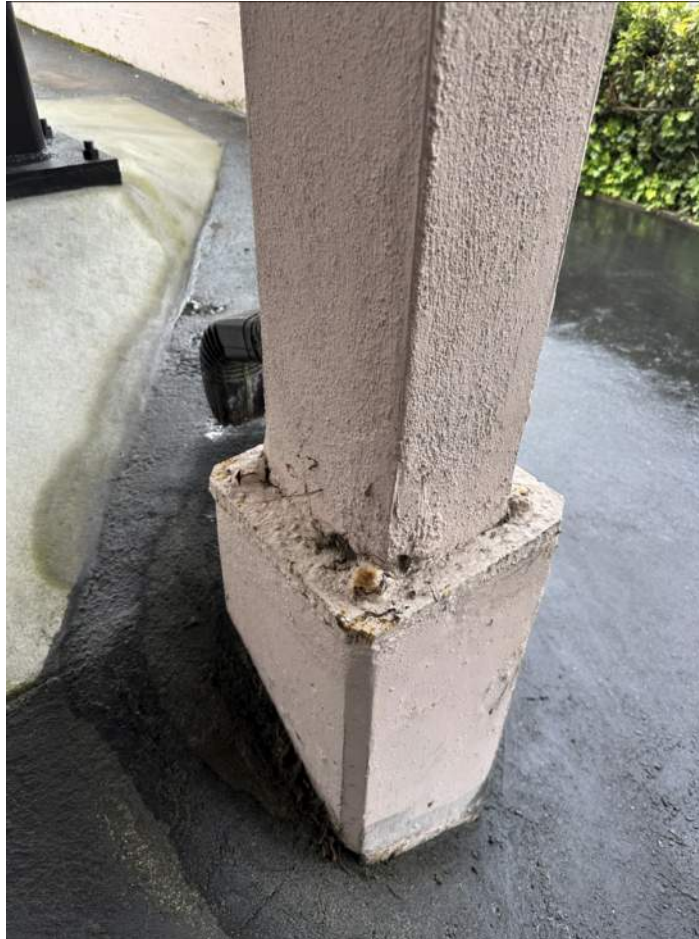
Figure 12- Corroded Base Plate and Anchors

4.8 Corroded Base Plate and Anchors: At the Southwest corner of the northmost building, there is a column to support the two stories of hotel space above. Although painted, the paint is blistered on the base plate and the anchor bolts are corroded. The finish should be removed for further investigation, and the base plate and anchor bolts may require replacing. Figure 12 shows the condition.

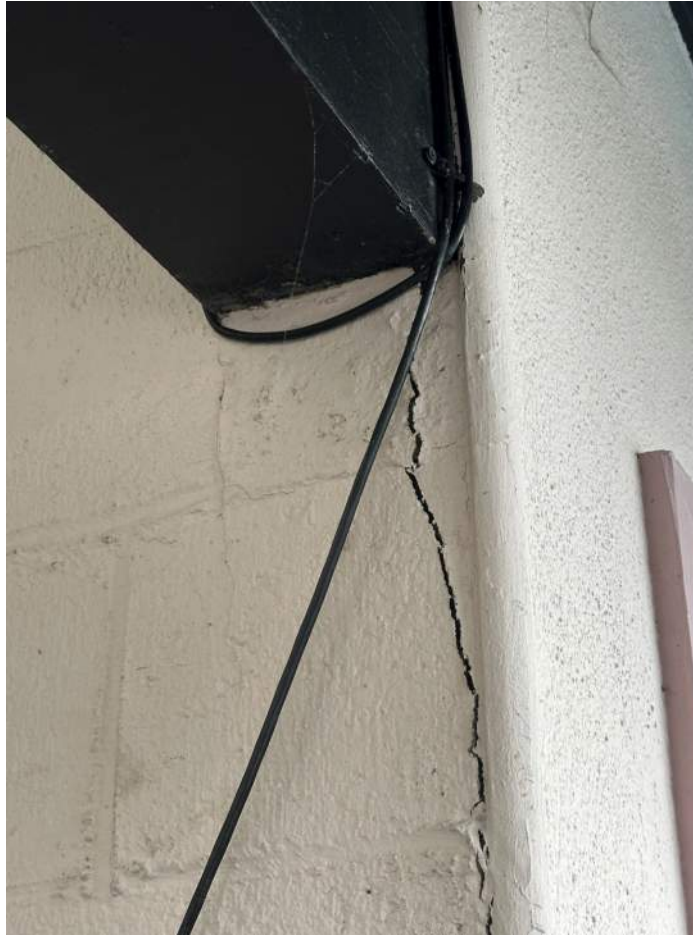
Figure 13- Fractured CMU Support Wall at Cantilevered 6x12

- 4.9 Fractured CMU at Cantilevered Beam: There is a 6x12 beam that cantilevers off the CMU wall at the north end of the building highlighted yellow in Figure 1. This beam supports the elevated walkway framing and the stair landings. The CMU support wall has cracked underneath beam and should be repaired.

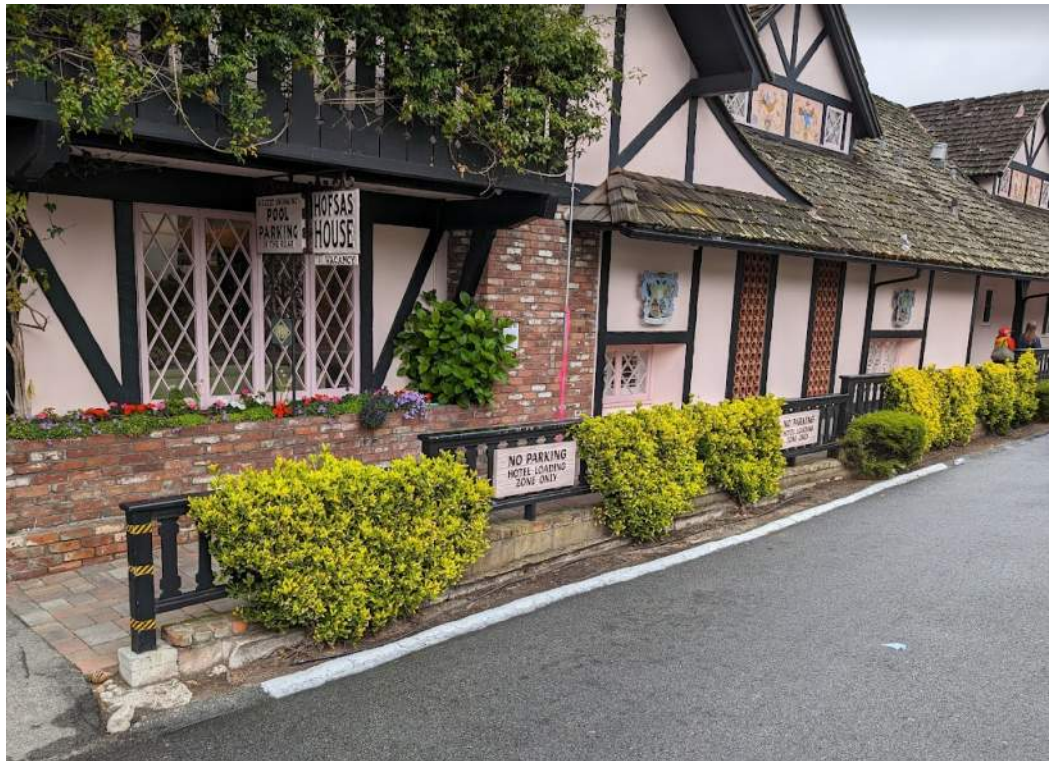
Figure 15 – Existing Pedestrian Loading Zone

- 5.1 Pedestrian Loading Zone: An approximate 30-foot length of San Carlos Street is marked white for “Hotel Loading Zone Only”. Immediately adjacent to the loading zone is a shallow curb, painted white, limited landscaping/bushes, and a brick/wood decorative wall. No direct access is available to the adjacent pedestrian walkway. While the location is generally appropriate, the loading zone is missing several features to provide pedestrian accessibility. A 5-foot wide, striped and hatched area is required adjacent to the loading zone. A direct connection to the walkway is also required, with a detectable warning surface located between where the loading zone interfaces with the walkway. While removing the existing curb, landscaping and wall appear feasible, it does not appear that sufficient space is available to provide the required accessible elements. In order to provide an accessible pedestrian loading zone, the area may need to be relocated and/or other significant improvements made to create a new location to serve the function.

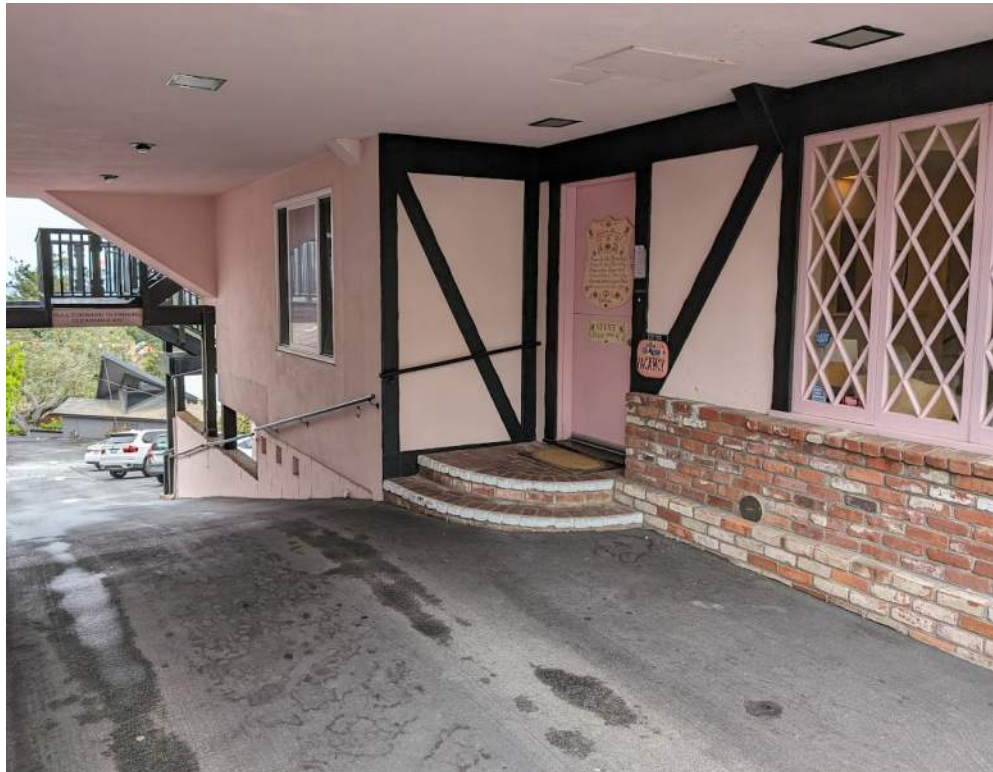
Figure 16 – Lobby Entrance

- 5.2 Lobby Entrance: The lobby entrance is located near the pedestrian loading zone, adjacent to the south driveway. The entrance is located near, and directly visible from, the public right-of-way along San Carlos Street. To enter the lobby, a pedestrian is required to take two steps up to the level of the lobby. No handrail is provided along the steps in the direct from the right-of-way. At the top of the steps, an in-swinging door provides access to the lobby. The threshold is in excess of ½”, and an adequately sized landing space is not provided at the door. Access from the right-of-way to entry also requires a pedestrian to traverse the primary driveway entrance to the on-site parking; no separate, protected walkway is provided.

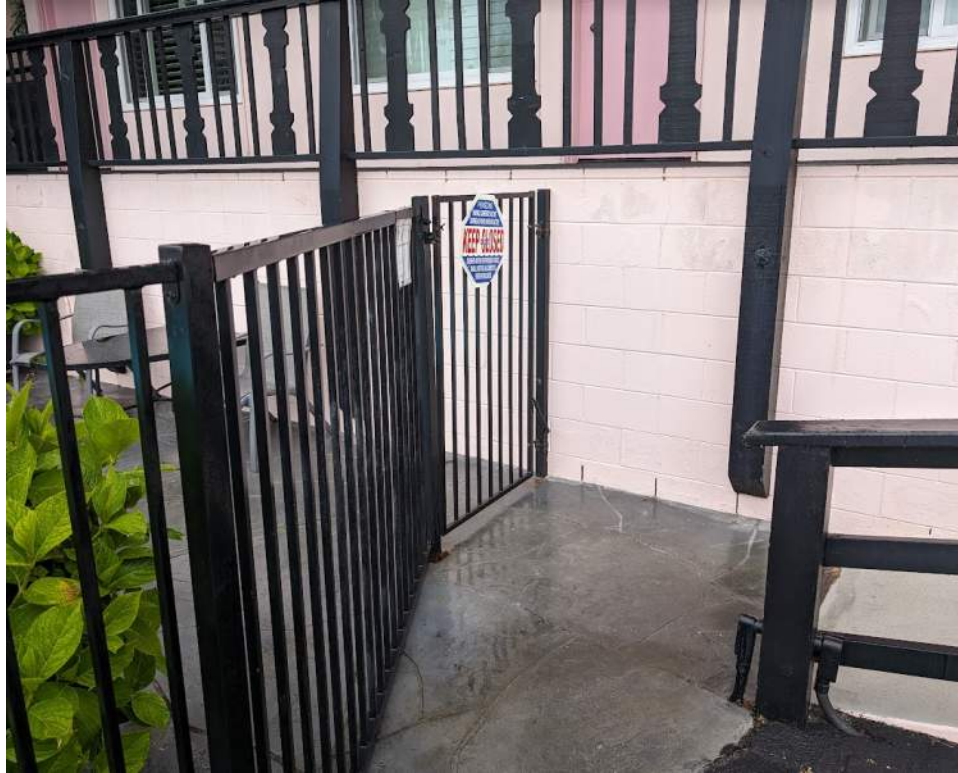
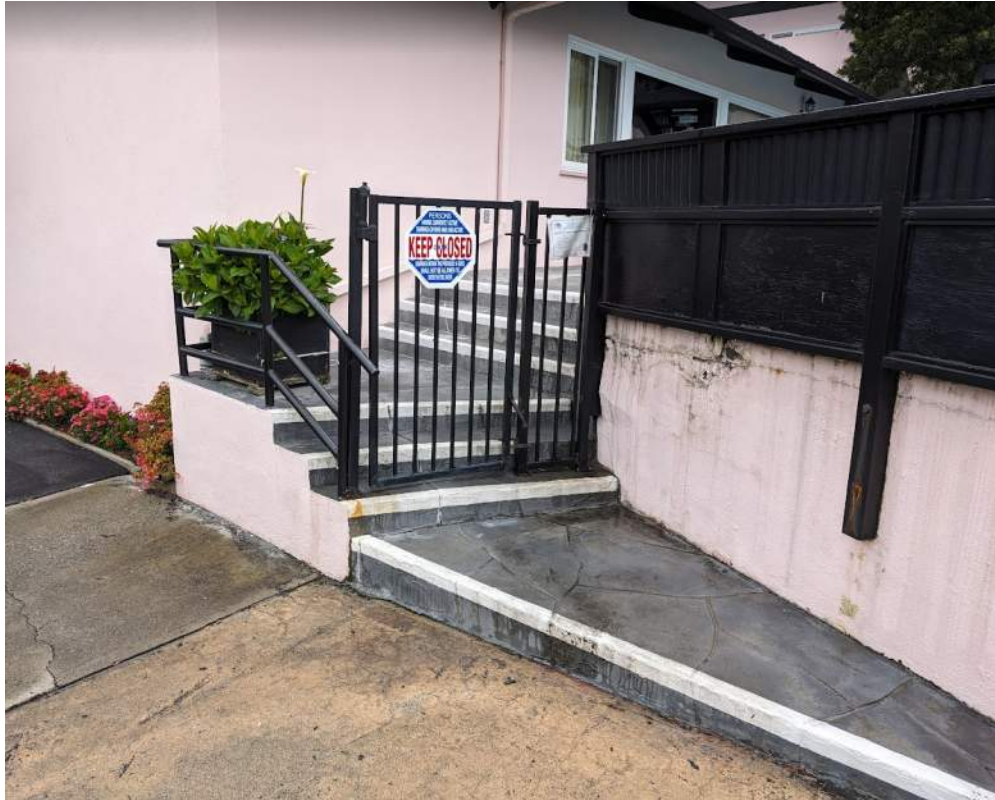
- 5.4 Pool Accessibility: A heated swimming pool amenity is located adjacent to the lowest parking area. An accessible lift is provided in order to enter the pool itself. To enter the pool area, a gate is located at the southeast corner. The gate latch is located at the top of fence and the area immediately outside of the gate lacks the required landing space. A gate is also located at the northwest corner of the pool area; the gate is located on a run of stairs, without adequate clearances around the gate or at either the top or bottom of the stair run. In addition, the deck area around the pool has areas which exceed 2%. To provide accessibility to the pool area, the southeast gate would need to be replaced, the landing area would need to be expanded, detectable warning would need to be added to separate the pedestrian zone from the parking lot, and the pool deck would need to be re-graded to provide level access.

Figure 17 – Southeast Pool Entrance

Figure 18 – Northwest Pool Entrance

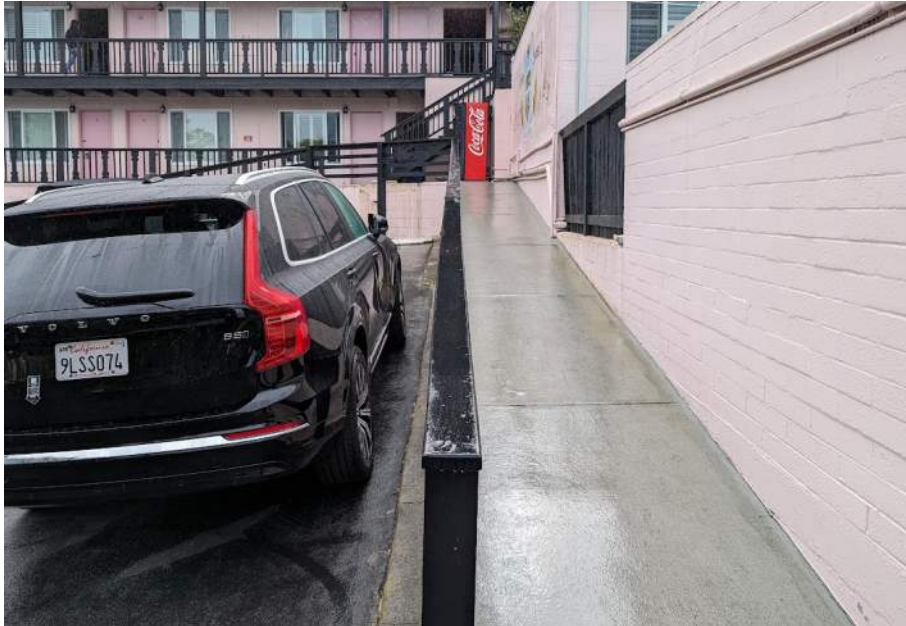
Figure 19 – Pedestrian Ramp

- 5.5 Non-Accessible Pedestrian Ramps: Pedestrian ramps are located in the lowest parking area, connecting parking and the pool area with the lowest level of rooms in the main building. The ramps lack detectable warning at the interface with the parking lot. The ramps lack appropriate handrails. The ramp slopes exceed 8.33%, and no intermediate landings are provided where the elevation change exceeds 30". All of these deficiencies would need to be corrected in order to provide accessibility. Given the total elevation change between the parking lot/pool and the building level, the ramp lengths would need to be extended. It is unclear if space is available for the extended length to be accommodated.

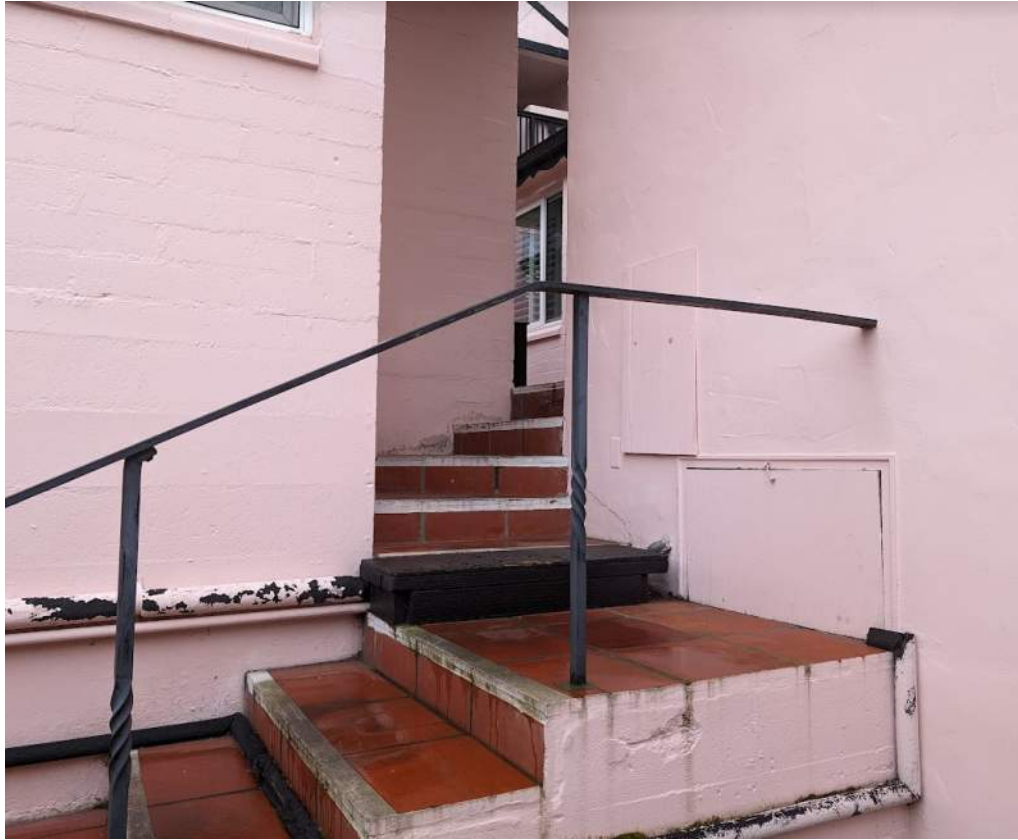
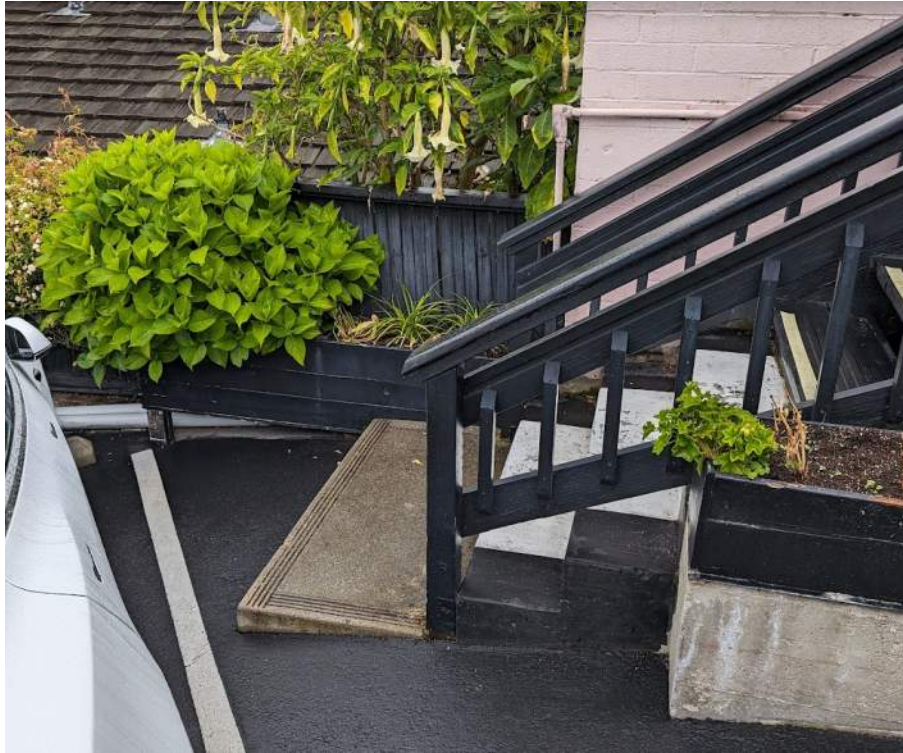
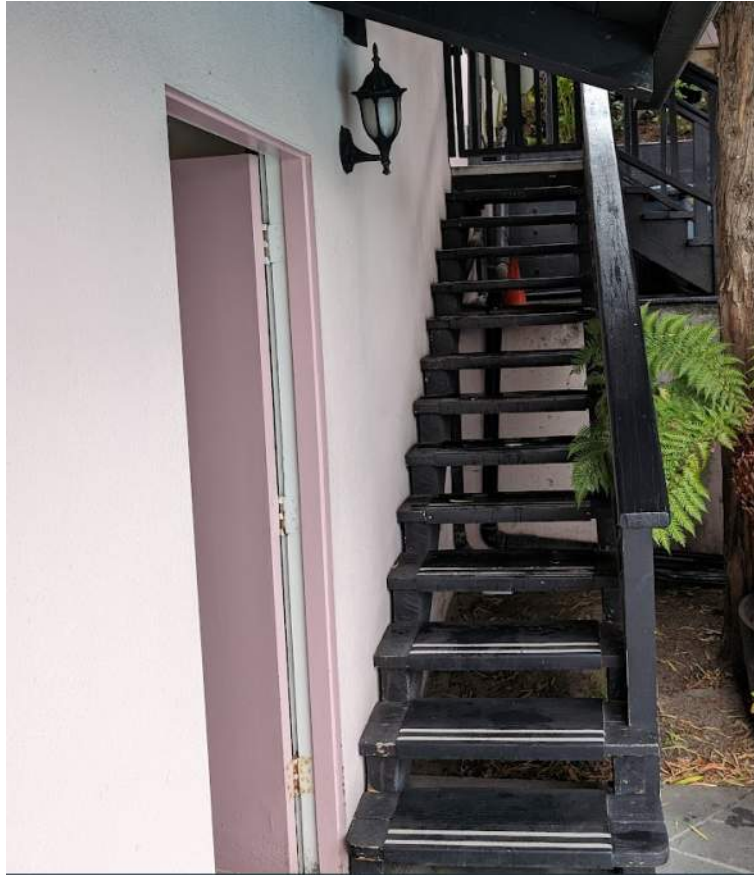
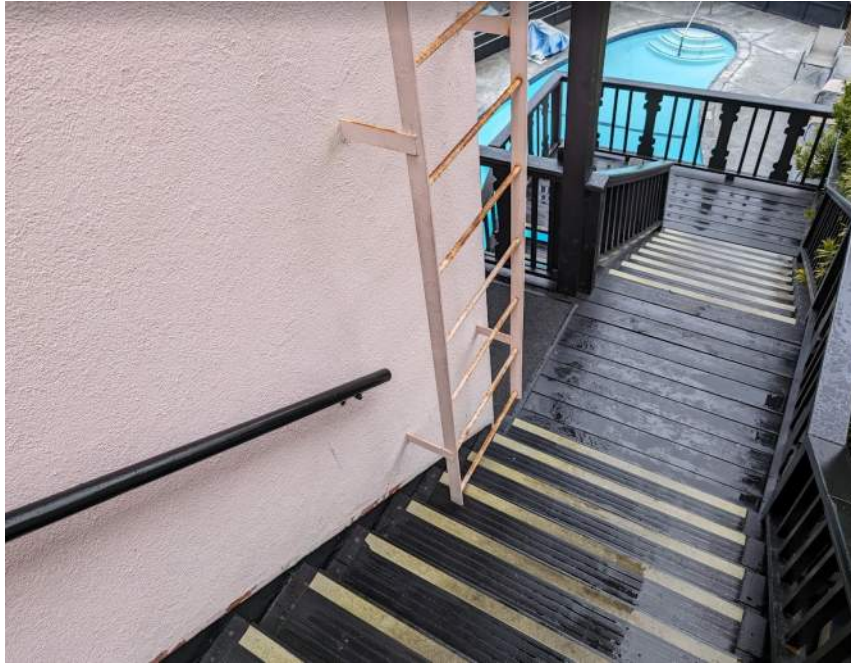
- 5.6 Site Stairs: Given the elevation change across the site, the multiple stories of guestrooms, and the lack of interior corridors, site stairs are provided throughout the site. With the exception of stairs constructed as a part of the 1957 building, numerous issues were identifiable across the approximately dozen stairs observed on-site. In general, all stairs lacked handrails with appropriate gripping areas; handrails were frequently only provided on one side of the stairs; handrails did not extend sufficiently beyond the length of the stair run. In addition, a stair located at the north end of the main building, extending down from San Carlos St, has a handrail obstructed by an emergency fire access ladder from a higher level.

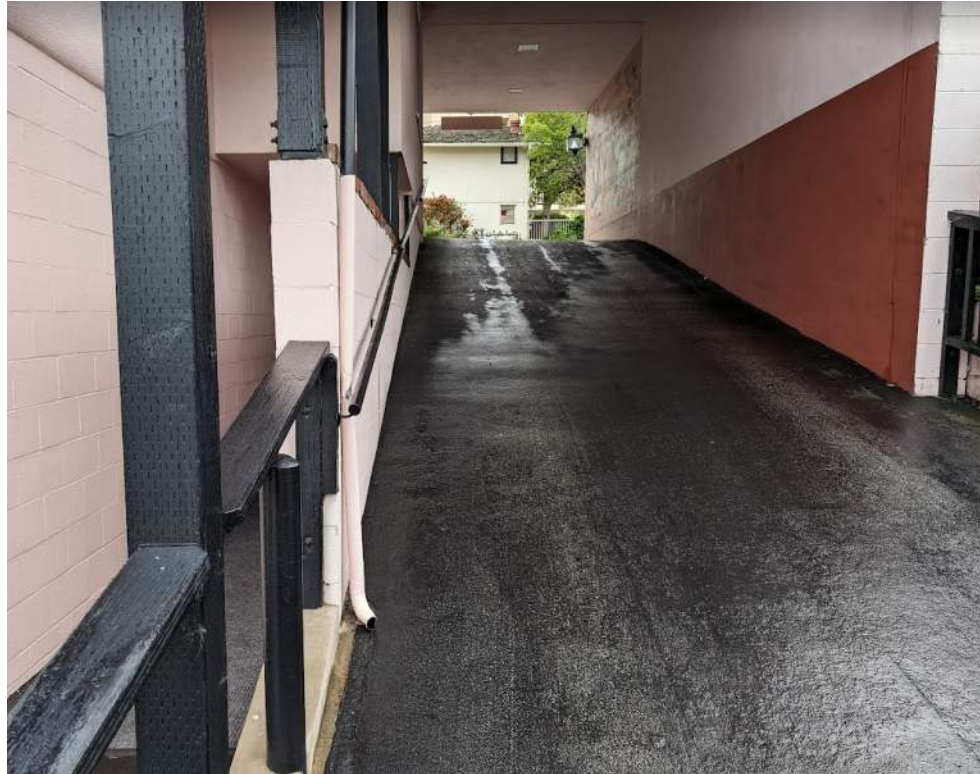
Figure 23 – Ramp at Primary Entrance Driveway

- 5.7 No Pedestrian Egress to Public Right-of-Way: Site users in the off-site parking lot and at the pool amenity have no egress path to the public right-of-way. In order to reach San Carlos St, a user would need to either walk up a steep driveway on either side of the site, or use various runs of stairs. An accessible path, separated from the driveway is needed from these lower site areas. The accessible path would need to be separated from the vehicular areas with a curbed walkway, likely with handrails. The walkway would likely require significant grading improvements and potential retaining walls; it may also severely impact vehicular access around the site.

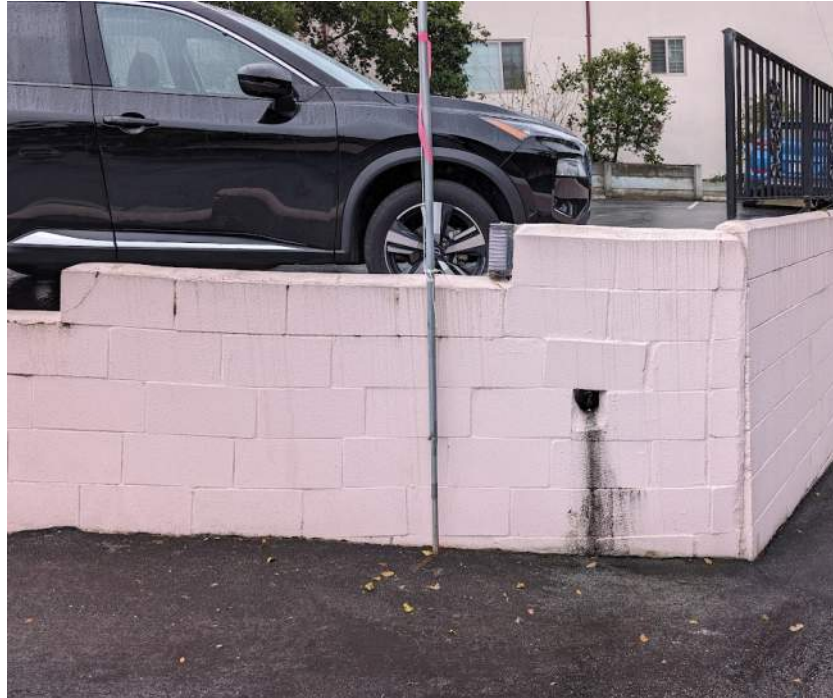
Figure 24 – CMU Retaining Wall

- 5.8 CMU Retaining Wall, Potential Movement: A CMU retaining is located at the southwest area of the site, supporting a parking lot for hotel users. The primary CMU retaining wall, located in the north-south orientation appears to be in good condition. The shorter CMU retaining wall, returning east-west and varying in height from approximately 4-feet high to flush appears to be out of plumb. The foundation of the wall is not observable, but it appears that the wall may be sliding and needs to be replaced/improved.

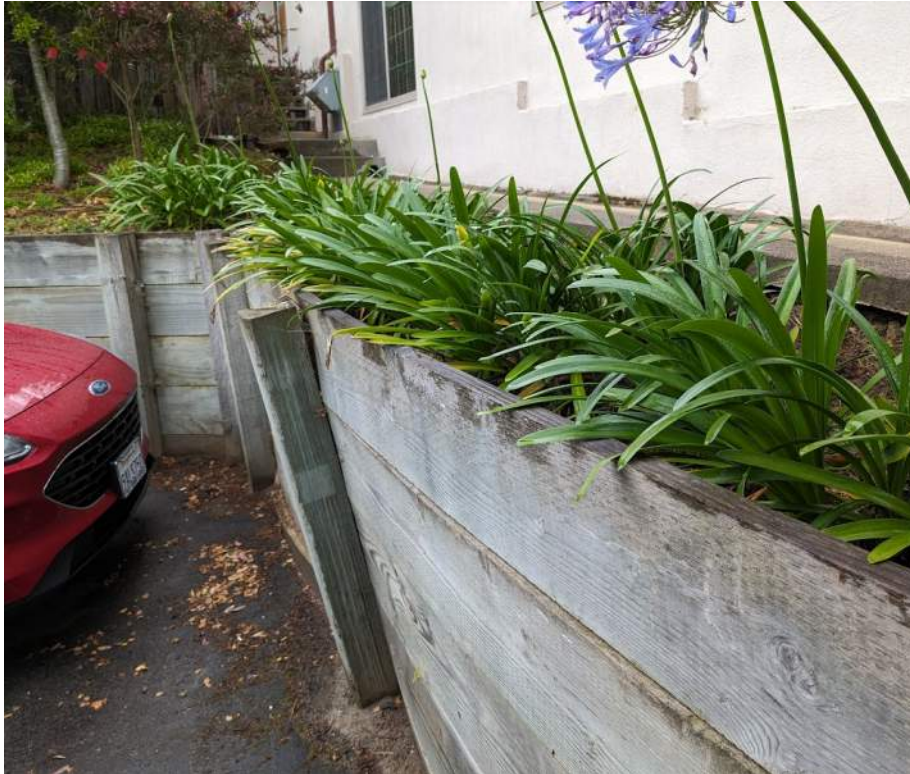
Figure 25 – Wood Retaining Help

- 5.9 Wood Retaining Wall, Structural Failure: Wood retaining walls are located around the parking at the southwest corner of the site. The parking lot is located lower than the adjacent site improvements. The wood retaining walls generally support landscape areas, with some concrete improvements. The wall is constructed of 2x12 planks with 6x6 posts spaced at 8' on center. Where the wall is the highest, approximately 4-feet, the wall is beginning to fail with planks being bowed out and posts beginning to rotate. Wall replacement is likely needed.

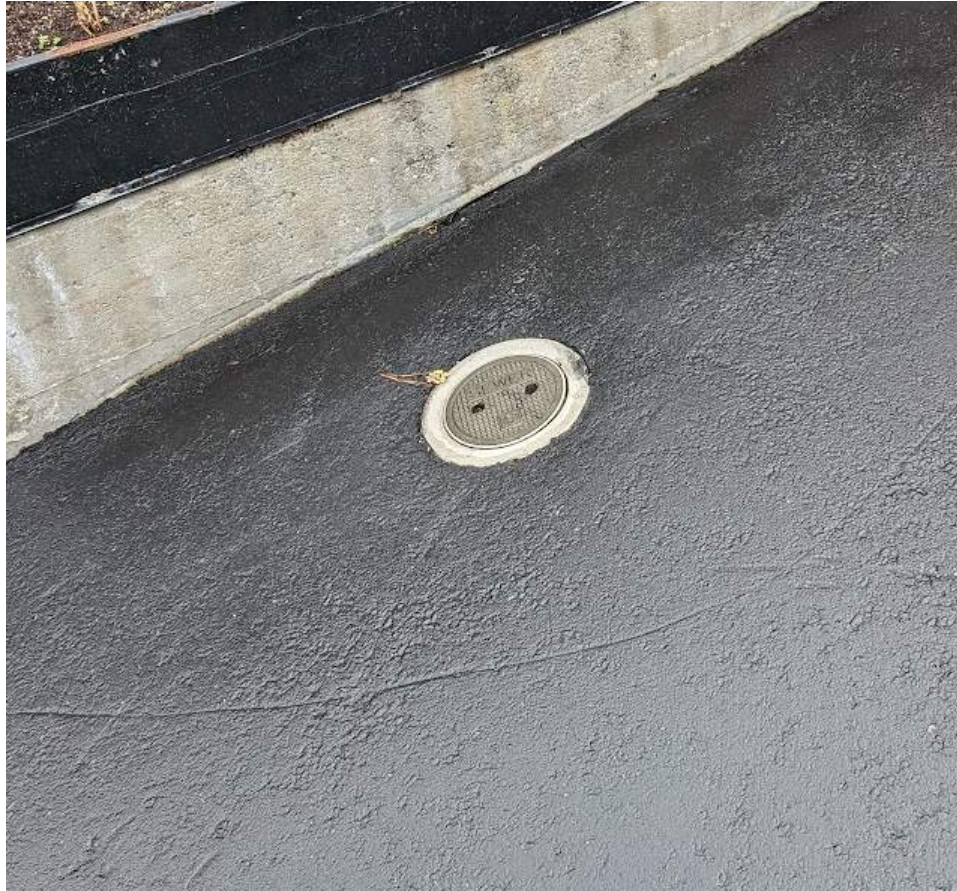
Figure 26 – Sanitary Sewer Cleanout

- 5.10 Sanitary Sewer Lateral: Relatively new sanitary sewer cleanout boxes were located throughout the parking lot at the rear of the site. Based on the cleanout box layout, it appears that sanitary sewer flows via gravity to Dolores Street. Given the appearance of the cleanout boxes and frequency of placement, we would expect that the sewer system may have been upgraded and is in relatively good condition. Further assessment could be done.

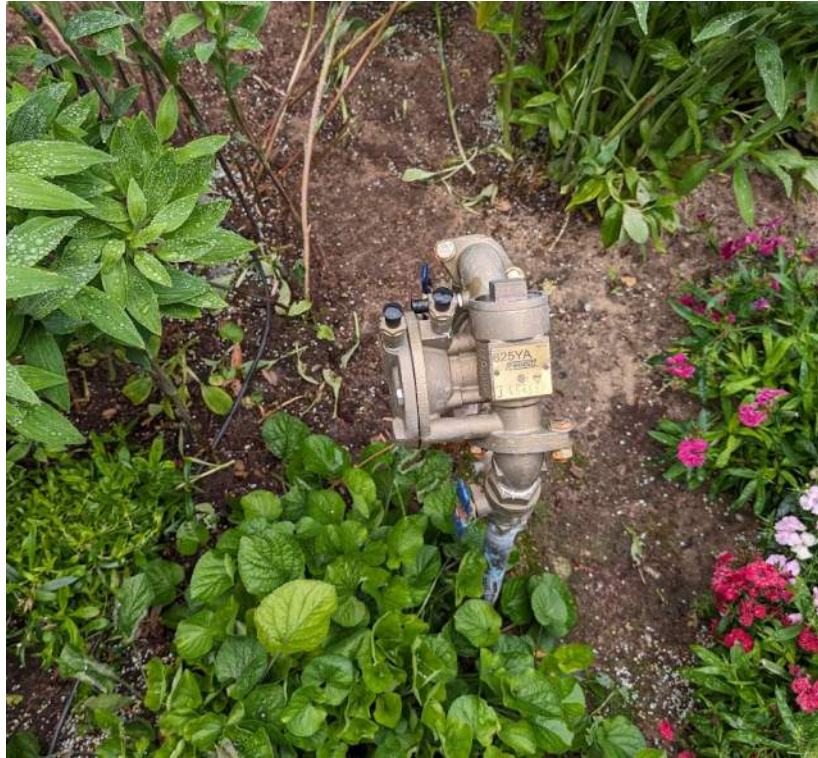
Figure 27 – Water Backflow Preventer

- 5.11 Domestic Water Service: Several water meters were identified along the frontage on San Carlos St, located inline with both the main building and the 1957 building. Backflow preventers were located on the domestic service lines. The backflow preventers appeared to be in good condition. No other observable notes on the water distribution.

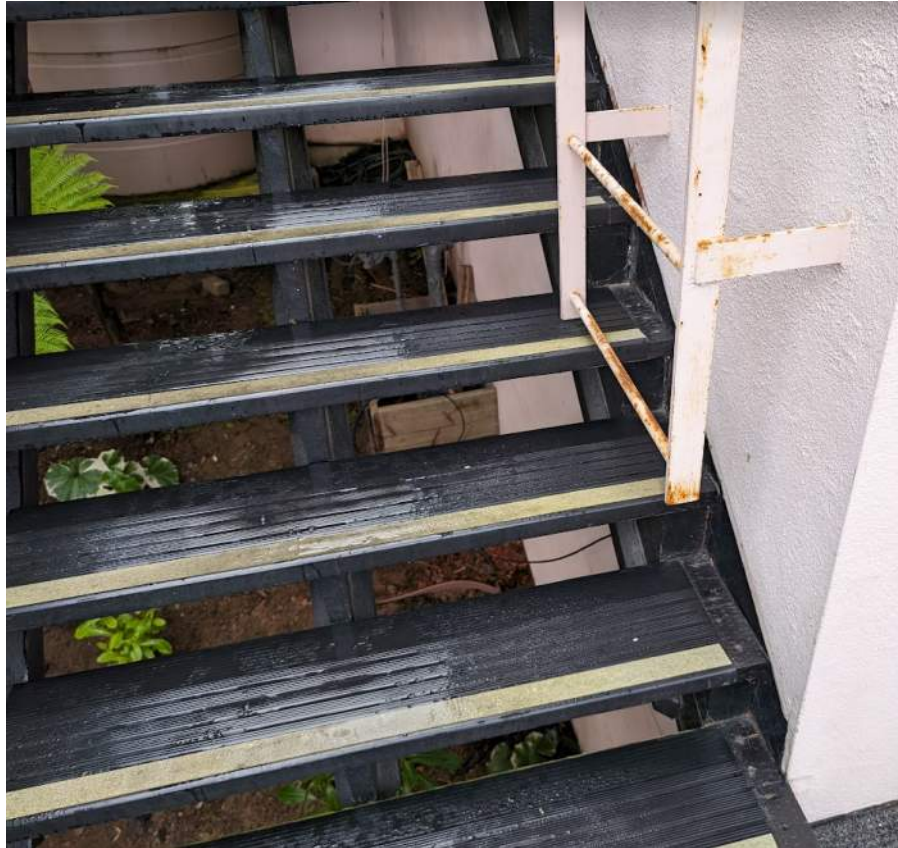
Figure 28 – Gas Meter Under Stairs

- 5.12 Gas Service Location, Limited Access & Ventilation: A gas meter was located on-site, in between the main building and the 1957 building. The gas meter is at a level that is approximately 2-stories beneath San Carlos St. The gas meter is located under site stairs, with limited access to the gas meter set. In addition, there are operable doors and windows located above the gas meter set. This location would not currently be acceptable by gas utility agencies and may pose a potential fire hazard if a gas leak leads to trapped gas.

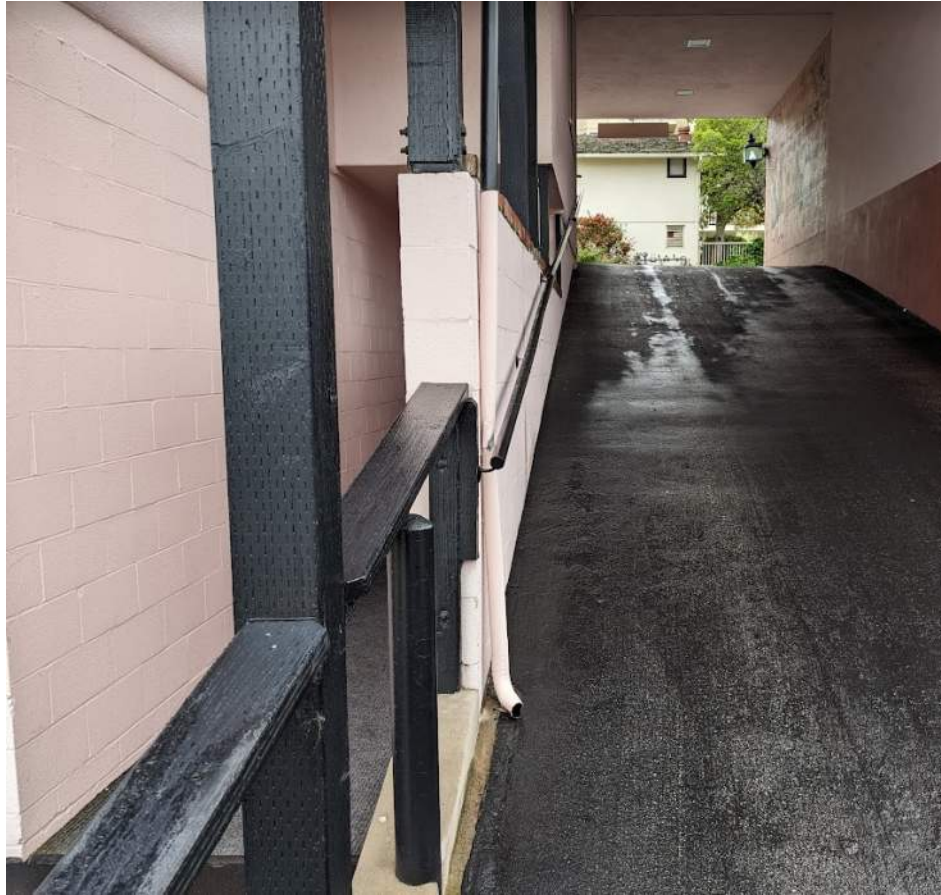
Figure 29 – Downspout onto Driveway

- 5.13 Disconnected Drainage System: As noted previously, the site experiences significant elevation change. The site is also generally paved. During our site visit, the site was wet but did not display any clear indication of drainage issues. With that said, the majority of roof downspouts are “disconnected” from the storm drain system – they are not directly piped but rather discharge onto pavement areas. Concentrated flow from downspouts are a hazard to pedestrians and cannot be done across pedestrian paths of travel. In the current site configuration, with limited pedestrian paths of travel, this is not a concern; however, it may be more of a concern requiring storm drain additions where pedestrian accessible improvements are added to correct previously noted issues.
