Date: 27 April 2023  
Client: City of Carmel  
Subject: Carmel Beach Coastal Protection Assessment  
Reference: Carmel Beach Adaptation Plan  
Project No.: 12176

## CARMEL BEACH COASTAL PROTECTION ASSESSMENT REPORT

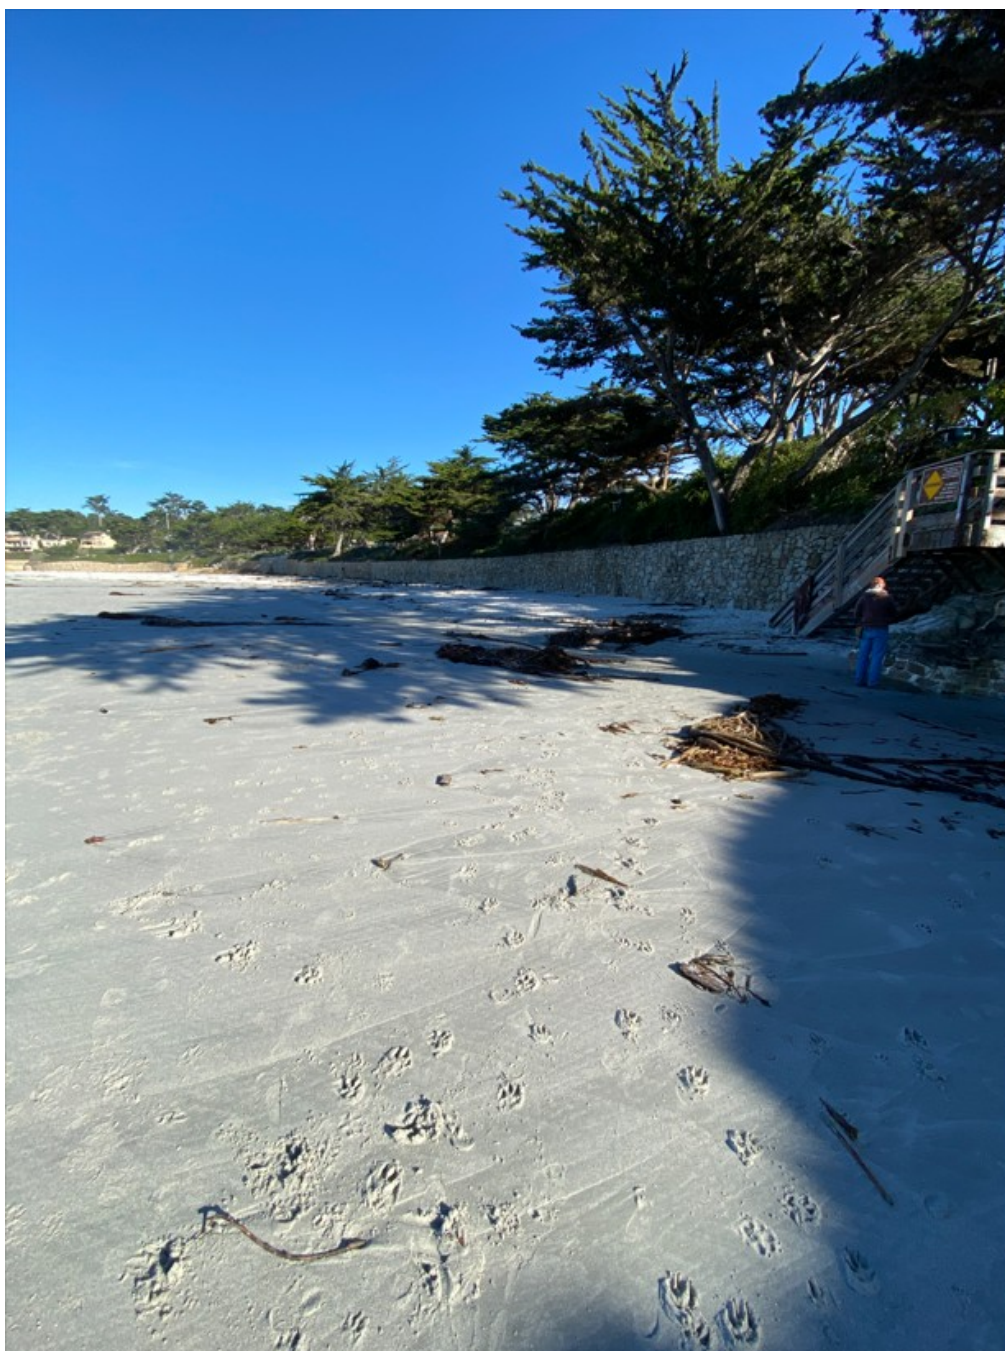
**Photograph 2: Unnamed shotcrete between S1 and S2 on December 22, 2022**

Photograph 2 shows some shotcrete or gunite fascia exists on the bedrock portion of the coastal bluff face between S1 and S2 (where located on the map contained in Appendix B) north from the Frank Lloyd Wright home on December 22, 2022. Its age, origin, and position relative to the boundary between the privately owned and publically owned upland parcel's common boundary line is unknown. It looks to be in good condition.

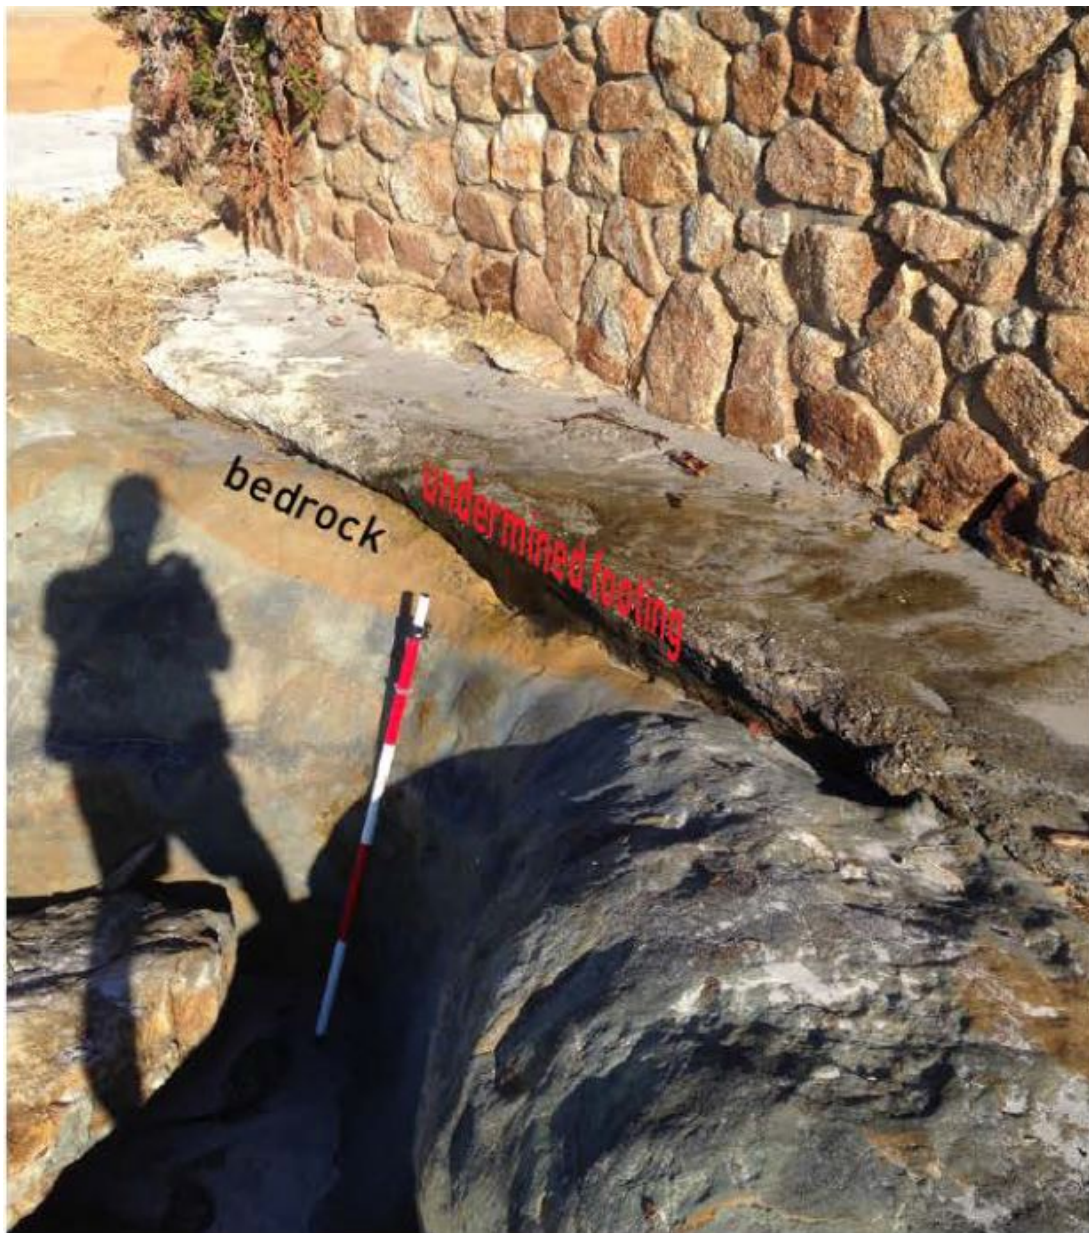
Photograph 11 shows an area at the northern end of Seawall S2 on December 22, 2022, where the edge of the seawall footing is exposed and it has been slightly undermined. Easton Geology inspected this location as well. Photograph 12 (below) is an Easton Geology photograph of the north end of Seawall S2 showing it was undermined in 2016. Comparison of that photo with the 2022 photo (above) shows there has been very little change in the conditions; there has been no continued undermining during that 7 year period. It is likely that this area was buried in beach sand during most of those 7 years; when the bedrock supporting the footing is buried, wave action does not contact the bedrock and no erosion or bedrock retreat occurs under the footing.

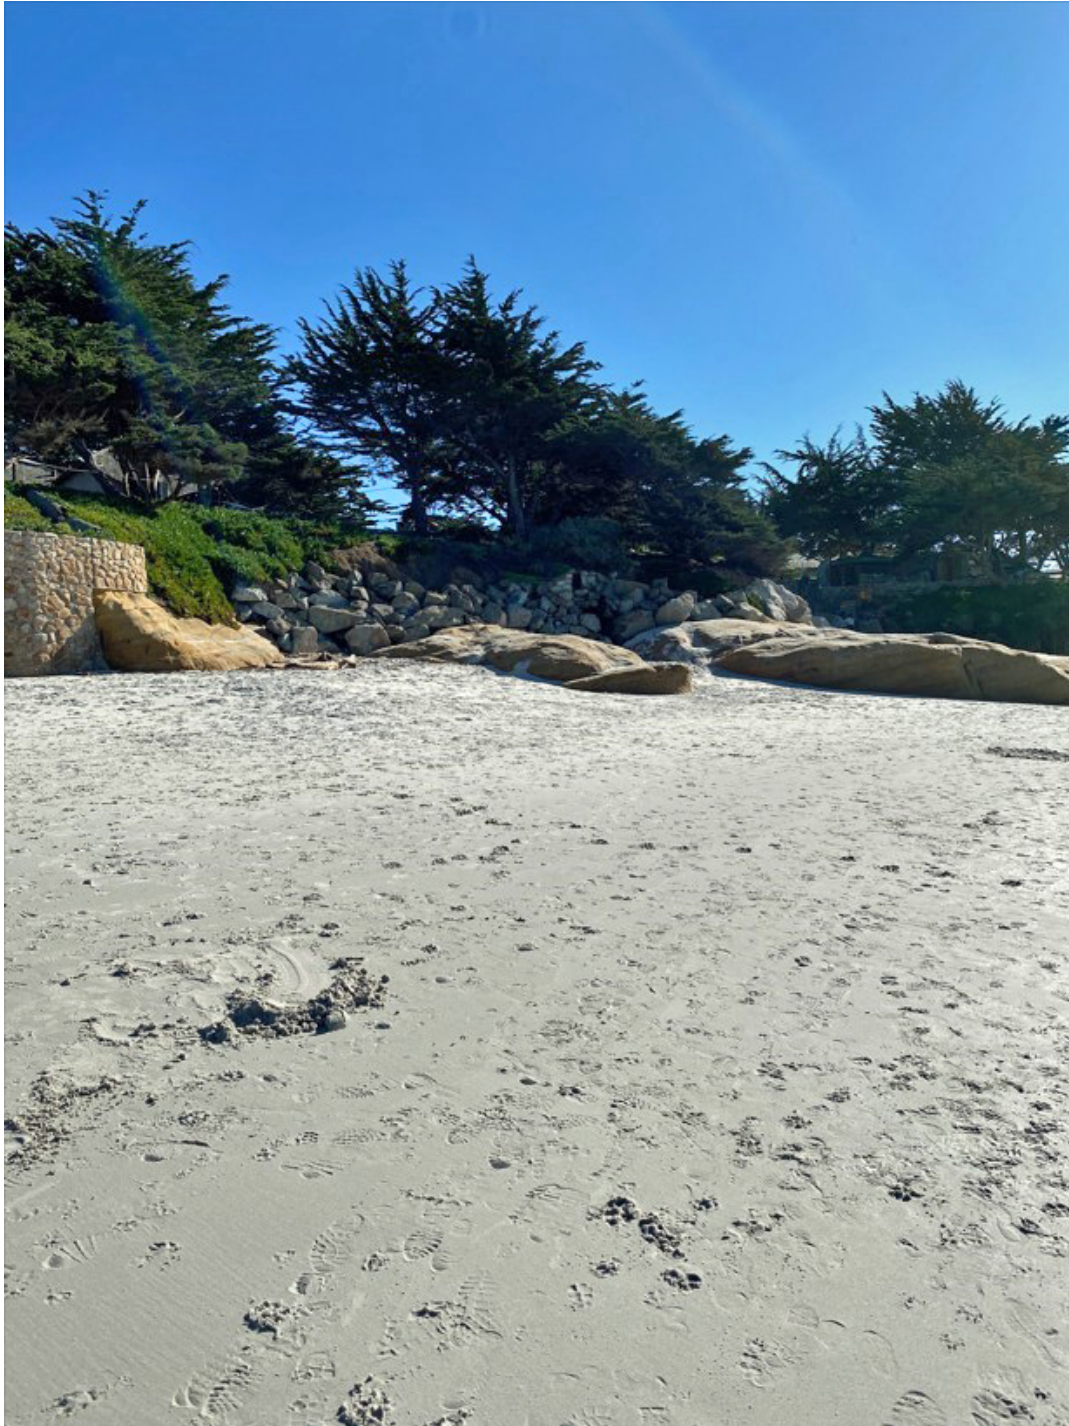
**Photograph 15: Showing Revetment R1 and Stairway ST2 on January 30, 2023**

Photograph 15 shows Revetment R1, which is located between Seawalls S2 and S3, and shows Stairway ST2 during our January 30, 2023 inspection after severe ocean storms occurred in January 2023 and it was still buried by beach sand. Whenever it is next exposed by natural beach sand scour processes, it should be inspected. That may not be for a decade but could be possible this winter. The estimated life of Stairway ST1 is 30 years or more. The south railing is bent from floating log impact. This does not pose a substantial risk to users of the stairs. We rank the repair as a low priority.

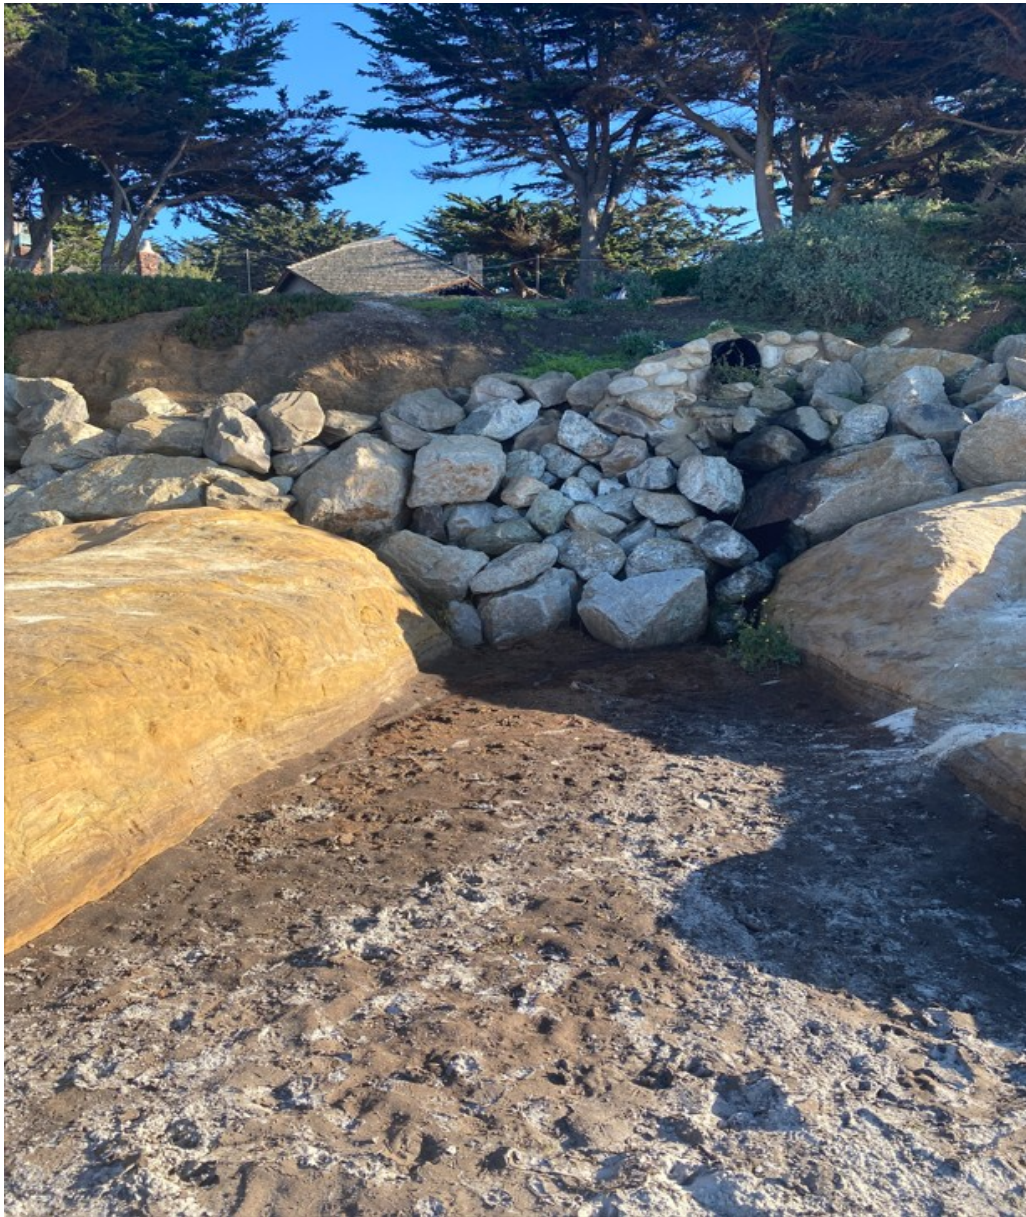
Photograph 17 shows the southern end of Revetment R1 on December 22, 2022, which consists of oversteep riprap, making it relatively unstable. One displaced boulder (a "fugitive" rock) can be seen poking out of the beach sand seaward of the revetment. Historic instability and the use of undersized boulders to construct this revetment have caused cavities to develop in the revetment and have diminished the erosion protection it provides. We recommend the holes in the revetment structure be filled and the 1 to 4 ton rocks be restacked. It is presently unsafe.

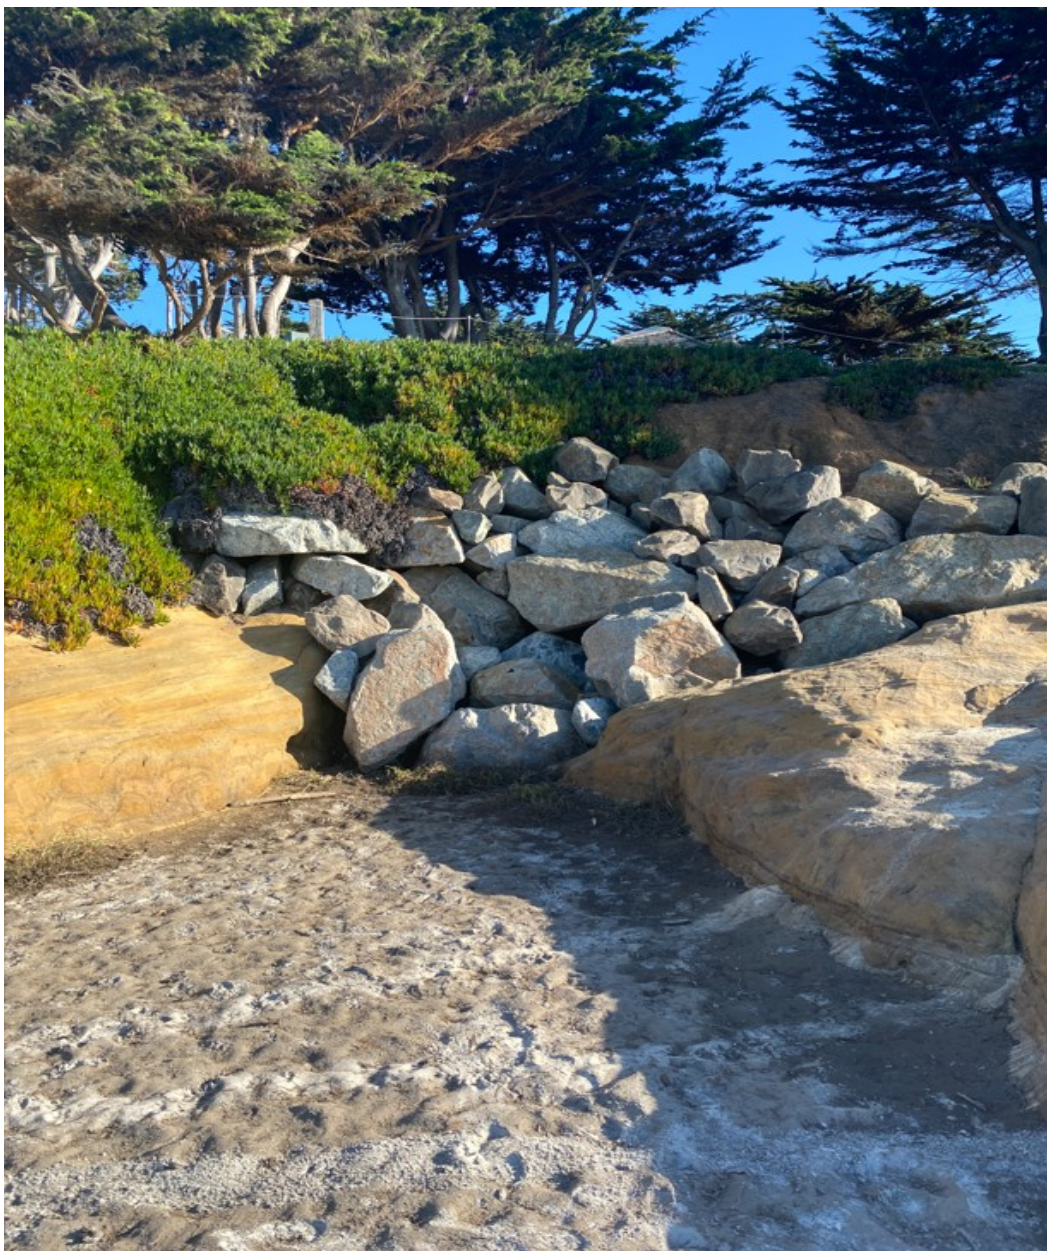
**Photograph 18: Revetment R1 Showing Undersized Overly Steep Riprap on December 22, 2022**

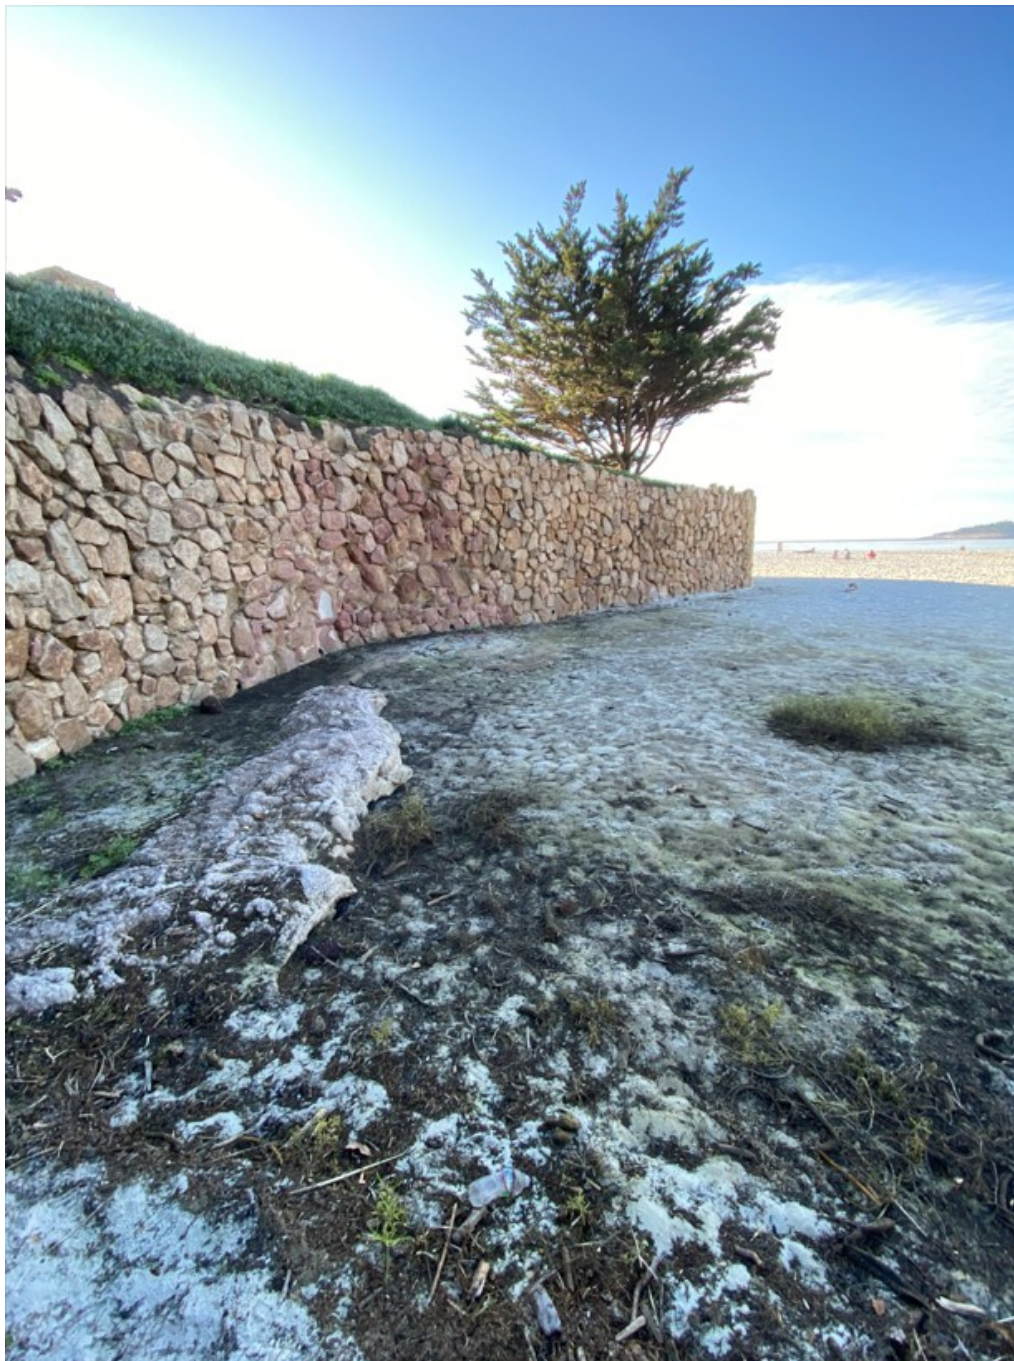
**Photograph 21: Very Southern End of Seawall S3 on December 22, 2022**

Photograph 21 shows Seawall S3 where it's foundation is founded on bedrock and steps upward at the very southern end of Seawall S3, which is located near 13th Avenue, on December 22, 2022. A vertical crack, which appears to be a shrinkage crack or expansion crack, is visible, but is not of concern.

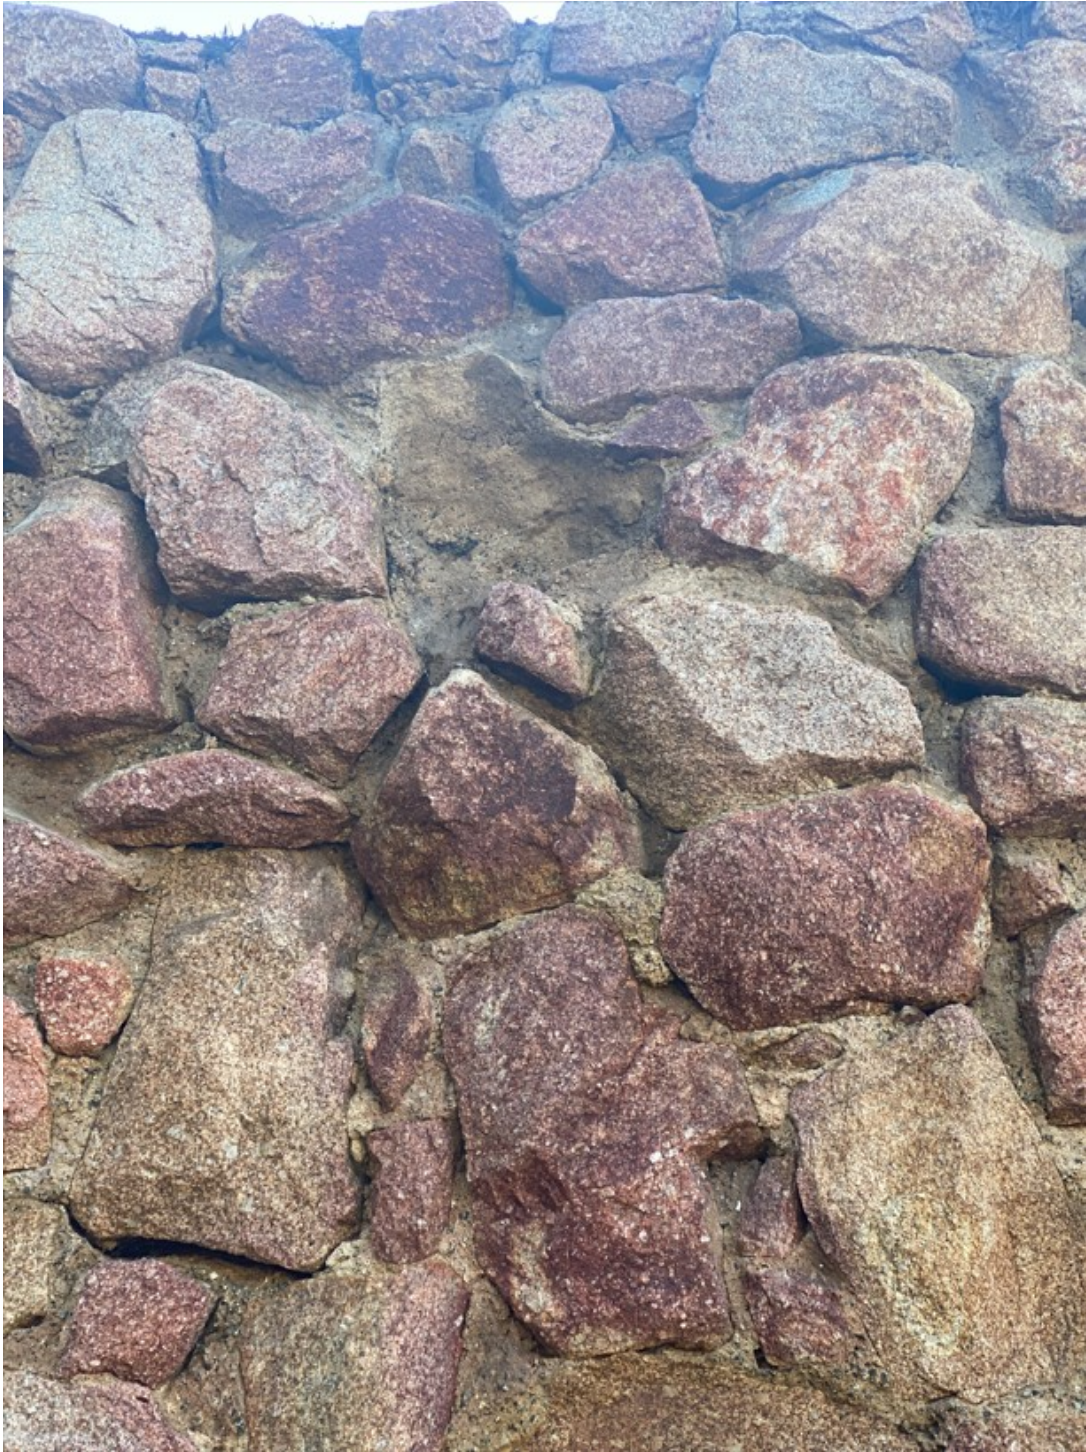
**Photograph 25: Looking North at Seawall S3 on December 22, 2022**

Photograph 25 is looking north along Seawall S3 on December 22, 2022. At that time the seawall foundation was buried by beach sand, which is normal. After severe ocean storms in January 2023, we revisited this location and it was still partially buried by beach sand. This seawall, including the portion of the foundation we were able to inspect, appears to be in satisfactory condition. Whenever it is next exposed by natural beach sand scour processes, it should be inspected. That may not be for a decade but could be possible during any winter. Except for the possible removal of some of the pumped concrete on the beach at the southern end, no repairs appear needed at this time, and the seawall does not pose any significant risks to beach users. This seawall appears to have more than 30 years of remaining life.

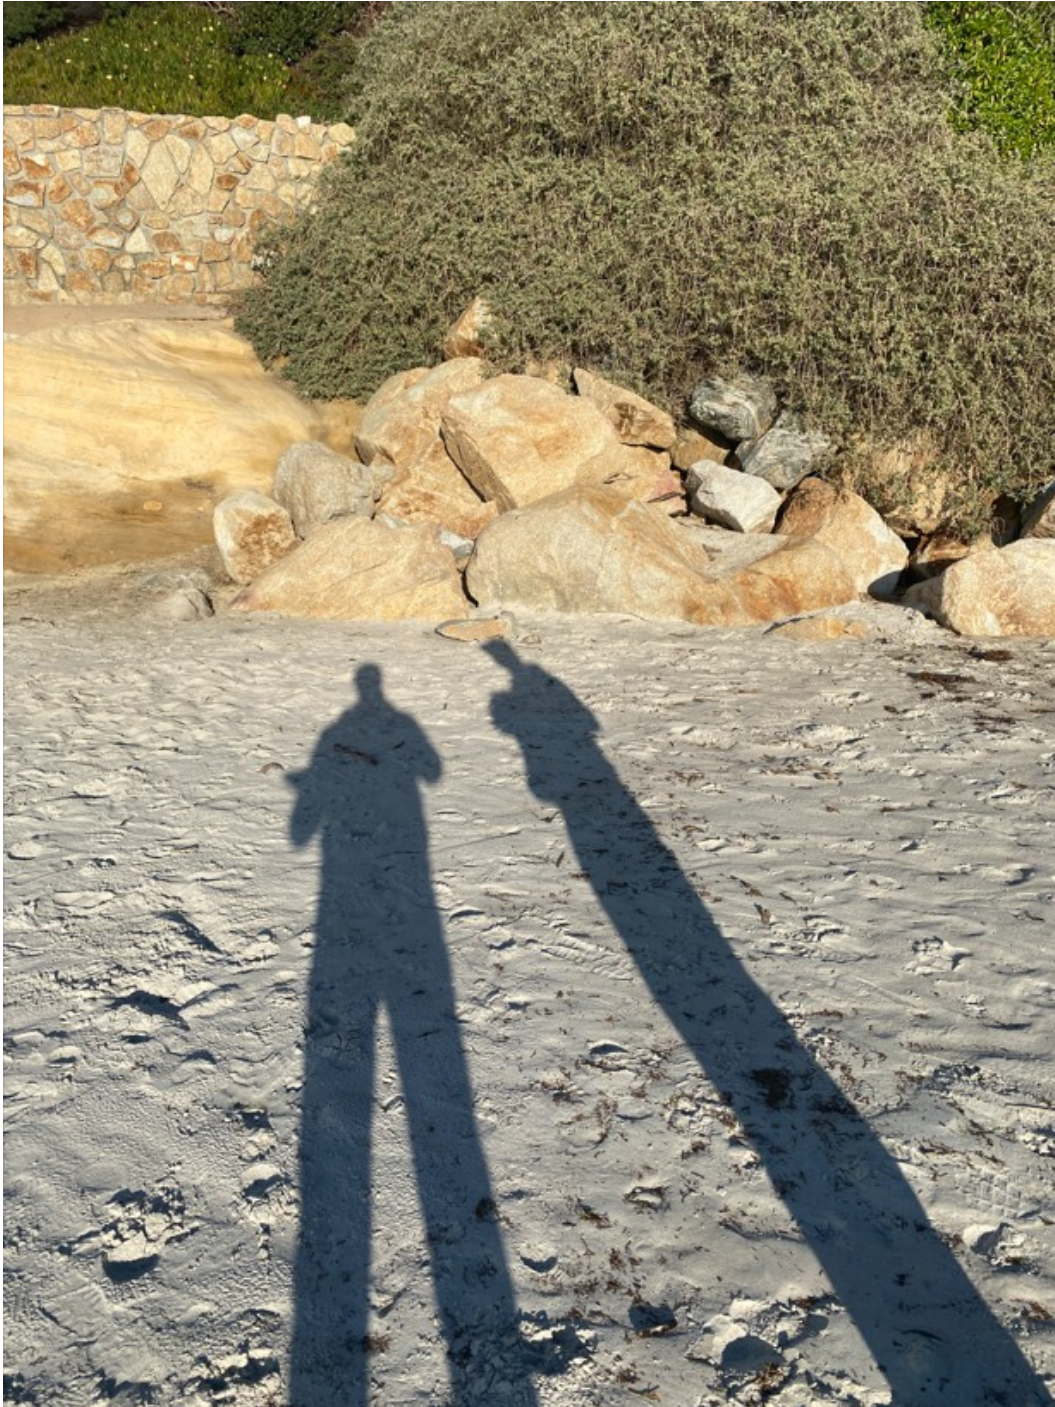
Photograph 33 shows the south end of Revetment R2 on December 22, 2022, which has some displaced fugitive riprap. The revetment surface gradient is not uniform and the coastal erosion protection this revetment provides could be improved from restacking the riprap boulders. Revetment R2 includes a large volume of undersized riprap, which is vulnerable to plucking from wave attack. Revetment R2 poses risks to beach users, and we recommend it as a high priority for repair. The base of the revetment was buried by beach sand during our inspections and so its condition is unknown. Whenever it is next exposed by natural beach sand scour processes, it should be inspected. That may not be for a decade but could be possible any winter.

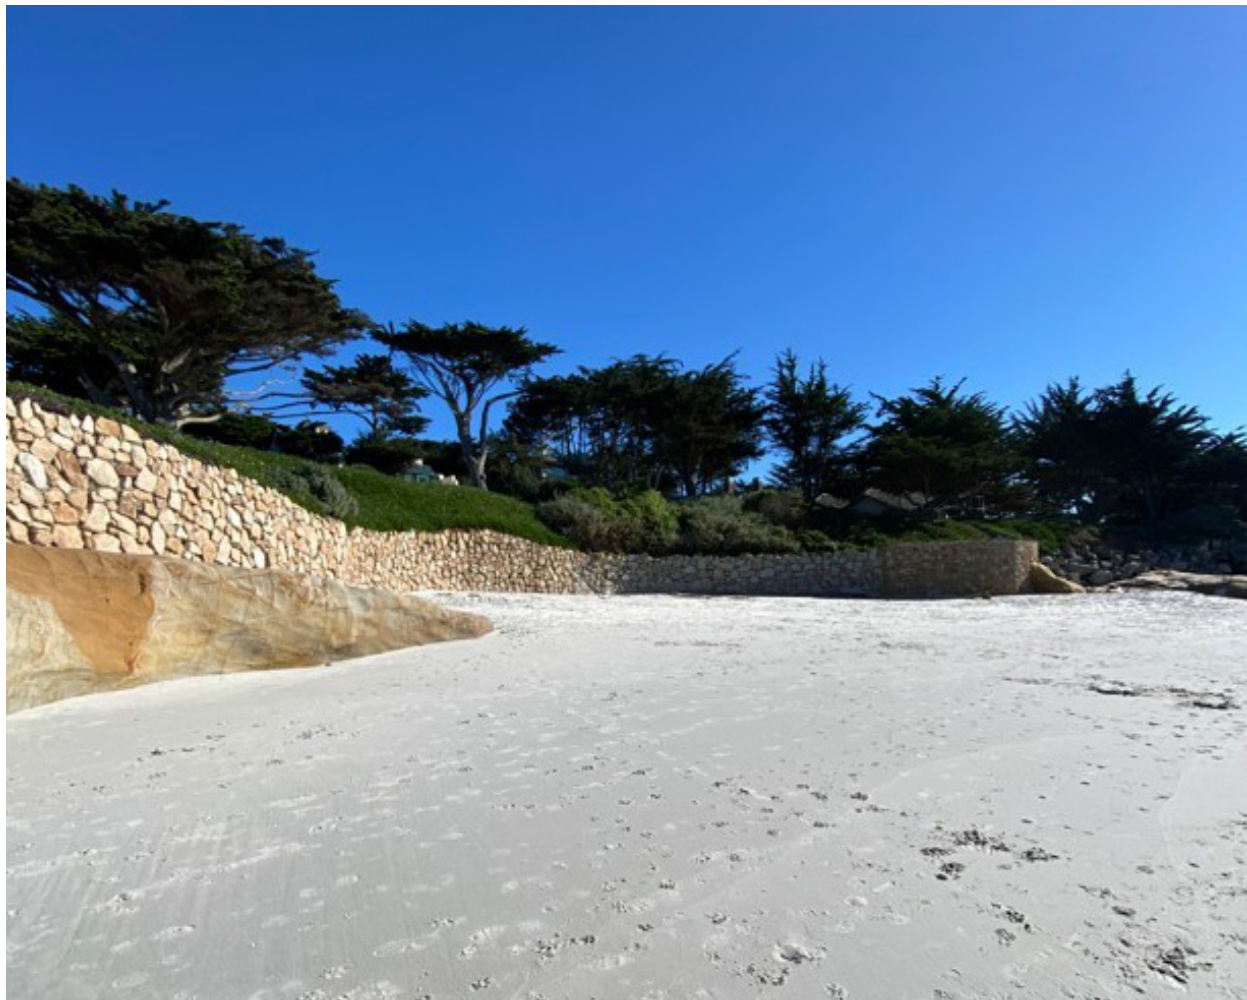
**Photograph 34: Showing North End of Revetment R2 on December 22, 2022**

Photograph 34 shows the north end of Revetment R2 on December 22, 2022,

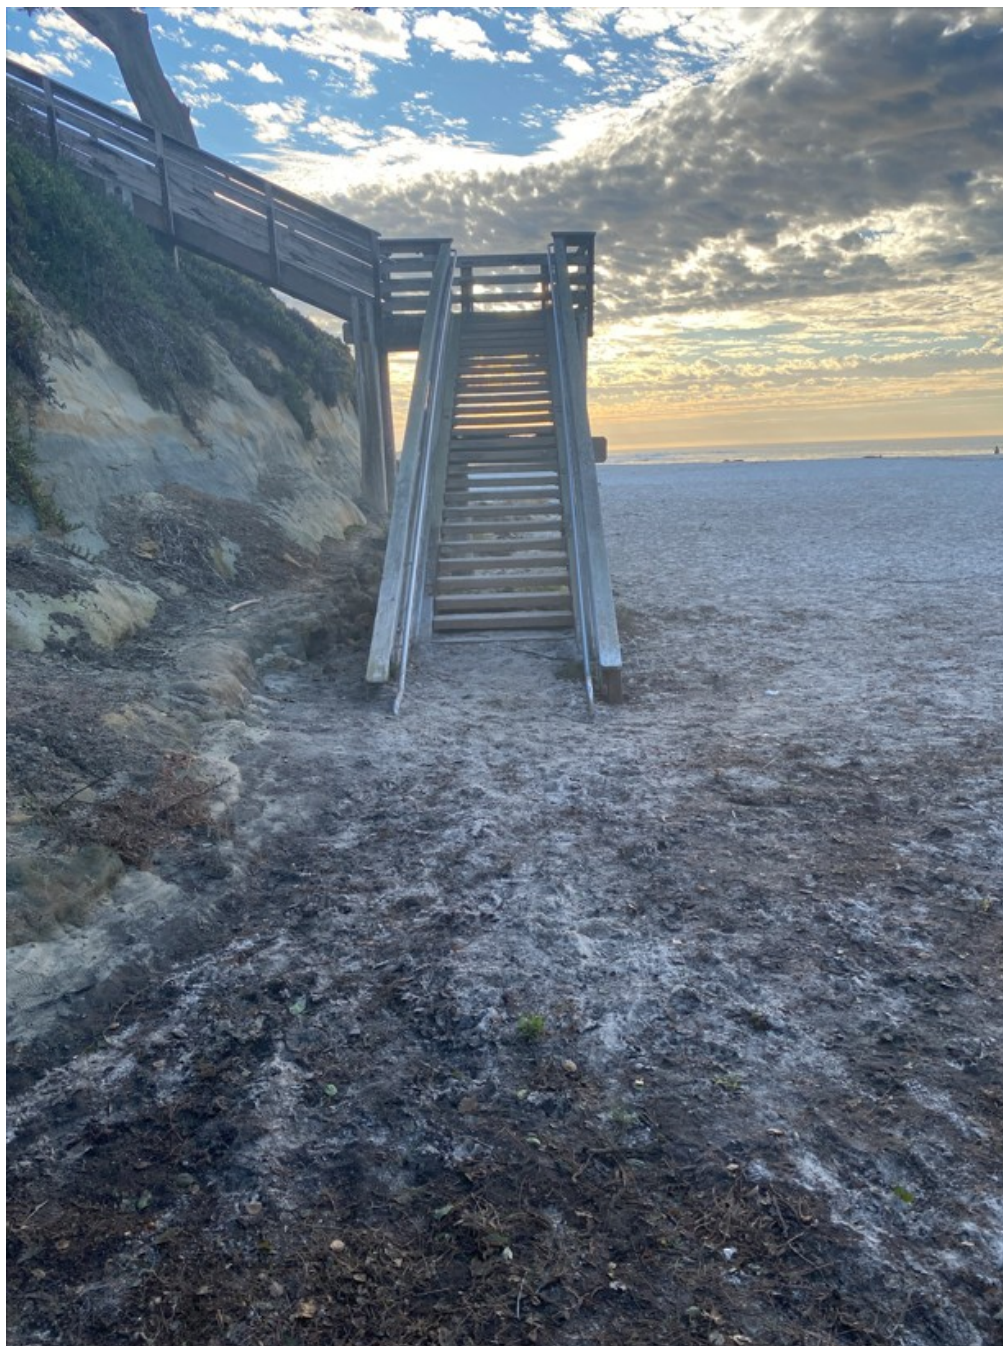
As shown in Photograph 40 (below) the foundation of Public Access Stairway ST4 was not exposed during either our December 2022 inspection or our January 2023 inspection. Whenever it is next exposed by natural beach sand scour processes, it should be inspected. That may not be for a decade but could be possible during any winter.

**Photograph 40: Showing Base of Stairway ST4 naturally buried in beach sand on December 22, 2022**

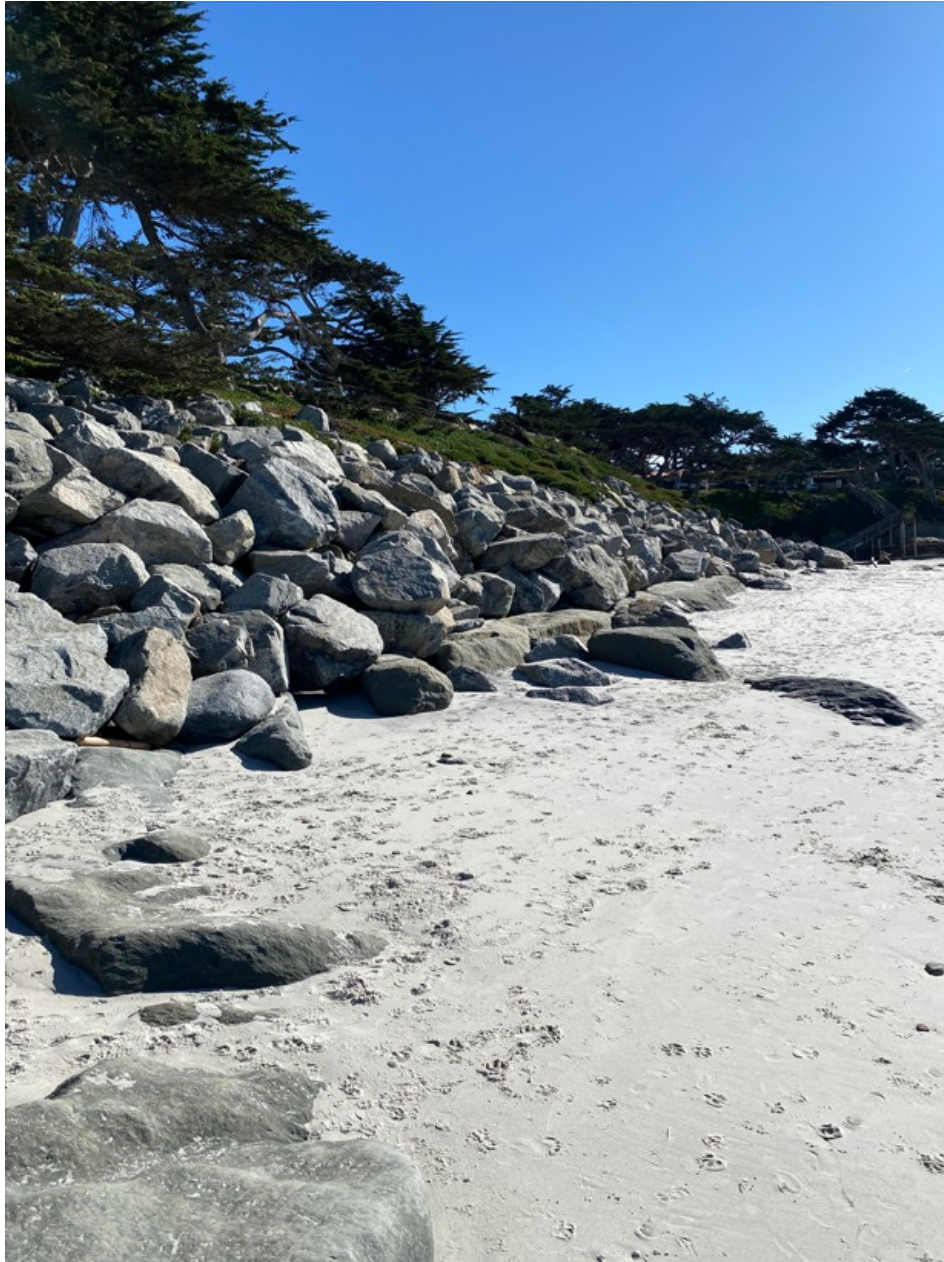
**Photograph 51: Showing the Middle Portion of Revetment R3 on January 30, 2023**

Photograph 51 shows the middle portion of Revetment R3 with bearing support on the bedrock platform and on the outboard side of keyway, with the bedrock still providing lateral support of the toe of the structure, except in a couple locations. Two over-steepened sections could benefit from re-stacking, however, this riprap revetment is in good condition and performing well.

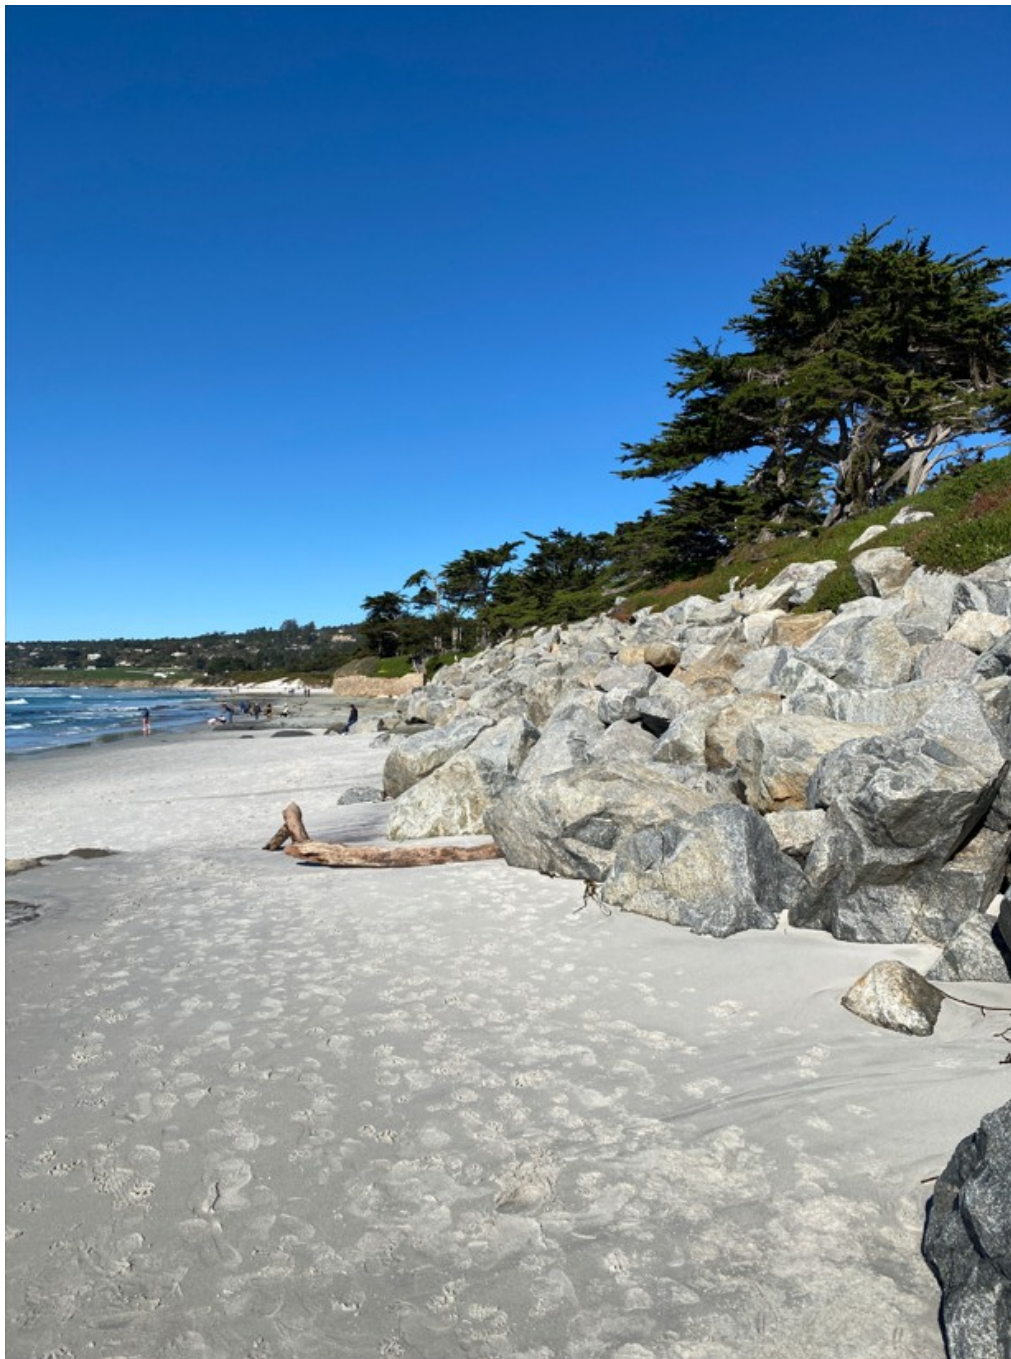
**Photograph 52: Showing Revetment R3 Looking North on January 30, 2023**

Photographs 51 and 52 show Revetment R3 looking north and south. The portion of R3 shown in Photograph 52 is in great condition.

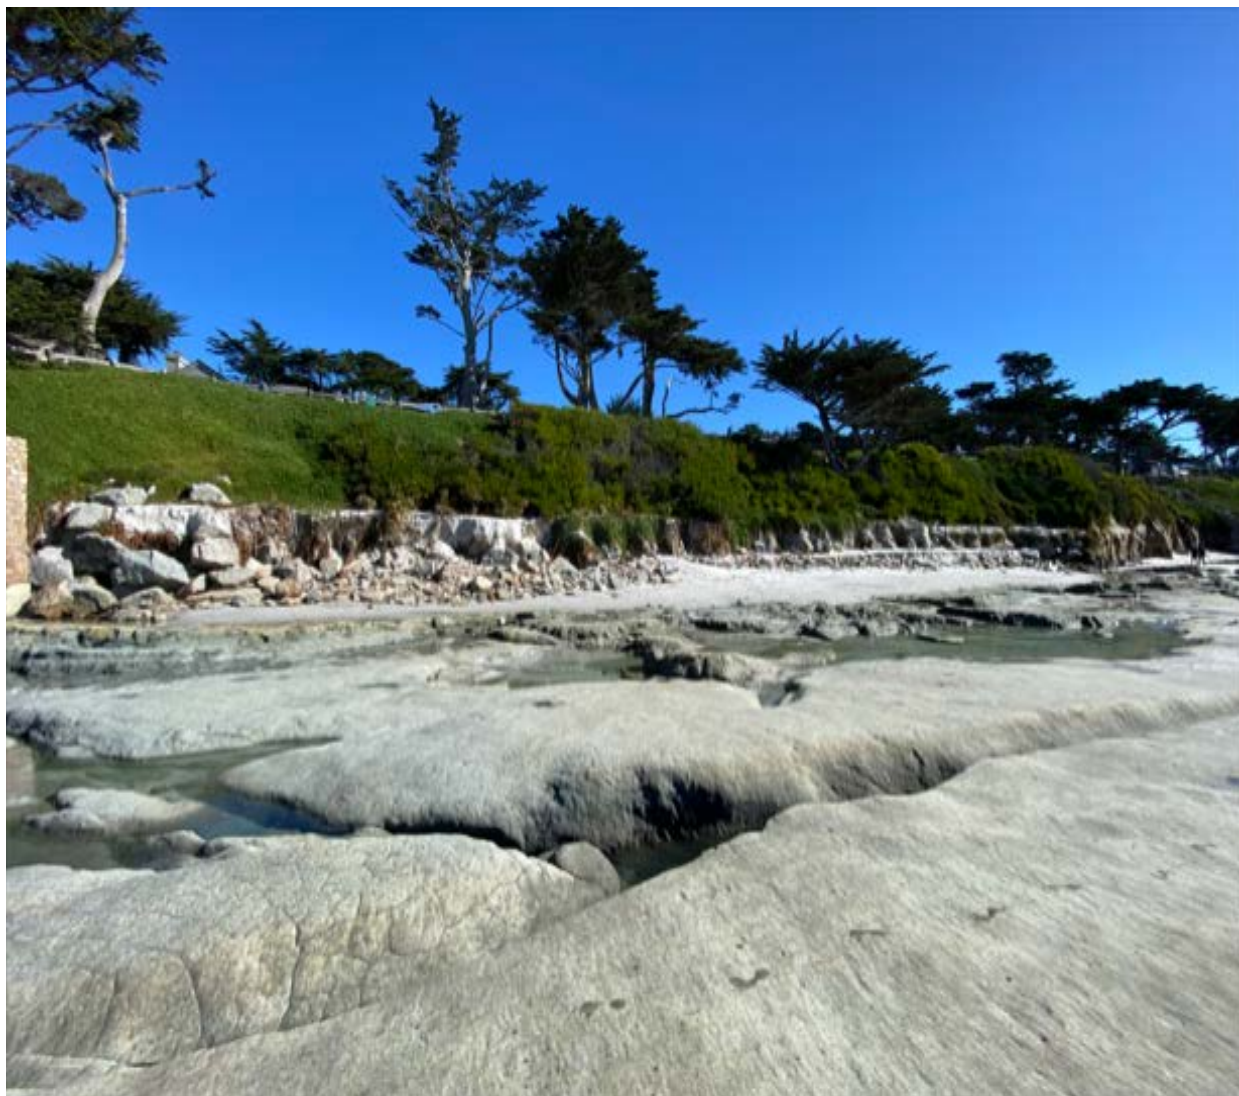
**Photograph 62: Northern 1/3 of Revetment R4 Showing Very Undersized Scattered Rock  
on January 30, 2023**

Photographs 61, 62 and 63 show Revetment R4, which is comprised of mostly undersized rock and broken concrete debris. The exposed portion of R4 where we observed substantially undersized scattered rock is approximately 225 feet in length and 8 to 10 feet tall. This structure has been undermined and has collapsed. Undersized riprap has been tumbling around in the wave action and is abrading the bedrock platform seaward of the riprap revetment structure toe. Future wave action could cause the steep slope below the path to slump, undermining the large cypress trees and public pathway along Scenic Road. A vertical concrete seawall at the toe of the bluff would be a preferred alternative here, as opposed to the riprap revetment structure, which requires more maintenance, and takes up a larger footprint.

We recommend that Revetment R4, which is composed of very undersized scattered rock be completely reconstructed or replaced with a vertical concrete seawall faced with rock fascia.

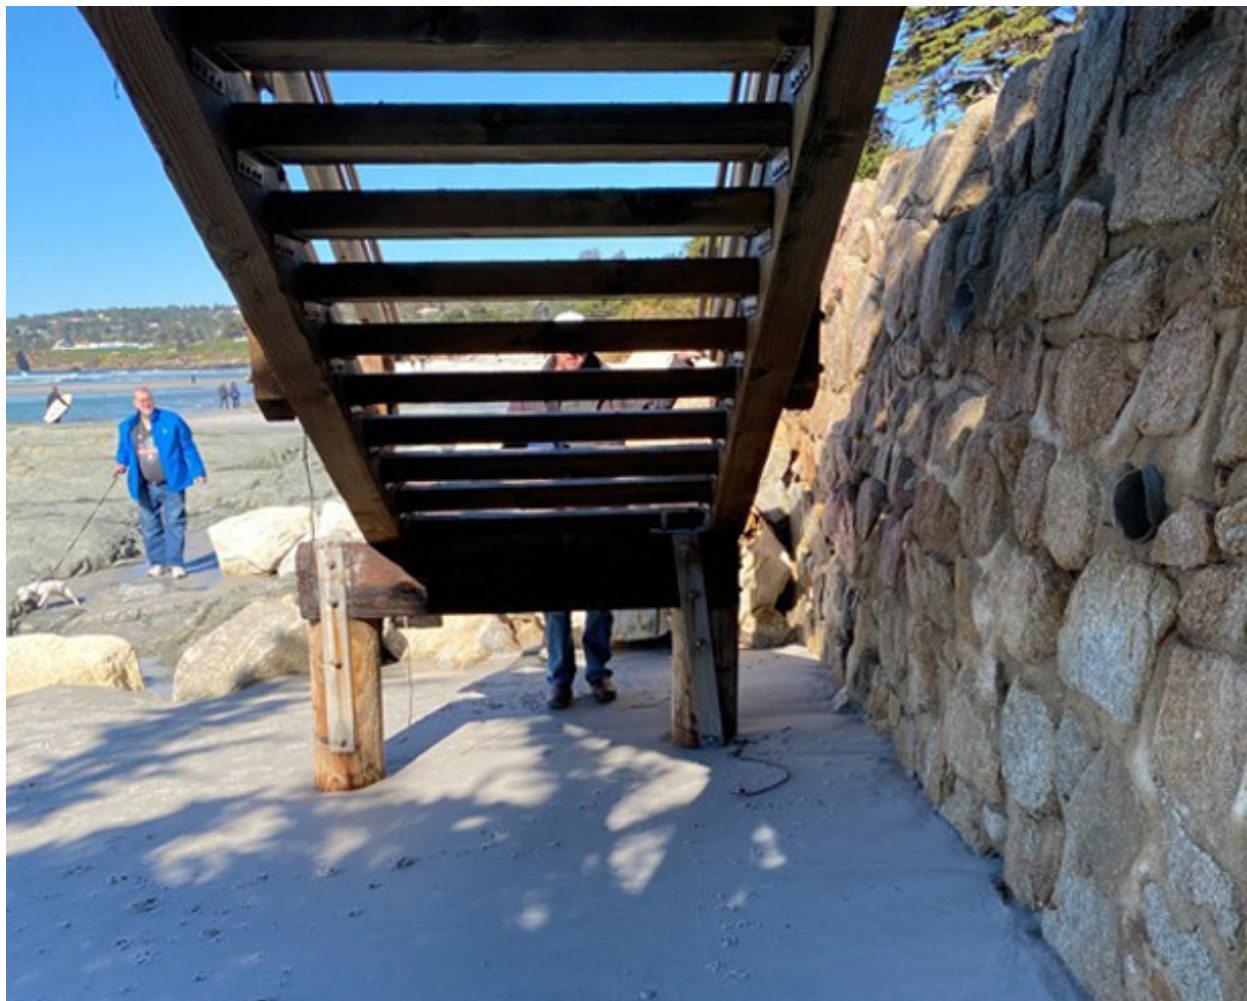
**Photograph 74: Stairway ST7 on January 30, 2023 Showing Undermining**

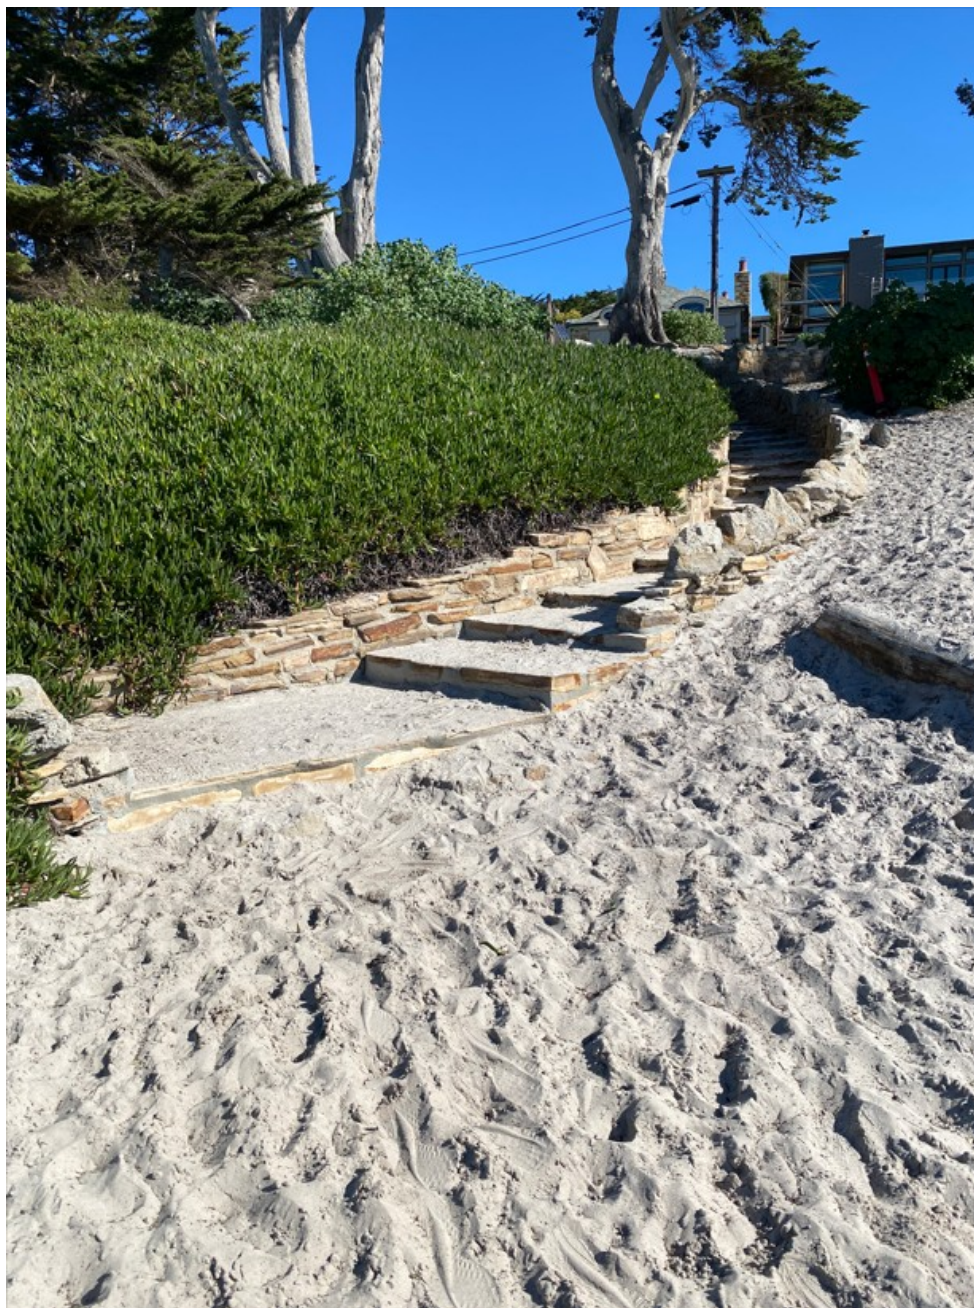
**Photograph 87: Toe Conditions at Seaward End of Stairway ST9 on January 30, 2023**
