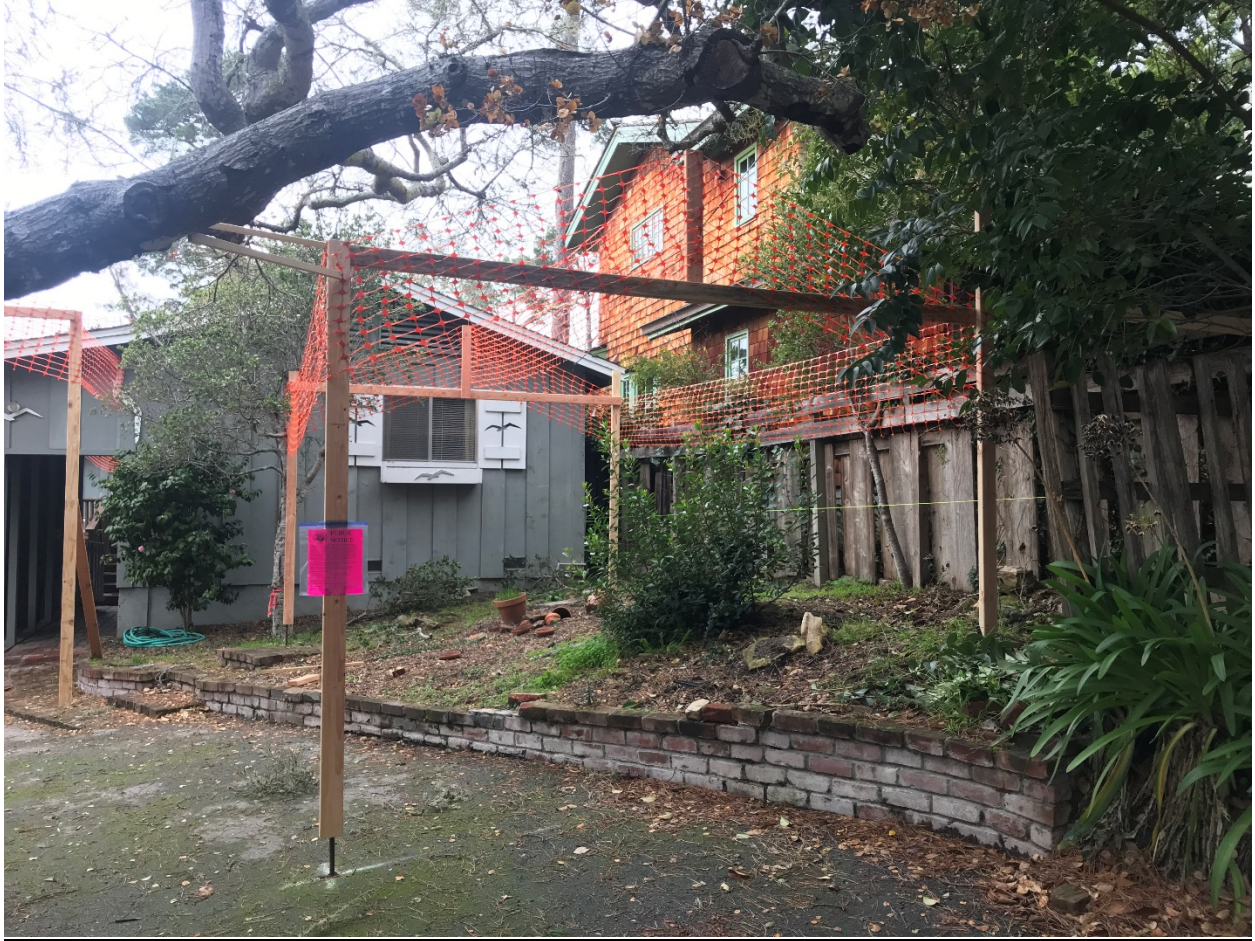
Figure 2: Story poles for detached garage. Tree in foreground proposed to be removed.

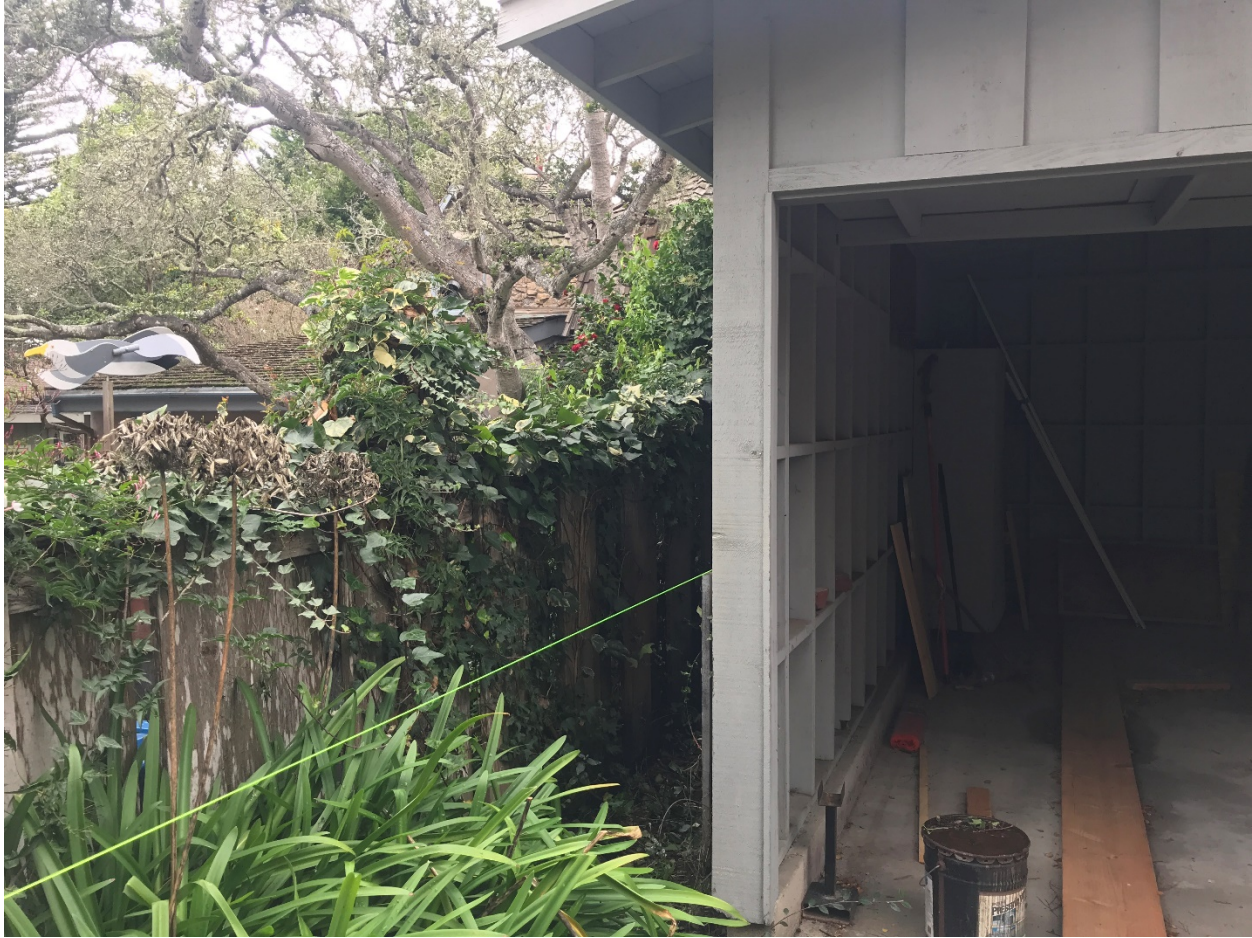
Figure 4: Non-conforming carport wall. The subject wall does not meet the composite setback requirements. The wall shall remain intact for the duration of construction, and any removal shall require the wall to be brought into a compliant location. The yellow/green string in the photo indicates the location of the 3' setback.

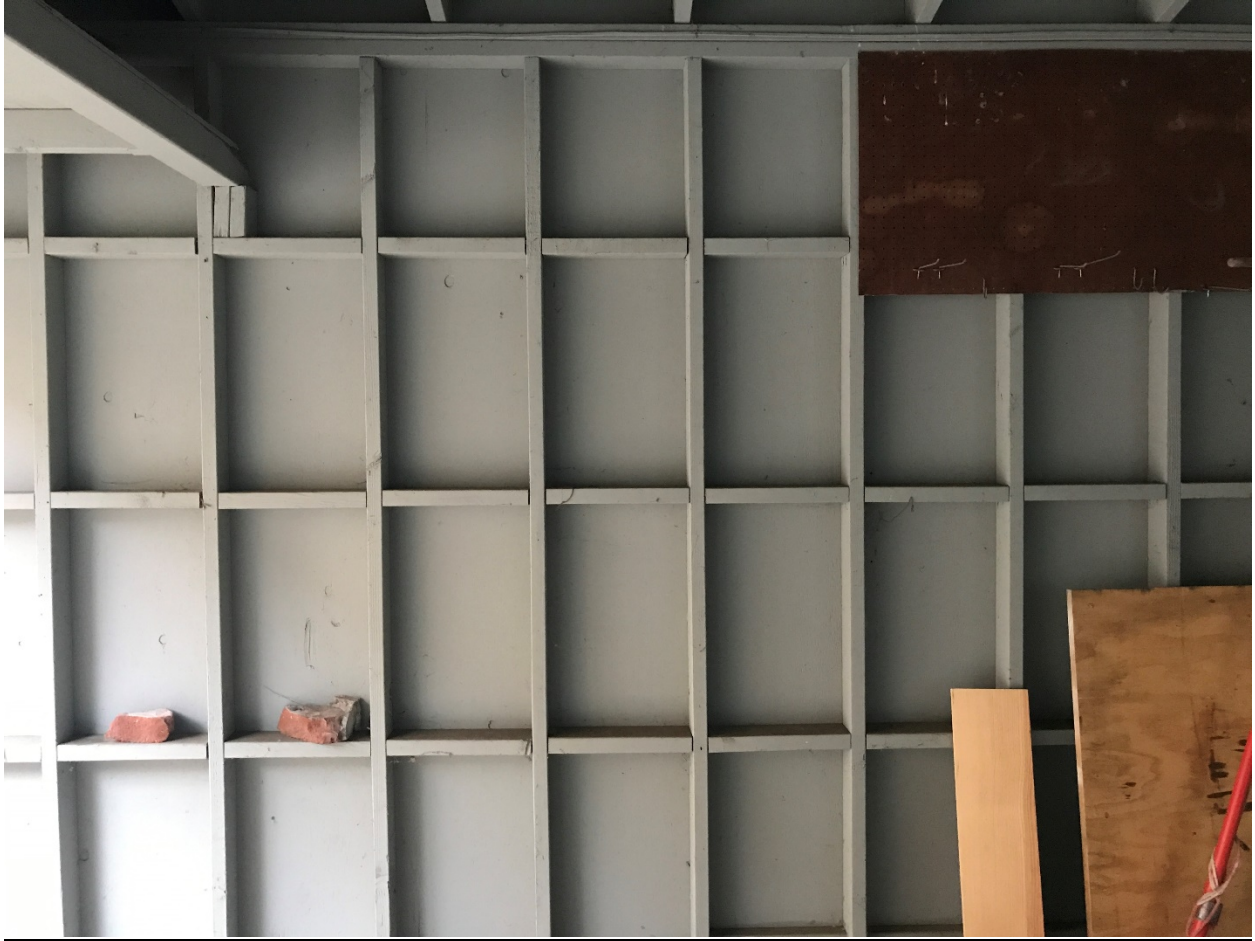
Figure 5: Interior of carport wall described in Figure 4.
