January 16, 2020

RE: Scenic Avenue 2N of 11th -Cypress Tree Assessment
APN: 010-303-009-000

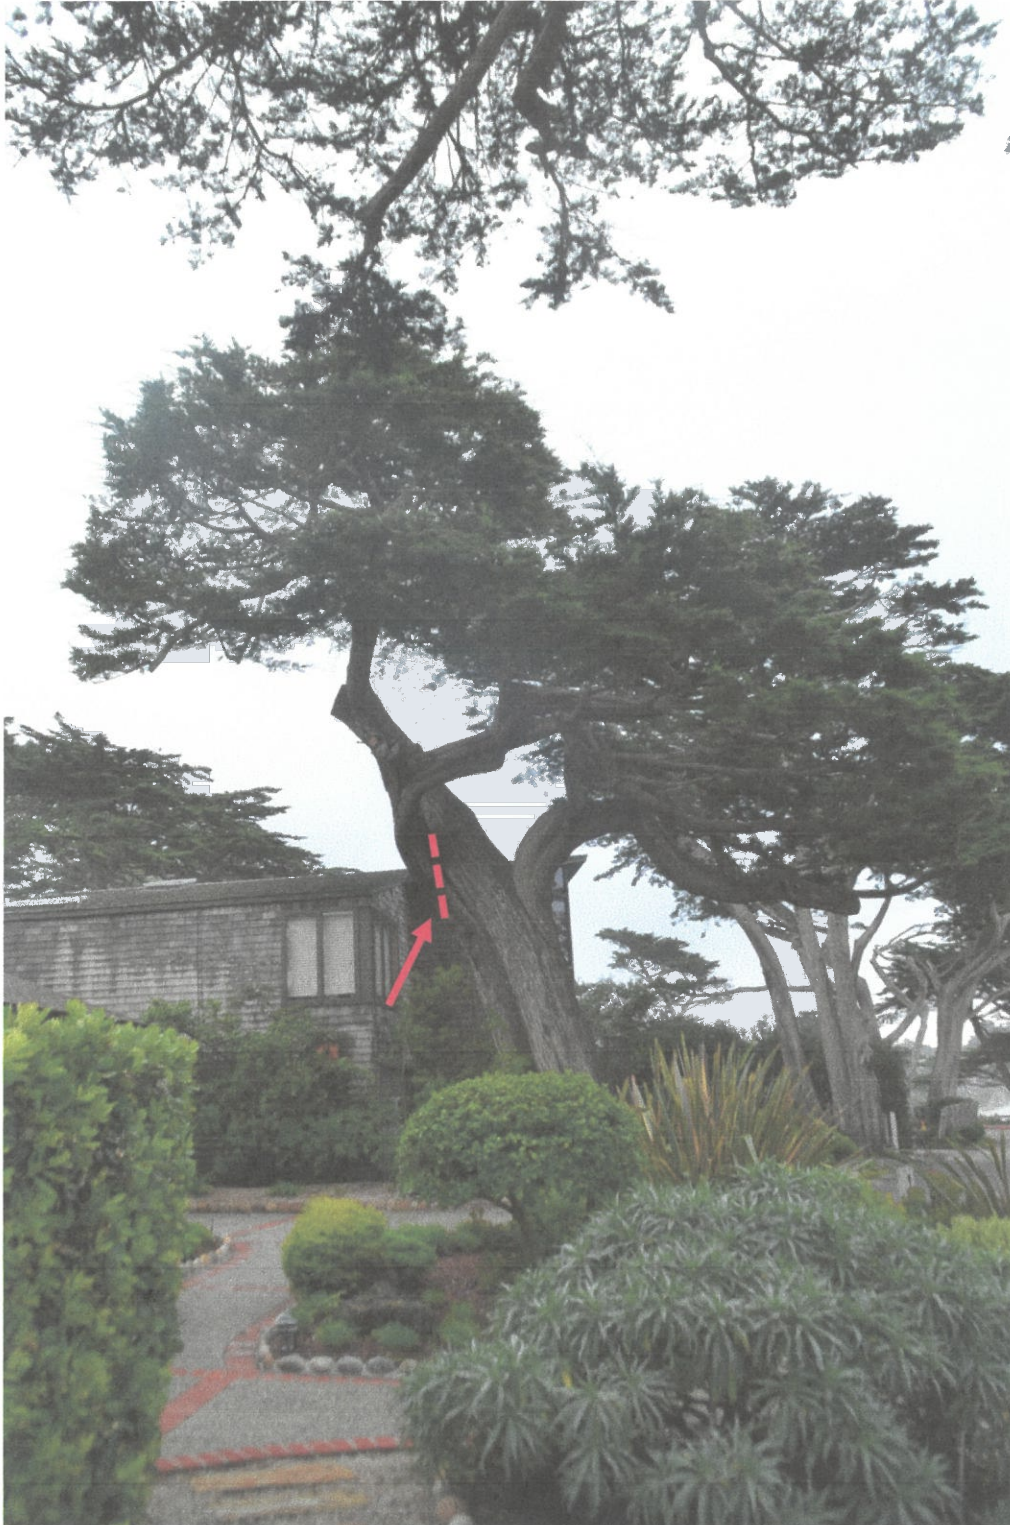
Tree #91 and limb recommended for removal to dashed area

Because the tree appears to remain a healthy tree its removal does not appear to be necessary at this time but the 31" stem needs to be significantly pruned back to the outside edge of 37" stem. It should not be removed in its entirety because it supports the 37" stem. The removal of the limb will not significantly alter air movement, contribute to erosion, or create a significant impact to wildlife; no active bird or animal nesting sites were observed at the time of assessment.

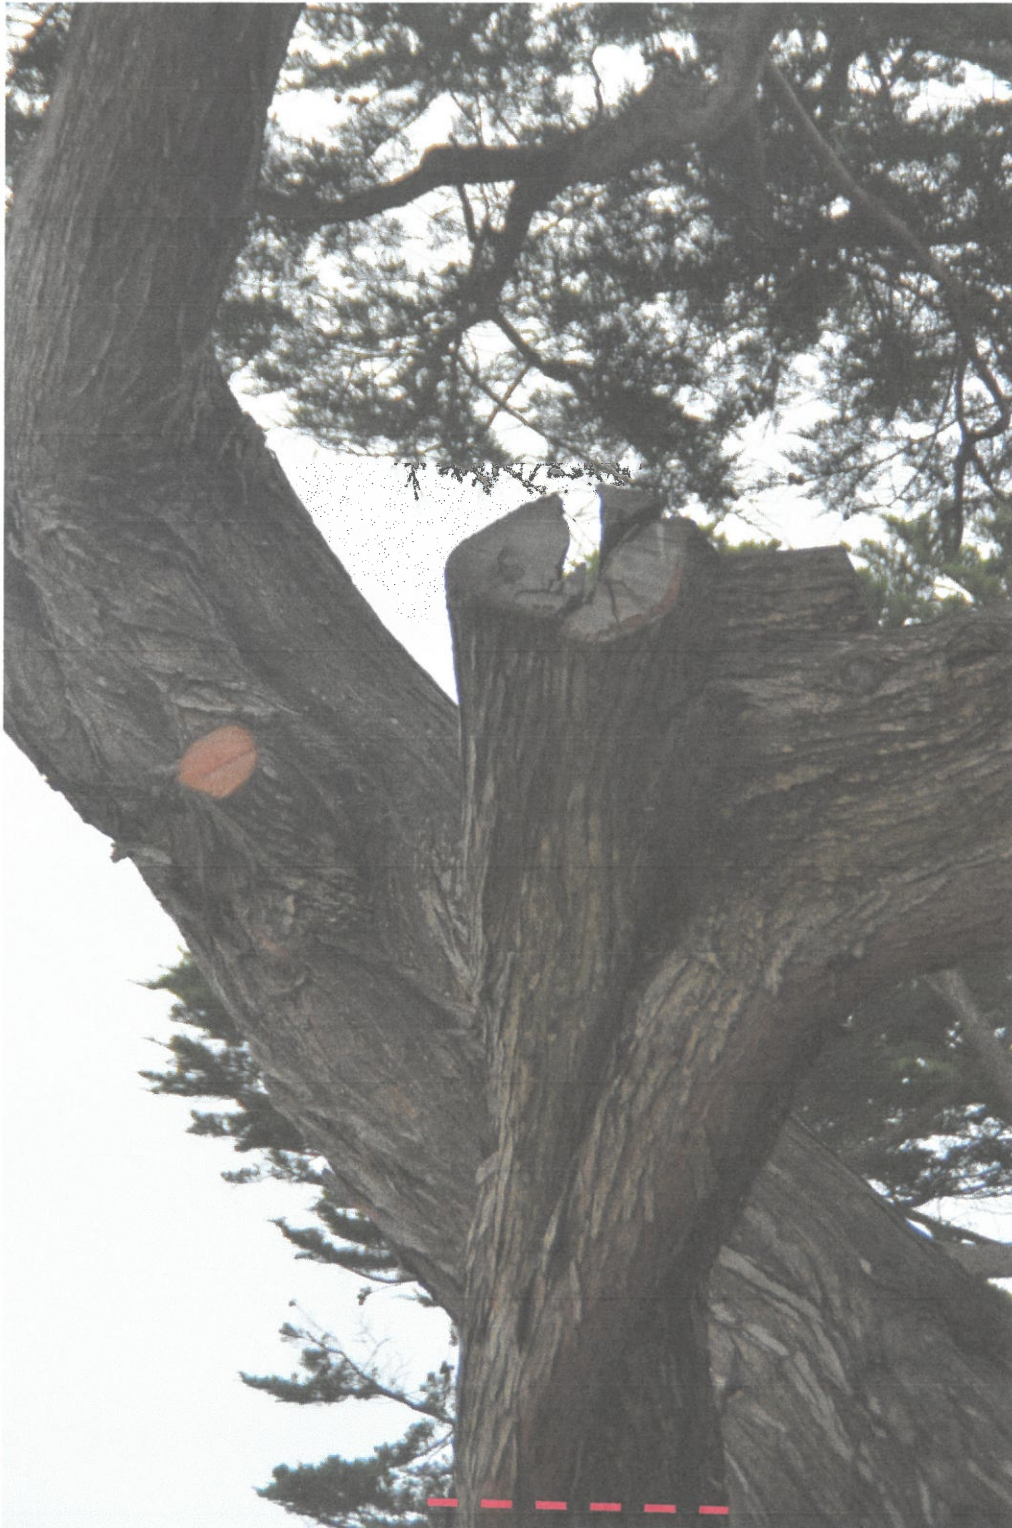
end branches are slipping downward placing downward and twisting torque on the tree stem, further compromising the structure of the tree. Obvious decay is seen from the ground, within the end of the fractured limb which is supported by the lower scaffold limbs (see attached pictures). The situation represents unacceptable risk for total failure of the 31" diameter stem. Significant damage will occur to adjacent areas when failure occurs. The tree has been determined to have a very high risk for limb failure and has a tree hazard evaluation form score of nine. Target ratings factored into the THEF score include surrounding high value landscape and structures.

Cracked limb off 31" diameter stem should be removed to dashed line

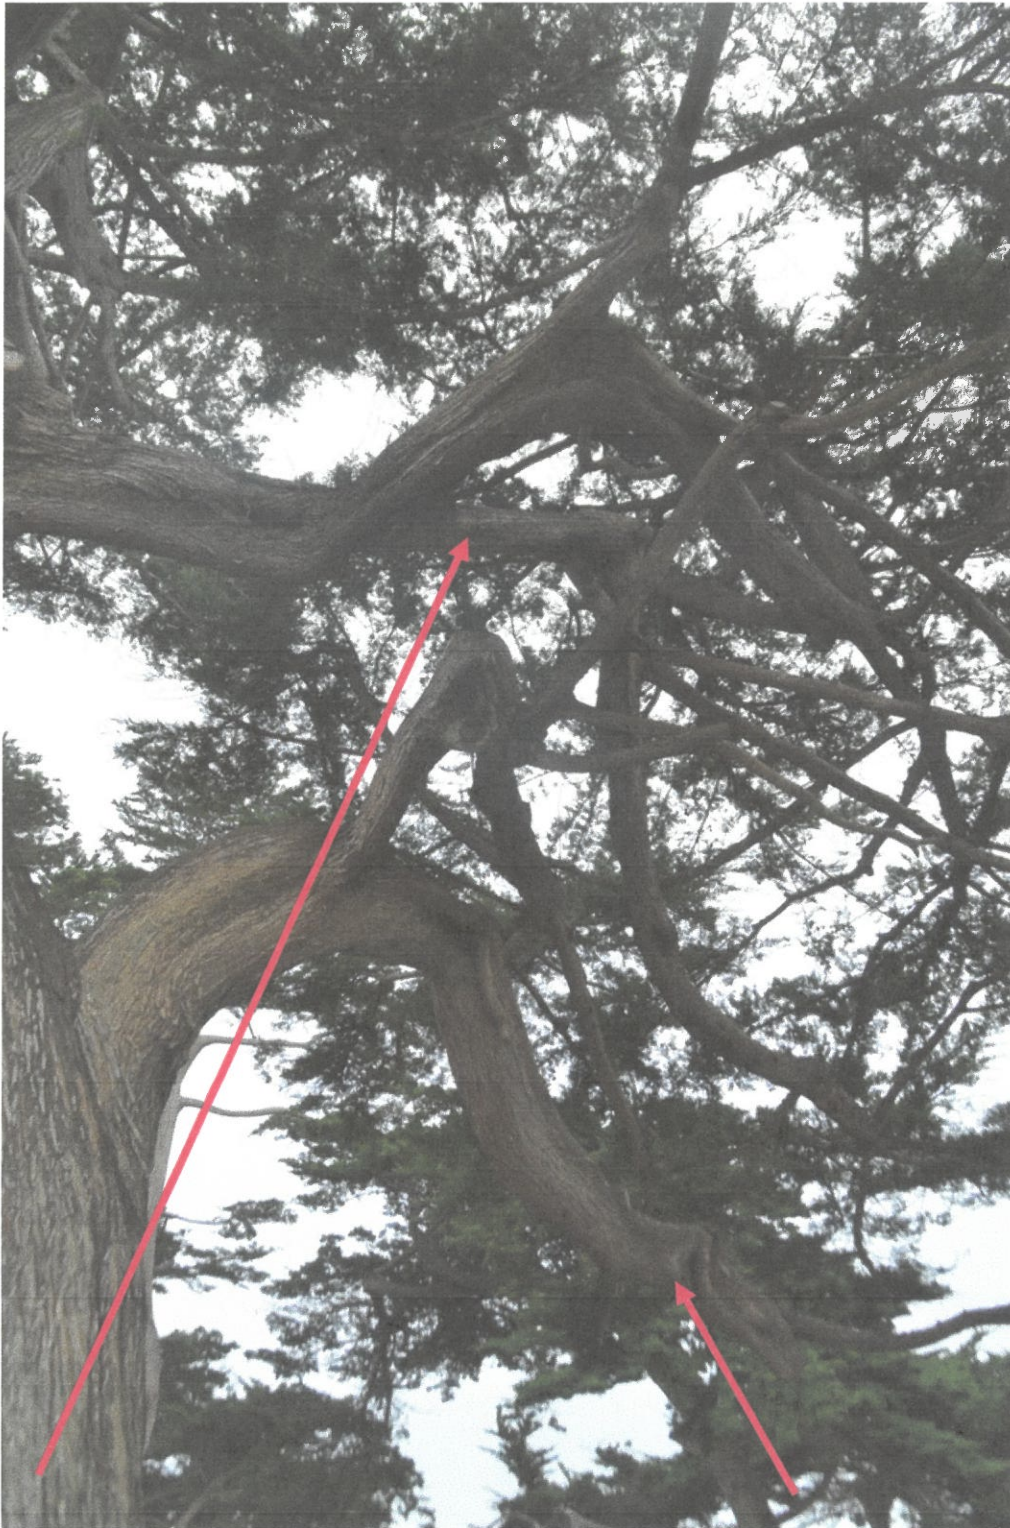
31" stem's branching is enmeshed with the branching of the 37" diameter stem

Fractured limb and wood separation of the 31" stem; dashed line represents recommended area to prune back.

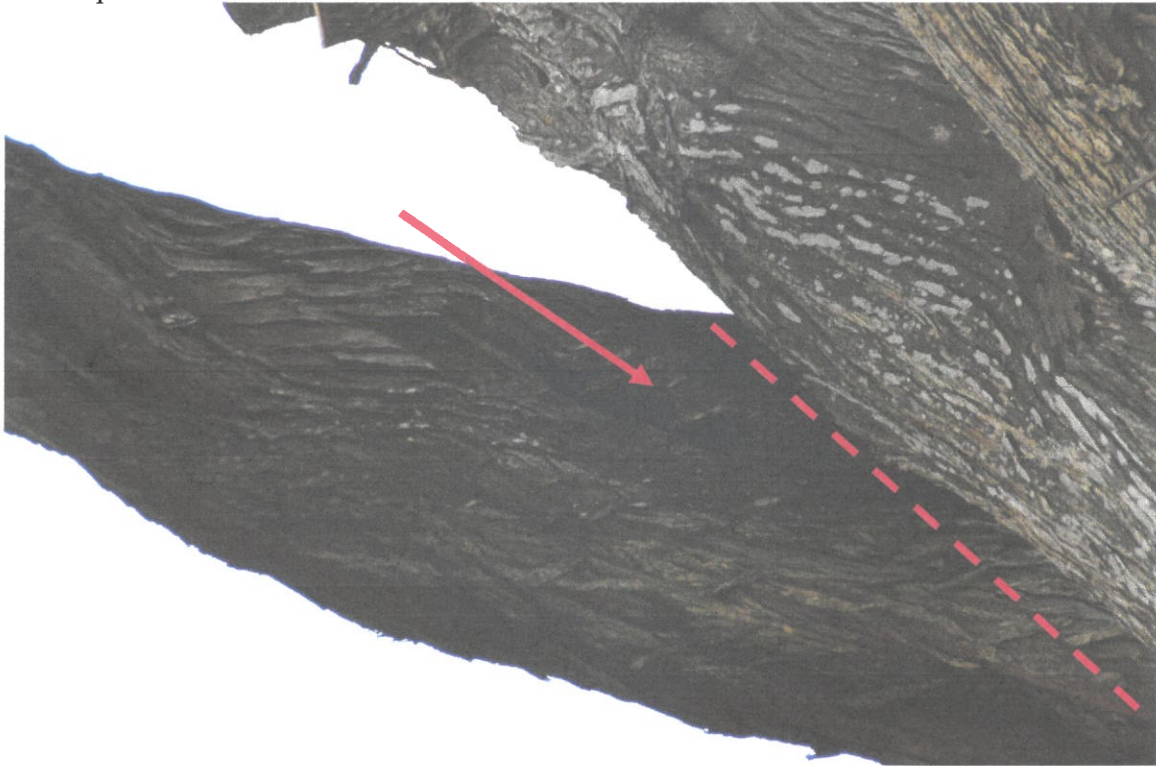
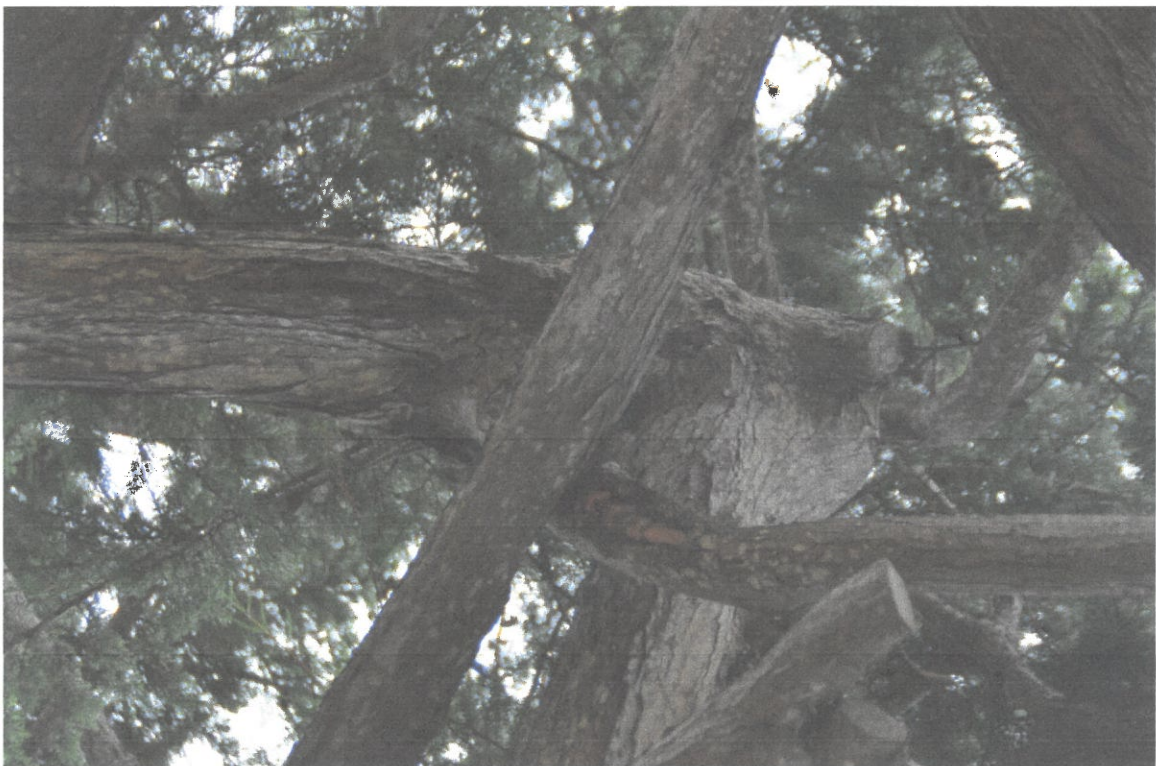
End weight of enmeshed crown branching and stem are now slipping downward

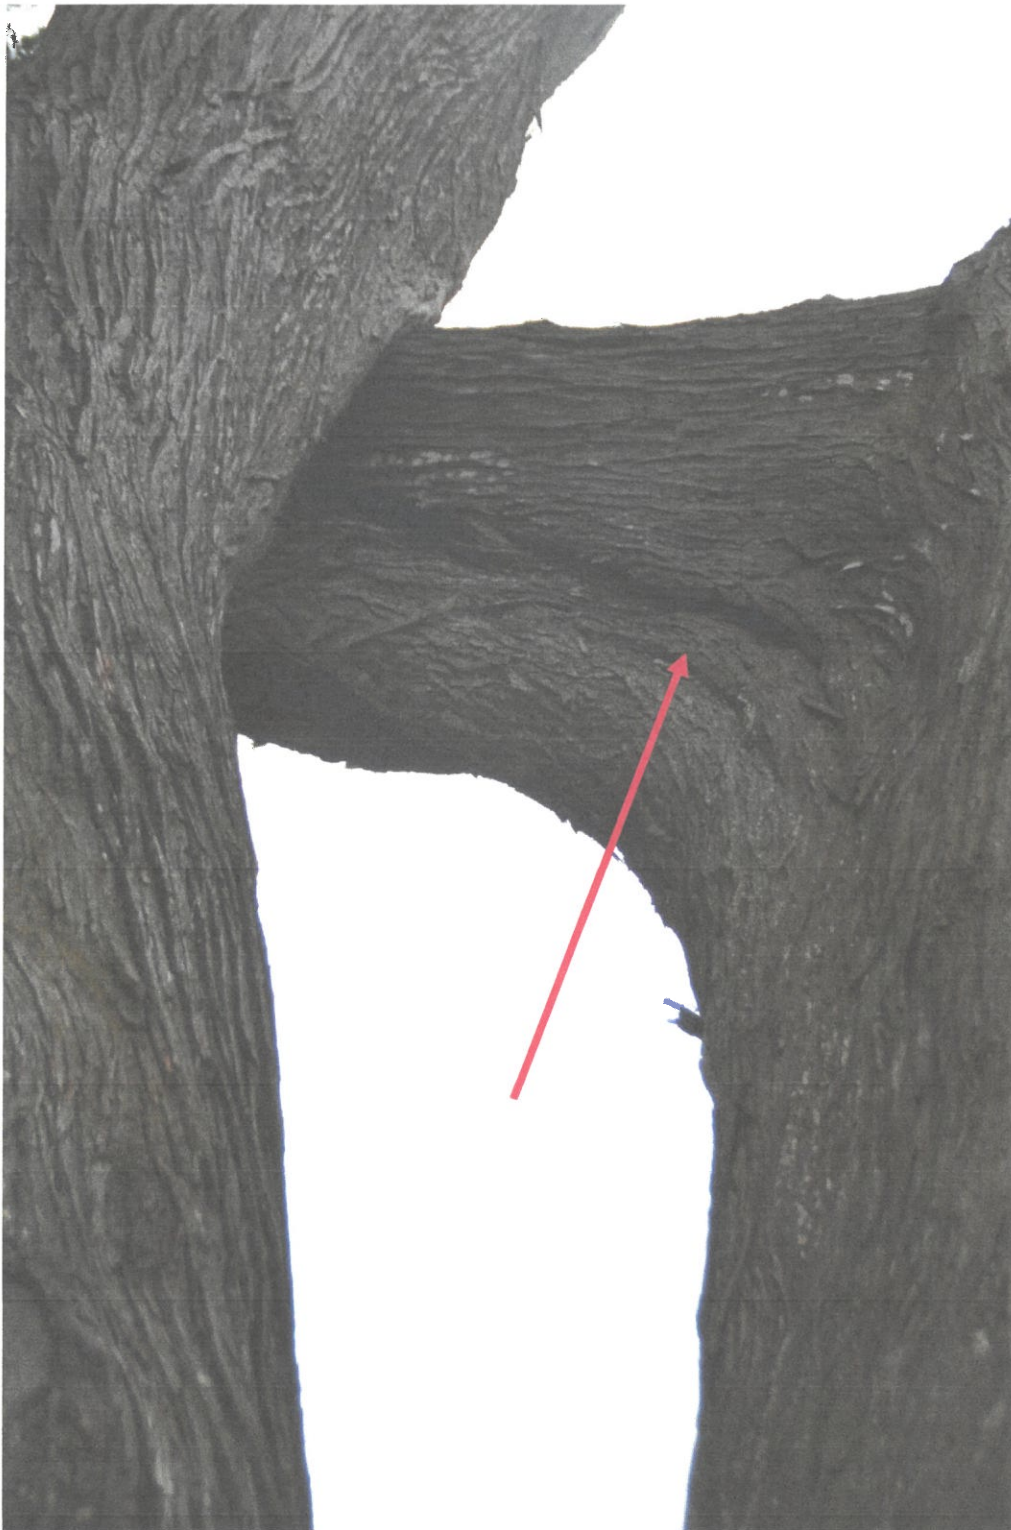
31" diameter stem is fractured but assists in supporting the 37" stem

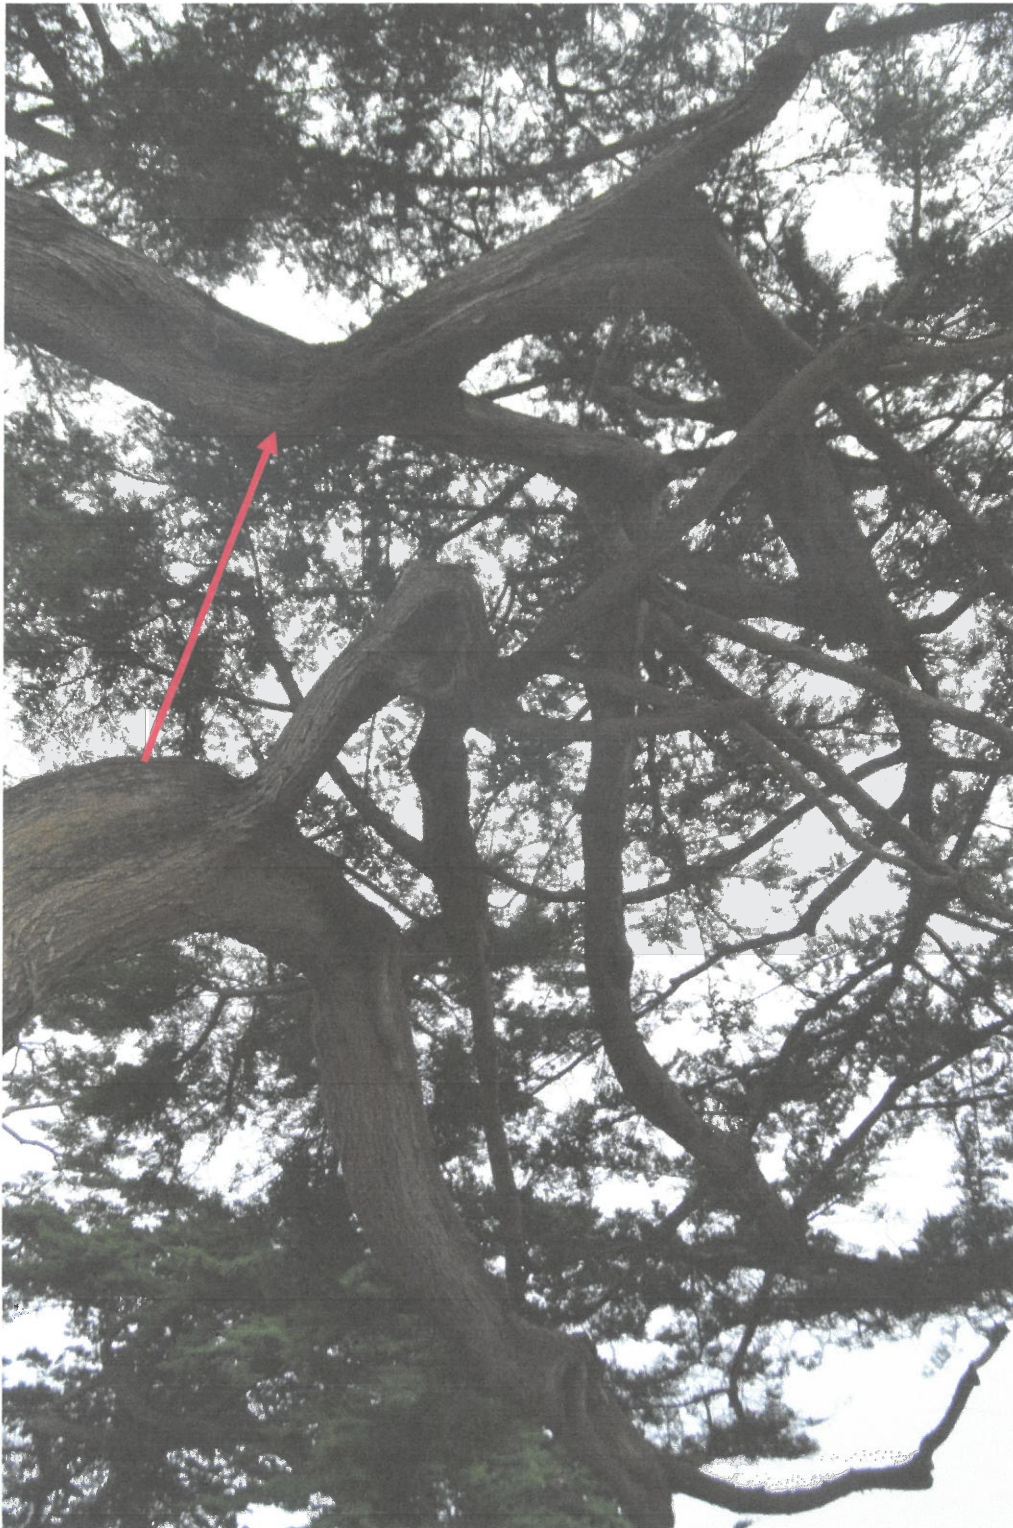
31" diameter stems branching should be removed
