Perry Newberry 2 SW of 4th – photos taken 2/7/2020

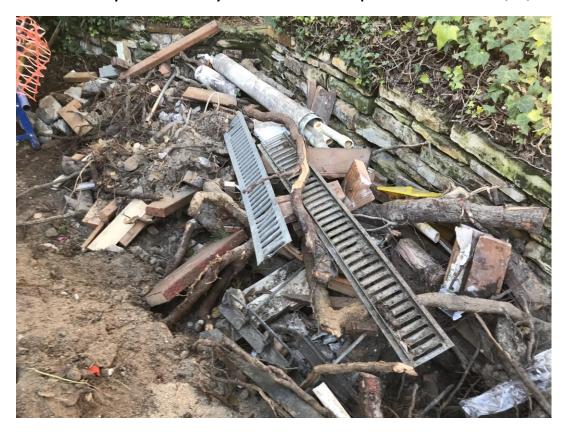
Figure 1Debris in drip line of oak

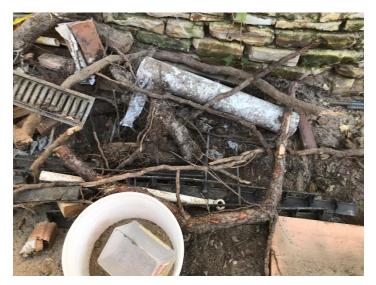
Figure 2 Debris in drip line of oak

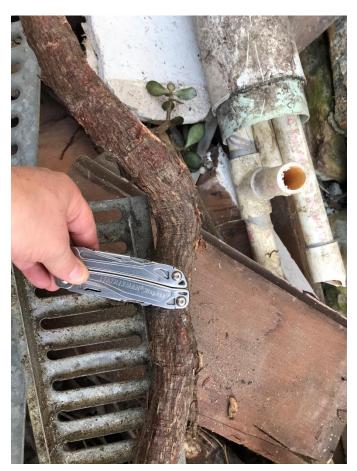
Figure 3 Removed root

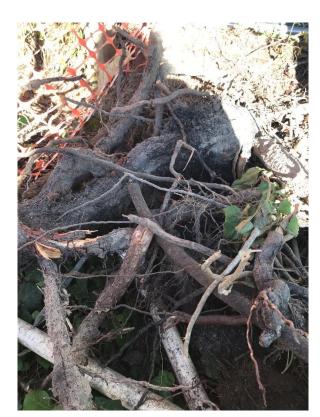
Figure 5 Pile of removed roots

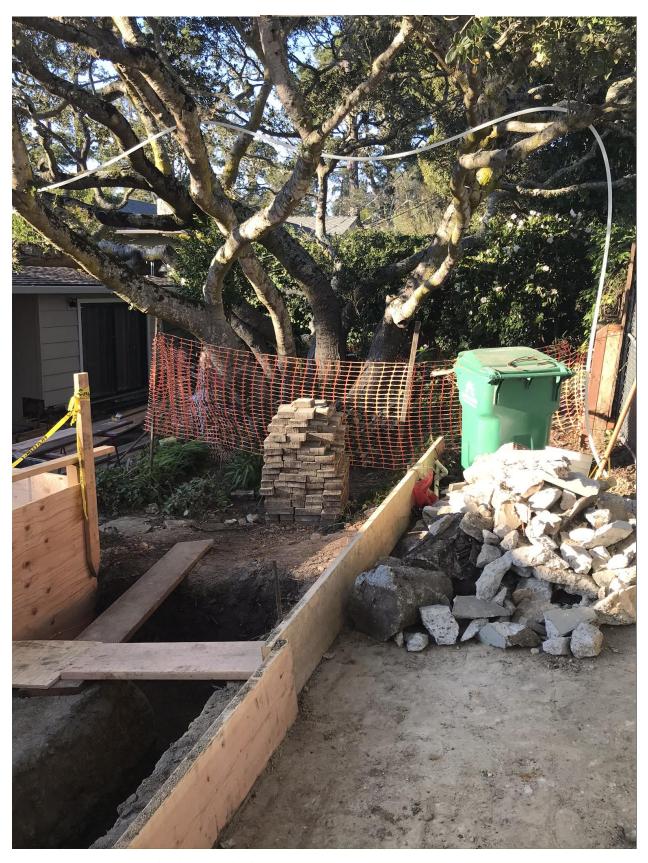
Figure 8 Construction material and debris in drip lines

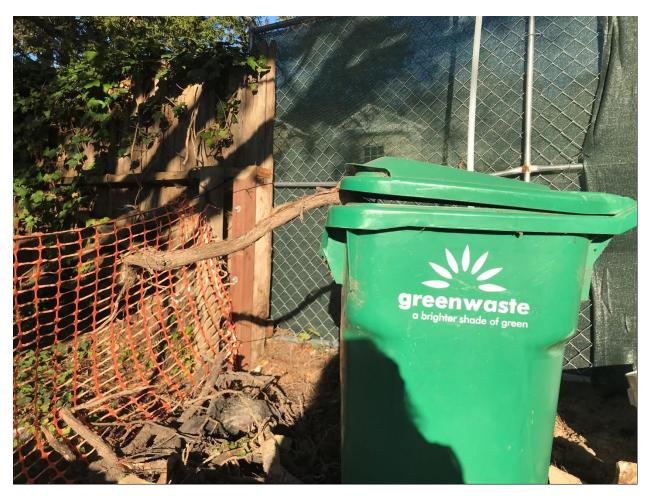
Figure 9 Root sticking out of waste toter
