ARBORIST REPORT

Guadalupe 4 NE of 3rd

Construction Impact Report

August 13, 2020

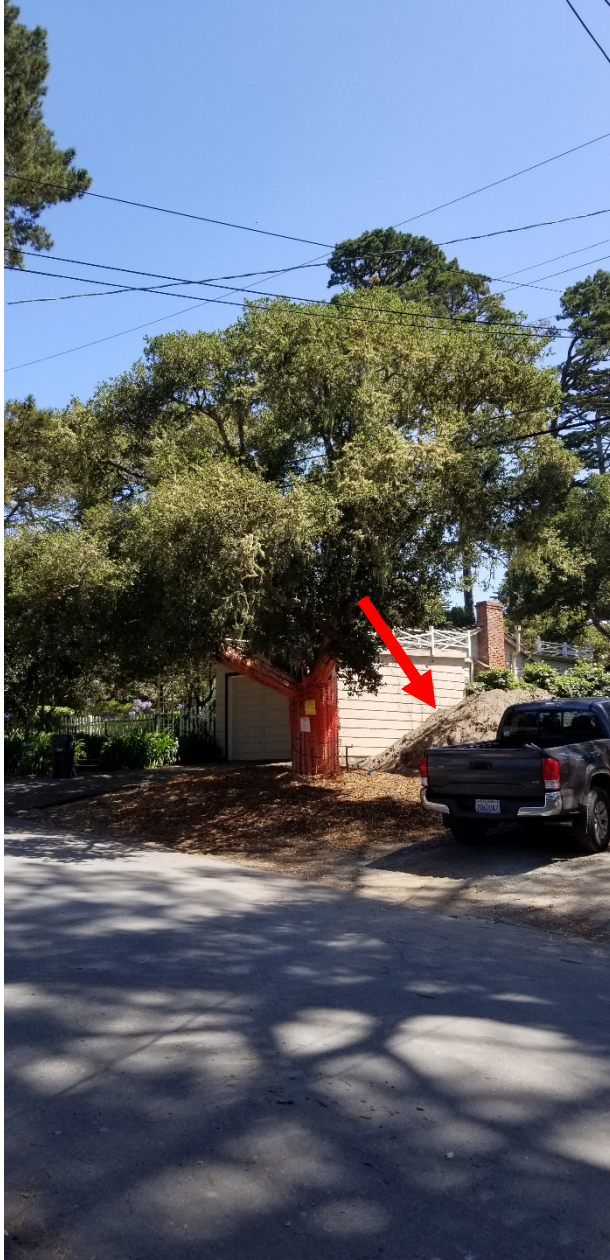
Tree-1

Tree #1 a large and healthy Coast Live oak did not have any visible evidence of excavation within the immediate root zone. A large pile 6-foot tall pile of soil is present east of the tree within the dripline. Dead branches up to 2-inches were noted within the canopy and power lines are present above the tree.

Figure 1: Tree #1 looking northeast, note piled soils on eastern root zone, indicated by red arrow.

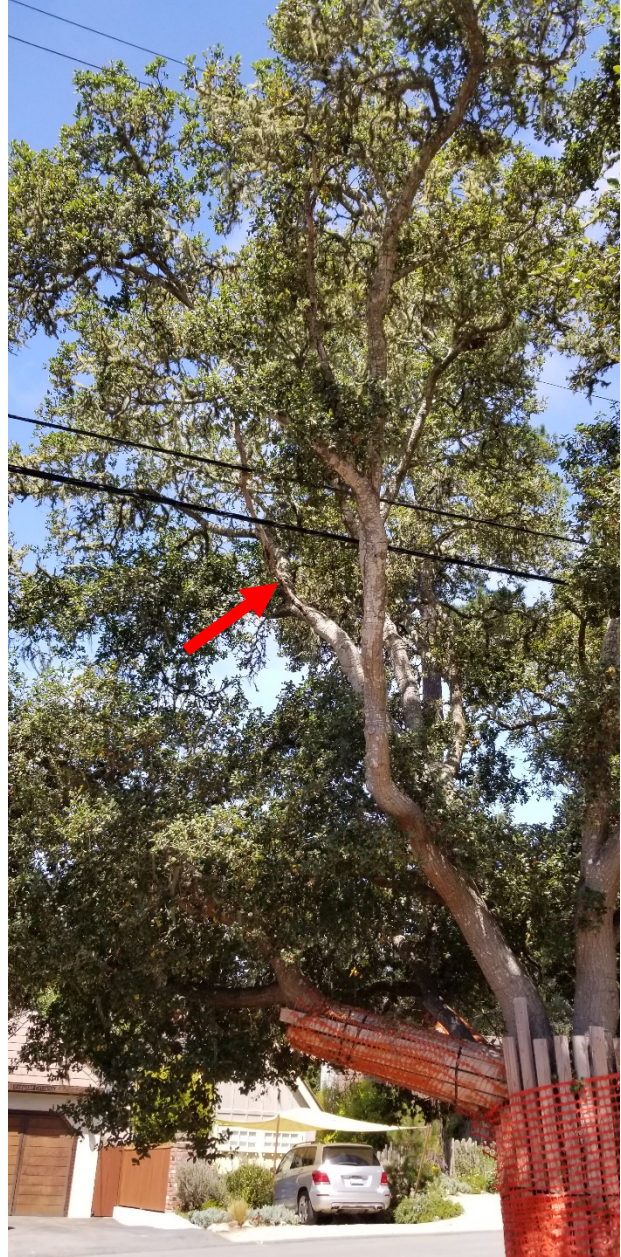
Figure 2: Dead branches noted by red arrow in upper canopy.

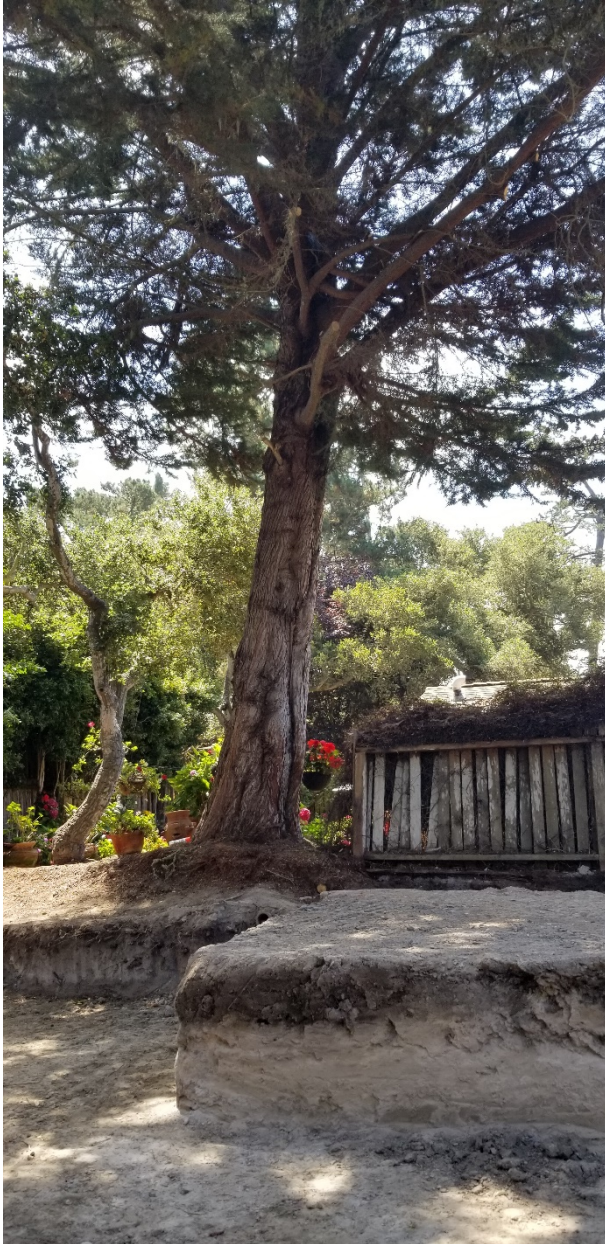
Tree-2

Tree #2 a large Monterey Cypress near 100-feet tall sustained substantial root zone damage on the northern side of the tree. The trunk has a lean and the canopy is heavy to the west. The south side of the tree appears to have had grade changes that may have resulted in root loss in the past depending on when the house at Guadalupe 3NE of 3rd was built. The foliage had minimal dead tissue and no pests or disease were visible.

Tree #'s 2, 4 and the multi-stem oak #5 sustained the most root damage, and as seen with tree #4 the damage resulted in tree failure. Tree #2 (Monterey Cypress) has sustained a significant amount of root loss from recent construction and may have been impacted in the past from the property to the south, as there is a noticeable grade change. If the grade change was completed recently (inside of 10-20 years) it may have impacted the trees stability. However, with the information we have now, and if no other grade changes have been made in ten or more years, I believe that the tree could be retained. A 30% crown reduction would reduce weight and stress on the root system, thus reducing likelihood of failure. This significant of a crown reduction would have significant impacts to the tree's health, and tree health or stability is never 100% guaranteed, additionally the pruning would likely reduce the esthetics of the tree due to extensive loss of canopy.

Figure 3: Looking south at tree #2 Note excavation with in 6-feet of base of tree to a depth of nearly 3-feet. Also, trunk can be seen growing at an angle to the west and heavy canopy.

1. Remove Tree #2
2. Consult with neighboring properties regarding the retention of the multi-stem Oak #5
 - a. Mitigations must be in place before winter winds and rains begin, or within 2 months of this report.

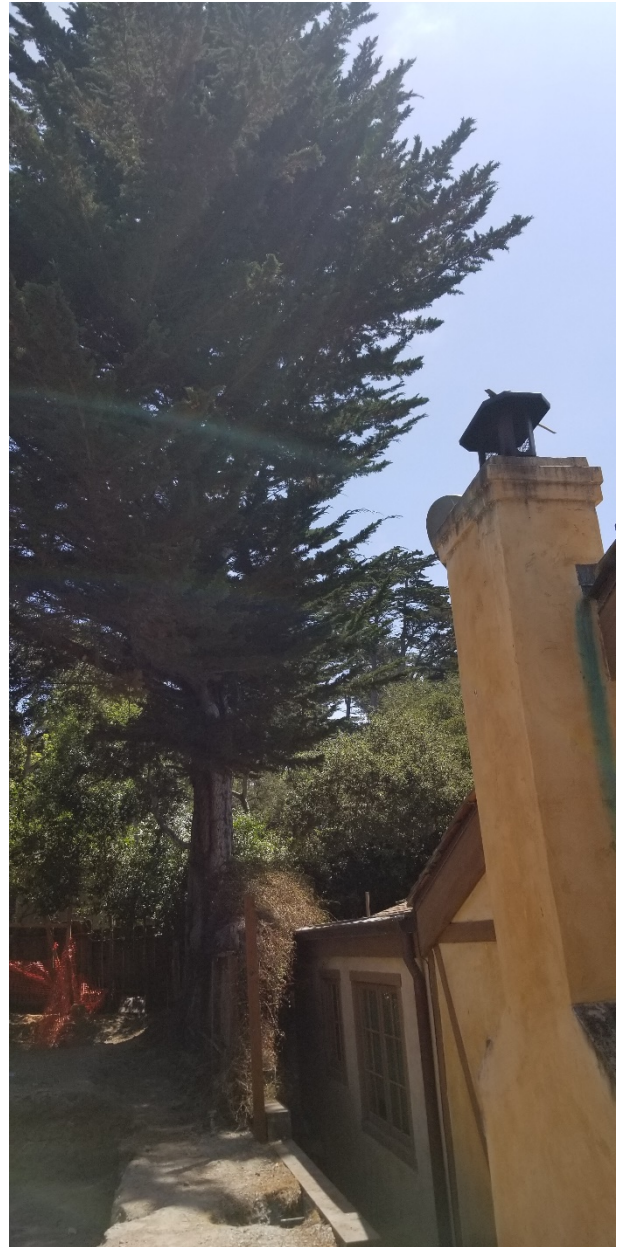
Figure 4: Looking east, note how house on right (Guadalupe 3NE of 3rd is built below the grade of base of tree. Southern canopy seen heavily cut back.

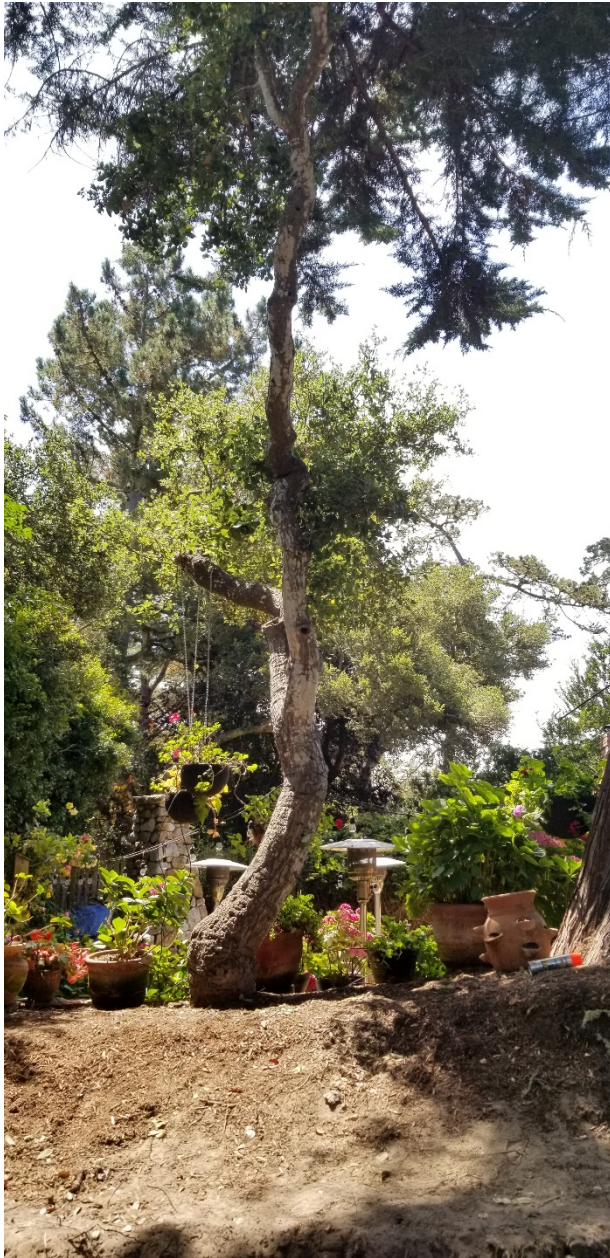
Tree-3 and Privets

Tree #3 a relatively small Coast Live Oak is present with the eastern dripline of Tree #4. Excavation was present 6-feet to the north of the trunk, but minimal impact from construction is suspected. The tree was noted for having a sparse canopy.

Figure 5: Tree #3 seen looking south, note limited foliage.

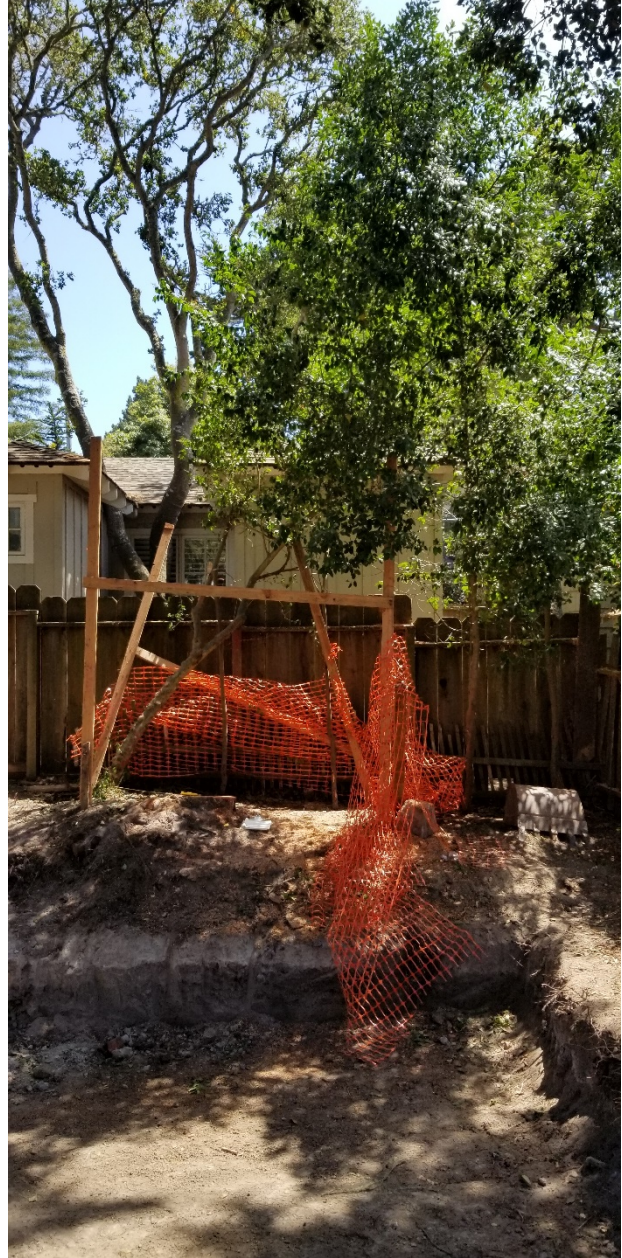
Figure 6: Small Privet trees seen looking east.

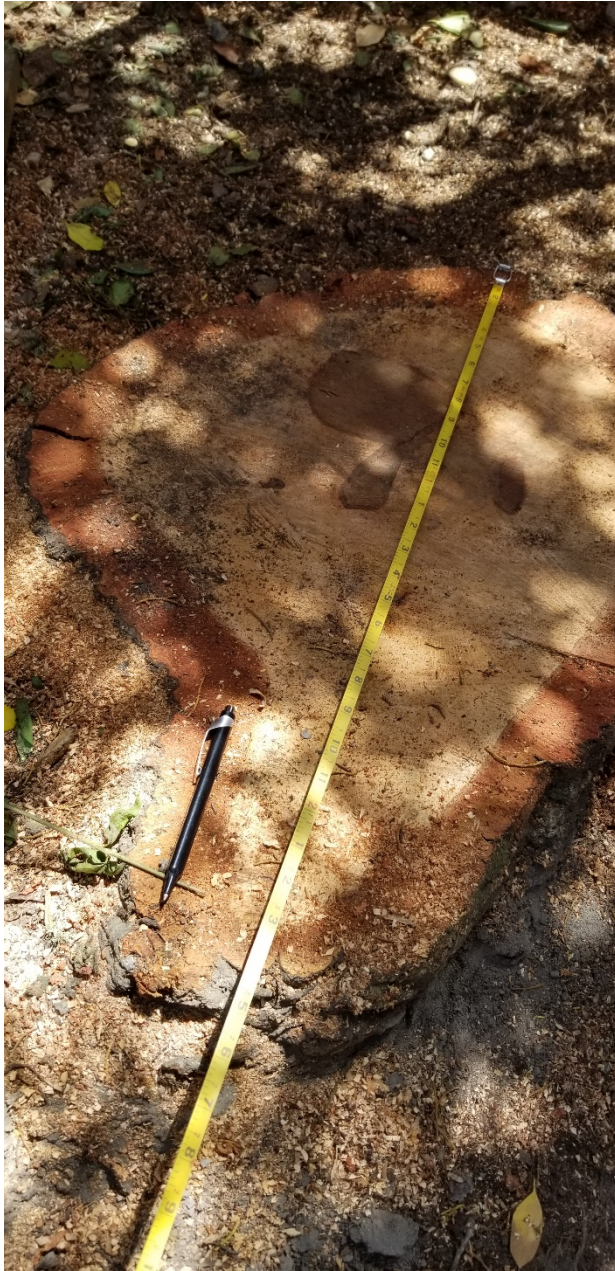
Tree-4 (Stump)

Tree #4 was reported to have been cut down because cut roots caused the tree to begin to fail to the east on an adjacent house. As much as 50% of the trees root zone had been removed during excavation and roots up to 4-inches could be seen severed in the bank wall.

Figure 7: Stump of tree #4 seen with measuring tape.

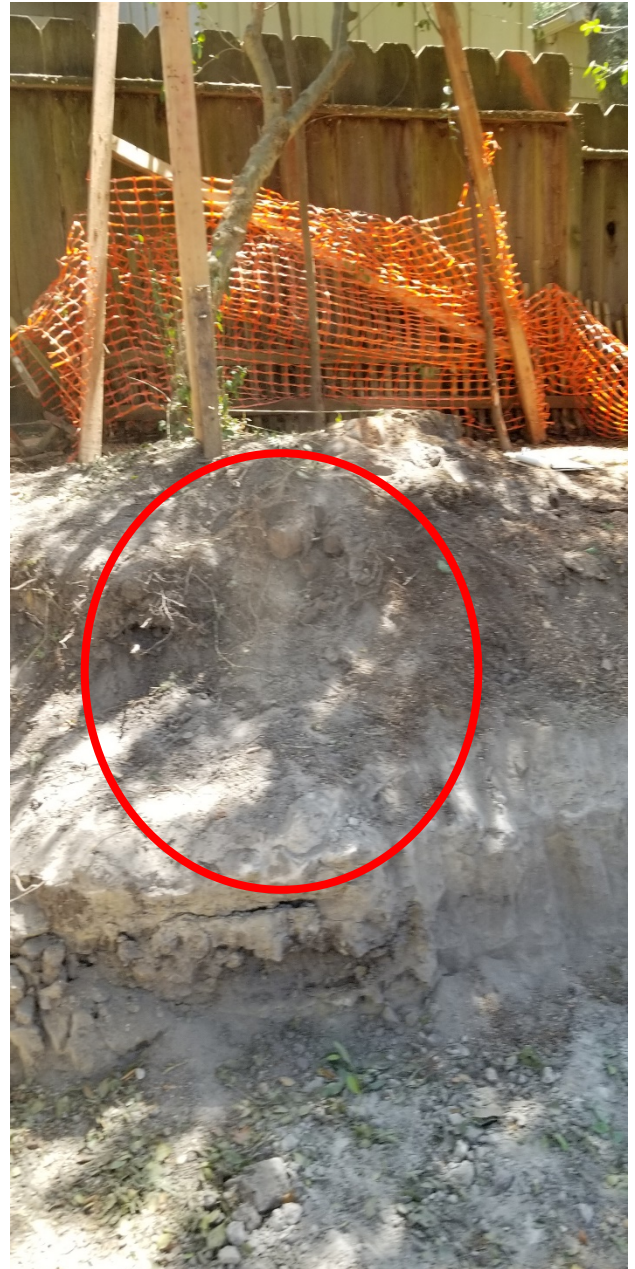
Figure 8: Excavated area shown on west side of stump, cut roots can be seen with evidence of heaving/unearthing from reported tree failure circled in red.

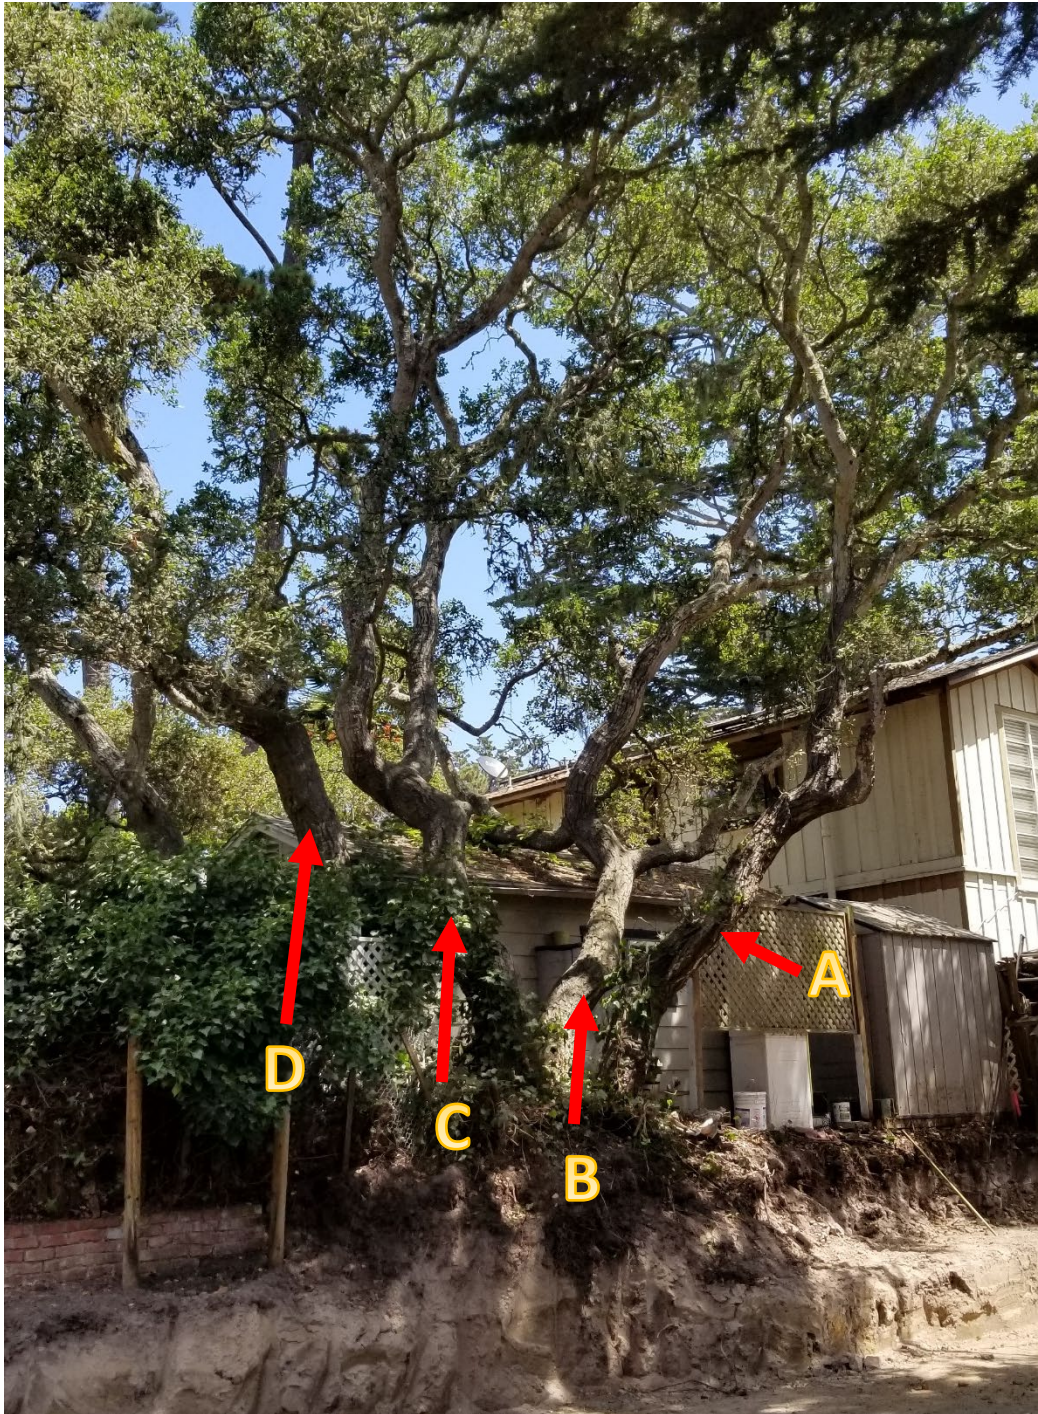
Multi-Stem Oak – Stems

Tree #5 is a multi-stem oak consisting of 4-large leaders. Any roots that may have been present on the southern side of the tree have been removed. A large broken root that had been broke by force was visible on below Leader "C". Leader "B" Could be seen resting on the roof of the cottage/shed in the back yard of Guadalupe 5NE of 3rd. Leader C was with in 2-feet of the roof as well. The grouping of trees displayed health canopies with minimal sings of pests or diseases.

Tree #5 is in most respects 4 different trees; however, the leaders have developed in a way where they act as one. Loss of one leader would have immediate impacts to the other leaders. The root systems have undoubtedly become intertwined and may have grafted in some areas. Disturbances to one tree could have health impacts or even structural impacts with the loss of anchoring from another leader's weight, as well as increased wind loading. The location of these leaders raises other concerns as they grow over and even touch the neighboring house to the north (no property boundaries were marked, and the tree stems appear to be on or near the property line). Although this tree has been impacted by construction and has several structural issues and site conflicts, it has an irreplaceable unique character. I believe the tree could be retained if a supplemental support system were installed. The system would require strategically placed support **props** and **cabling**.

Figure 9: Multi-Stem Oak #5 seen looking northeast. Note Stem “B” Resting on roof and “C” within 2-feet.

- b. Establish support system plan in the field with a certified arborist and affected parties, to determine acceptable property line encroachment for support structures.

- c. Removal of the entire oak is advised if no support system is installed.
3. Any further excavation or construction within the dripline of any retained tree should be supervised or approved by a certified arborist.
