CITY OF CARMEL-BY-THE-SEA FOREST AND BEACH COMMISSION Staff Report

TO:	Forest and Beach Commissioners
SUBMITTED BY:	Sara Davis, City Forester
SUBJECT:	Notice of Violation of the Trees and Shrubs Ordinance, and Assessment of fees and special conditions due to unauthorized root cutting of 8 trees on Santa Rita Street, 2 SW of Fifth Avenue.

ARBORIST REPORT

Santa Rita 2 SW of 5th

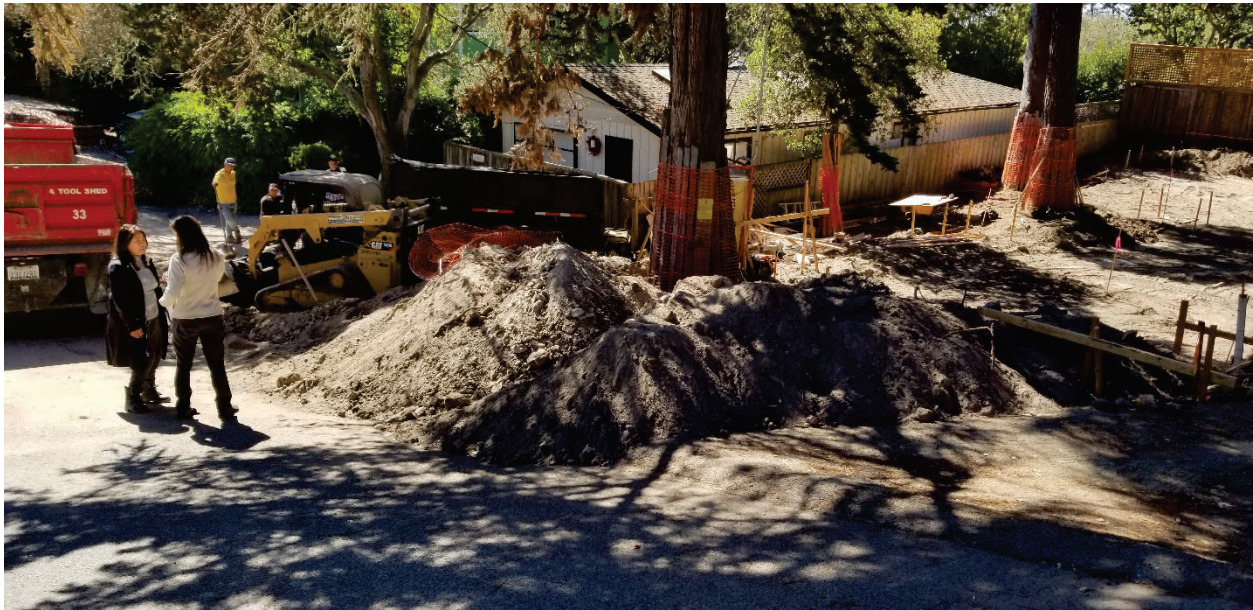
Figure 4: Looking southwest from street, note large pile of soil.

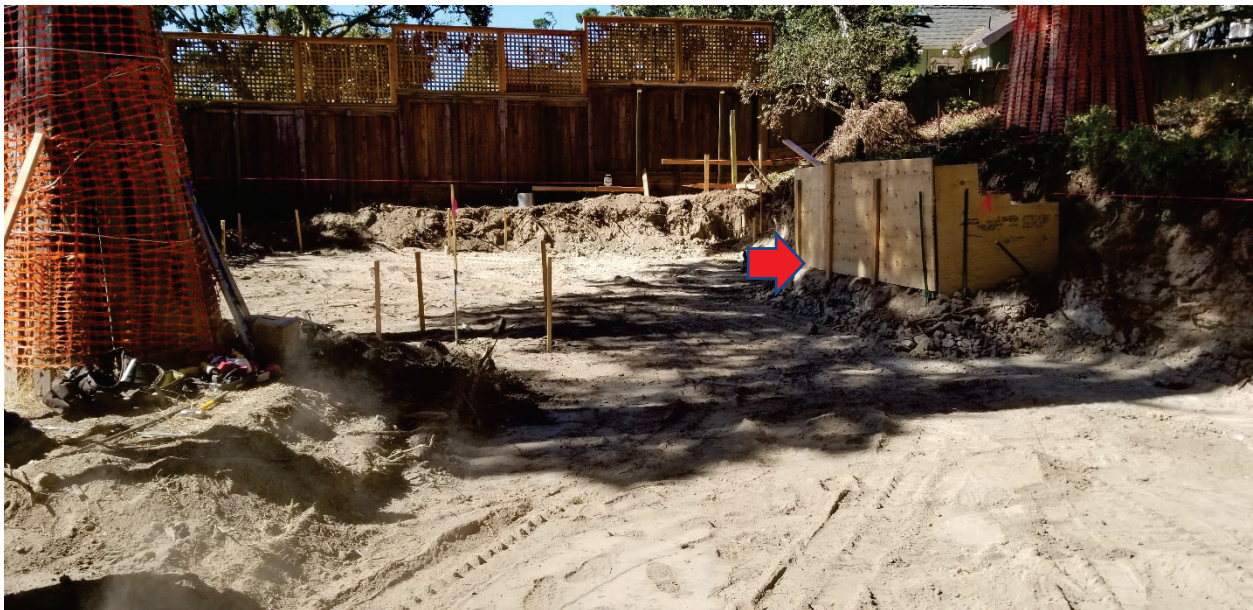
Entering the construction area, the soil was extremely dry and dusty. Freshly torn roots were observed throughout the area. A wooden box was present on north side of the cut wall near trees 6-8. I was informed the box had been placed and filled up with dirt in effort to protect the roots from drying out. To the east and west of the box fresh cuts could be seen on roots up to 3-inches in diameter as well as roots that had been torn from the wall from machinery. The majority of the southern root zones of trees 6-8 are believed to have been removed or damaged during construction.

Figure 3: Looking west inside excavation area, red arrow shows box that was constructed around exposed roots of tree #7.

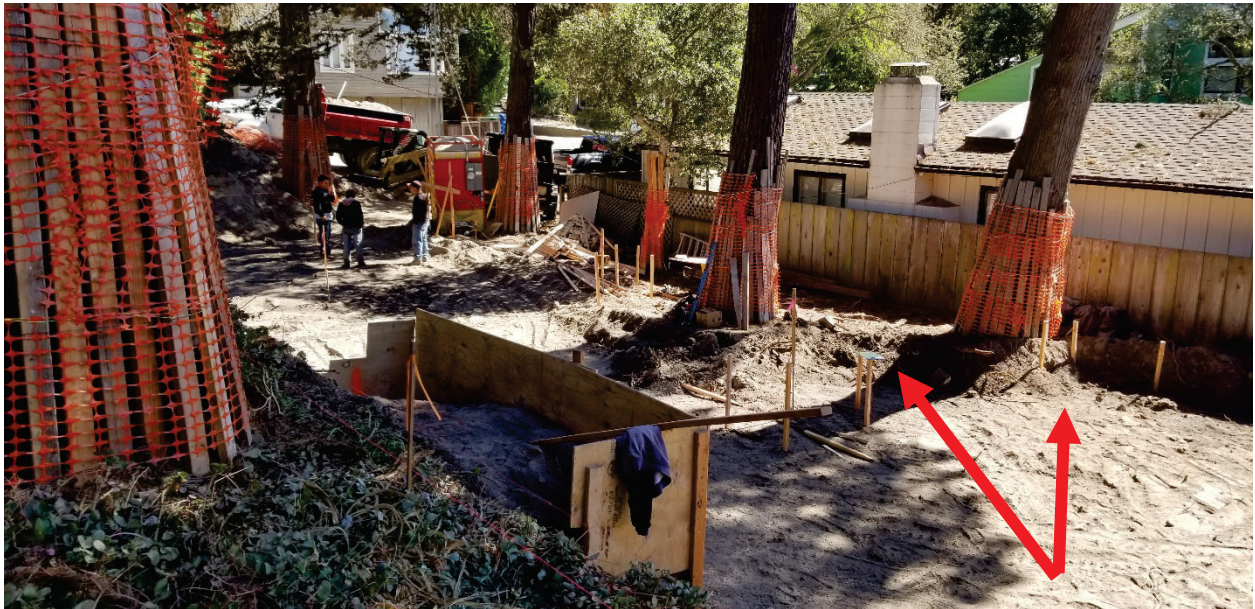
Damage done to trees 4 and 5 on the south side of the lot is suspected to have the most immediate impact. Excavation with in 1-foot of the trunk on the majority of the northern dripline 1-foot deep, resulted in extensive root loss. Both trees 4 and 5 display canopies heavy to the south and the loss of tension roots may result in whole tree failure.

Figure 5: Looking southeast from Tree #7, red arrows note how close excavation was preformed near trees 4 and 5.

1. Removal of tree #'s 4, 5 and 7.
2. Safety pruning of any trees retained. Trimming should be focused on removing any dead/broken branches over 1-inch in diameter, reducing overextended/heavy limbs, balancing canopies, and reducing wind loading. All pruning should be preformed in accordance of ANSI-A300 standards. (Tree Care Industry Association, Inc., 2017).
3. Low nitrogen fertilizer soil injections for trees that sustained extensive compaction. Establish 6 to 8-inches of mulch beneath canopies.
4. Continued monitoring of any tree retained, with re-inspection in 1-year by certified arborist to assess structural integrity and health of trees.

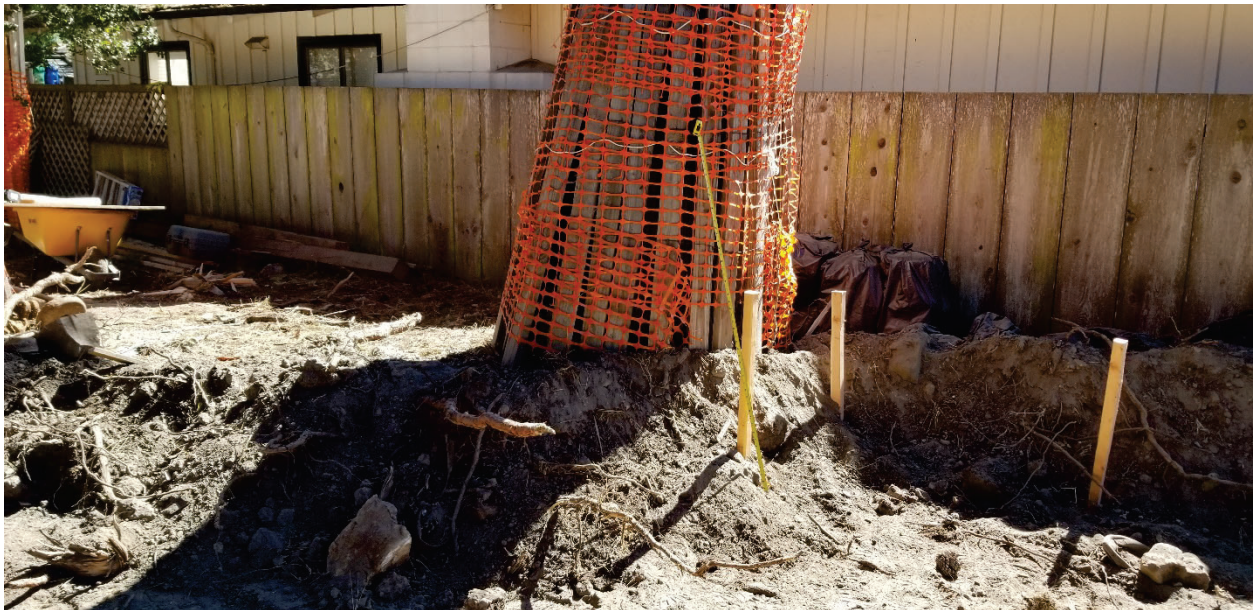
Figure 6: Looking south at Tree #5, Note roots ripped from ground with in 1-foot of trunk.

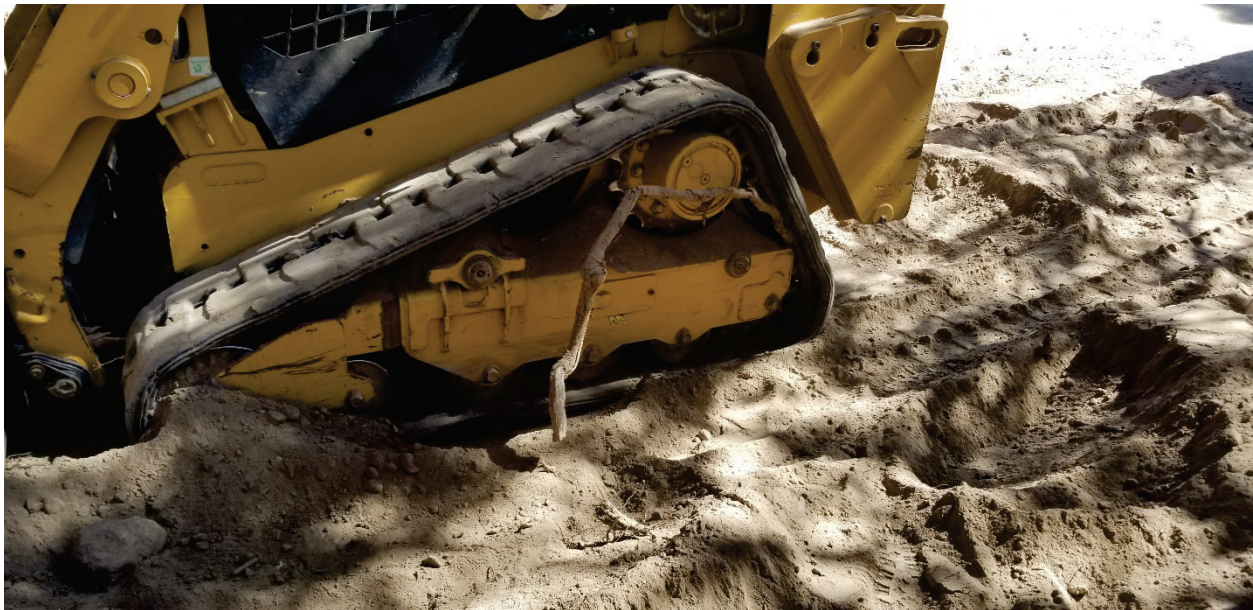
The excavation on this lot was done with blatant disregard to the trees on site. The roots seen thrown about the property and stuck in heavy machinery's wheels suggests extensive damage to root systems. Ripping roots from the ground with machinery can result in fractures in the trunk of a tree. The wounds provide a path for pathogenic, wood decaying fungi to further reduce structural integrity of trunk and root system and health of the tree. The loss of roots reduces the trees ability to absorb water and nutrients, leading to canopy decline. Construction damage can often take several years to reflect in the canopy, due to stored nutrients in the tree, but often result in extensive canopy dieback or catastrophic failure.

Figure 7: Skid-steer loader operating on site, note roots stuck in tracks an indication that little to no caution of roots was taken during excavation.

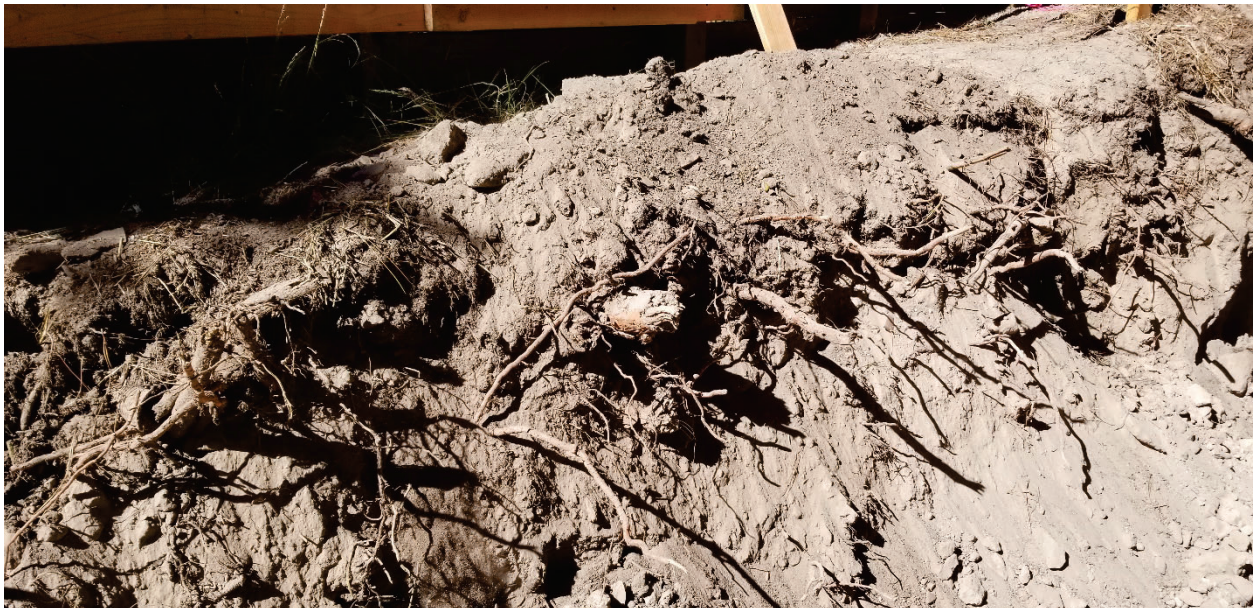
Figure 8: Roots seen on southern wall ripped rather than cut cleanly.

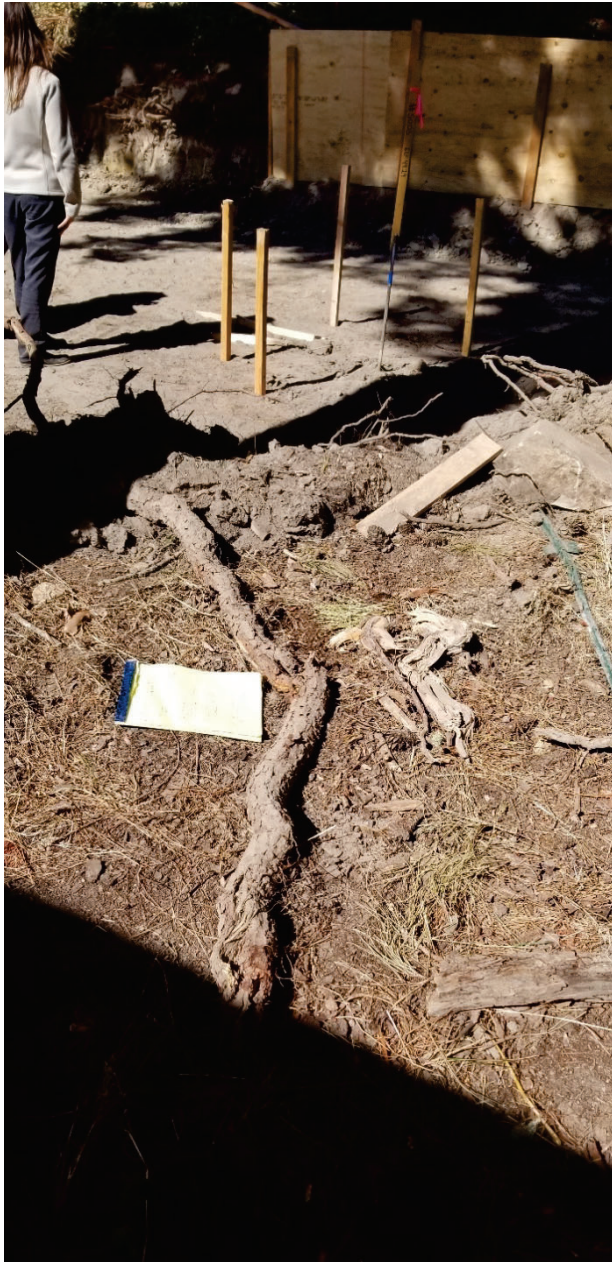
Figure 9: 6-foot long 4-inch diameter root seen laying next to tree 4.

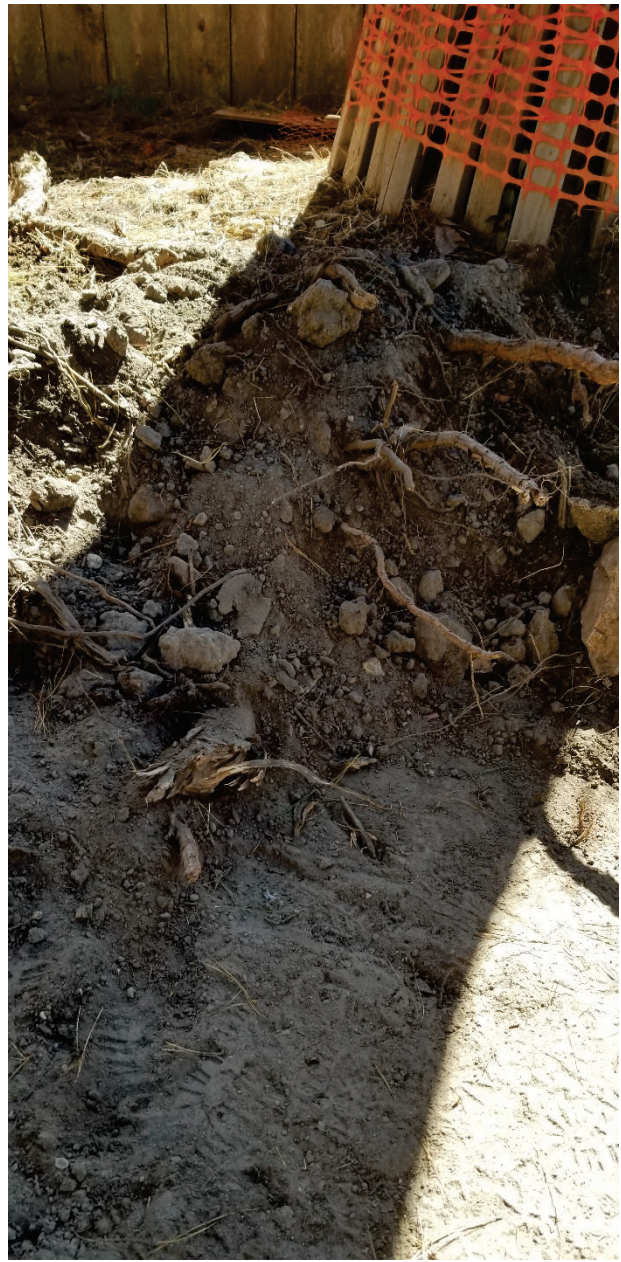
Figure 10: Torn remnants of roots with in 1-foot of trunk.
