CITY OF CARMEL-BY-THE-SEA FOREST AND BEACH COMMISSION Staff Report

TO:	Forest and Beach Commissioners
SUBMITTED BY:	S Davis, City Forester
SUBJECT:	Final special conditions and approval of reissuance of a building permit for the Mei home project located at Santa Rita Street, 2 Southwest of Fifth Avenue.

ARBORIST REPORT

Root damage during construction.

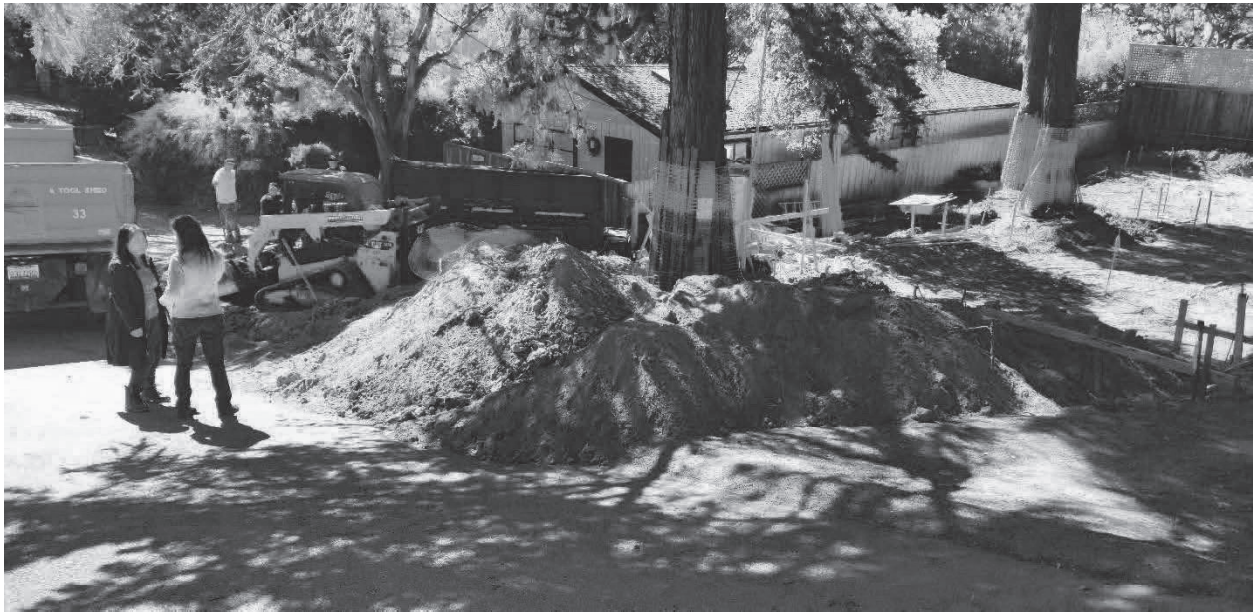
On the day of my inspection active excavation was underway with the use of a skid steer loader (Bobcat) and a Mini excavator. Crews were observed excavating soil from the northern side of the lot up to 5-feet deep and 1-2feet on the southern side. Soil removed from the construction area was being piled in the city right-of-way on the east side of the lot. The 6-foot tall and nearly 30-foot across pile of soil had roots up to 4-inches in diameter and 4-feet long intermixed in the soil.

Figure 4: Looking southwest from street, note large pile of soil.

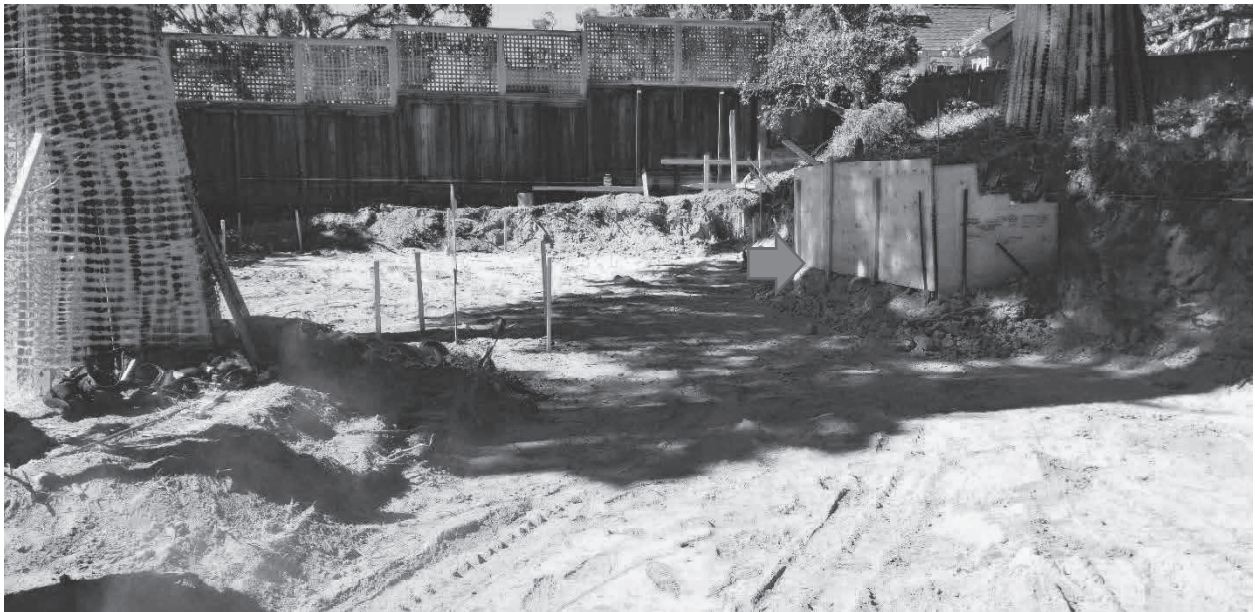
Entering the construction area, the soil was extremely dry and dusty. Freshly torn roots were observed throughout the area. A wooden box was present on north side of the cut wall near trees 6-8. I was informed the box had been placed and filled up with dirt in effort to protect the roots from drying out. To the east and west of the box fresh cuts could be seen on roots up to 3-inches in diameter as well as roots that had been torn from the wall from machinery. The majority of the southern root zones of trees 6-8 are believed to have been removed or damaged during construction.

Figure 3: Looking west inside excavation area, red arrow shows box that was constructed around exposed roots of tree #7.

1. Removal of tree #'s 4, 5 and 7.
2. Safety pruning of any trees retained. Trimming should be focused on removing any dead/broken branches over 1-inch in diameter, reducing overextended/heavy limbs, balancing canopies, and reducing wind loading. All pruning should be performed in accordance of ANSI-A300 standards. (Tree Care Industry Association, Inc., 2017).
3. Low nitrogen fertilizer soil injections for trees that sustained extensive compaction. Establish 6 to 8-inches of mulch beneath canopies.
4. Continued monitoring of any tree retained, with re-inspection in 1-year by certified arborist to assess structural integrity and health of trees.

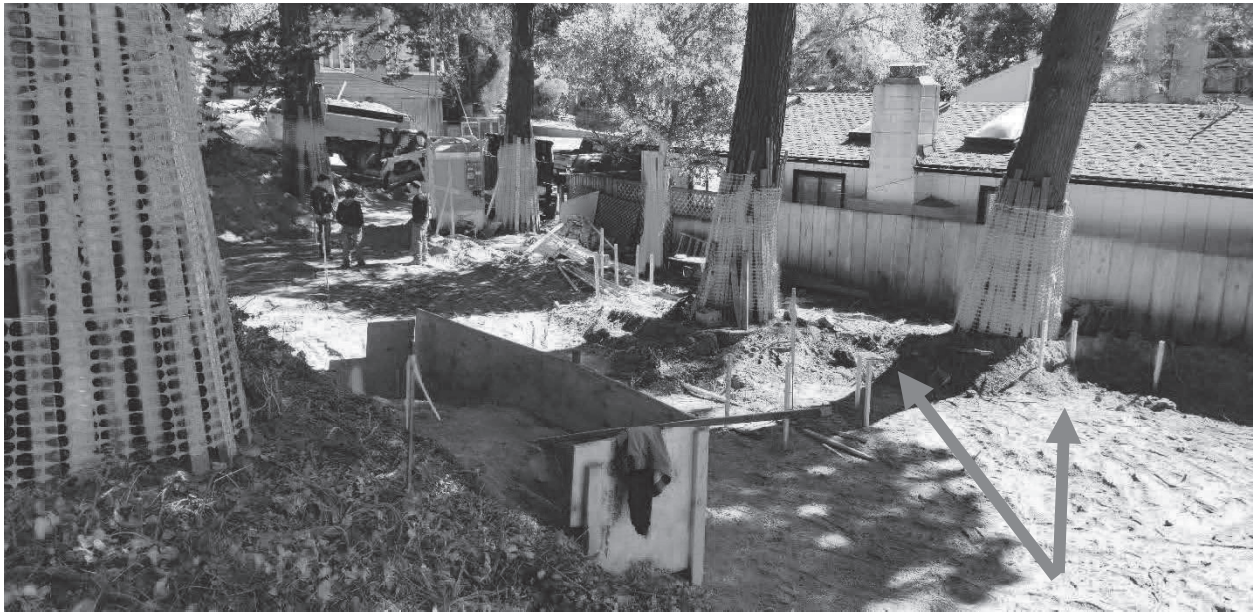
Damage done to trees 4 and 5 on the south side of the lot is suspected to have the most immediate impact. Excavation with in 1-foot of the trunk on the majority of the northern dripline 1-foot deep, resulted in extensive root loss. Both trees 4 and 5 display canopies heavy to the south and the loss of tension roots may result in whole tree failure.

Figure 5: Looking southeast from Tree #7, red arrows note how close excavation was preformed near trees 4 and 5.

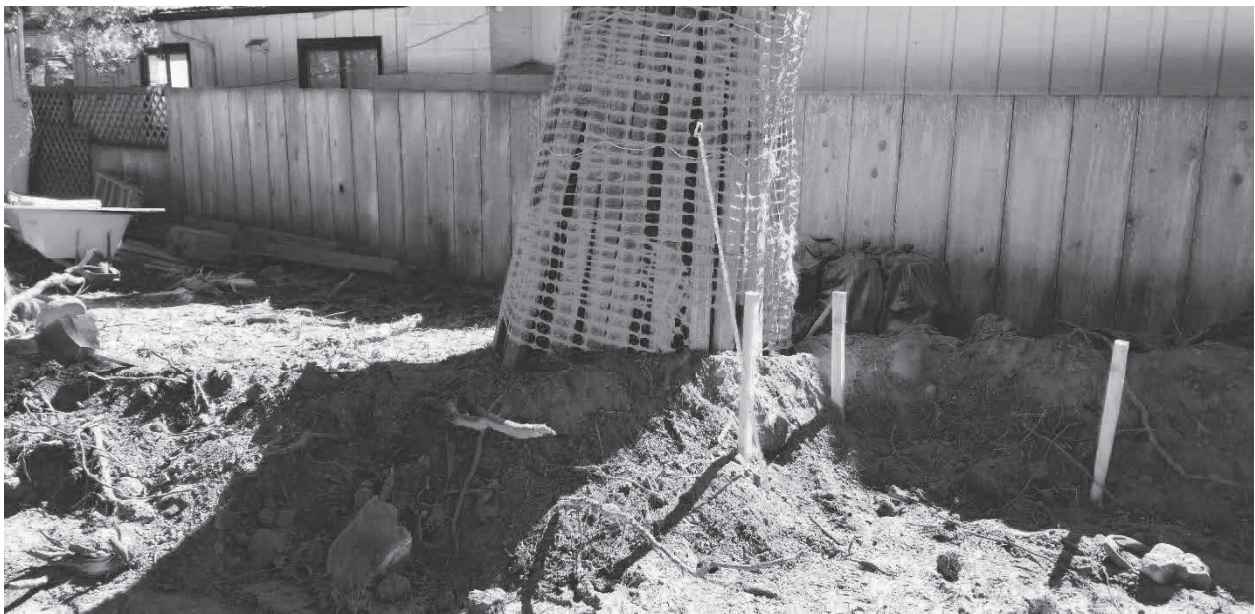
Figure 6: Looking south at Tree #5, Note roots ripped from ground with in 1-foot of trunk.

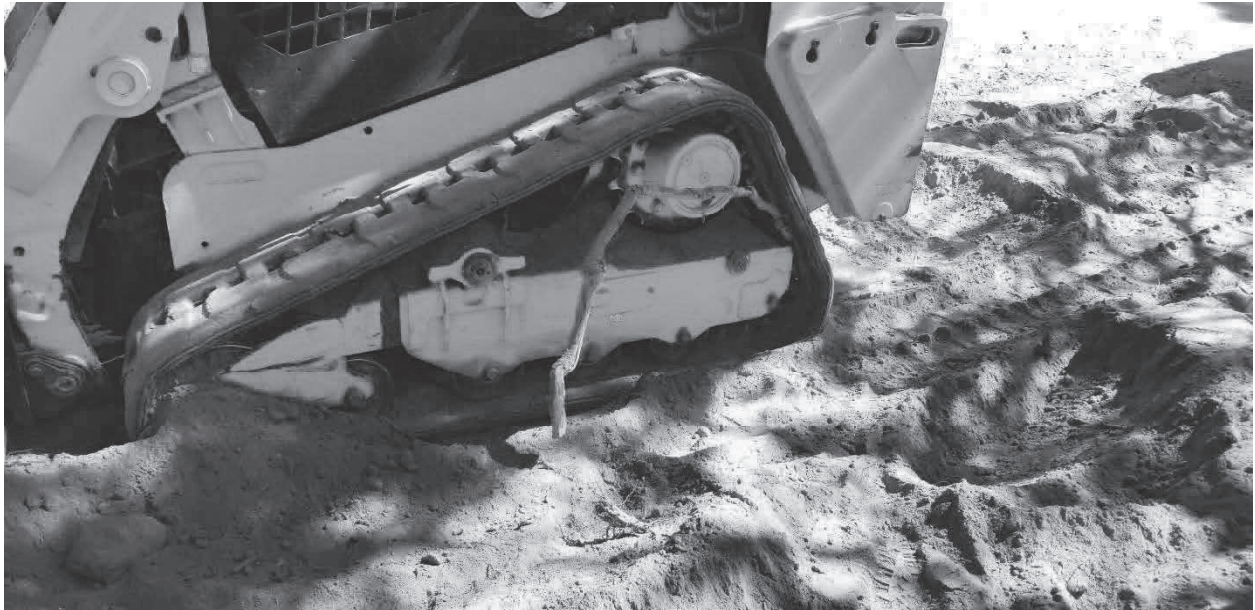
The excavation on this lot was done with blatant disregard to the trees on site. The roots seen thrown about the property and stuck in heavy machinery's wheels suggests extensive damage to root systems. Ripping roots from the ground with machinery can result in fractures in the trunk of a tree. The wounds provide a path for pathogenic, wood decaying fungi to further reduce structural integrity of trunk and root system and health of the tree. The loss of roots reduces the trees ability to absorb water and nutrients, leading to canopy decline. Construction damage can often take several years to reflect in the canopy, due to stored nutrients in the tree, but often result in extensive canopy dieback or catastrophic failure.

Figure 7: Skid-steer loader operating on site, note roots stuck in tracks an indication that little to no caution of roots was taken during excavation.

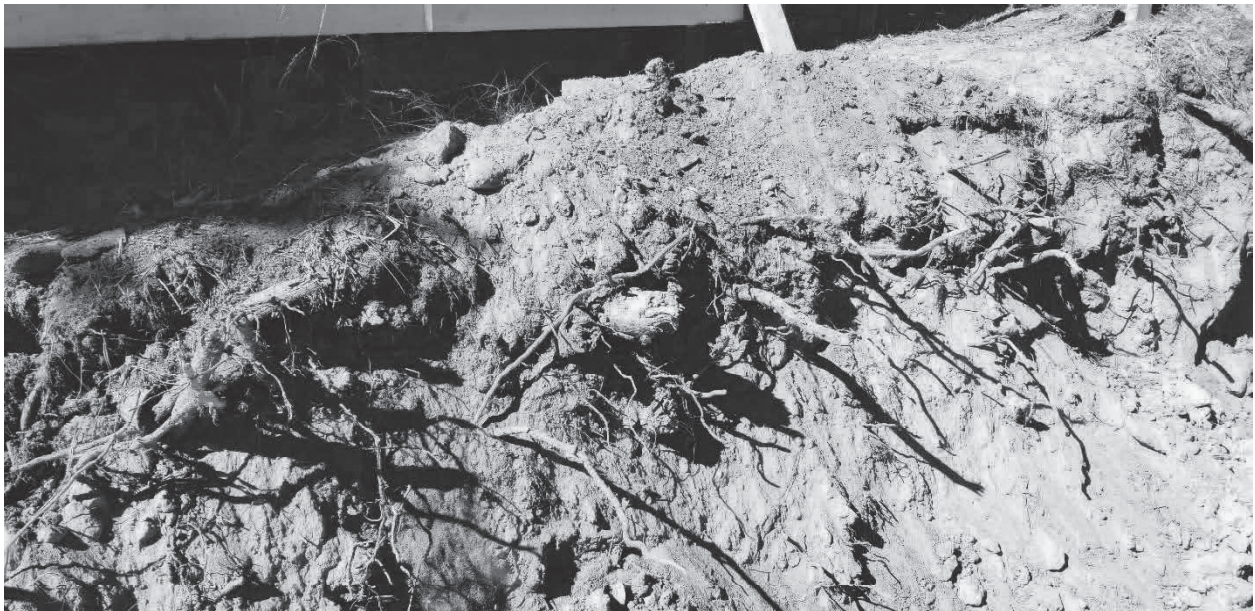
Figure 8: Roots seen on southern wall ripped rather than cut cleanly.

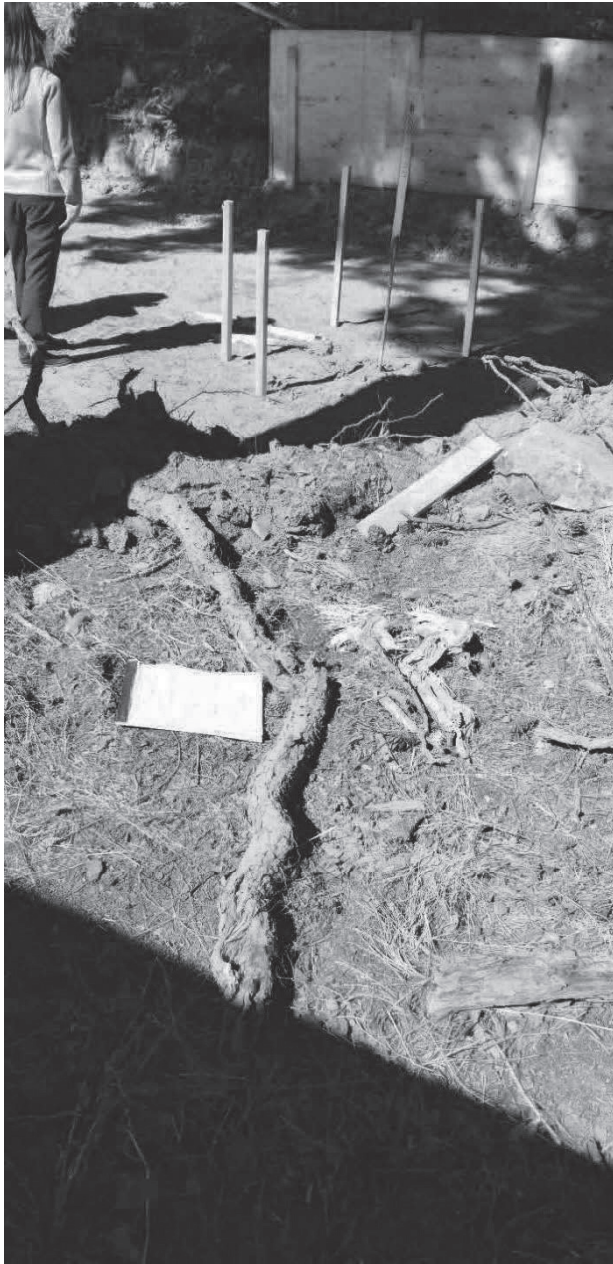
Figure 9: 6-foot long 4-inch diameter root seen laying next to tree 4.

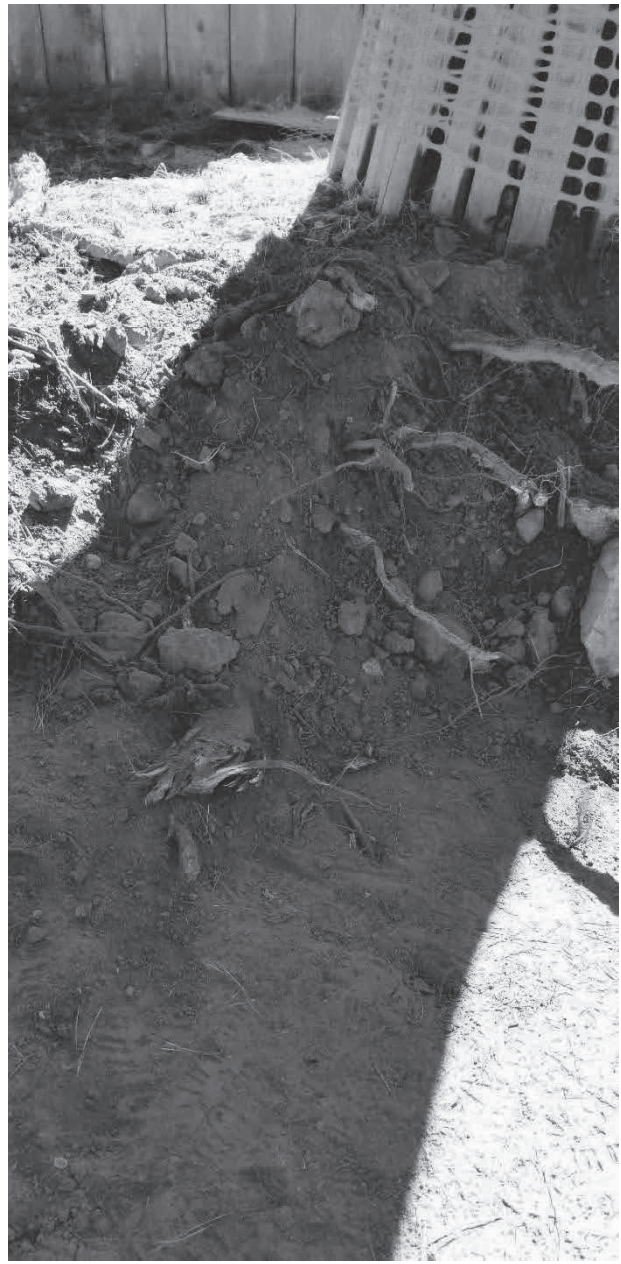
Figure 10: Torn remnants of roots with in 1-foot of trunk.
