RE: Pine Removal- 1st 2 SW of Monterey Street, Carmel CA
APN: N/A

1st 2SW of Monterey, Carmel by the Sea Tree Assessment

Prepared by Frank Ono
1213 Miles Avenue
Pacific Grove CA, 93950
Telephone (831) 373-7086

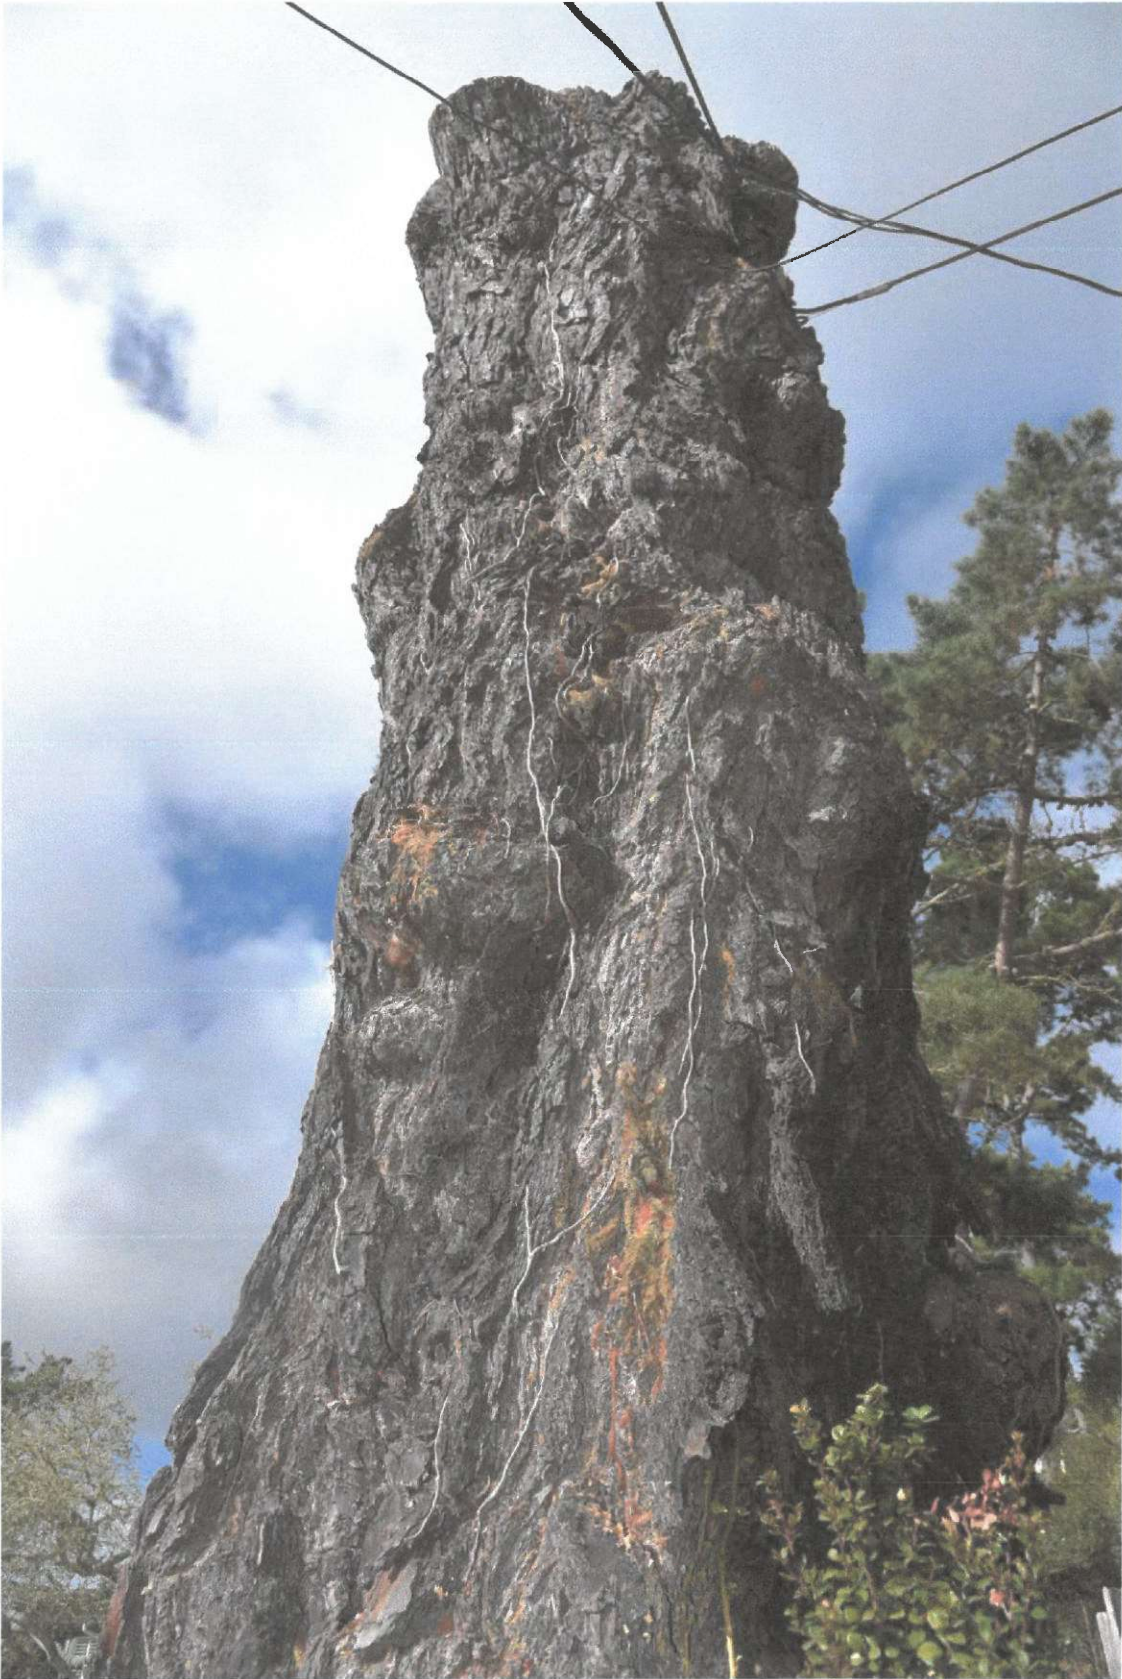
I was informed that on October 2, 2020, a Monterey pine with structural problems was mistakenly identified as a tree ordered for removal by the City of Carmel by the Sea. The crown of the tree was removed before the discovery of the error. After the error was discovered, work was stopped, leaving a 20-25-foot bole to remain until the hearing before the Carmel Forest and Beach Commission is held.

Remaining bole of subject tree

The tree was problematic structurally. Erratic limb growth from topping and the problematic base of the tree creates liability for the city. Because the tree was a standing liability, it reasonable to assume the tree as a good candidate for abatement.

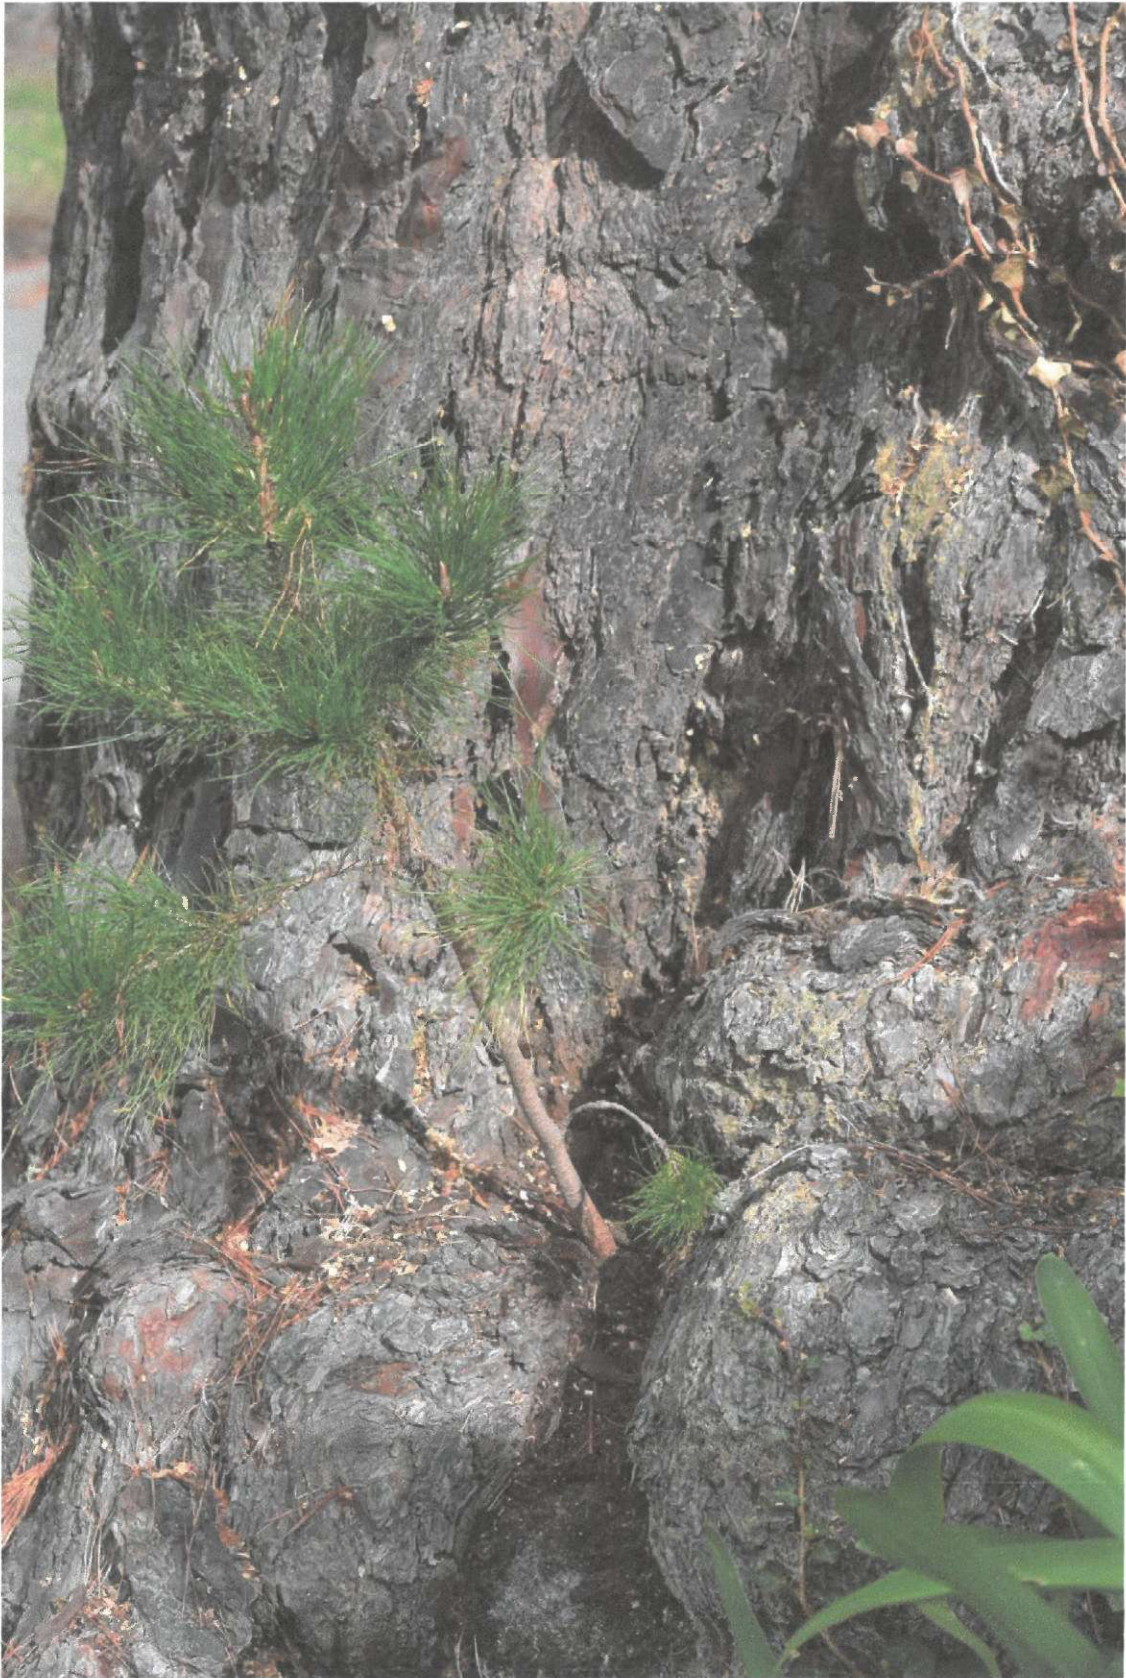
- The base of the tree has an area on the west side of the trunk there is a separation of the root collar bark at the base of a decay seam, with decaying wood and emergence of small 3-4-year-old pine sapling growing out from the wood.

The tree was previously topped, and its roots disturbed by construction. The tree's root collar was damaged, most likely during street improvement construction, where the small sapling is now happily growing. The sapling appears to be healthy as its roots are most likely embedded in moist decaying wood.

Small 3-4-year-old Pine sapling growing out from base of the tree at the base of a decay seam

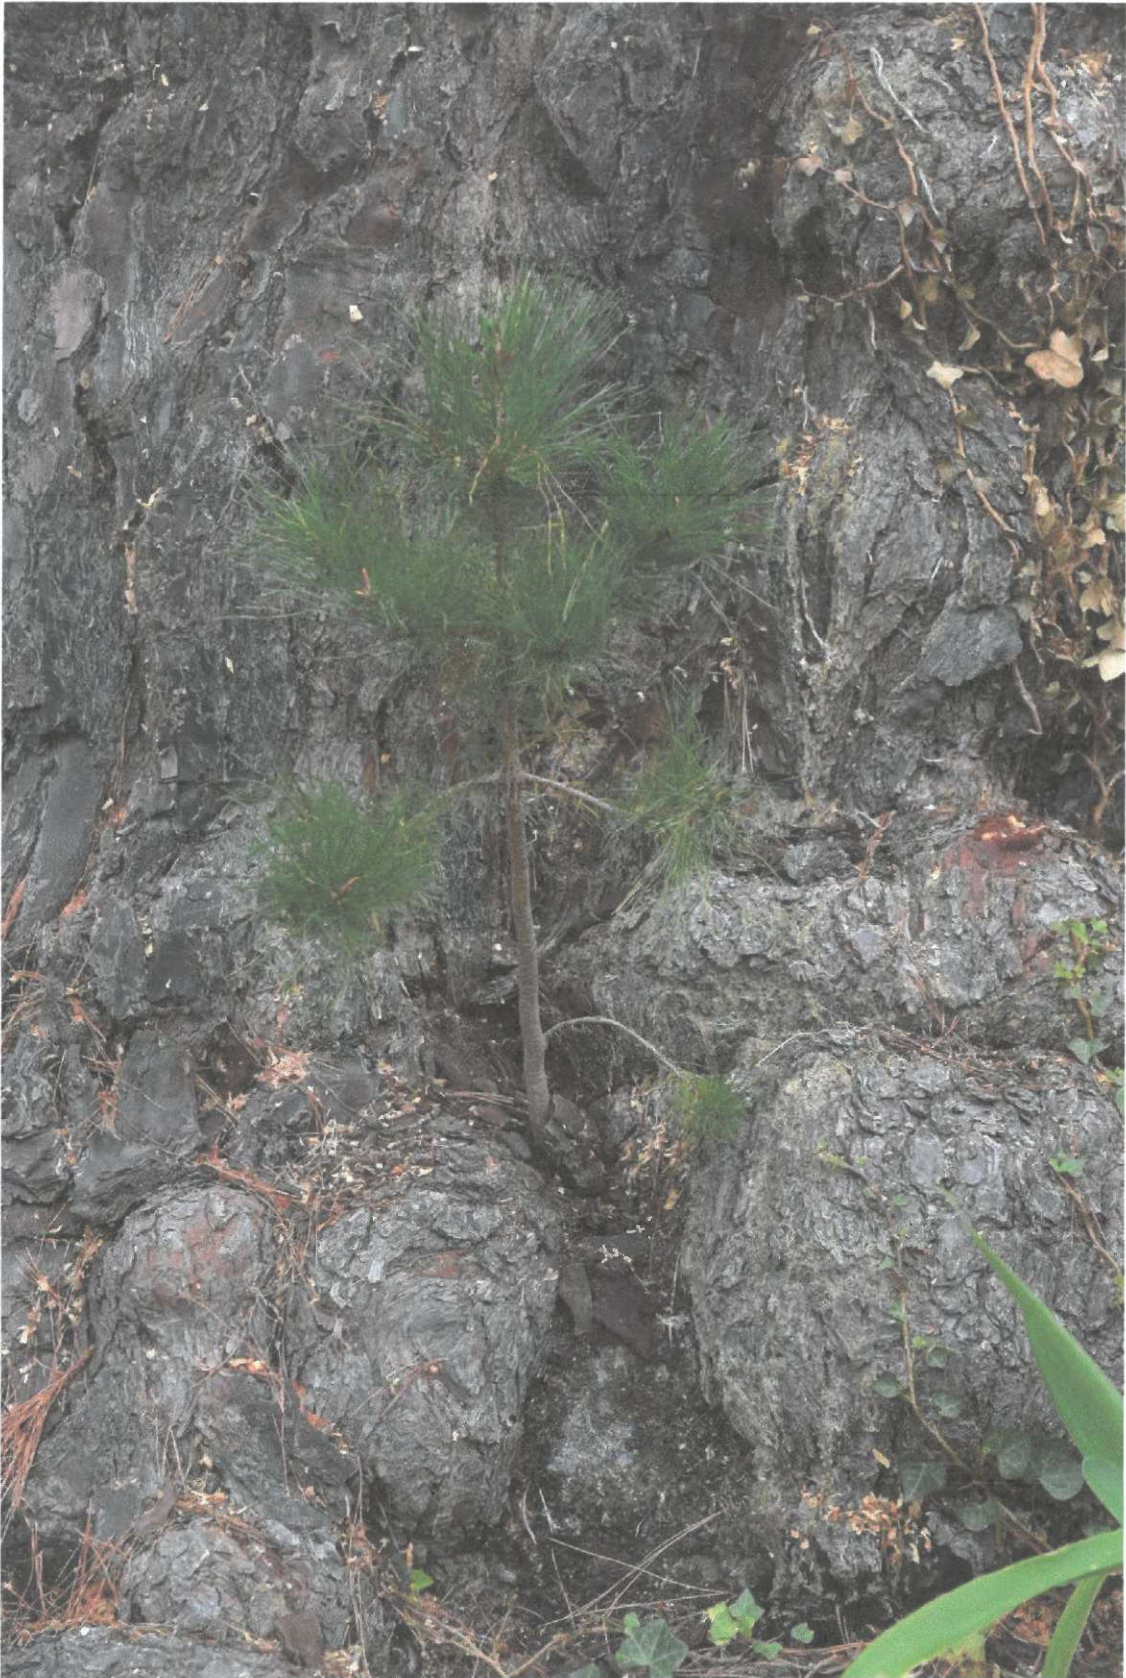
Pine sapling

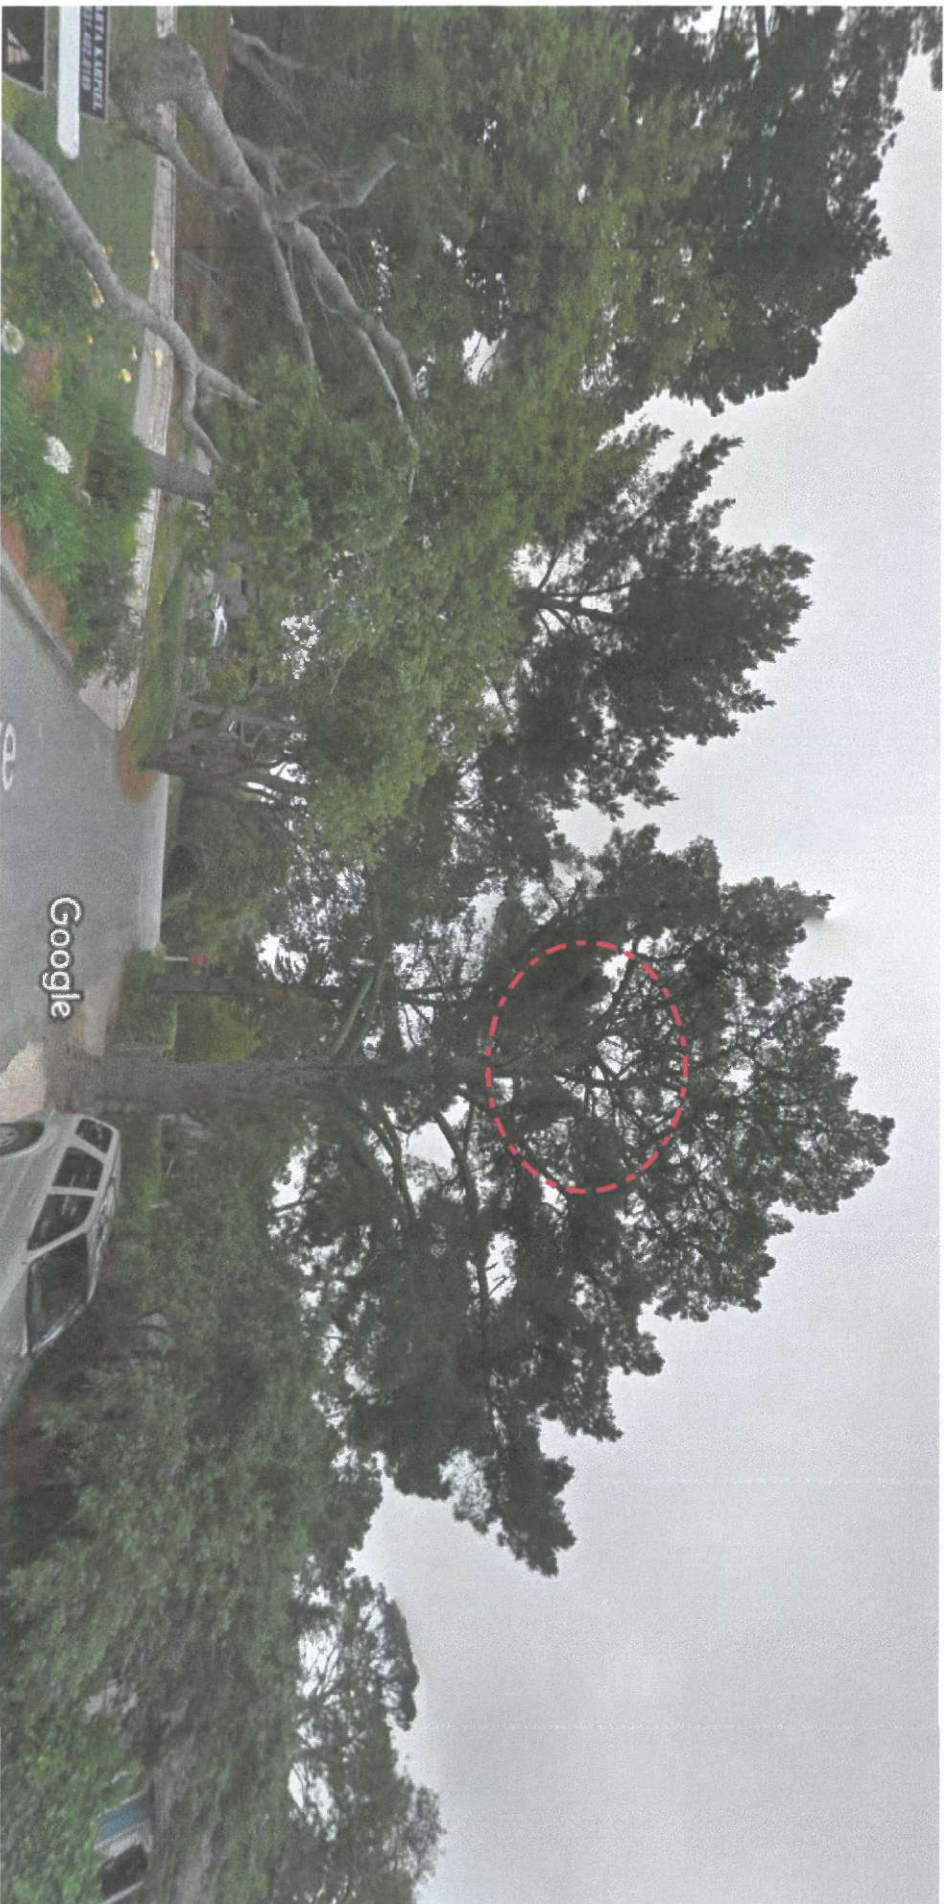
- The crown of the tree was removed. The height of the tree could not be determined, however, according to the 2018 Google image, the tree had a thinning crown spread of 40 feet. Other google photographs reveal that the tree was previously topped with overextended limbs growing toward the structures to the south. The overextended limbs have been pruned by lions tailing.

The google images also show erratic growth typical of pine when they are topped. Topping is often used to reduce the size of a tree. Topping is not a viable method of height reduction and does not reduce future risk, rather topping increases risk in the long term, due to the formation of weakly attached limbs it causes. Topping is the indiscriminate use of heading cuts of tree branches or stems to lateral branches that are not large enough to assume the terminal role.

The photographs reveal there are weakly attached leaders formed from the topping of the tree. The limbs have grown out and become overextended toward the structures beneath them. When pine is topped it retards vertical growth and this pine shows a distinct pattern of weakly attached limbs formed from the stem where the topping occurred. In the photographs, the limbs reacted to the topping. They are overextended and lions tailed (lions tail pruning damages the health, and structural stability of the tree. It is a pruning method where all of the interior branches are removed, leaving only tufts of leaves and small branches at the ends of the large limbs. Trees suffer from malnutrition, sunburn, and increased limb breakage. Removing excessive amounts of leaves reduces the ability of a tree to make food. The reduction of foliage on branches to a small tuft at the end of a long limb creates a lever that catches the wind, often snapping the branch off).

Topped pine

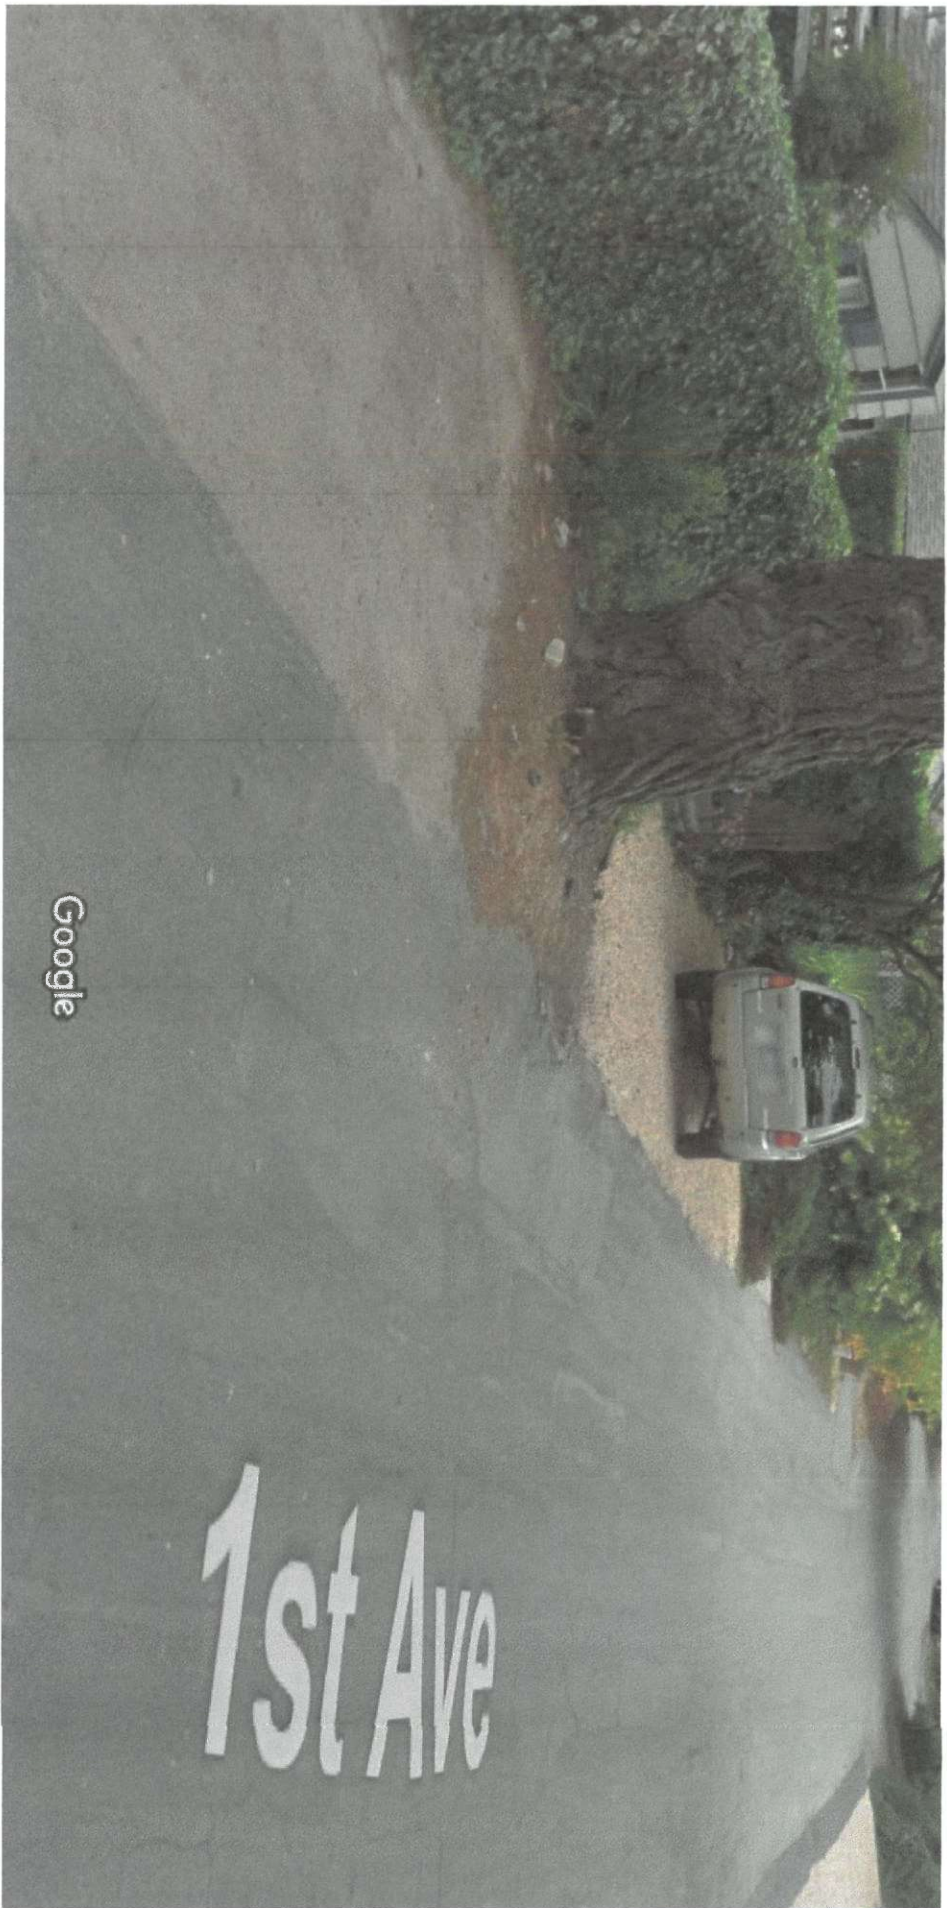
- The area on the north side of the tree appears to have been recently paved. Historical photographs reveal that the street was targeted for underground work and root removal.

previous root disturbance and repair, prior to 2011

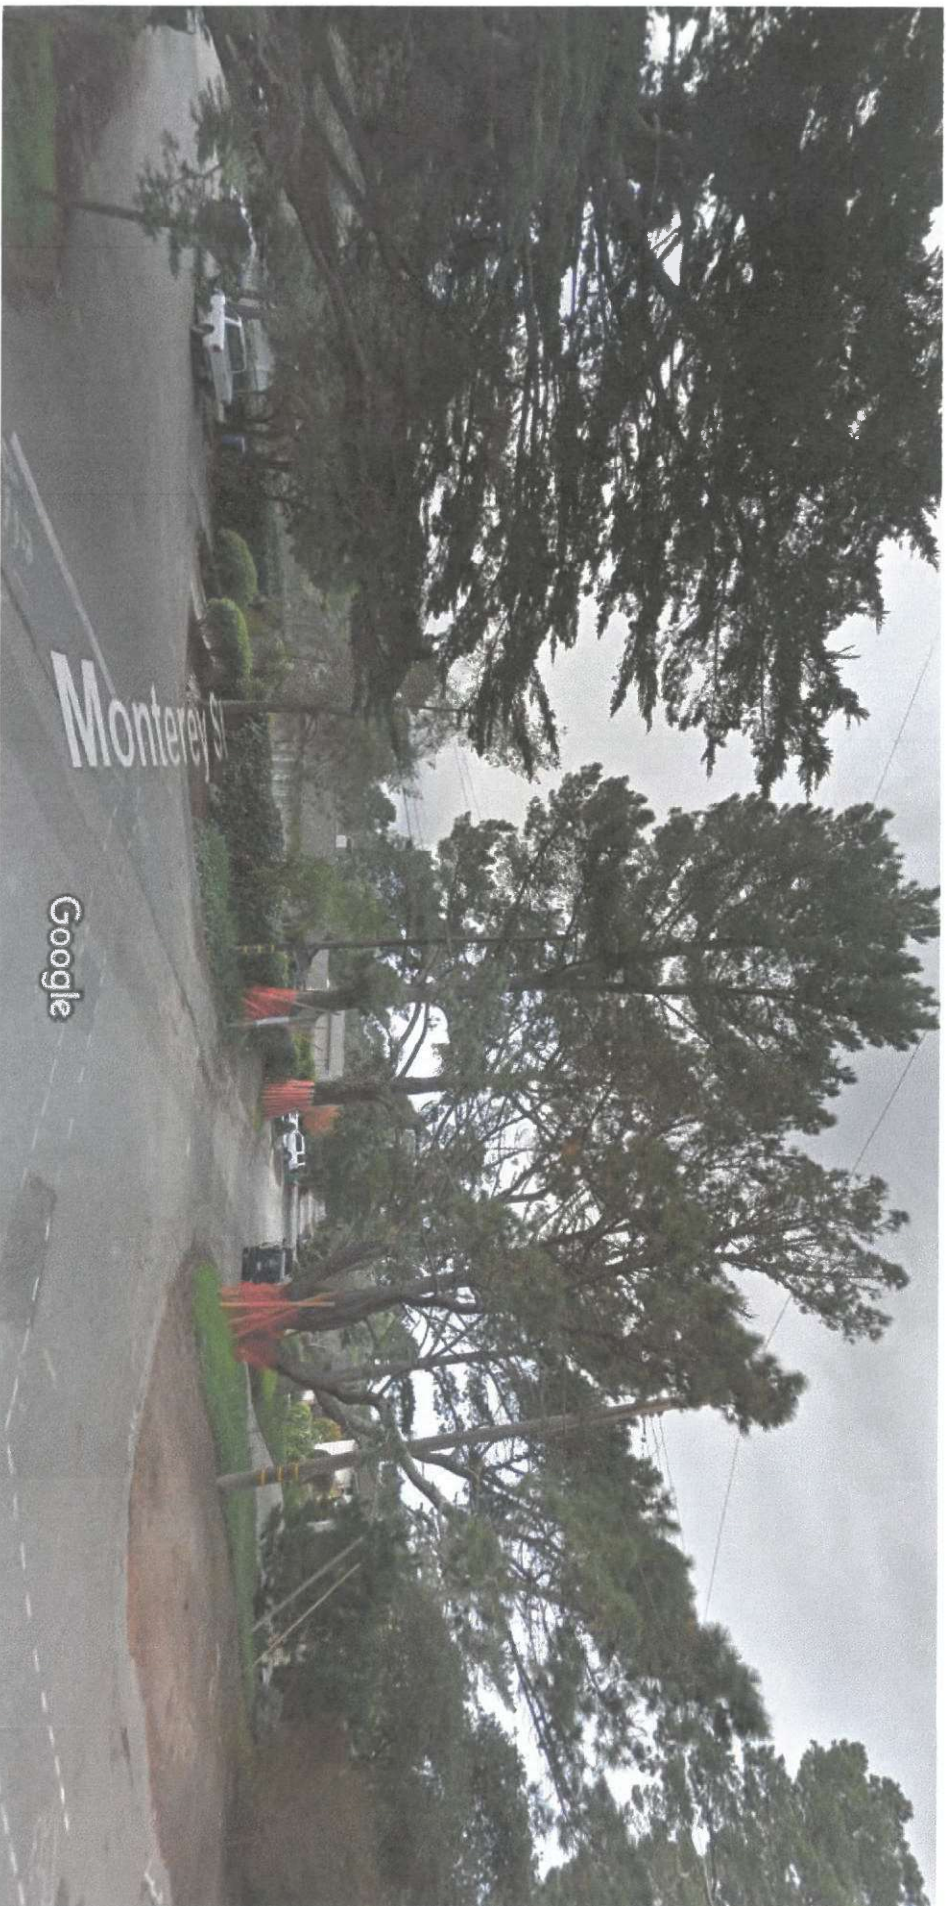
Construction in street adjacent to subject pine
