**SCOPE OF INSPECTION:** The limited, visual inspections, evaluations and reports for this building are intended for the exclusive use of the City of Carmel-by-the Sea / Historic resources Board only. The inspection is NOT an engineering evaluation of the property or structures.

**CLAUSEN RESIDENCE**  
DOLORES ST. 5 NW SECOND AVE.  
CARMEL-BY-THE-SEA, CALIFORNIA

**A-1.0.2**

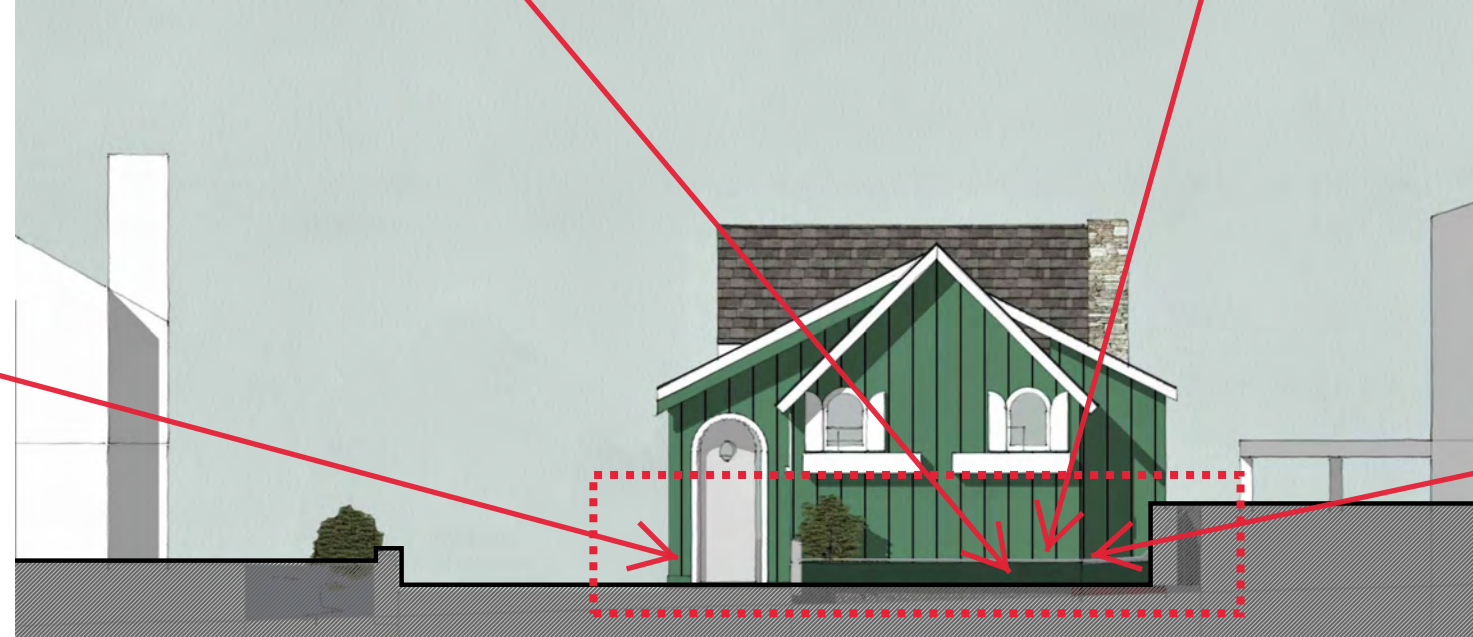
EAST ELEVATION

**SITE:**  
The flagstone stone patio surrounding the front portion of the building doesn't slope away from the foundations. Water has entered the building causing wood deterioration. This damp environment is destroying the floor framing and provide conditions for mold growth. water stains were observed in the interior of the living room.

To reduce the amount of "water and moisture intrusion" into the building, the exterior ground levels should be maintained below the bottom of the wood siding, and the top of the concrete foundation. the exterior of the building should be properly sealed and additional sub-floor vents will increase the crawl spaces ventilation and reduce moisture. At ground level, properly installed french drains along eaves will re-direct running water away from foundations.

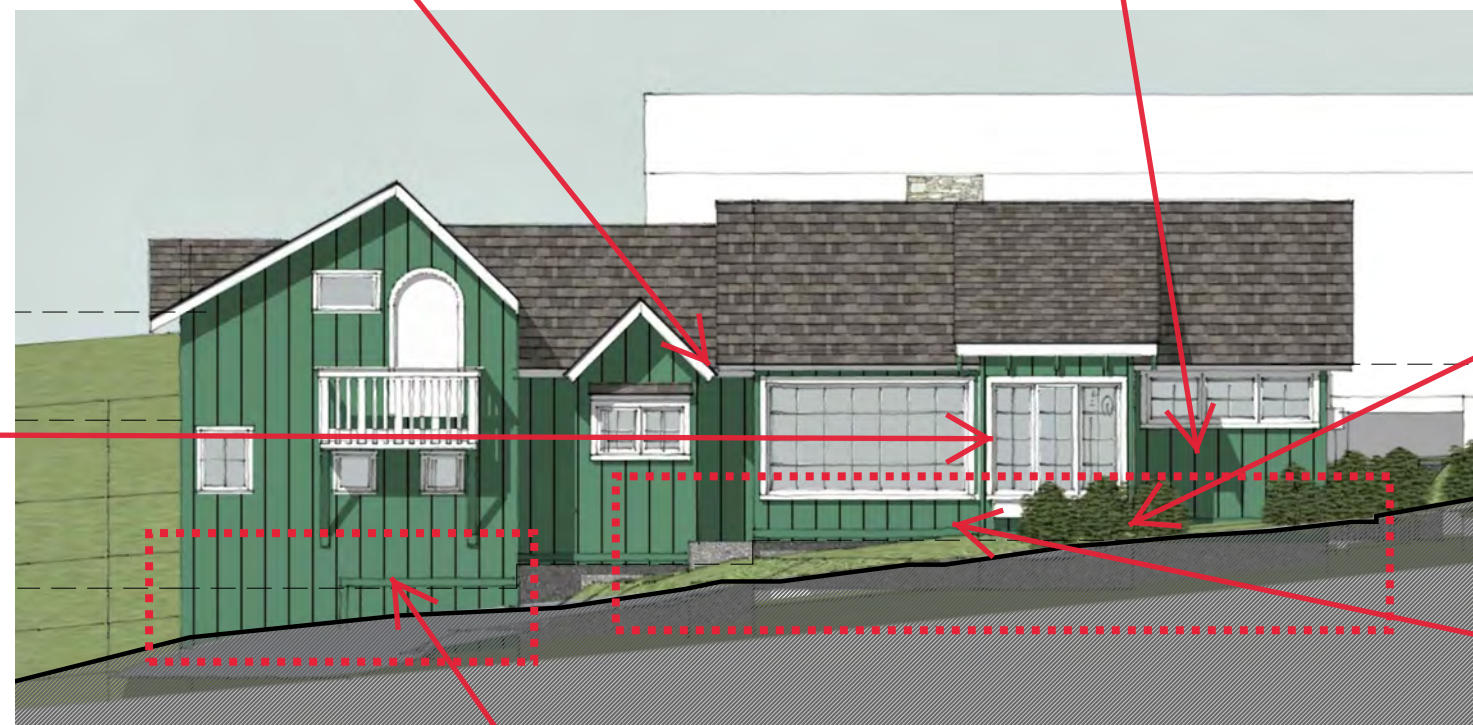
SOUTH ELEVATION

The structure shows some moderate to serious exterior wall maintenance deficiencies. Paint peeling and rotted wood can be found mostly in the lower portion of the walls due to splashing rain water and moisture absorption from siding in direct contact with the ground.

Rotted boards and trims will require to be replaced "like for like" using the same materials and installation methods. The vertical joints of the board and batten wall should be completely sealed and caulked, with the caulk being pliable without gaps or voids. A good weather protective paint or varnish finish should be maintained on exterior wood.

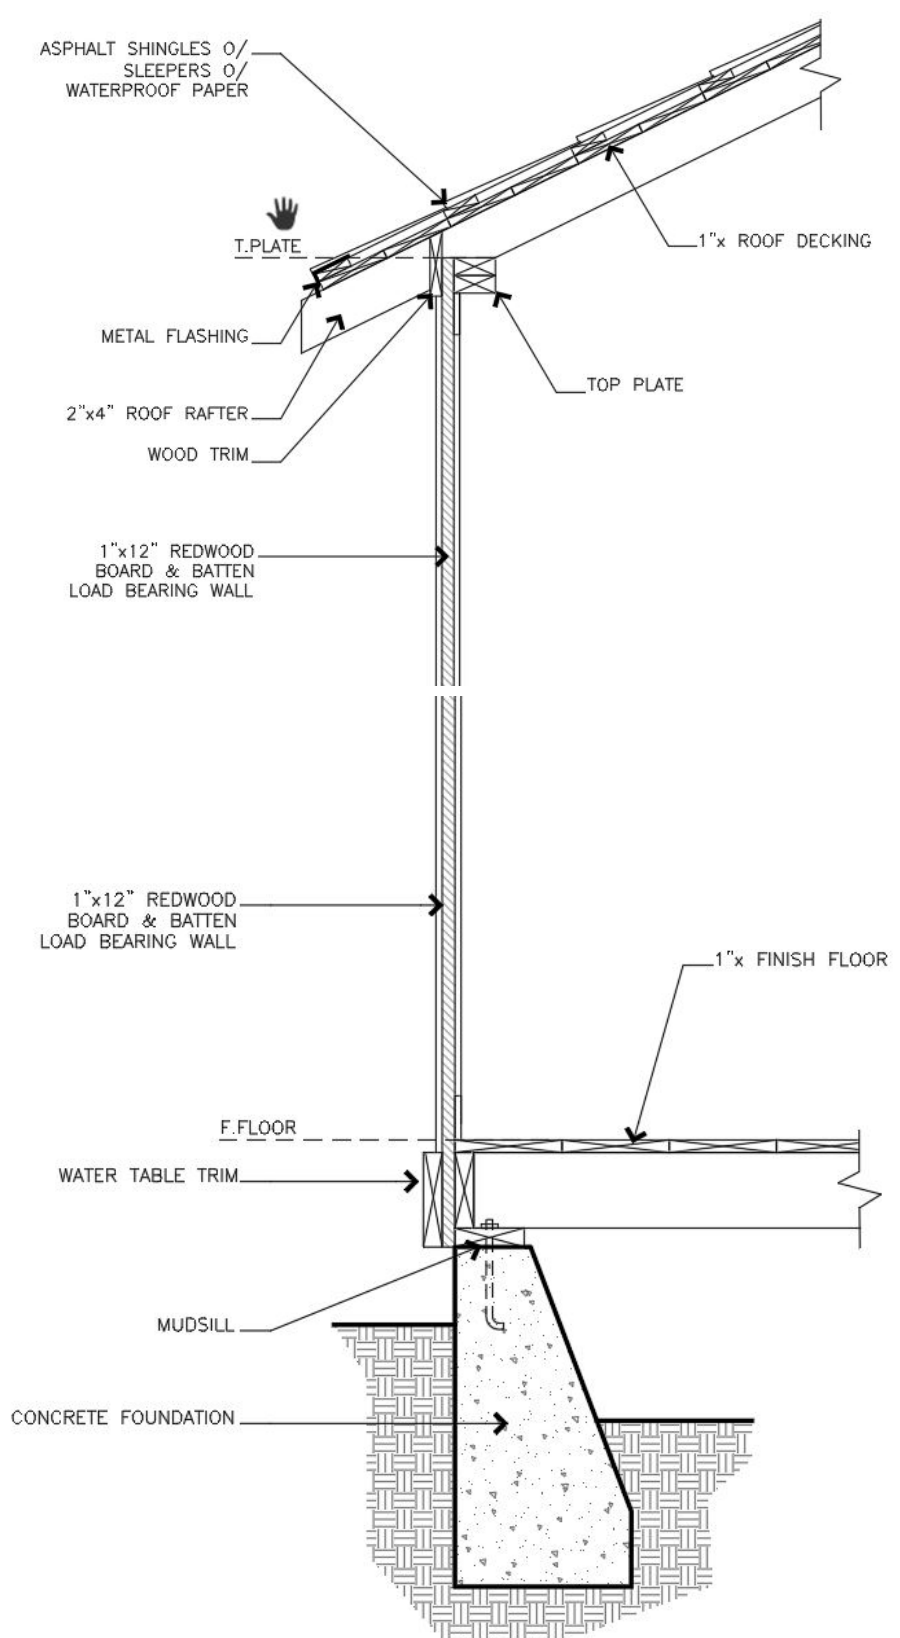
Existing Single-Wall Construction - Assembly Detail

This type of construction is essentially a shell—just an outer wall around a floor built off the ground. The walls are typically made from thick 1" x 12" redwood planks featuring board and batten to fit them together. The walls are supported by a few 2" x 4" studs at window and door openings. The walls, typically around 8 feet tall, were capped by roofing rafters spaced 2 feet apart, tied together with flat 1" x 8" or 1"x6" decking supporting the asphalt shingles.
