In review of the property file, permit history, and online records for the Complex, staff notes the following regarding the timeline wall (the information below is not intended to be an all-encompassing timeline, but is intended to provide additional context to materials and information already provided in the past staff reports and attachments).

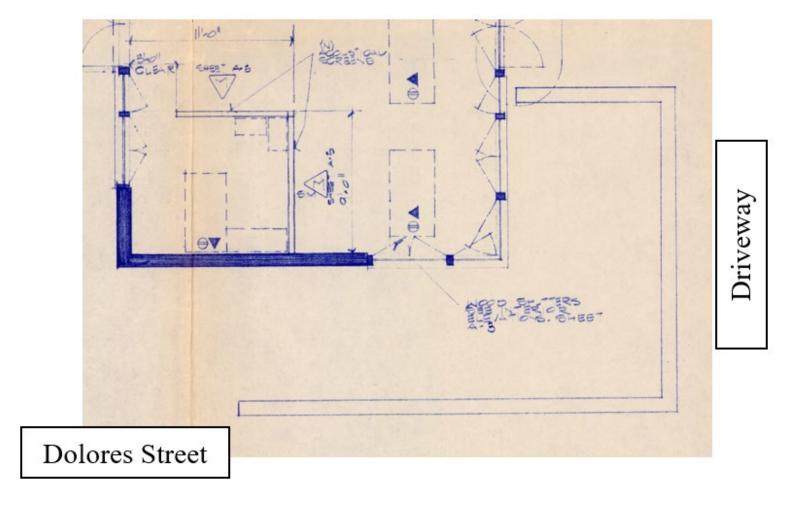
Figure 1. Partial Floor Plan.

• Plans from a 1978 office remodel (BP# 78-132) show the wall running parallel to Dolores Street, making a 90-degree turn east following the driveway, then making another 90-degree turn north, returning to the building. Heights of the wall are not noted.

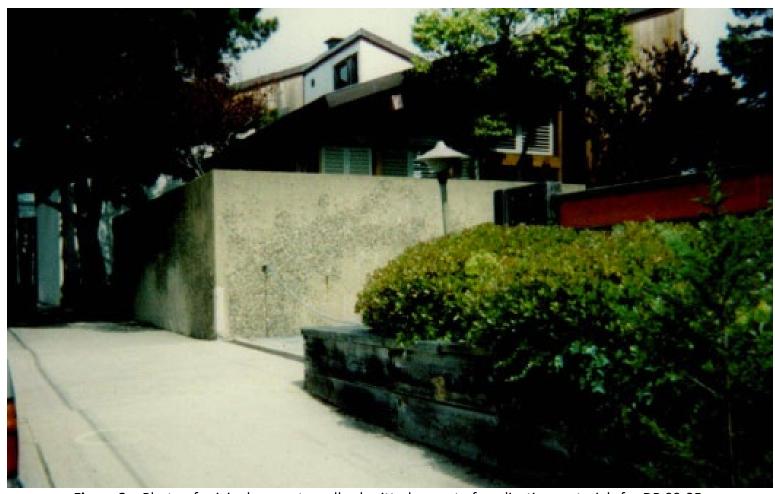
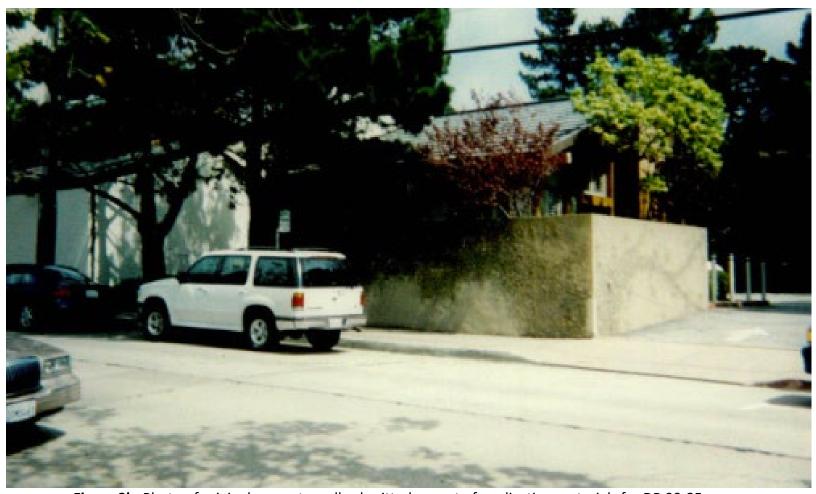
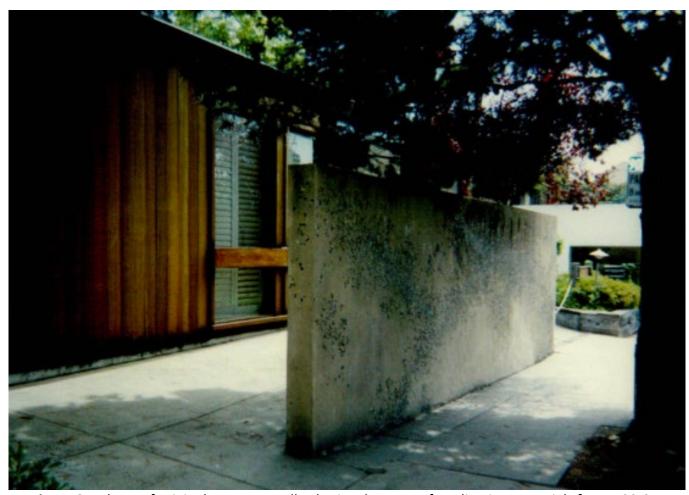
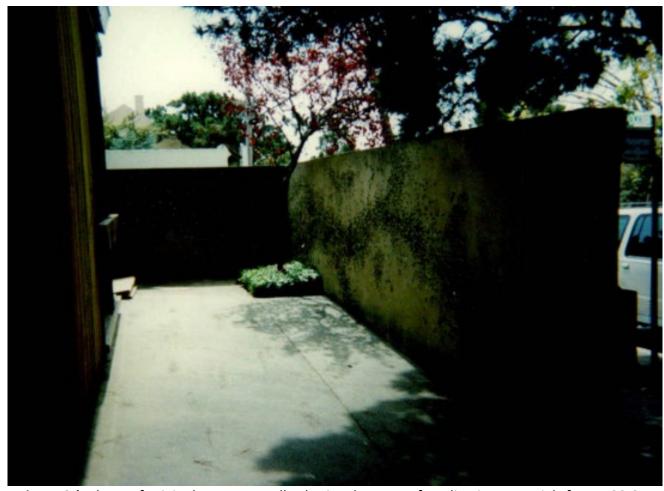
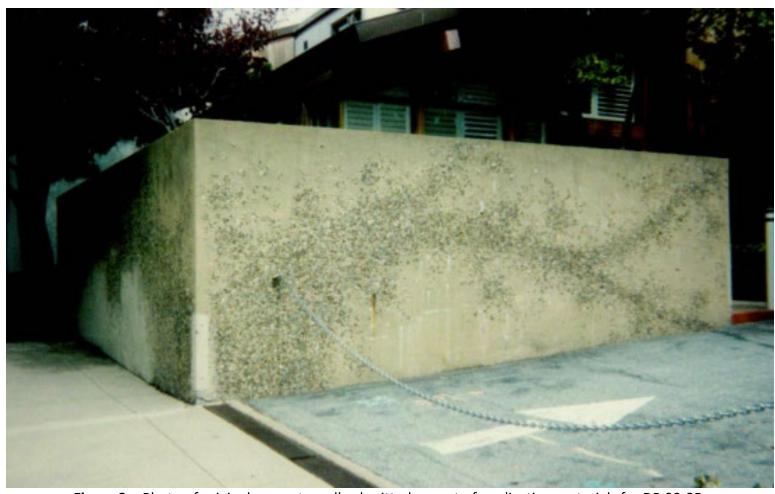
Figure 3a. Photo of original concrete wall submitted as part of application materials for DR 99-35.

Figure 3b. Photo of original concrete wall submitted as part of application materials for DR 99-35.

Figure 3c. Photo of original concrete wall submitted as part of application materials for DR 99-35.

Figure 3d. Photo of original concrete wall submitted as part of application materials for DR 99-35.

Figure 3e. Photo of original concrete wall submitted as part of application materials for DR 99-35.

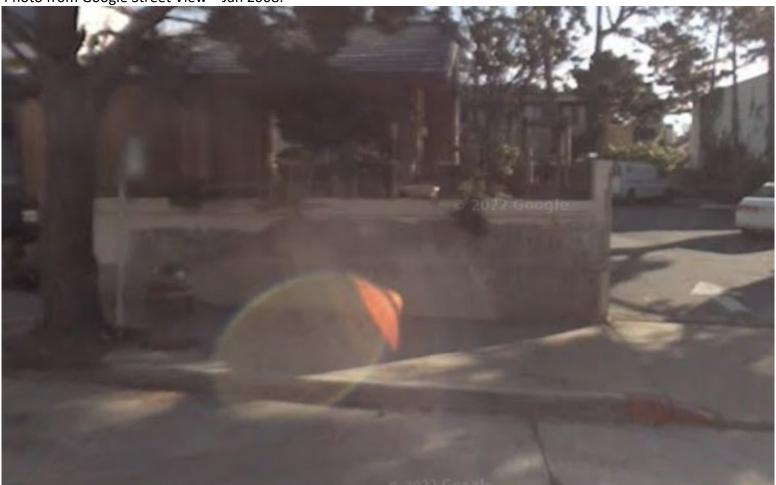
Figure 4. Wall viewed from Dolores Street. January 2008. Image shows wall had been cut down on Dolores Street Elevation with planter on top.

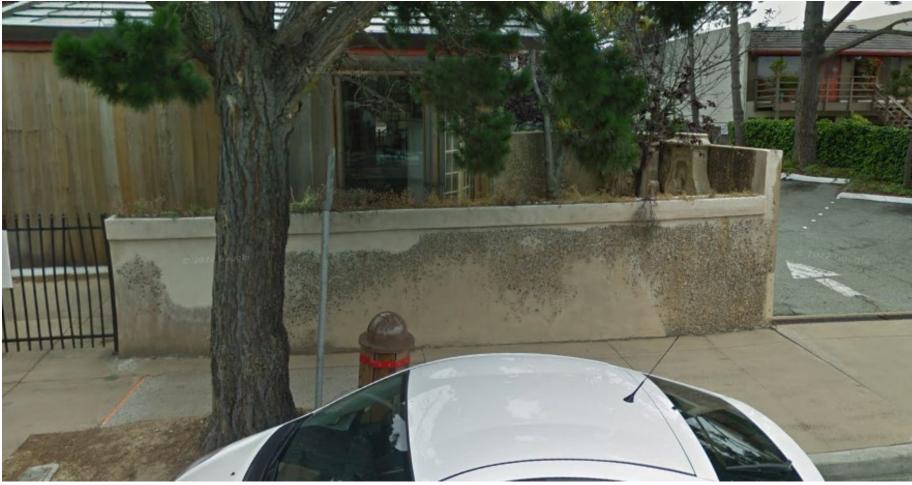
Figure 5. Wall viewed from Dolores Street. June 2011. Image shows wall had been cut down on Dolores Street Elevation with planter on top. Portion of wall returning to Community Room visible beyond.

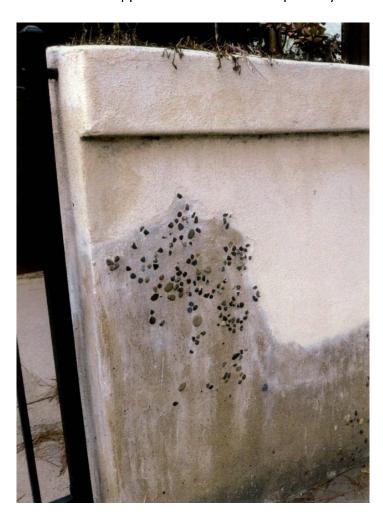
Figure 6a. Photos from application materials submitted with DR 13-24 (Photo 1). Photo is a of the northern most portion of the wall fronting Dolores Street where the wall connects to a steel gate (see Figure 5, above). Wall has been installed with a planter, a lip has been added to the top area around the planter, and the wall appears to have been partially plastered over.

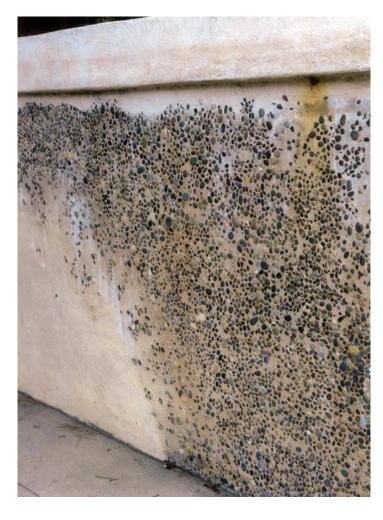
Figure 6b. Photos from application materials submitted with DR 13-24 (Photo 2). Photo is of the mid-section of the wall fronting Dolores Street (see Figure 5, above). Wall has been installed with a planter, a lip has been added to the top area around the planter, and the wall appears to have been partially plastered over. Original aggregate is shown on the right with plastered area shown on the planter lip and left side of the wall.

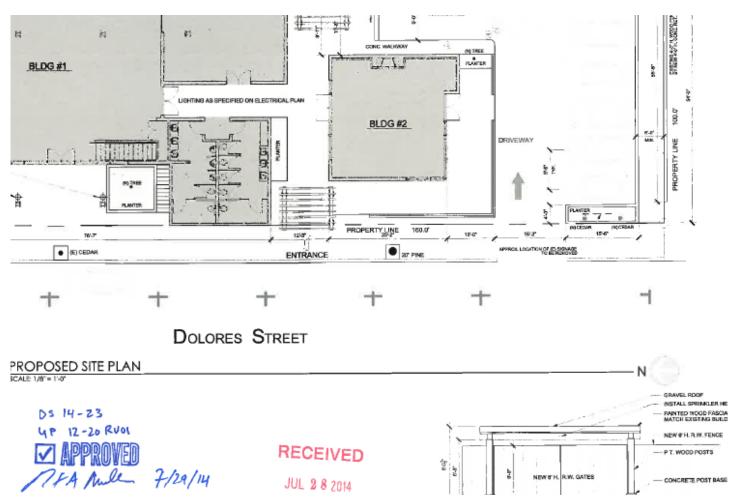
Figure 7. Partial as-built approved site plan. Wall shown in existing configuration. Return to community room demolished and new wall addition constructed.

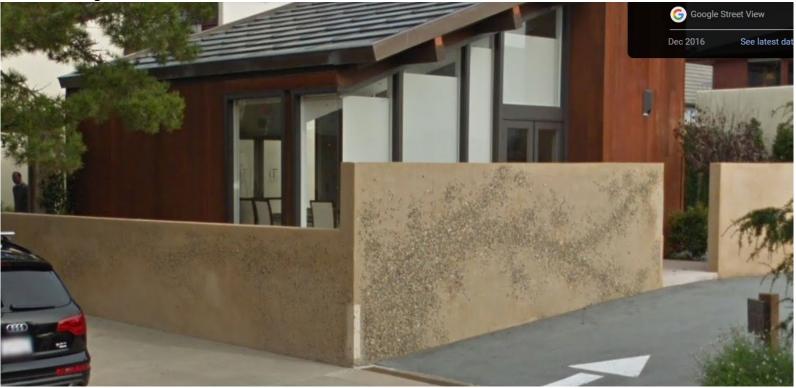
Figure 8. Wall viewed from Dolores Street. December 2016. Wall on fronting Dolores is repaired. All wall portions appear to be painted or stained from previous condition (see Figures 3, 5, and 6)
