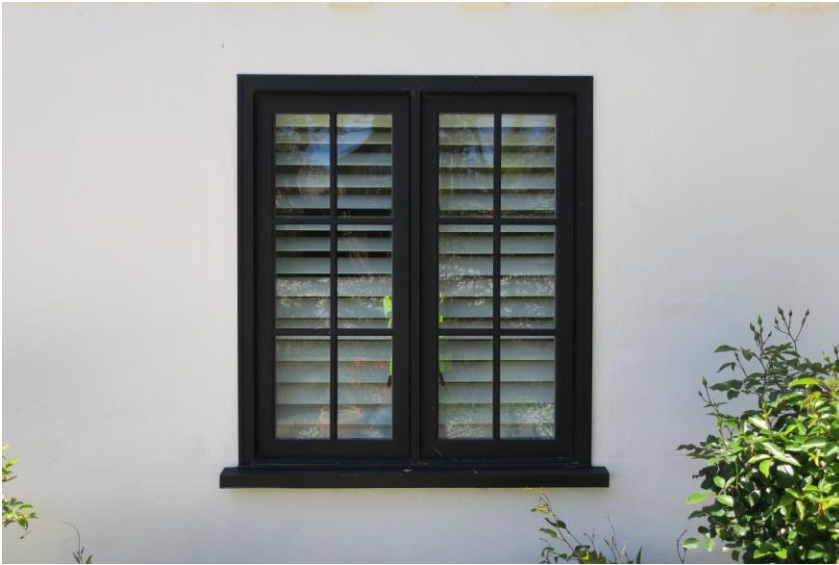
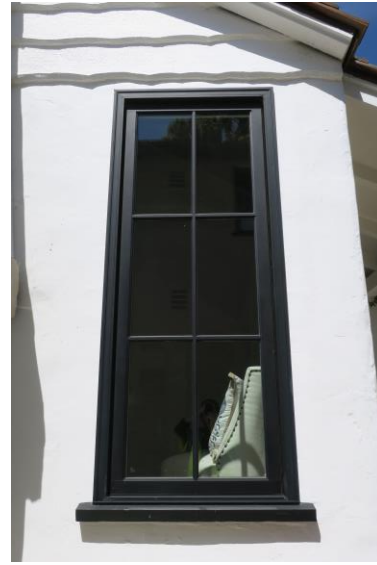
Aluminum-clad wood 6-lite replacement windows.

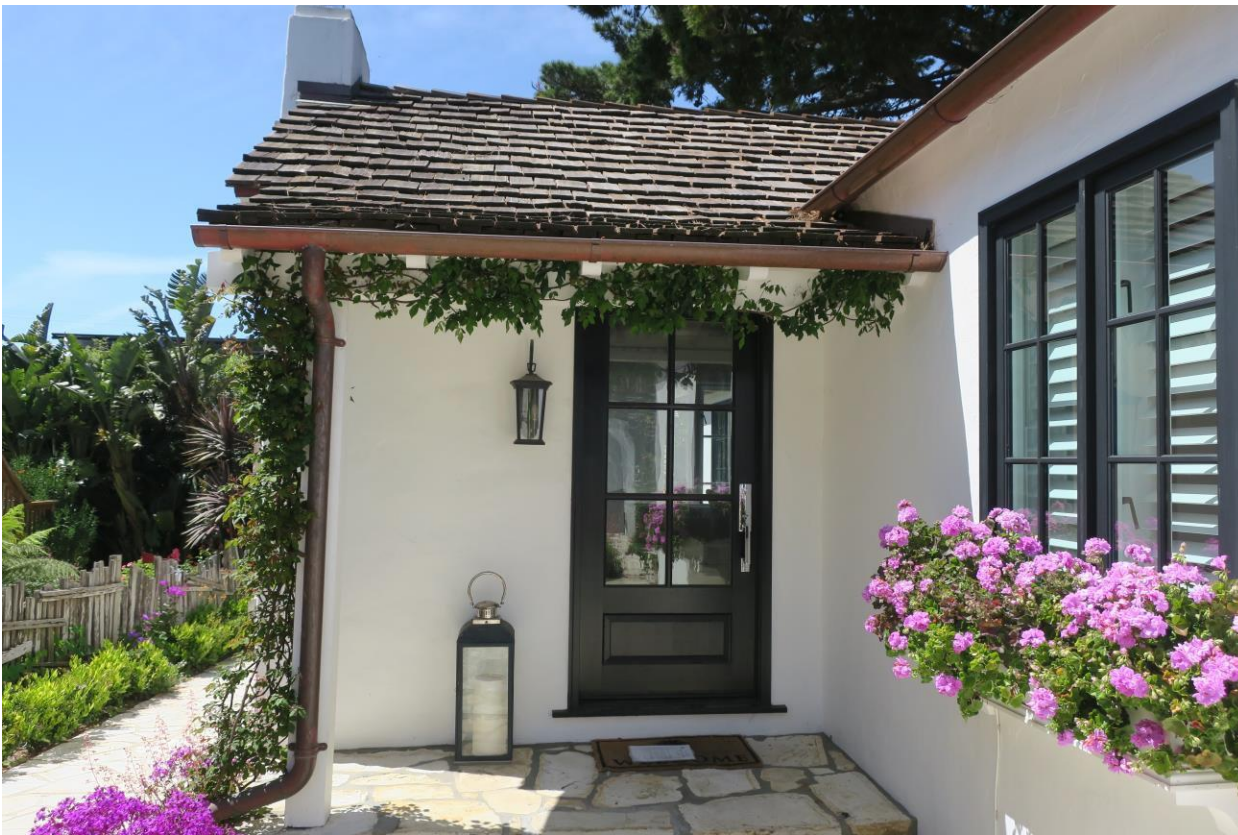
Replacement front door.

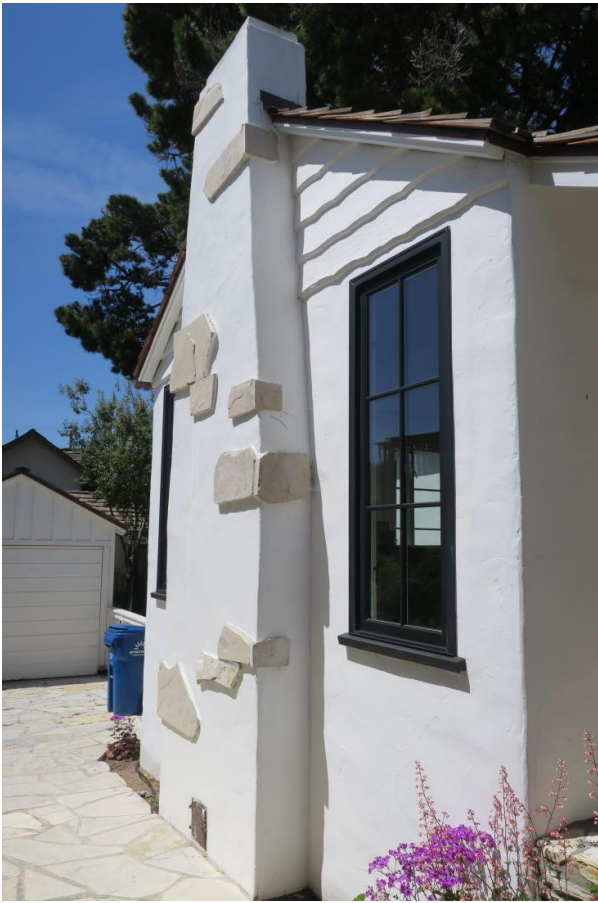
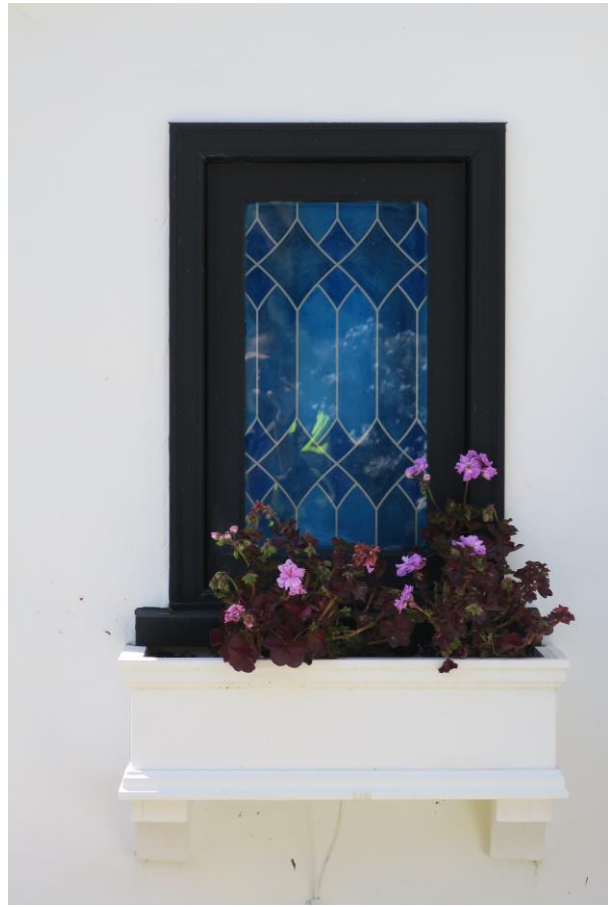
Original brick chimney on the south elevation covered over with stucco and stone, and replacement leaded glass window on the east elevation.

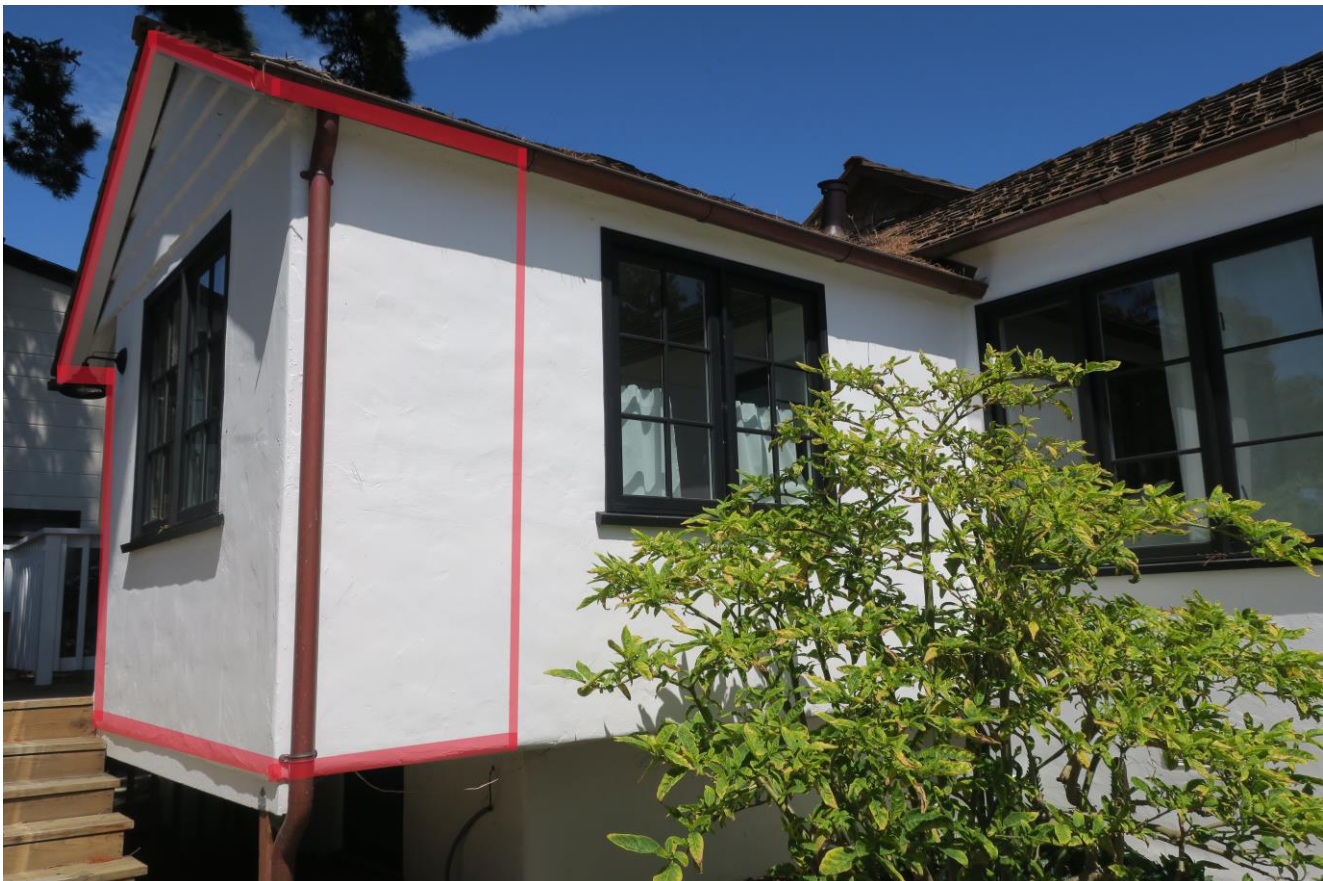
Rear (west) and south elevation, with the 1941 rear addition by Miles Bain outlined in red.

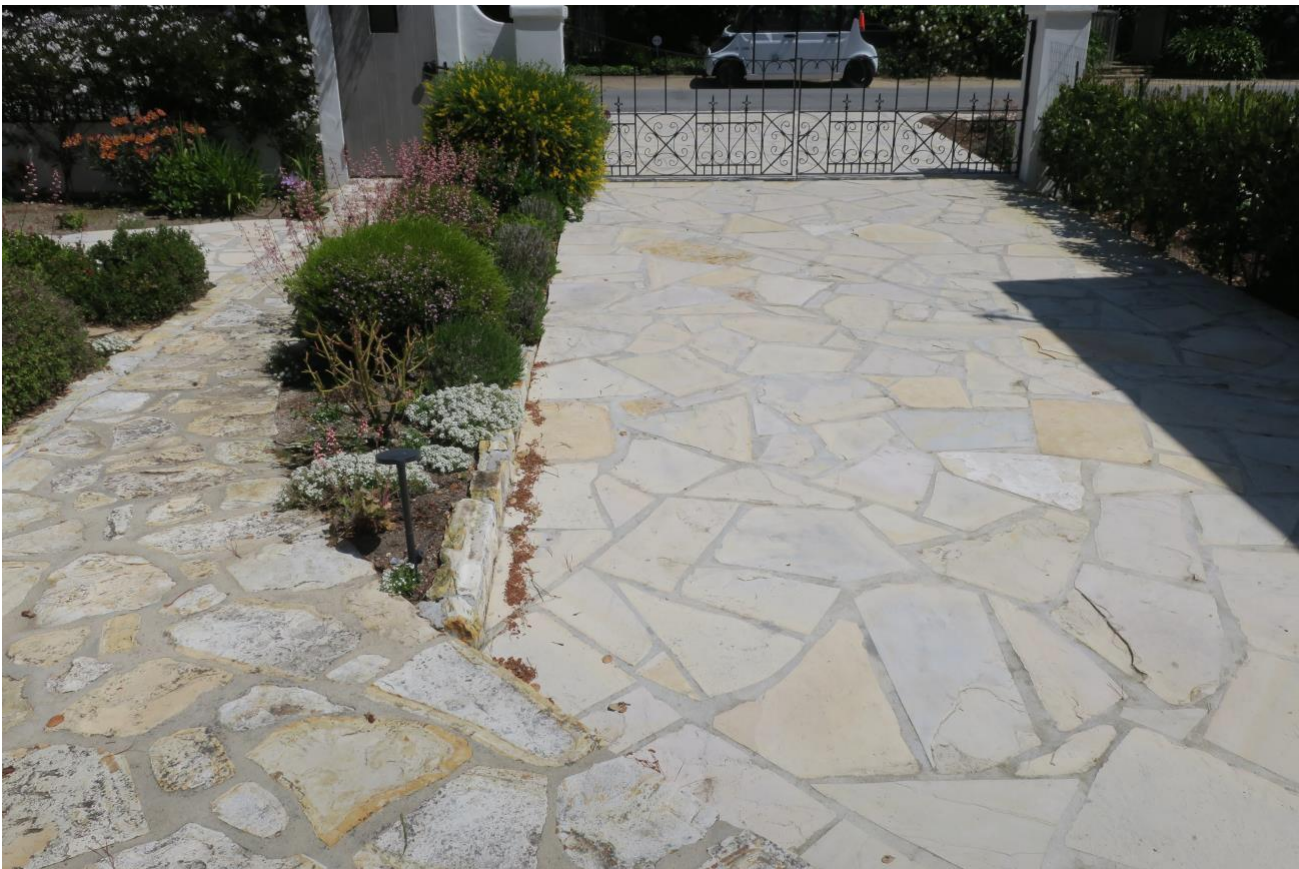
Original Carmel stone walkway (left) and recent stonework and driveway gate (right).

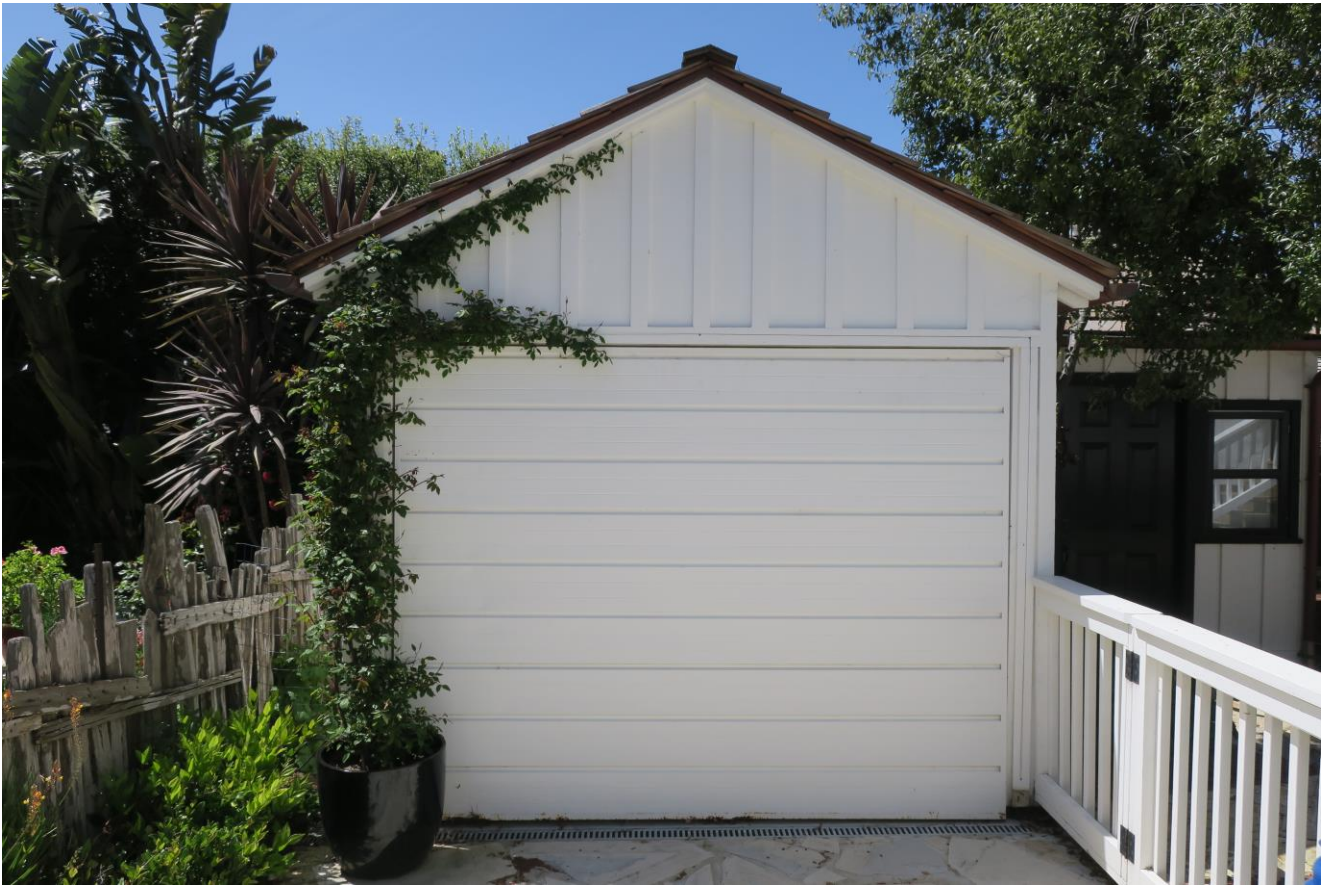
Detached garage at the southwest rear corner of the property, looking west. The earliest Sanborn map depicting the property shows a garage in this location, however, this structure may be a reconstruction.
