Verizon Wireless South Carmel Polygon

Exhibit E: Vaulting Feasibility Analysis

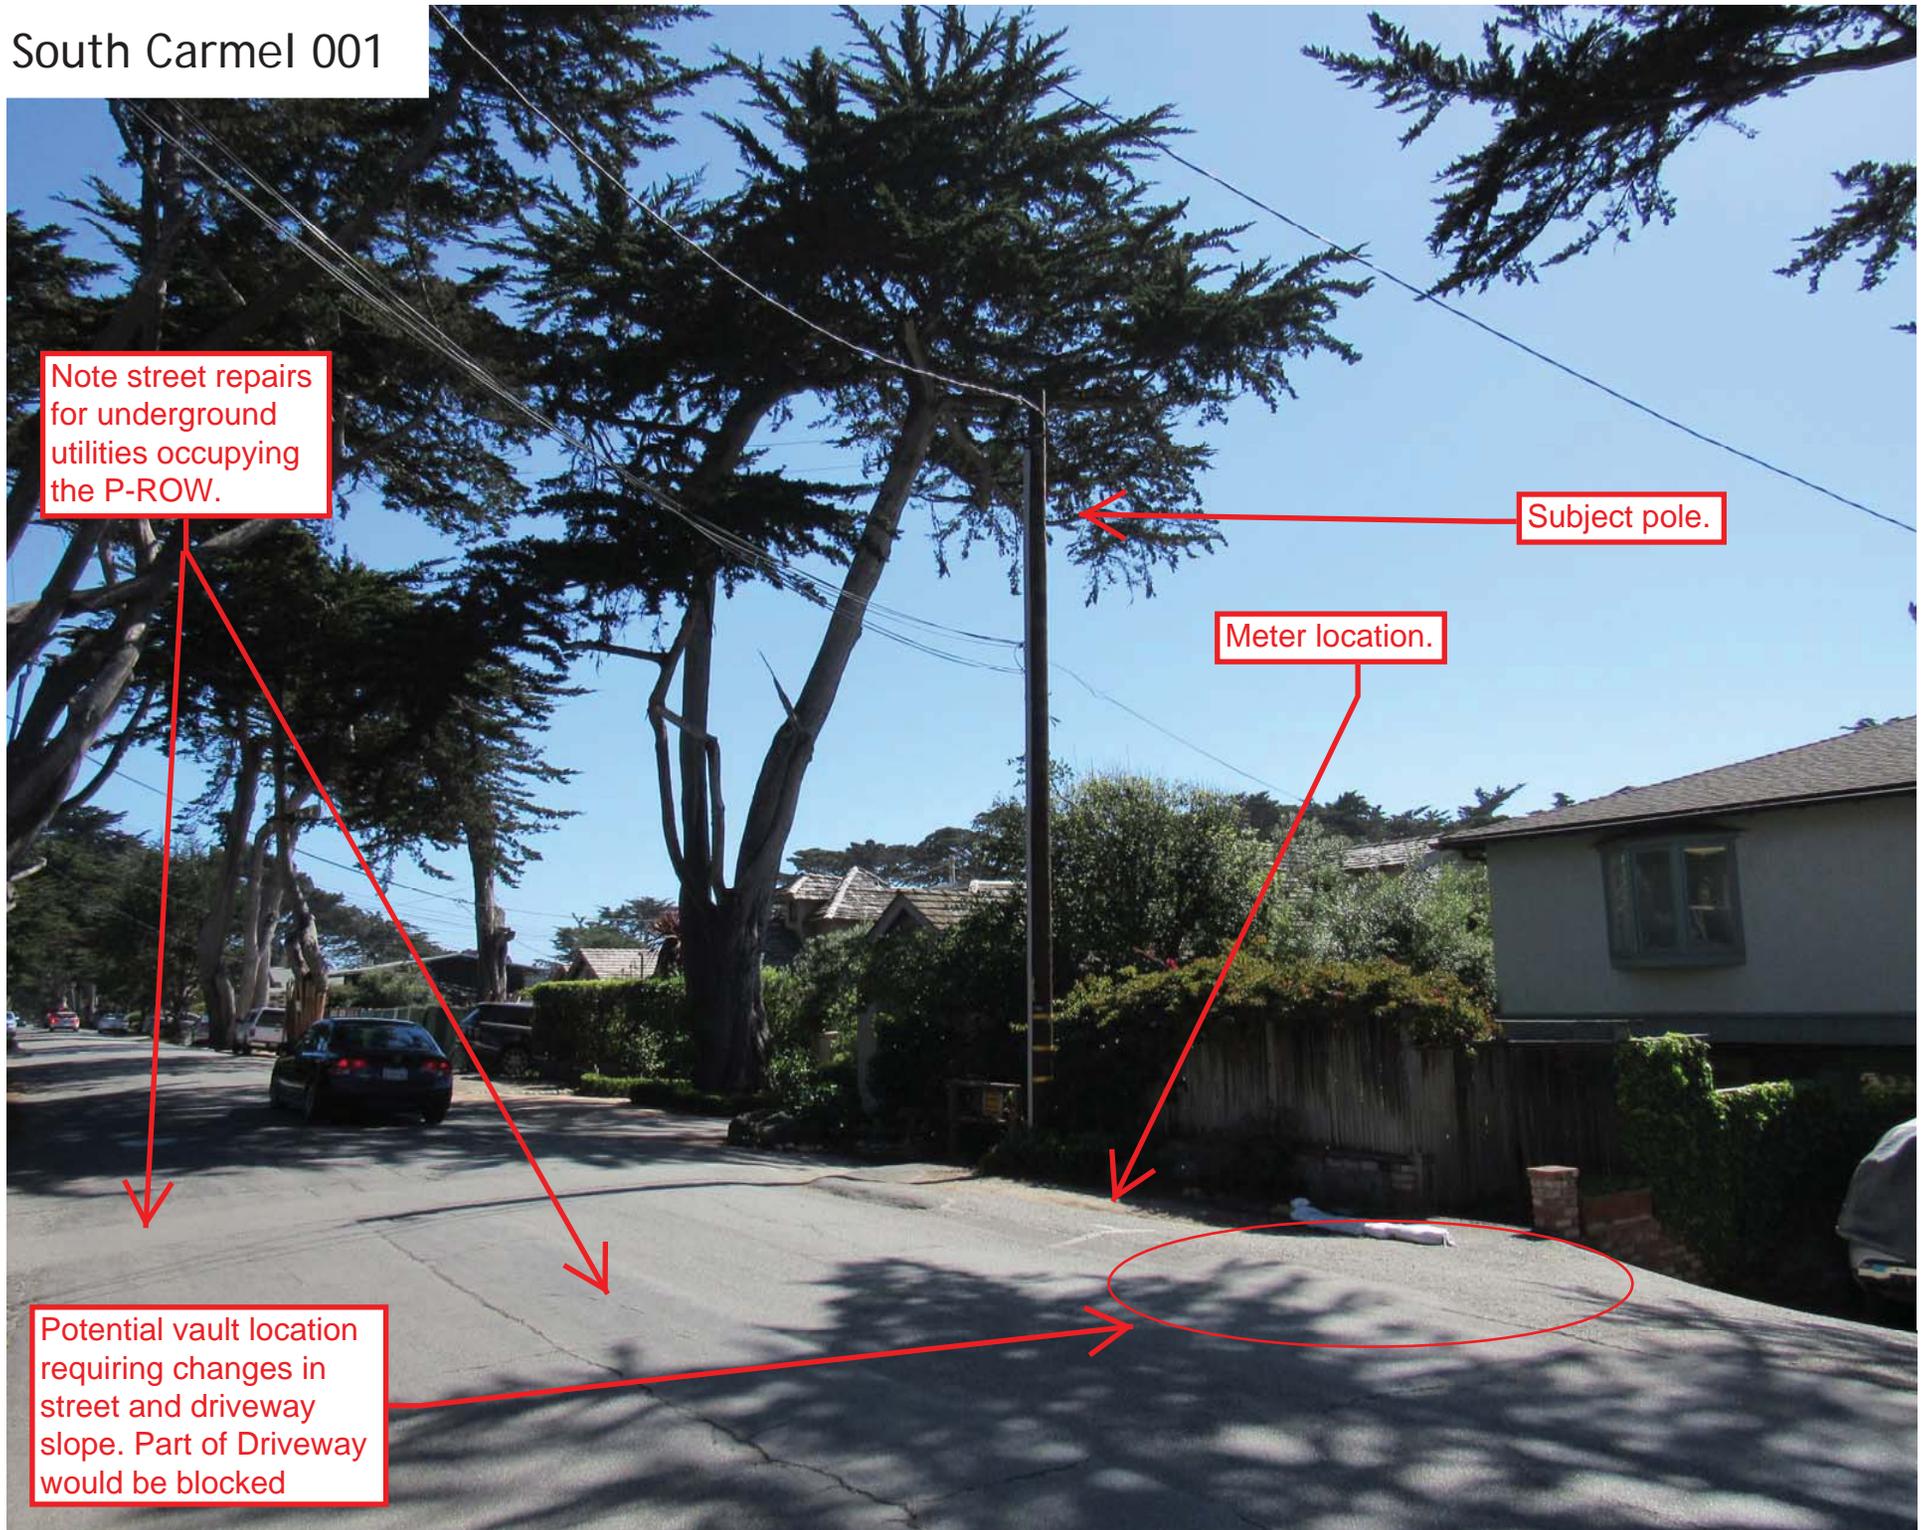
South Carmel 001

Note street repairs for underground utilities occupying the P-ROW.

Subject pole.

Meter location.

Potential vault location requiring changes in street and driveway slope. Part of Driveway would be blocked

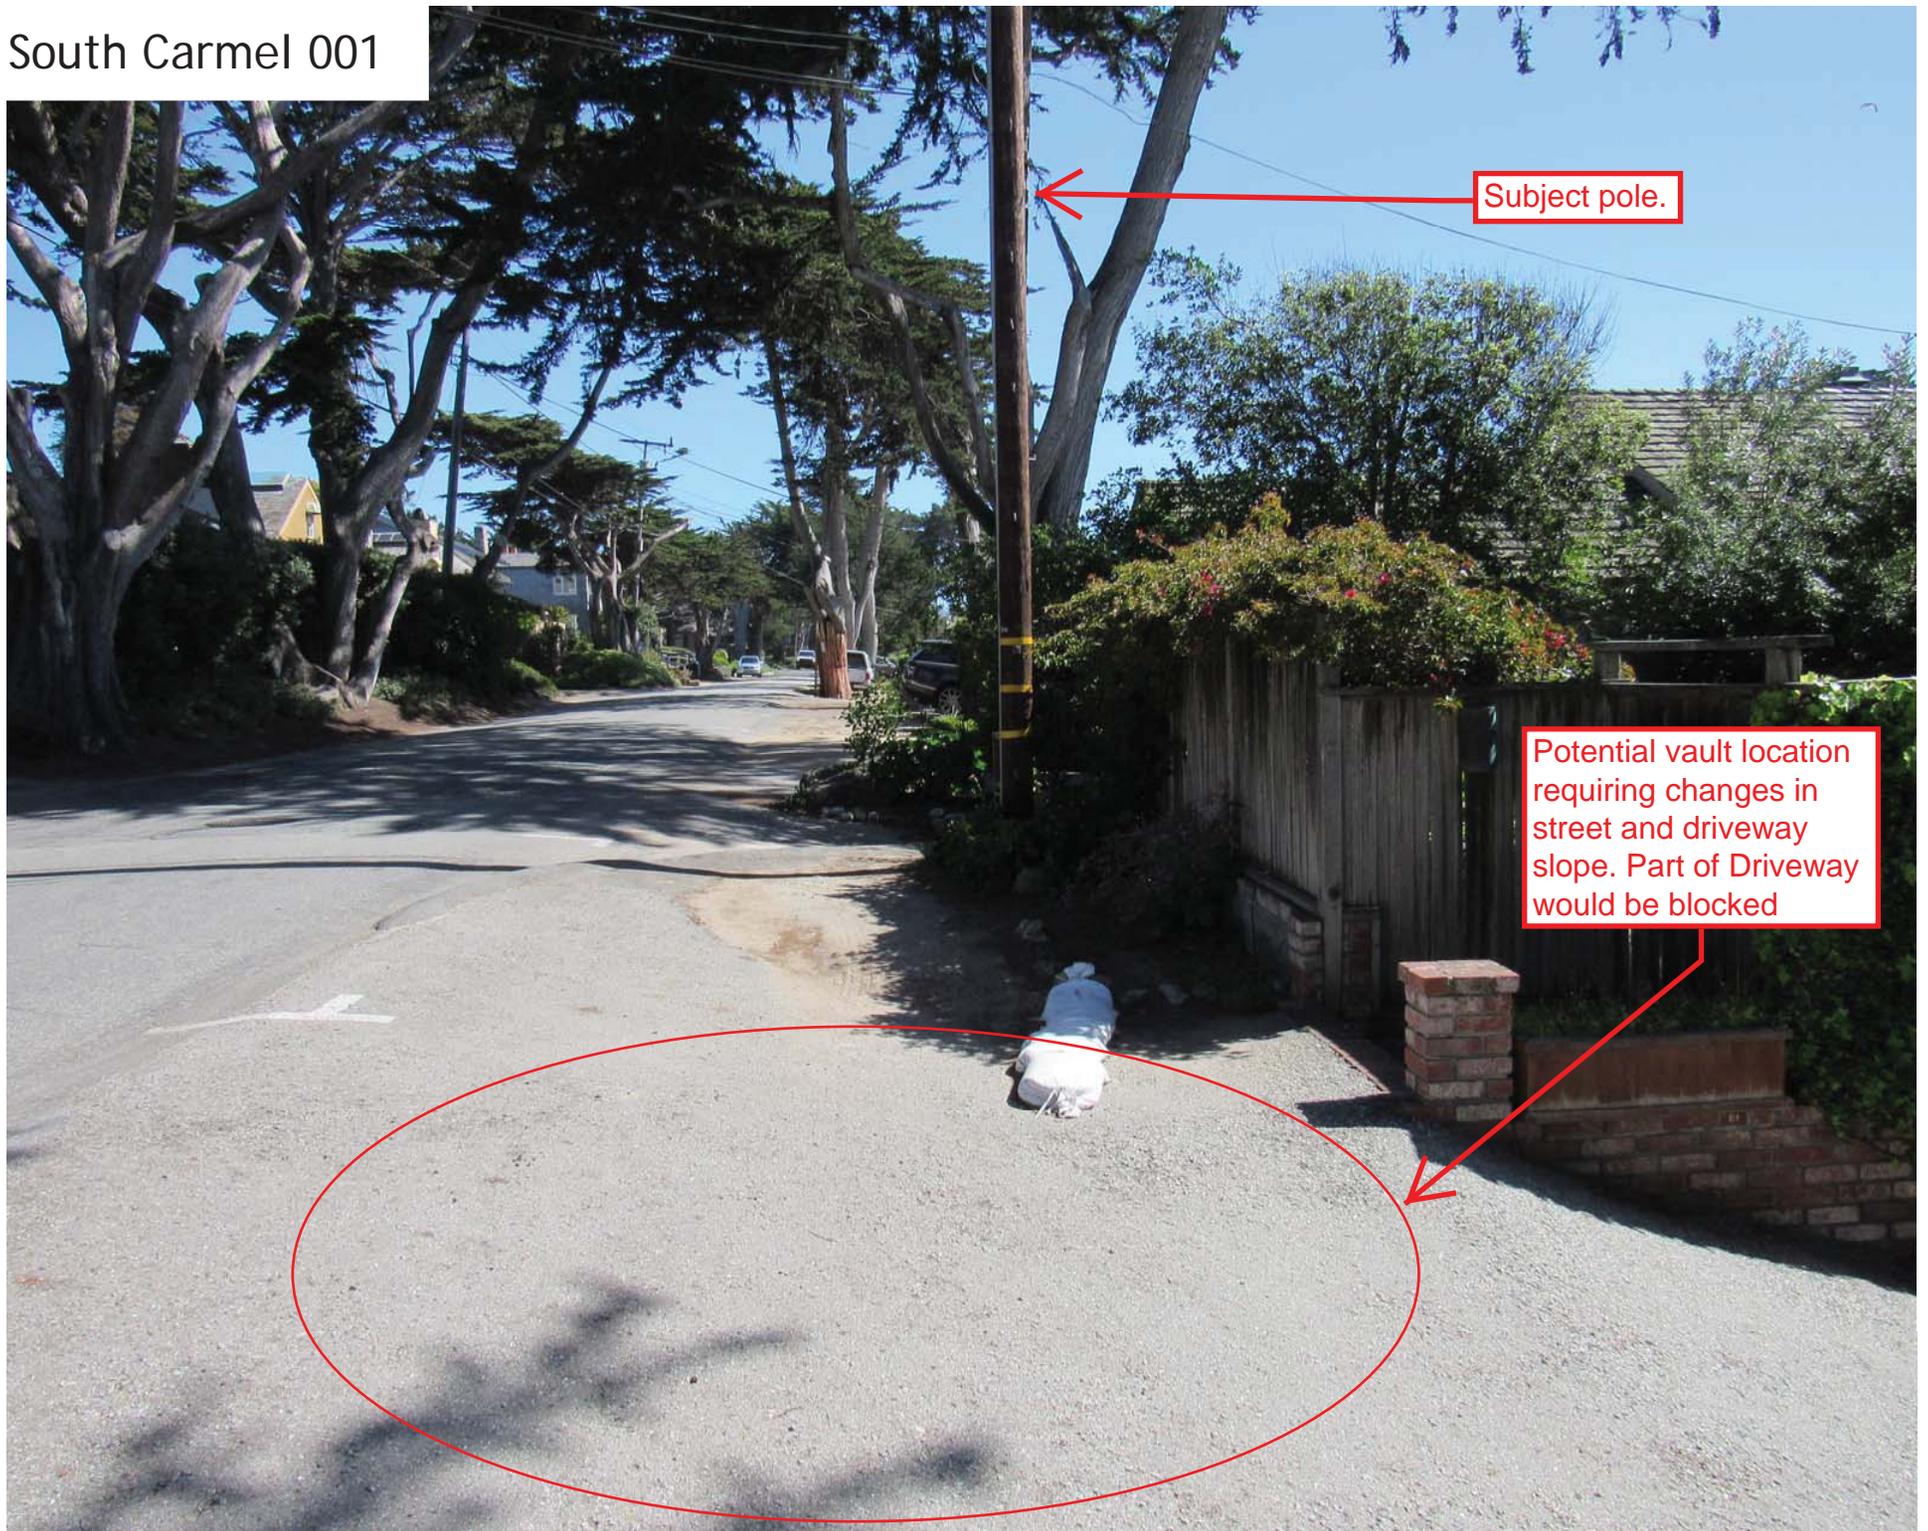
Subject pole.

Potential vault location requiring changes in street and driveway slope. Part of Driveway would be blocked

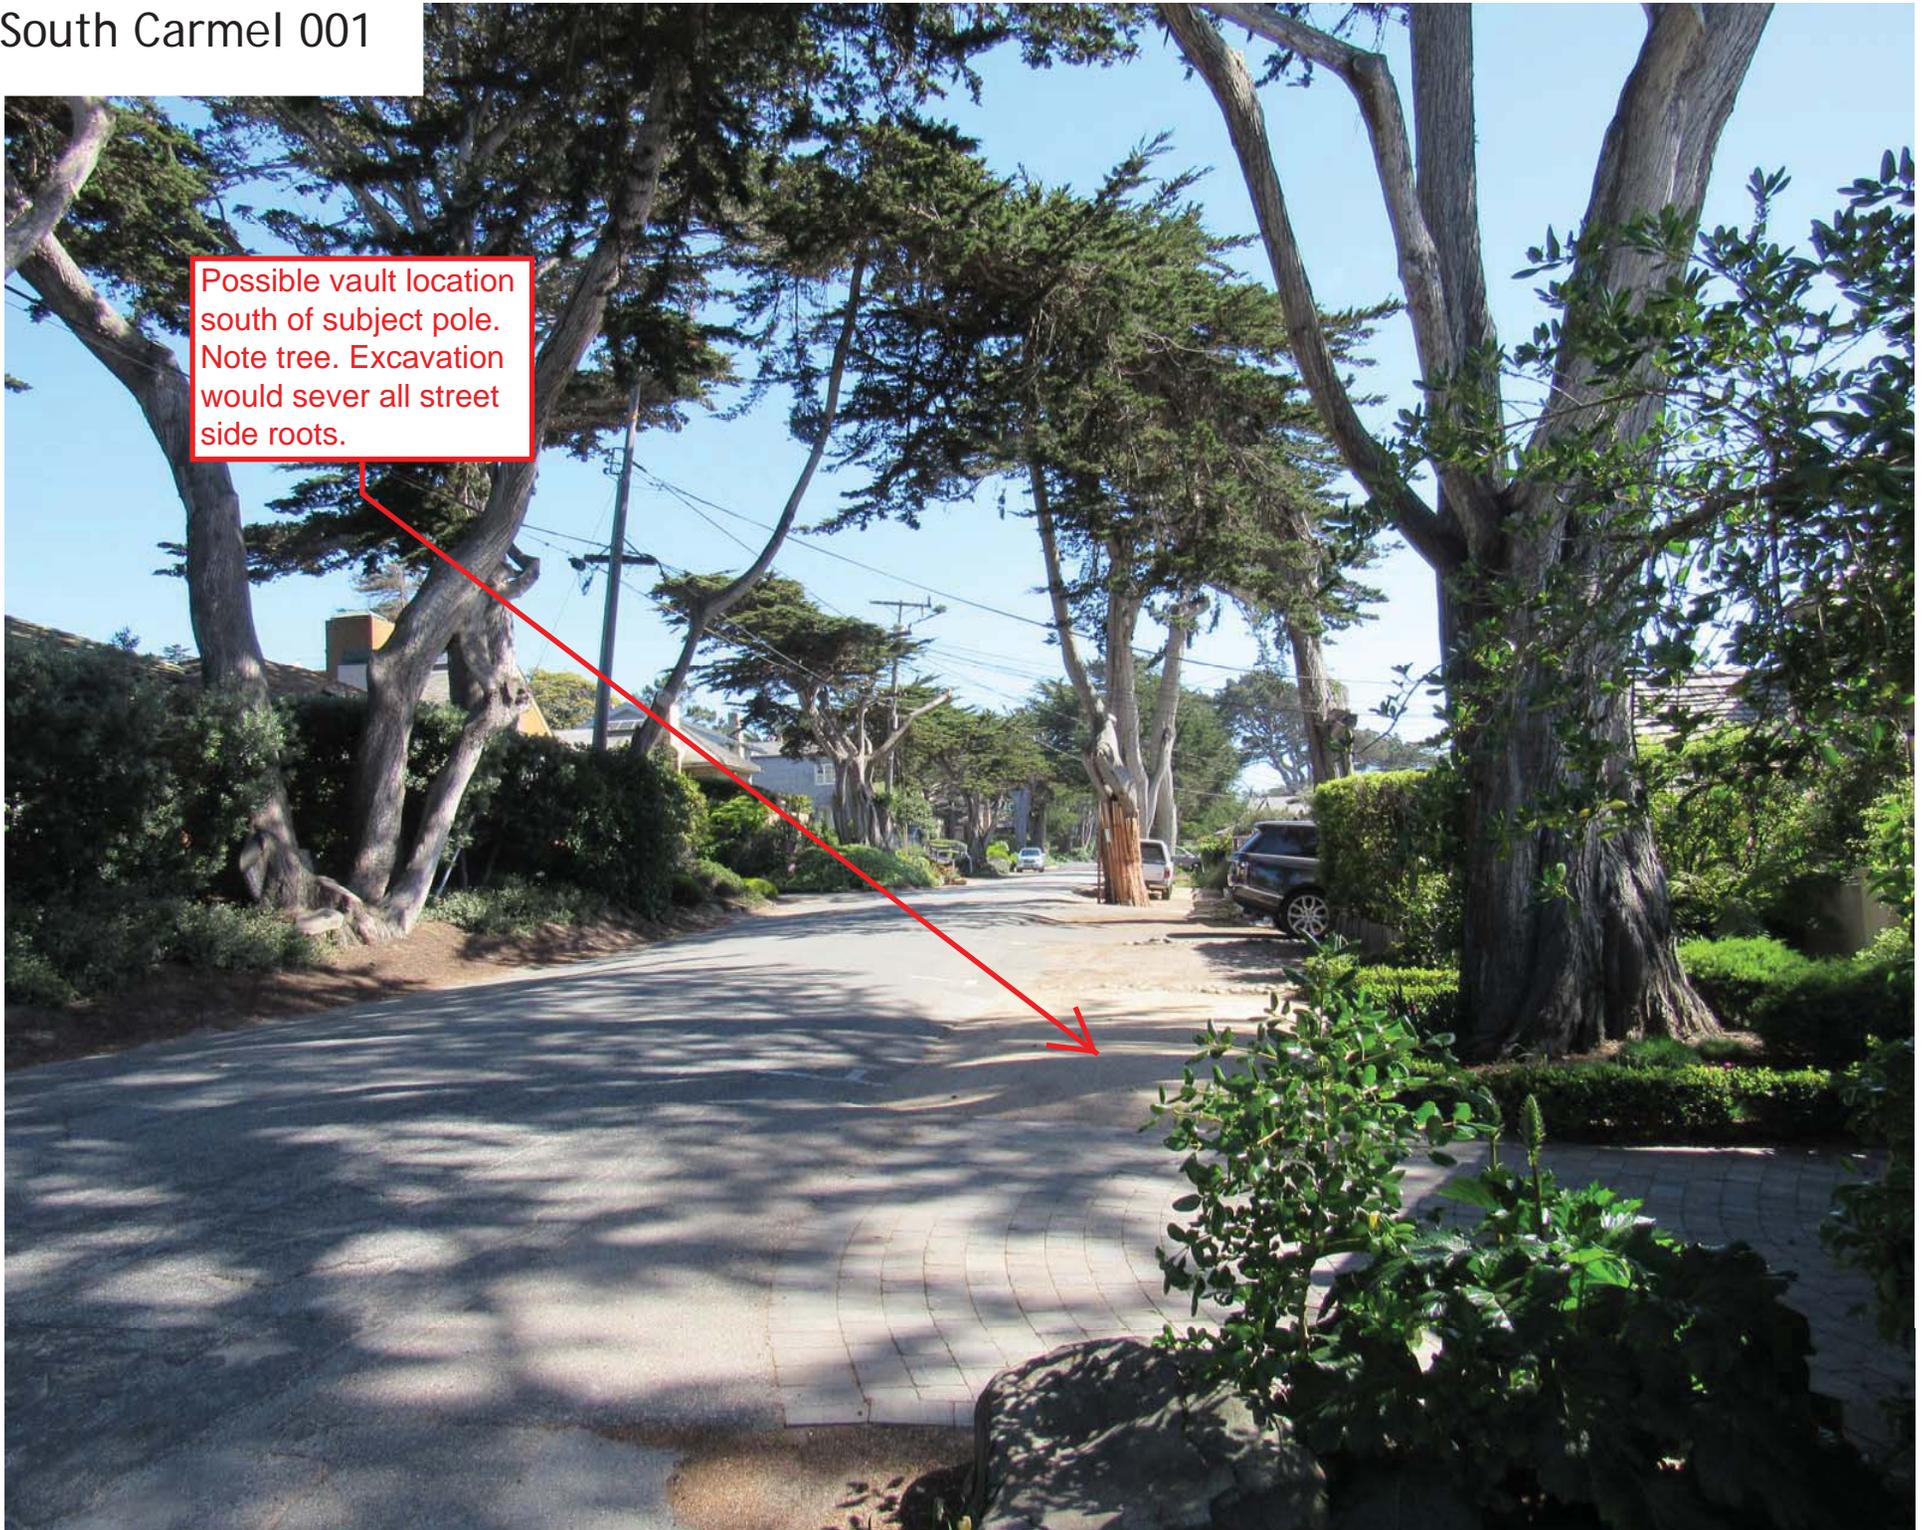
Possible vault location south of subject pole. Note tree. Excavation would sever all street side roots.

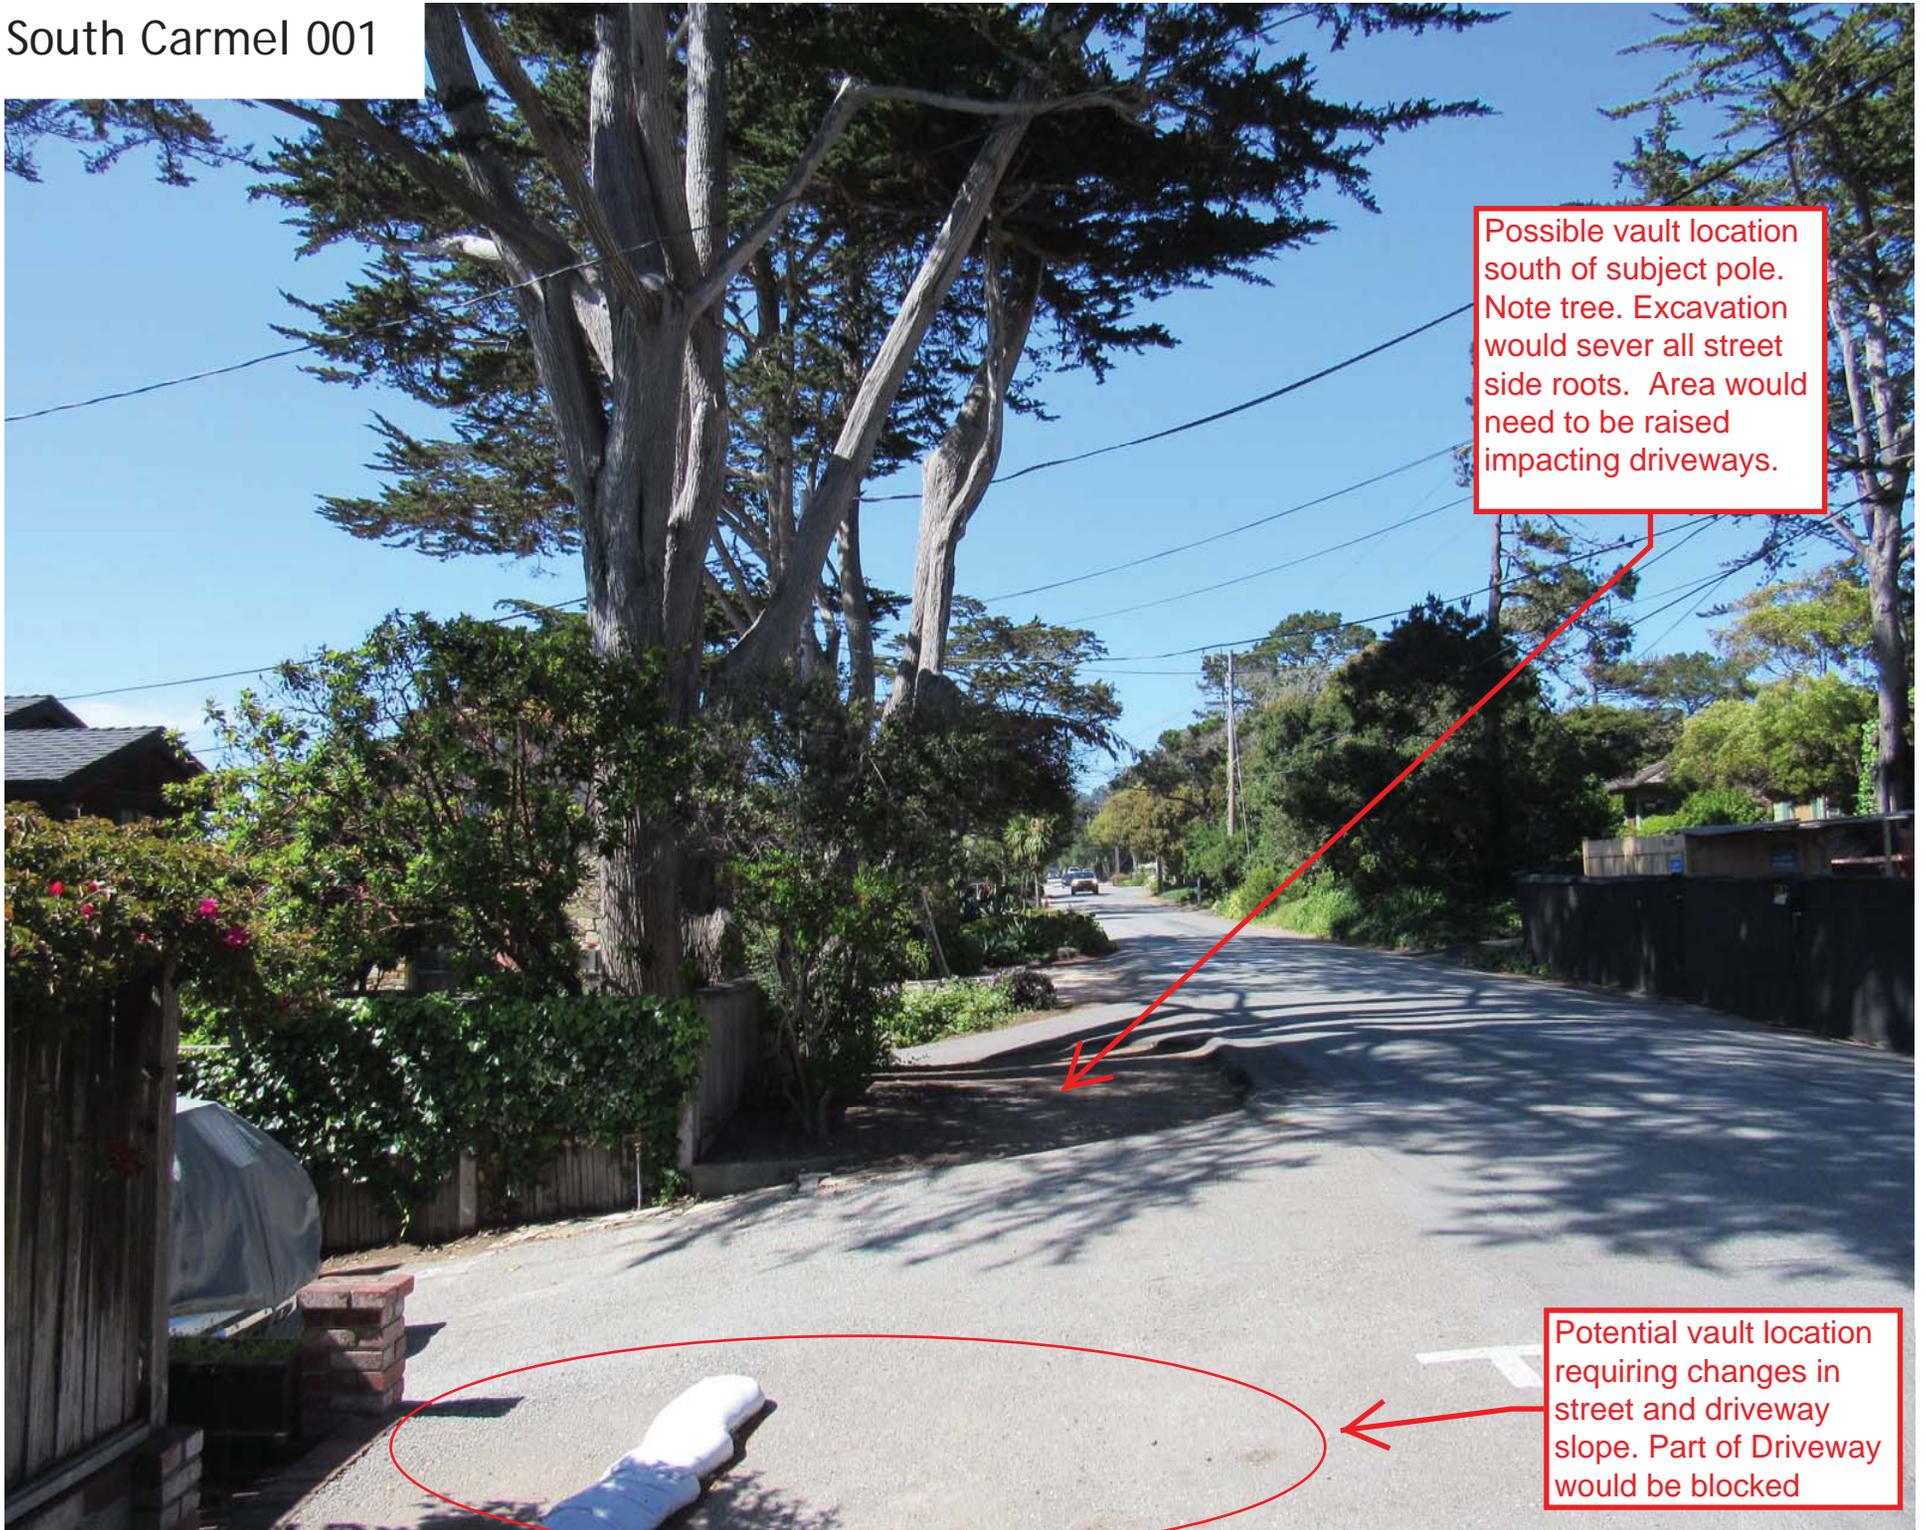
Possible vault location south of subject pole. Note tree. Excavation would sever all street side roots. Area would need to be raised impacting driveways.

Potential vault location requiring changes in street and driveway slope. Part of Driveway would be blocked

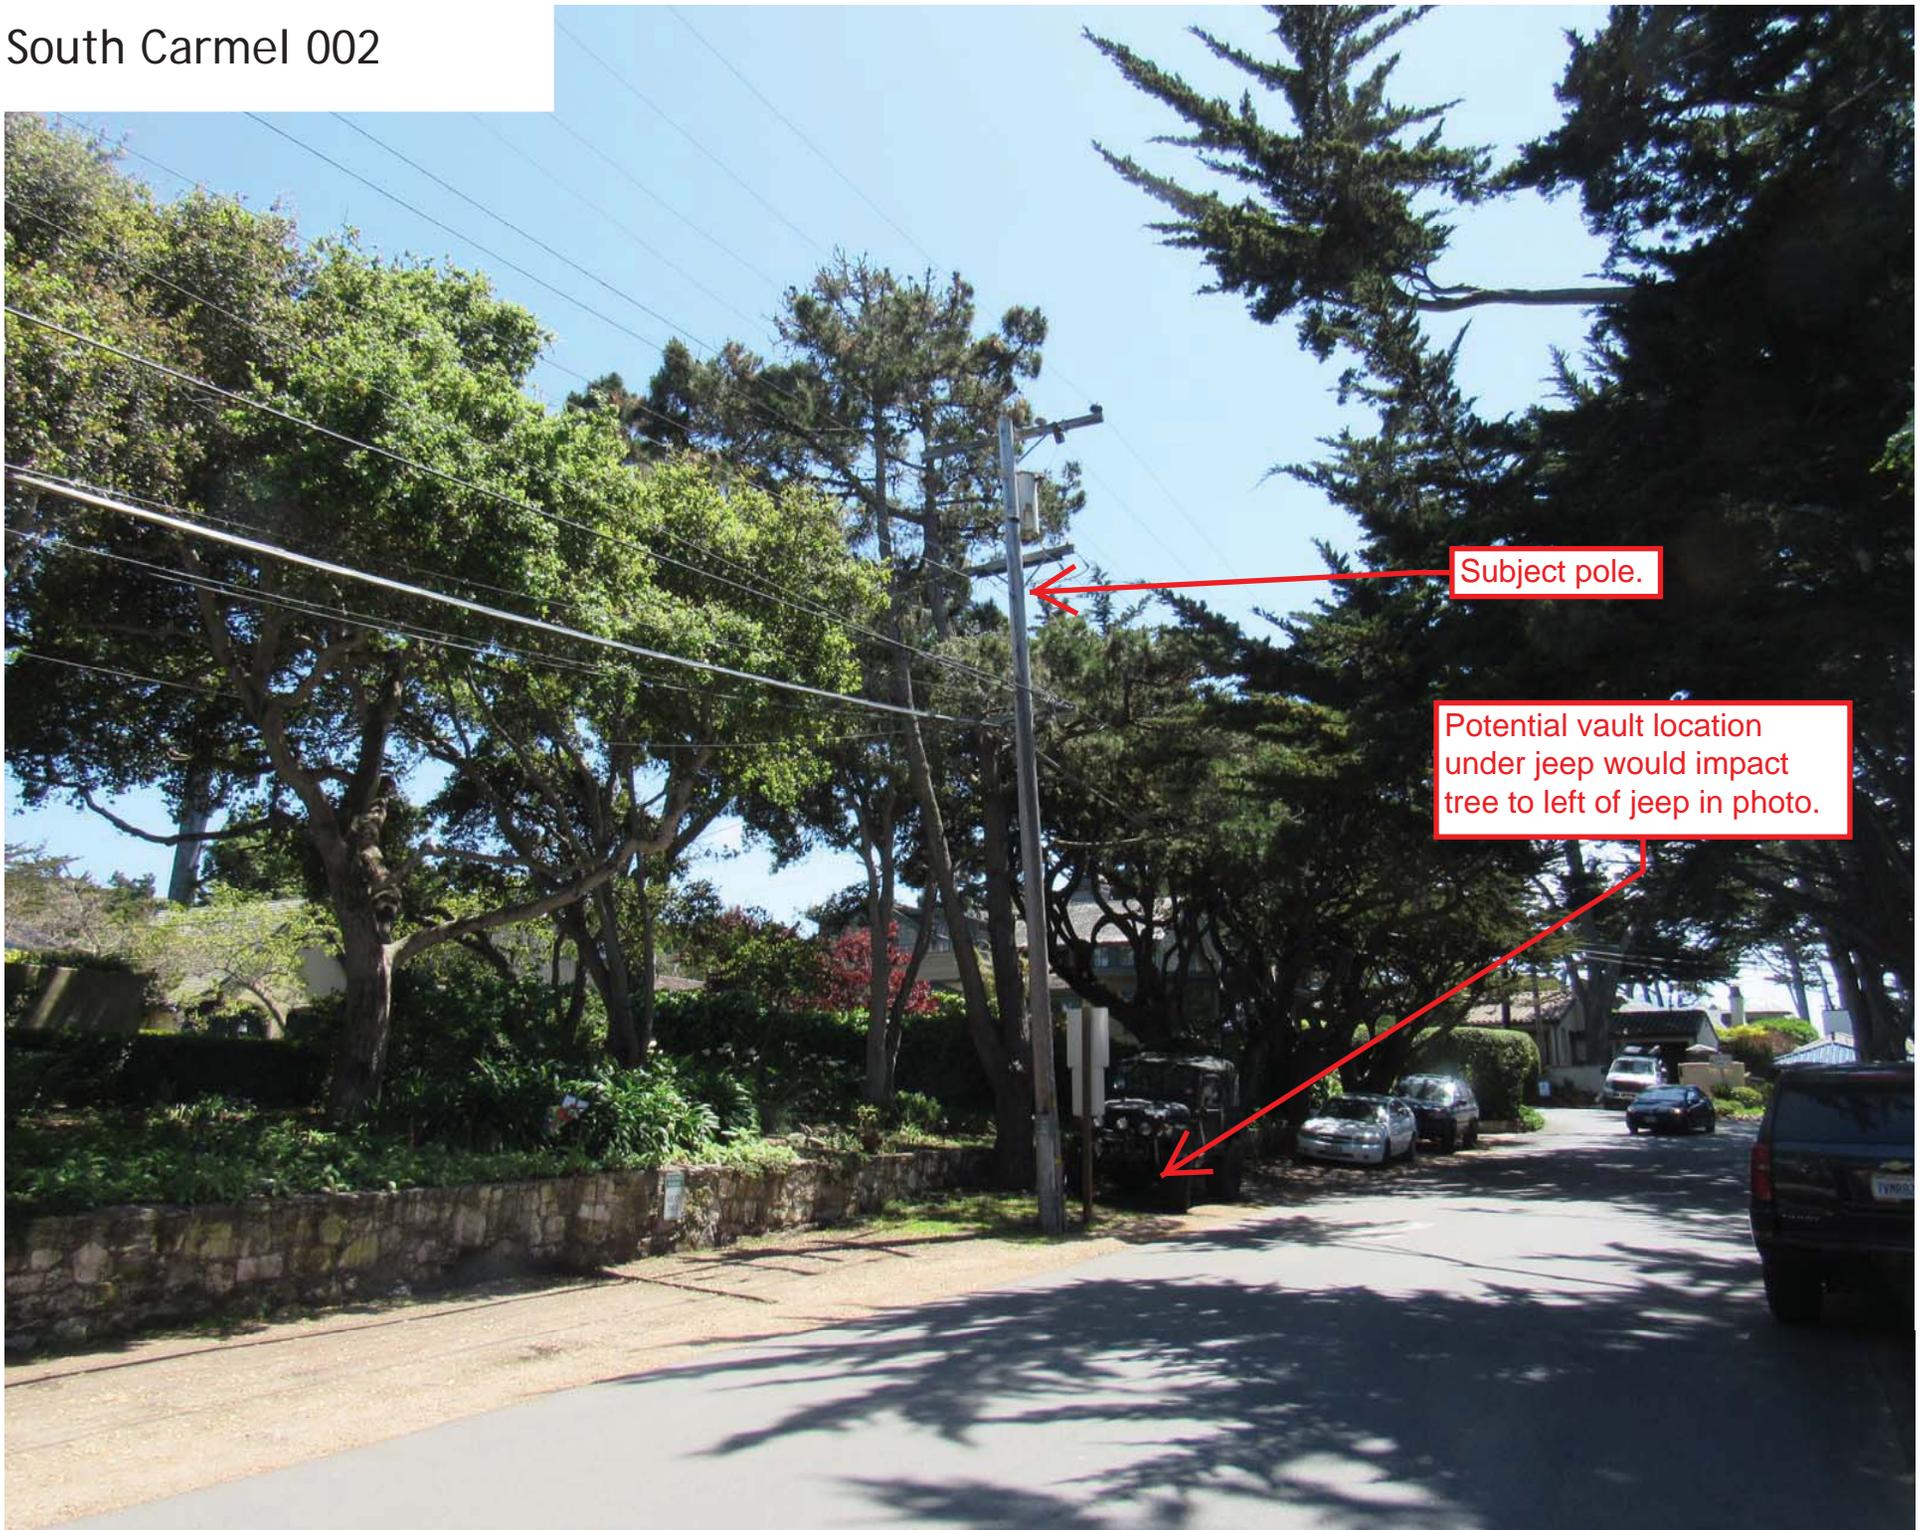
South Carmel 002

Subject pole.

Potential vault location
under jeep would impact
tree to left of jeep in photo.

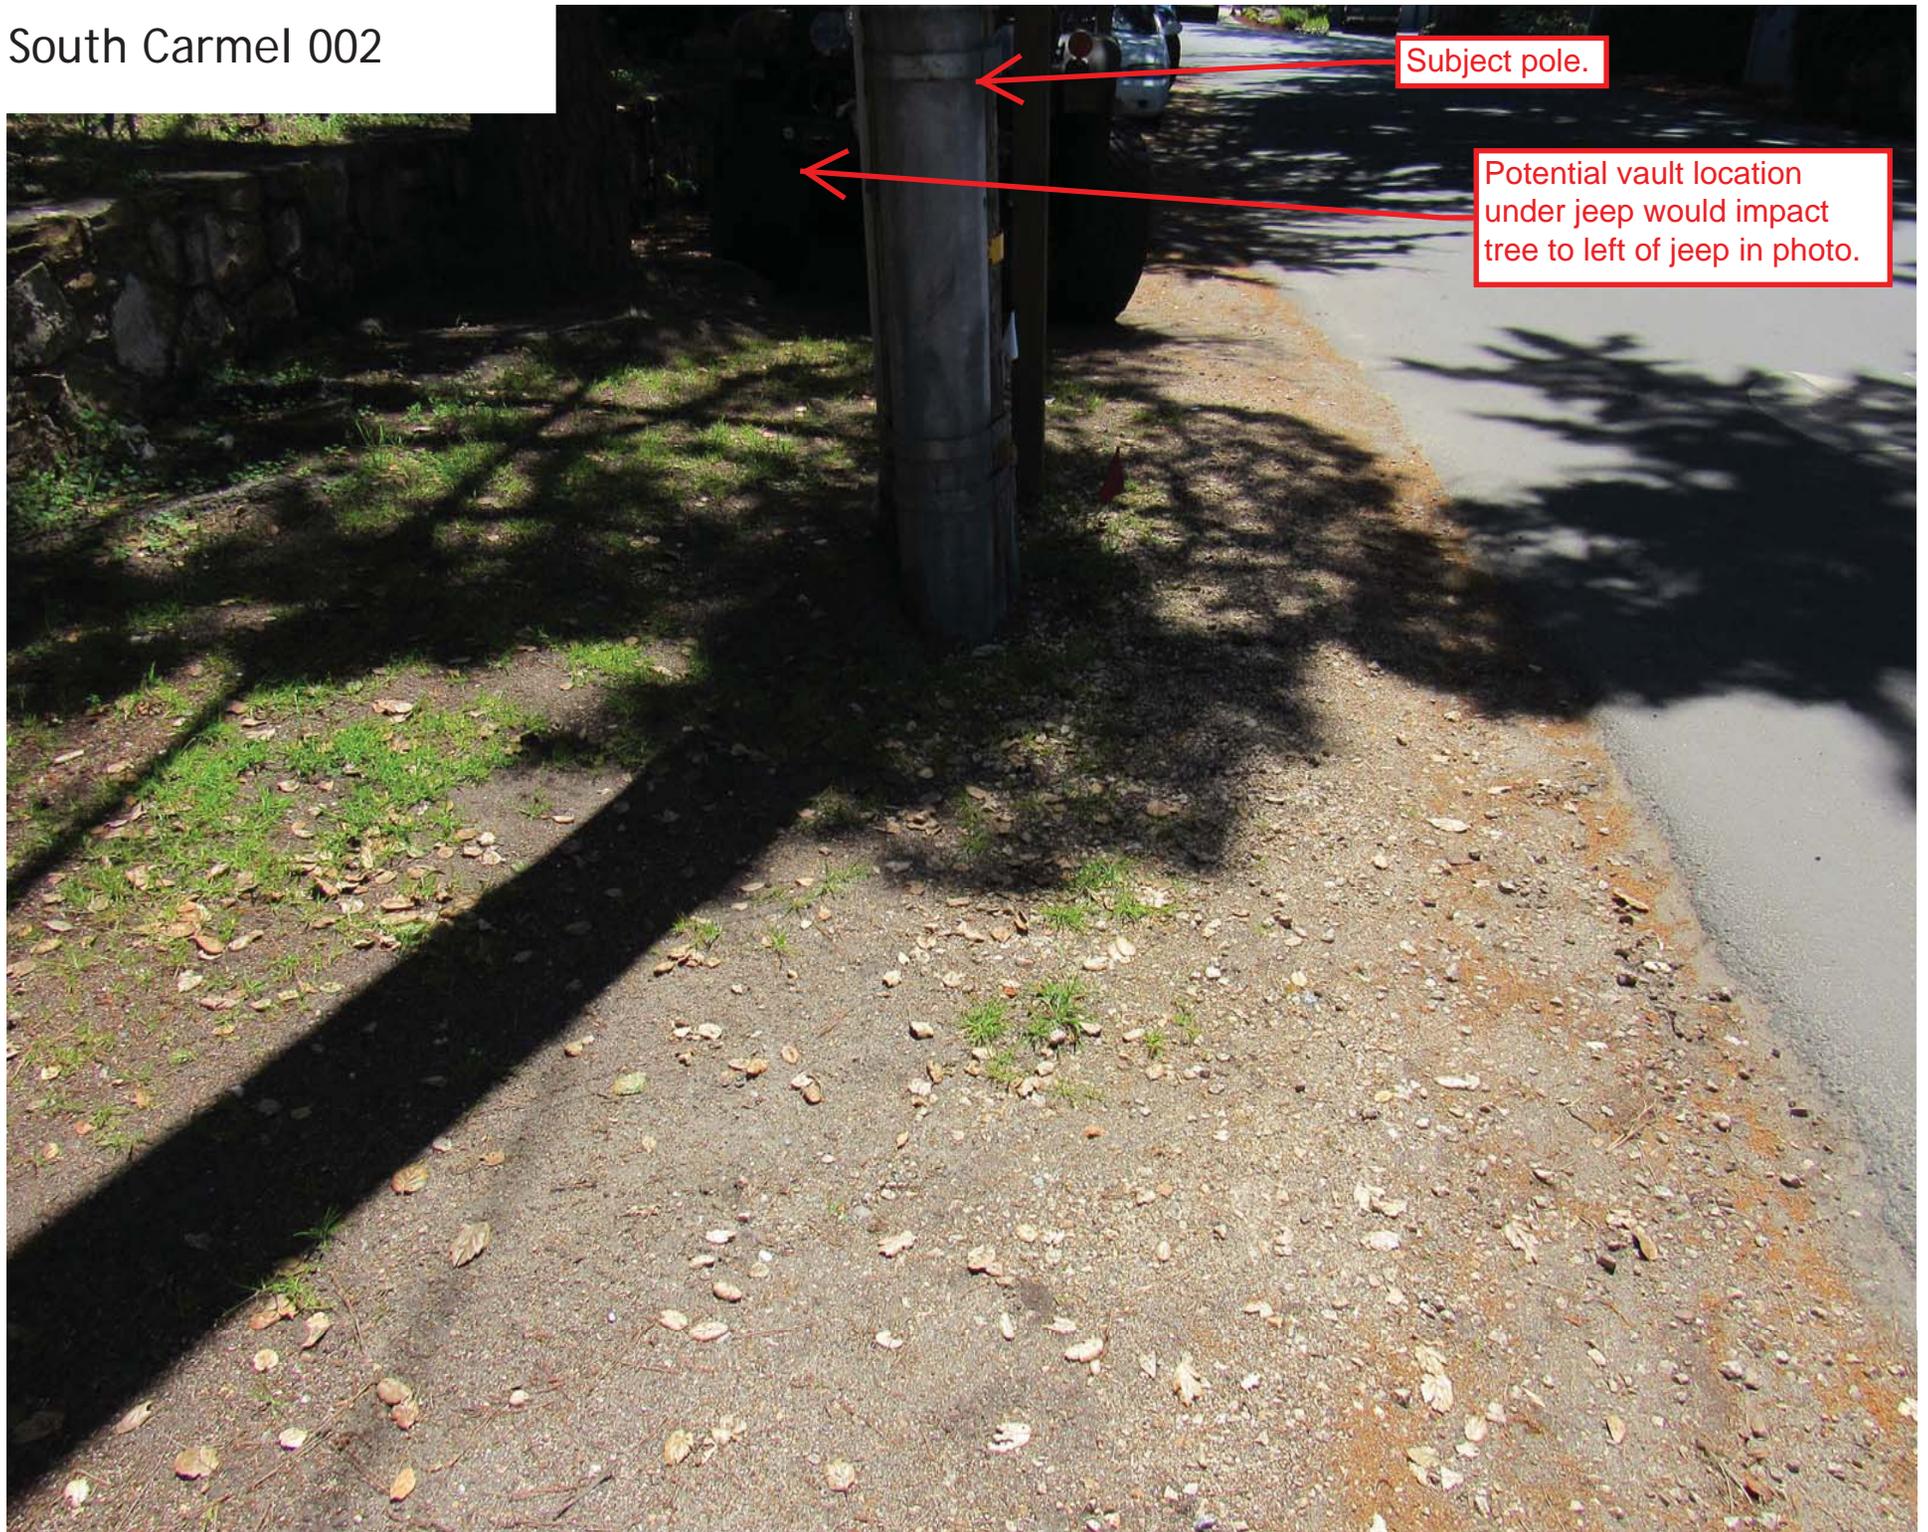
South Carmel 002

Subject pole.

Potential vault location under jeep would impact tree to left of jeep in photo.

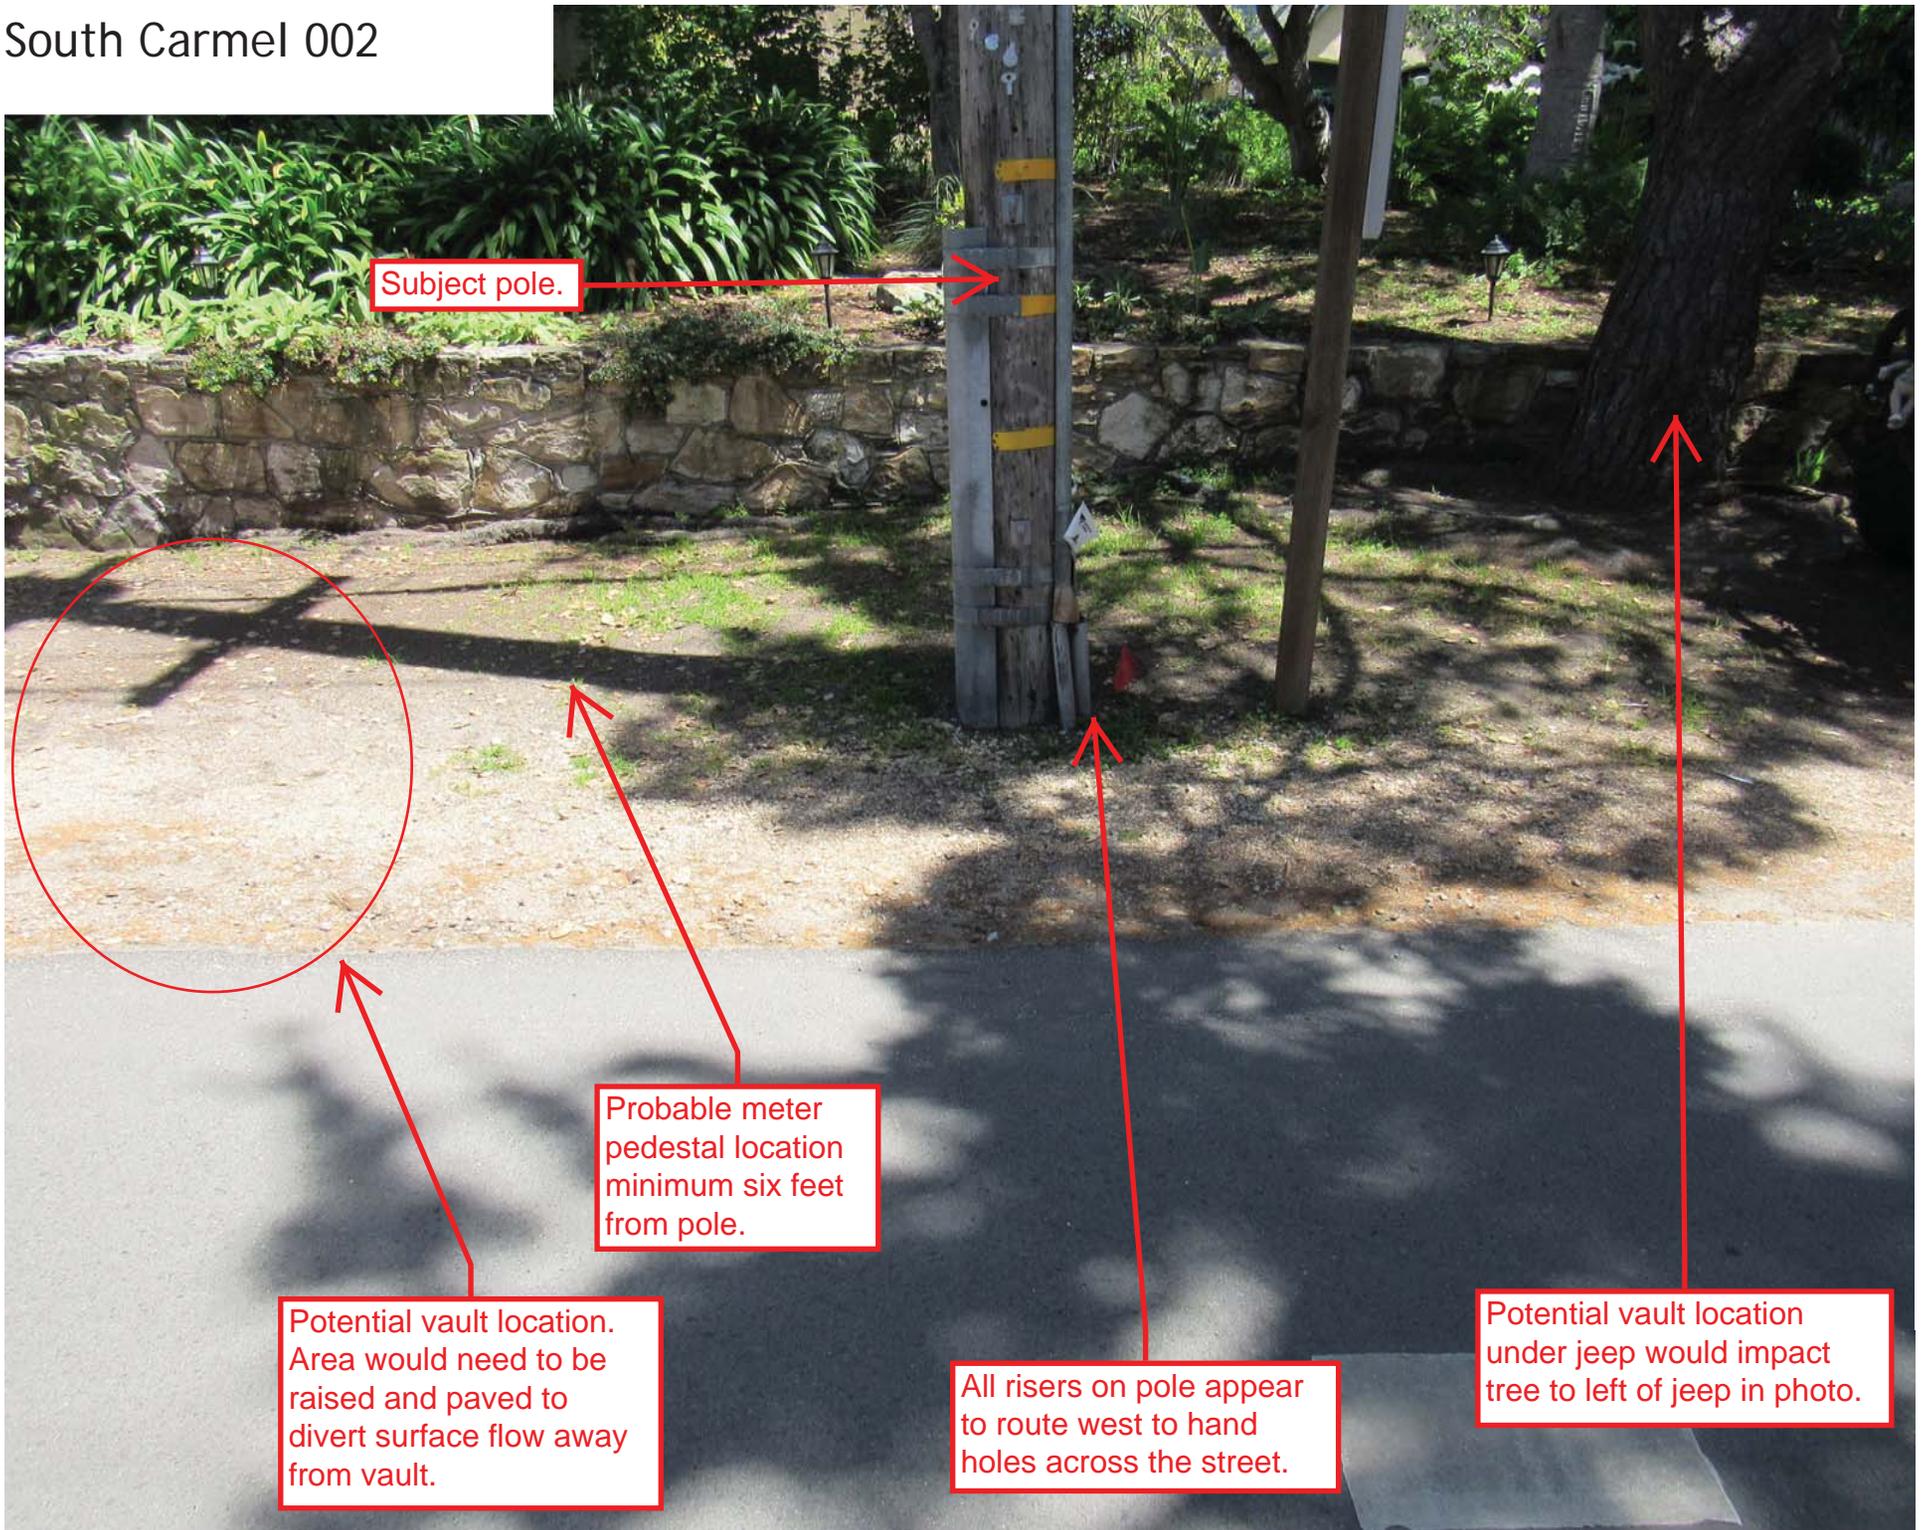
Subject pole.

Probable meter pedestal location minimum six feet from pole.

Potential vault location. Area would need to be raised and paved to divert surface flow away from vault.

All risers on pole appear to route west to hand holes across the street.

Potential vault location under jeep would impact tree to left of jeep in photo.
