Verizon Wireless South Carmel Polygon

Exhibit E: Vaulting Feasibility Analysis

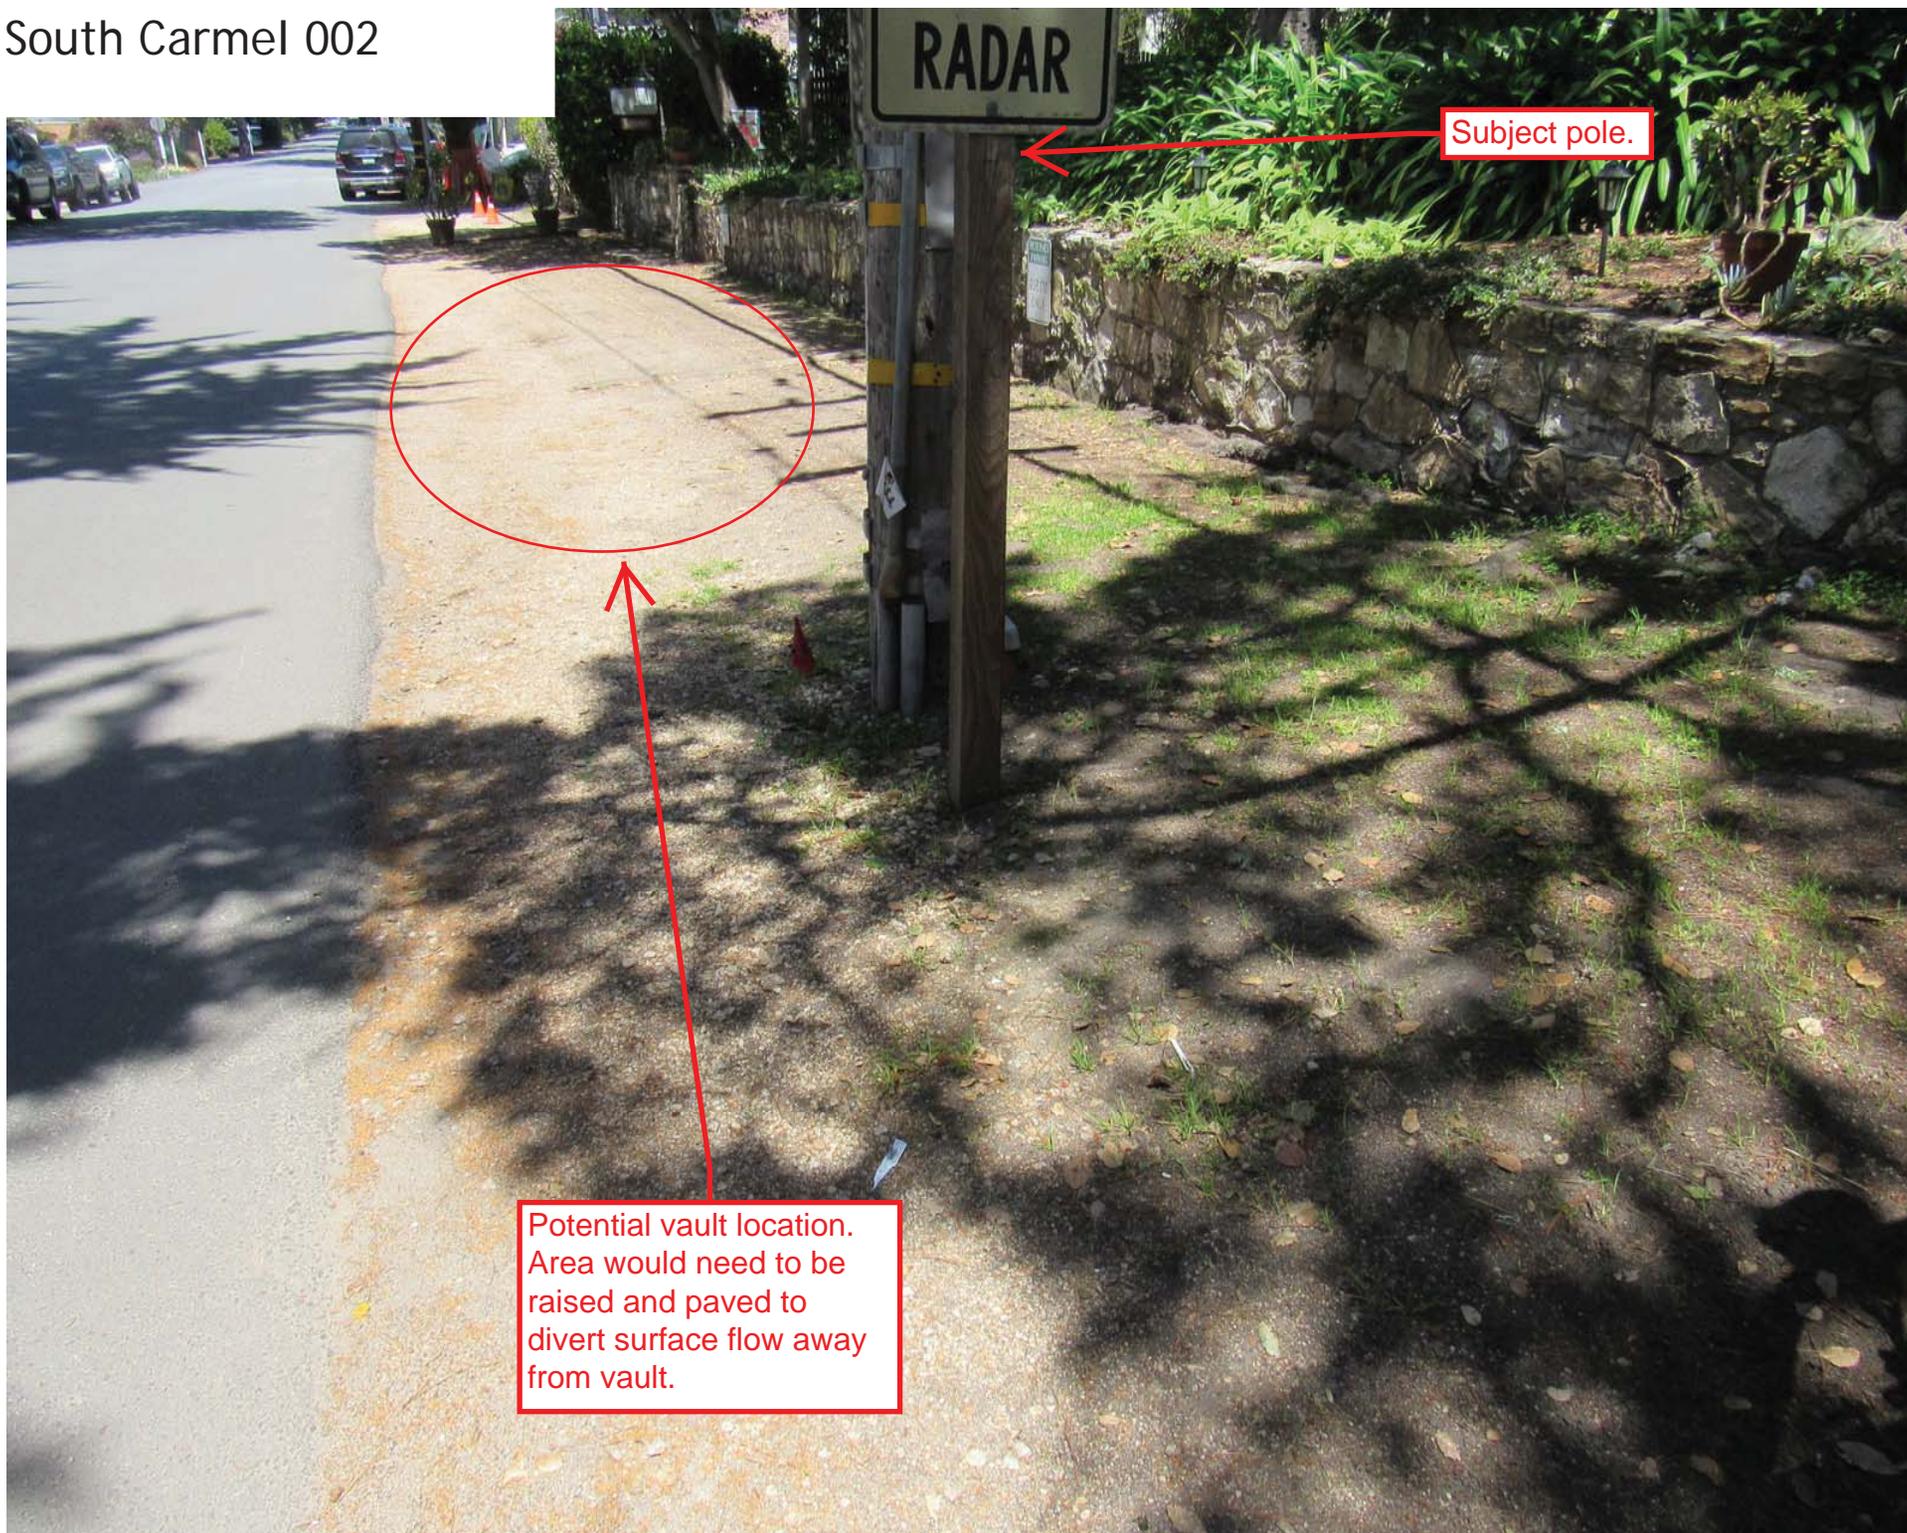
Subject pole.

Potential vault location.
Area would need to be raised and paved to divert surface flow away from vault.

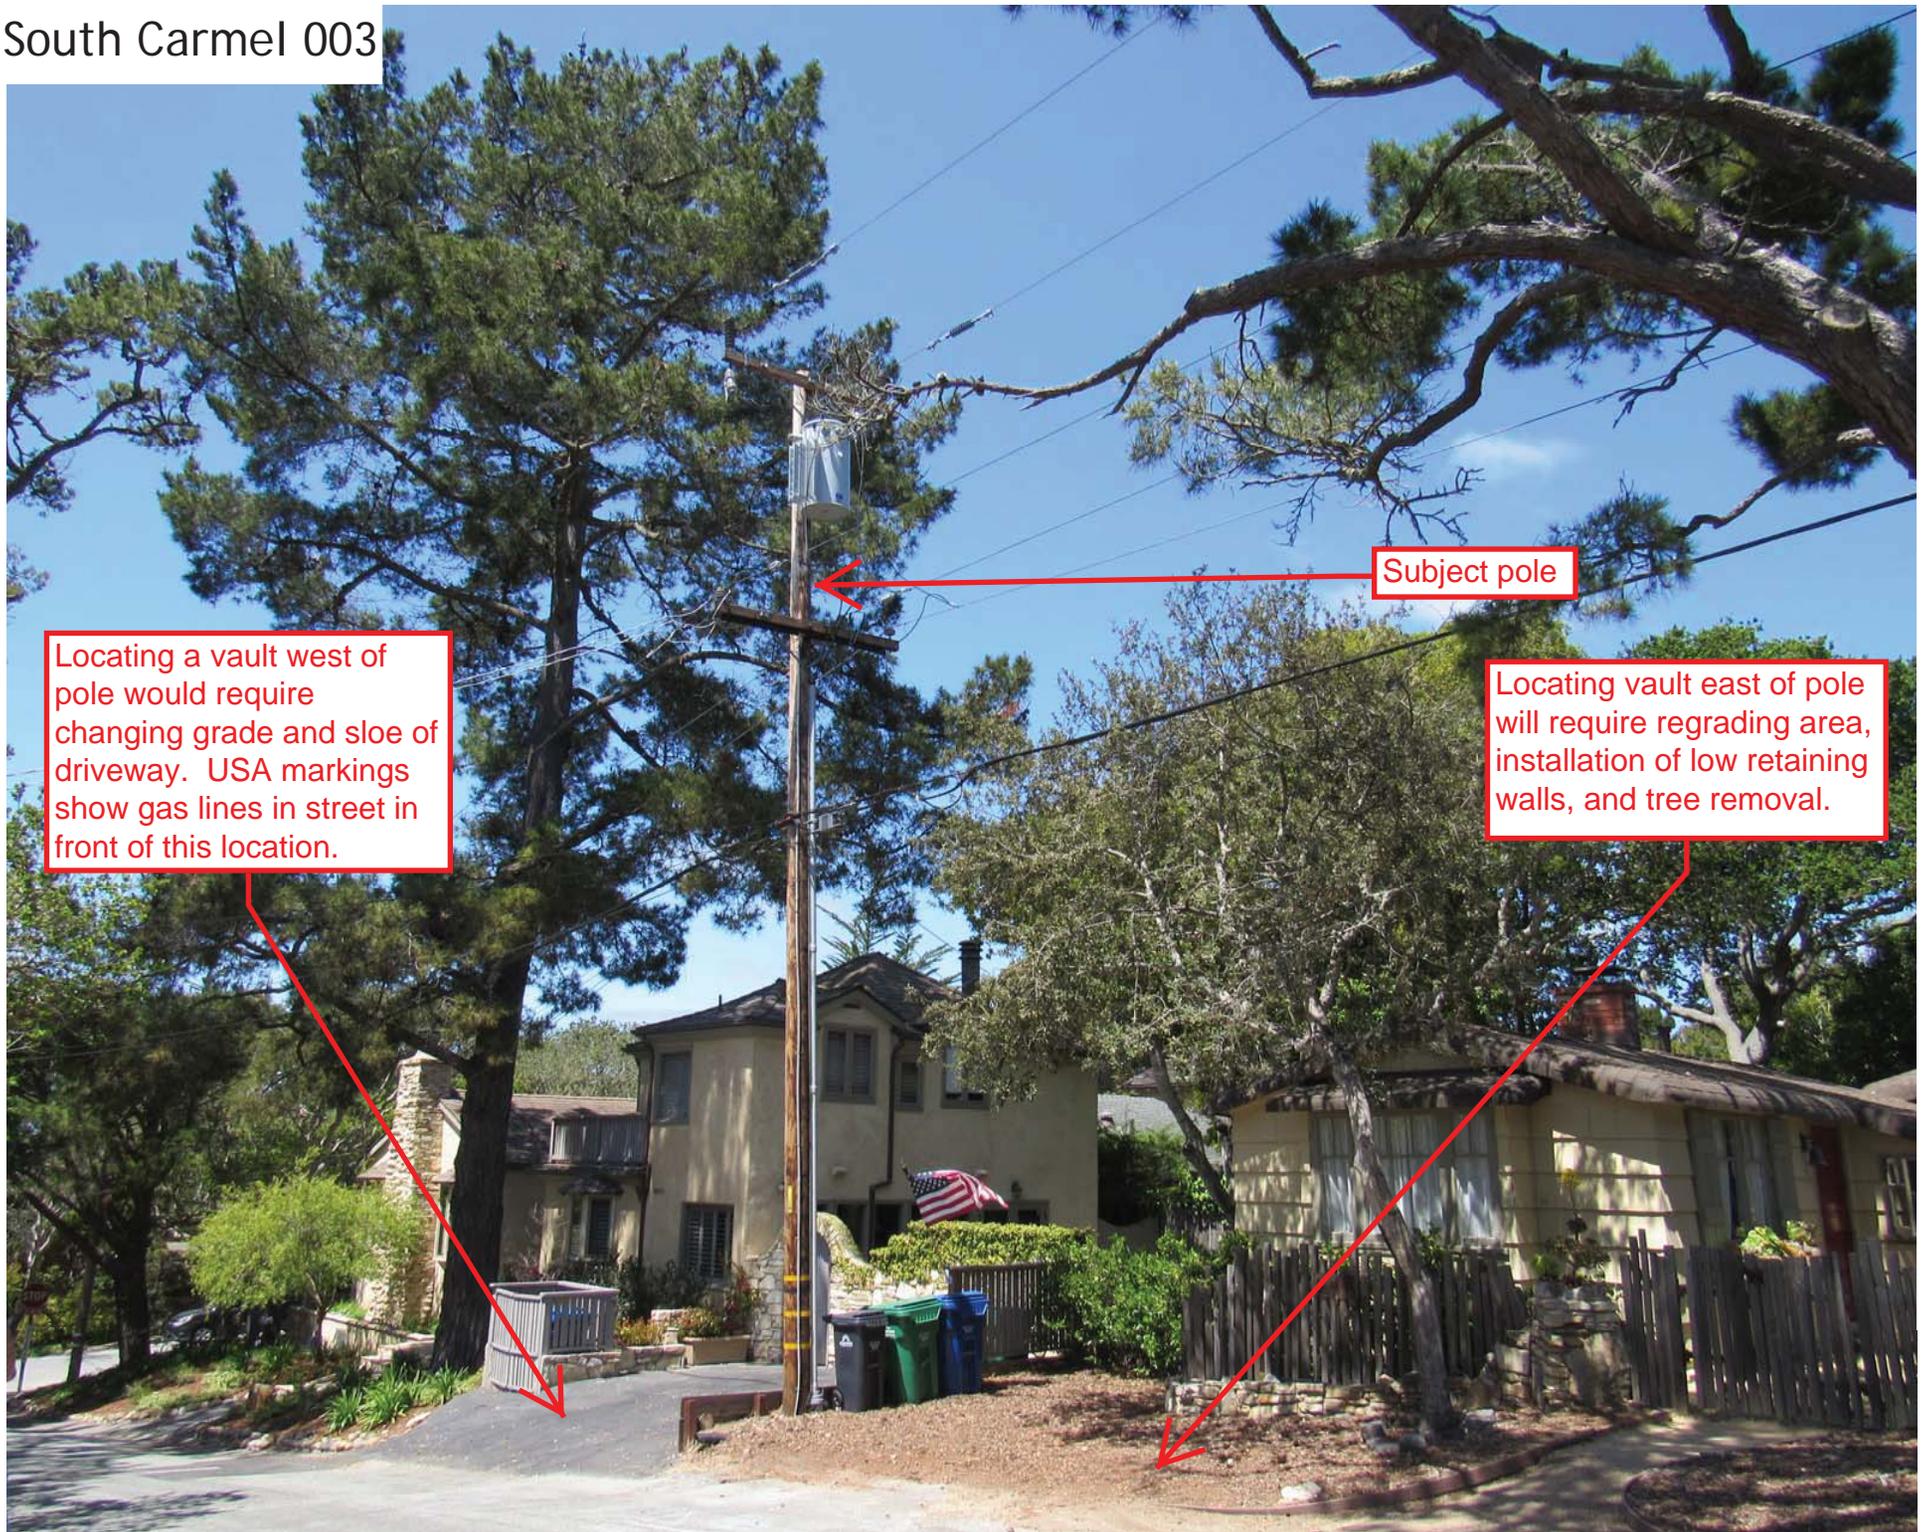
Subject pole

Locating a vault west of pole would require changing grade and slope of driveway. USA markings show gas lines in street in front of this location.

Locating vault east of pole will require regrading area, installation of low retaining walls, and tree removal.

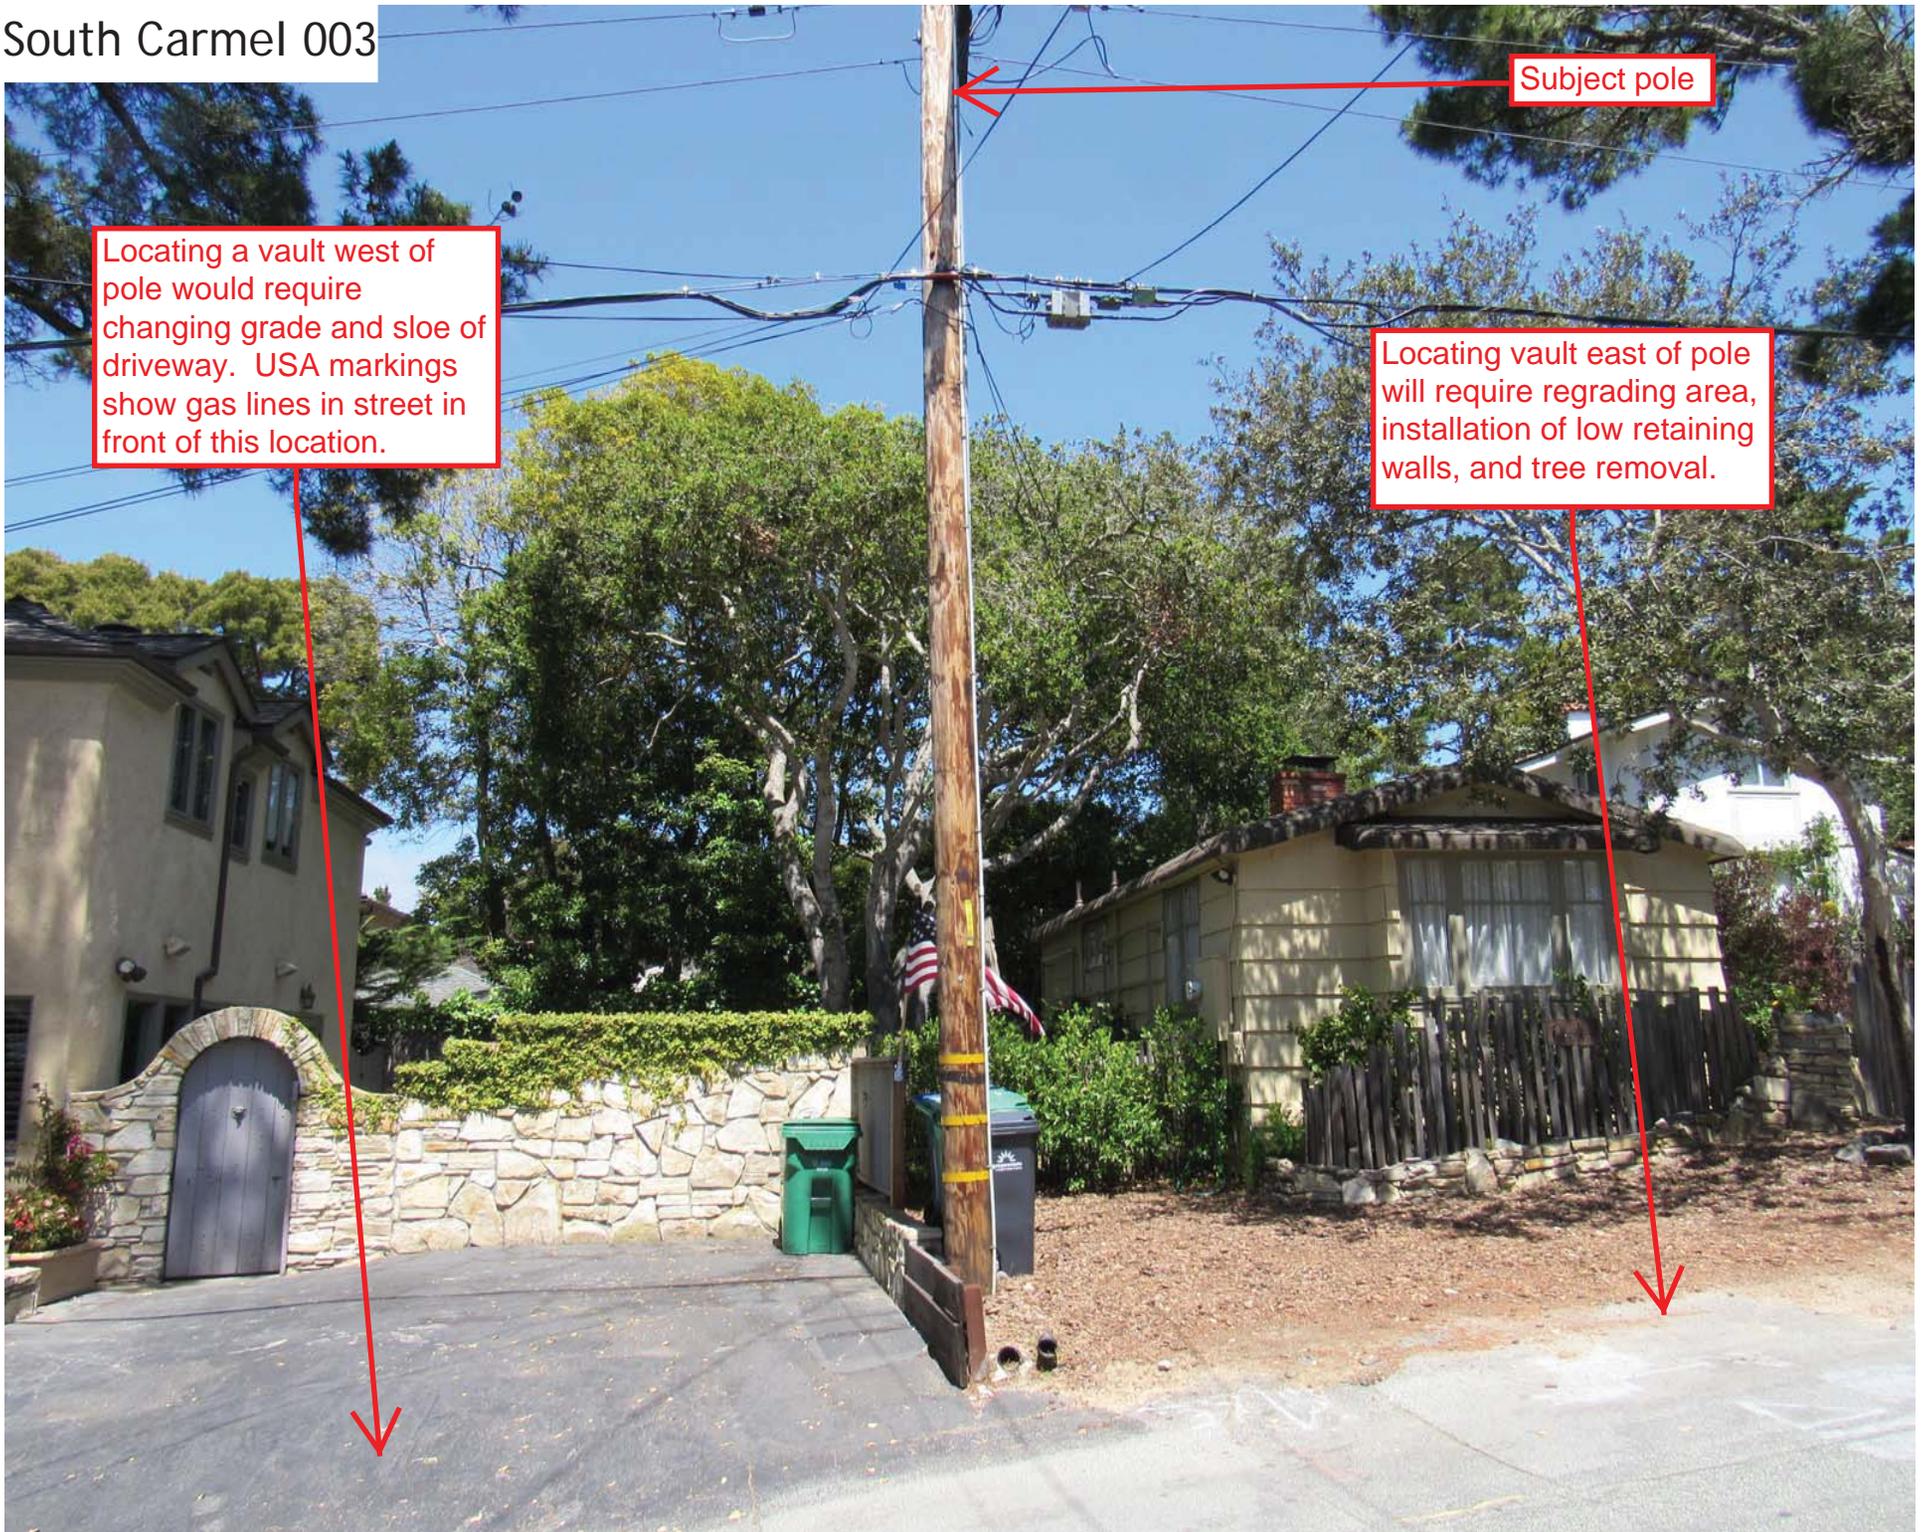
Subject pole

Locating a vault west of pole would require changing grade and slope of driveway. USA markings show gas lines in street in front of this location.

Locating vault east of pole will require regrading area, installation of low retaining walls, and tree removal.

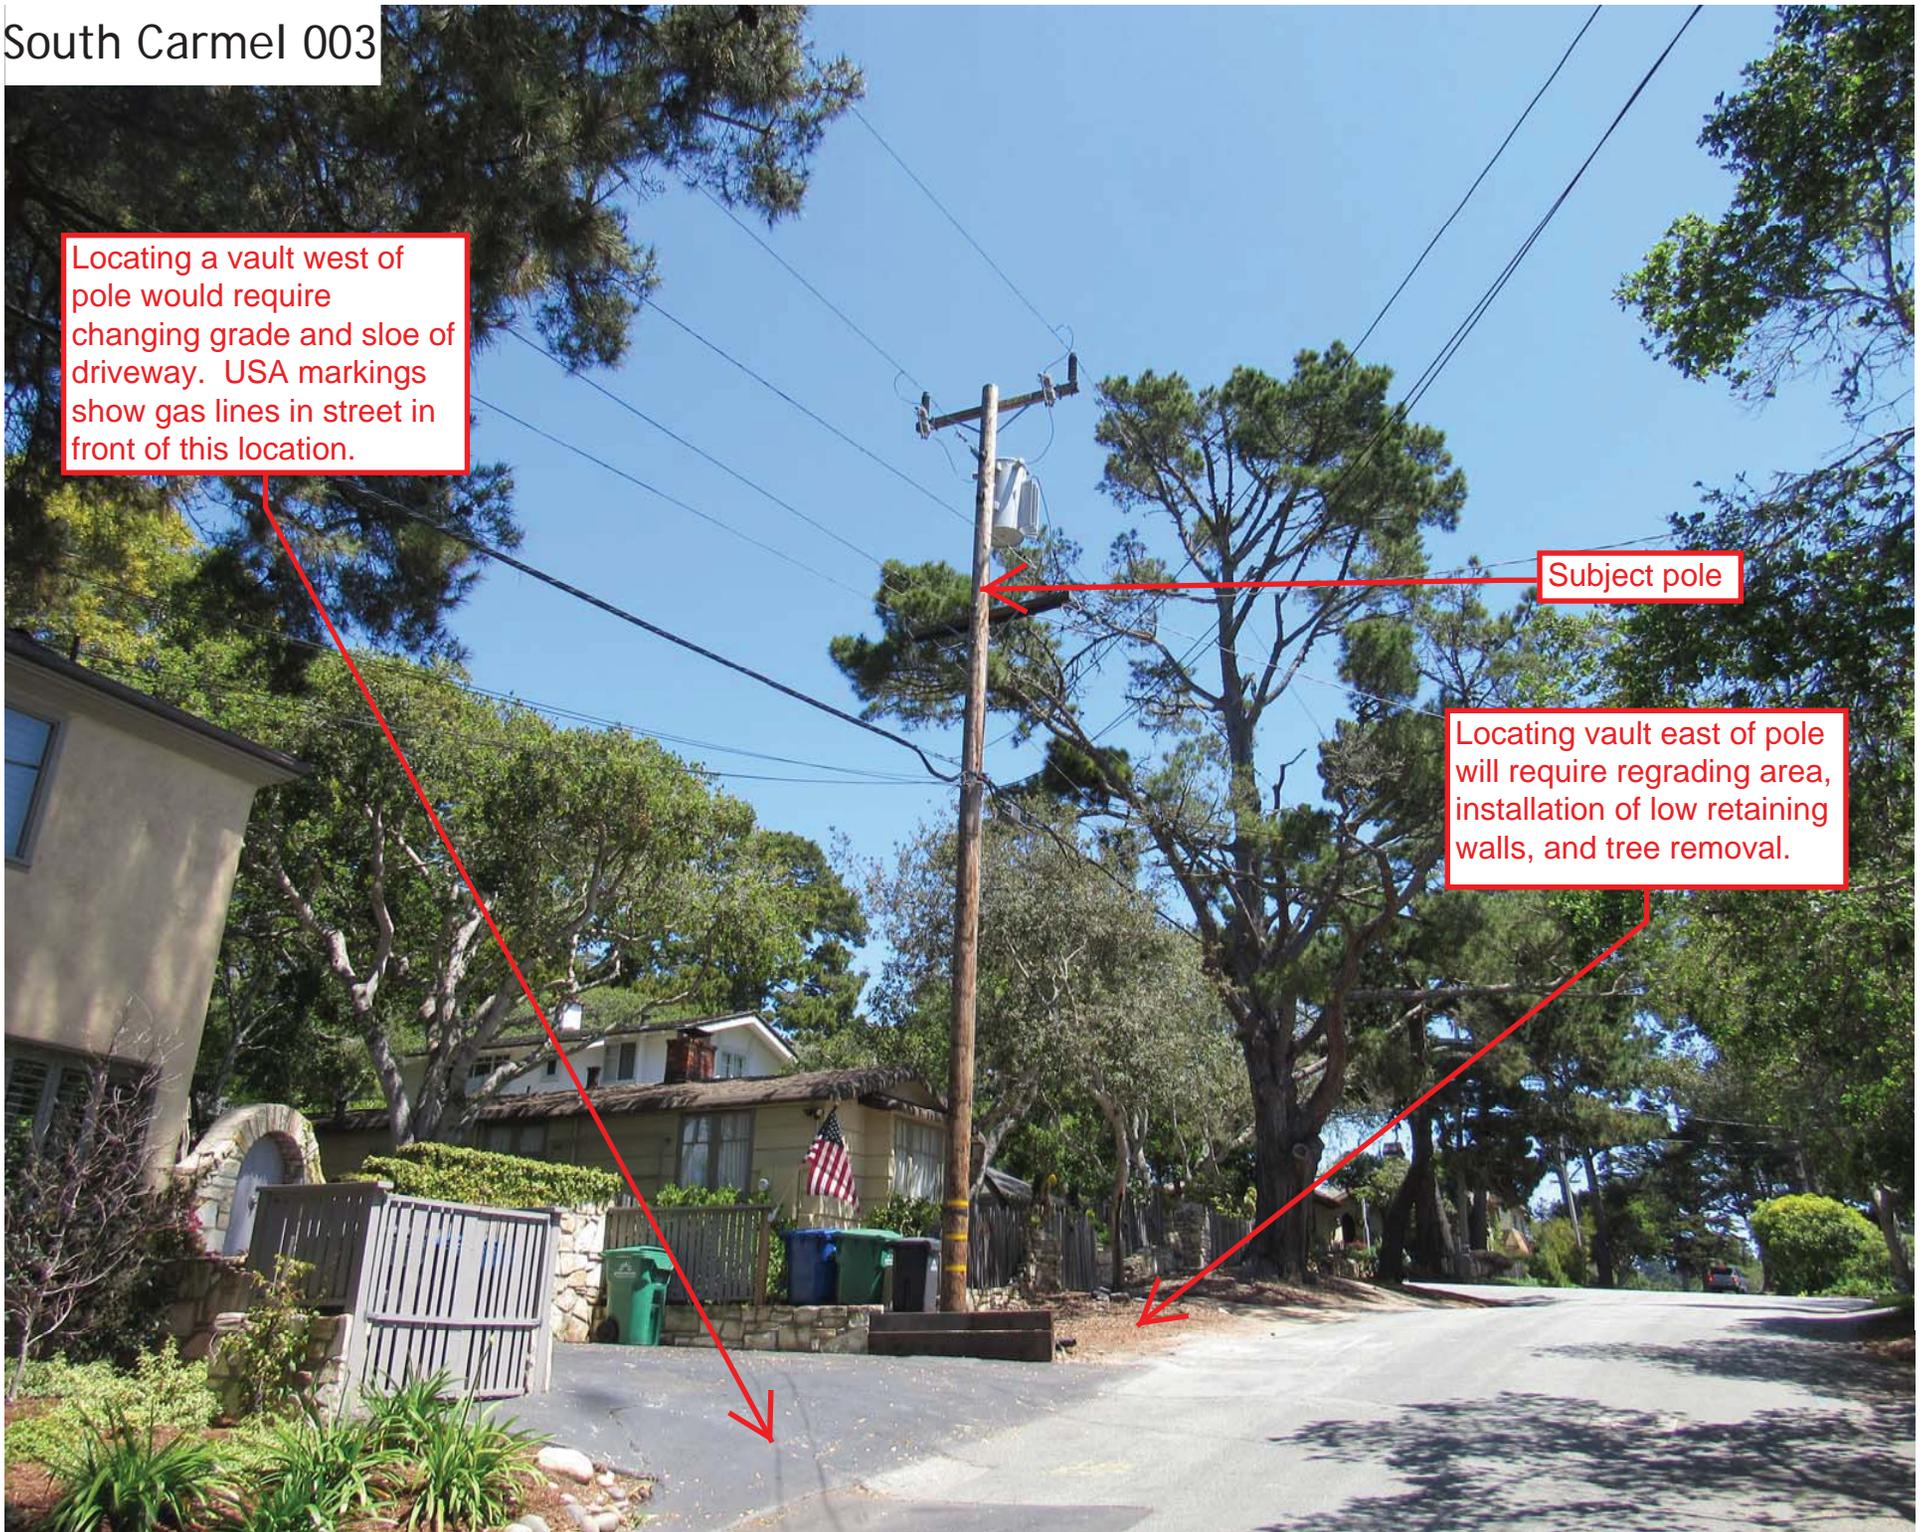
Locating a vault west of pole would require changing grade and slope of driveway. USA markings show gas lines in street in front of this location.

Subject pole

Locating vault east of pole will require regrading area, installation of low retaining walls, and tree removal.

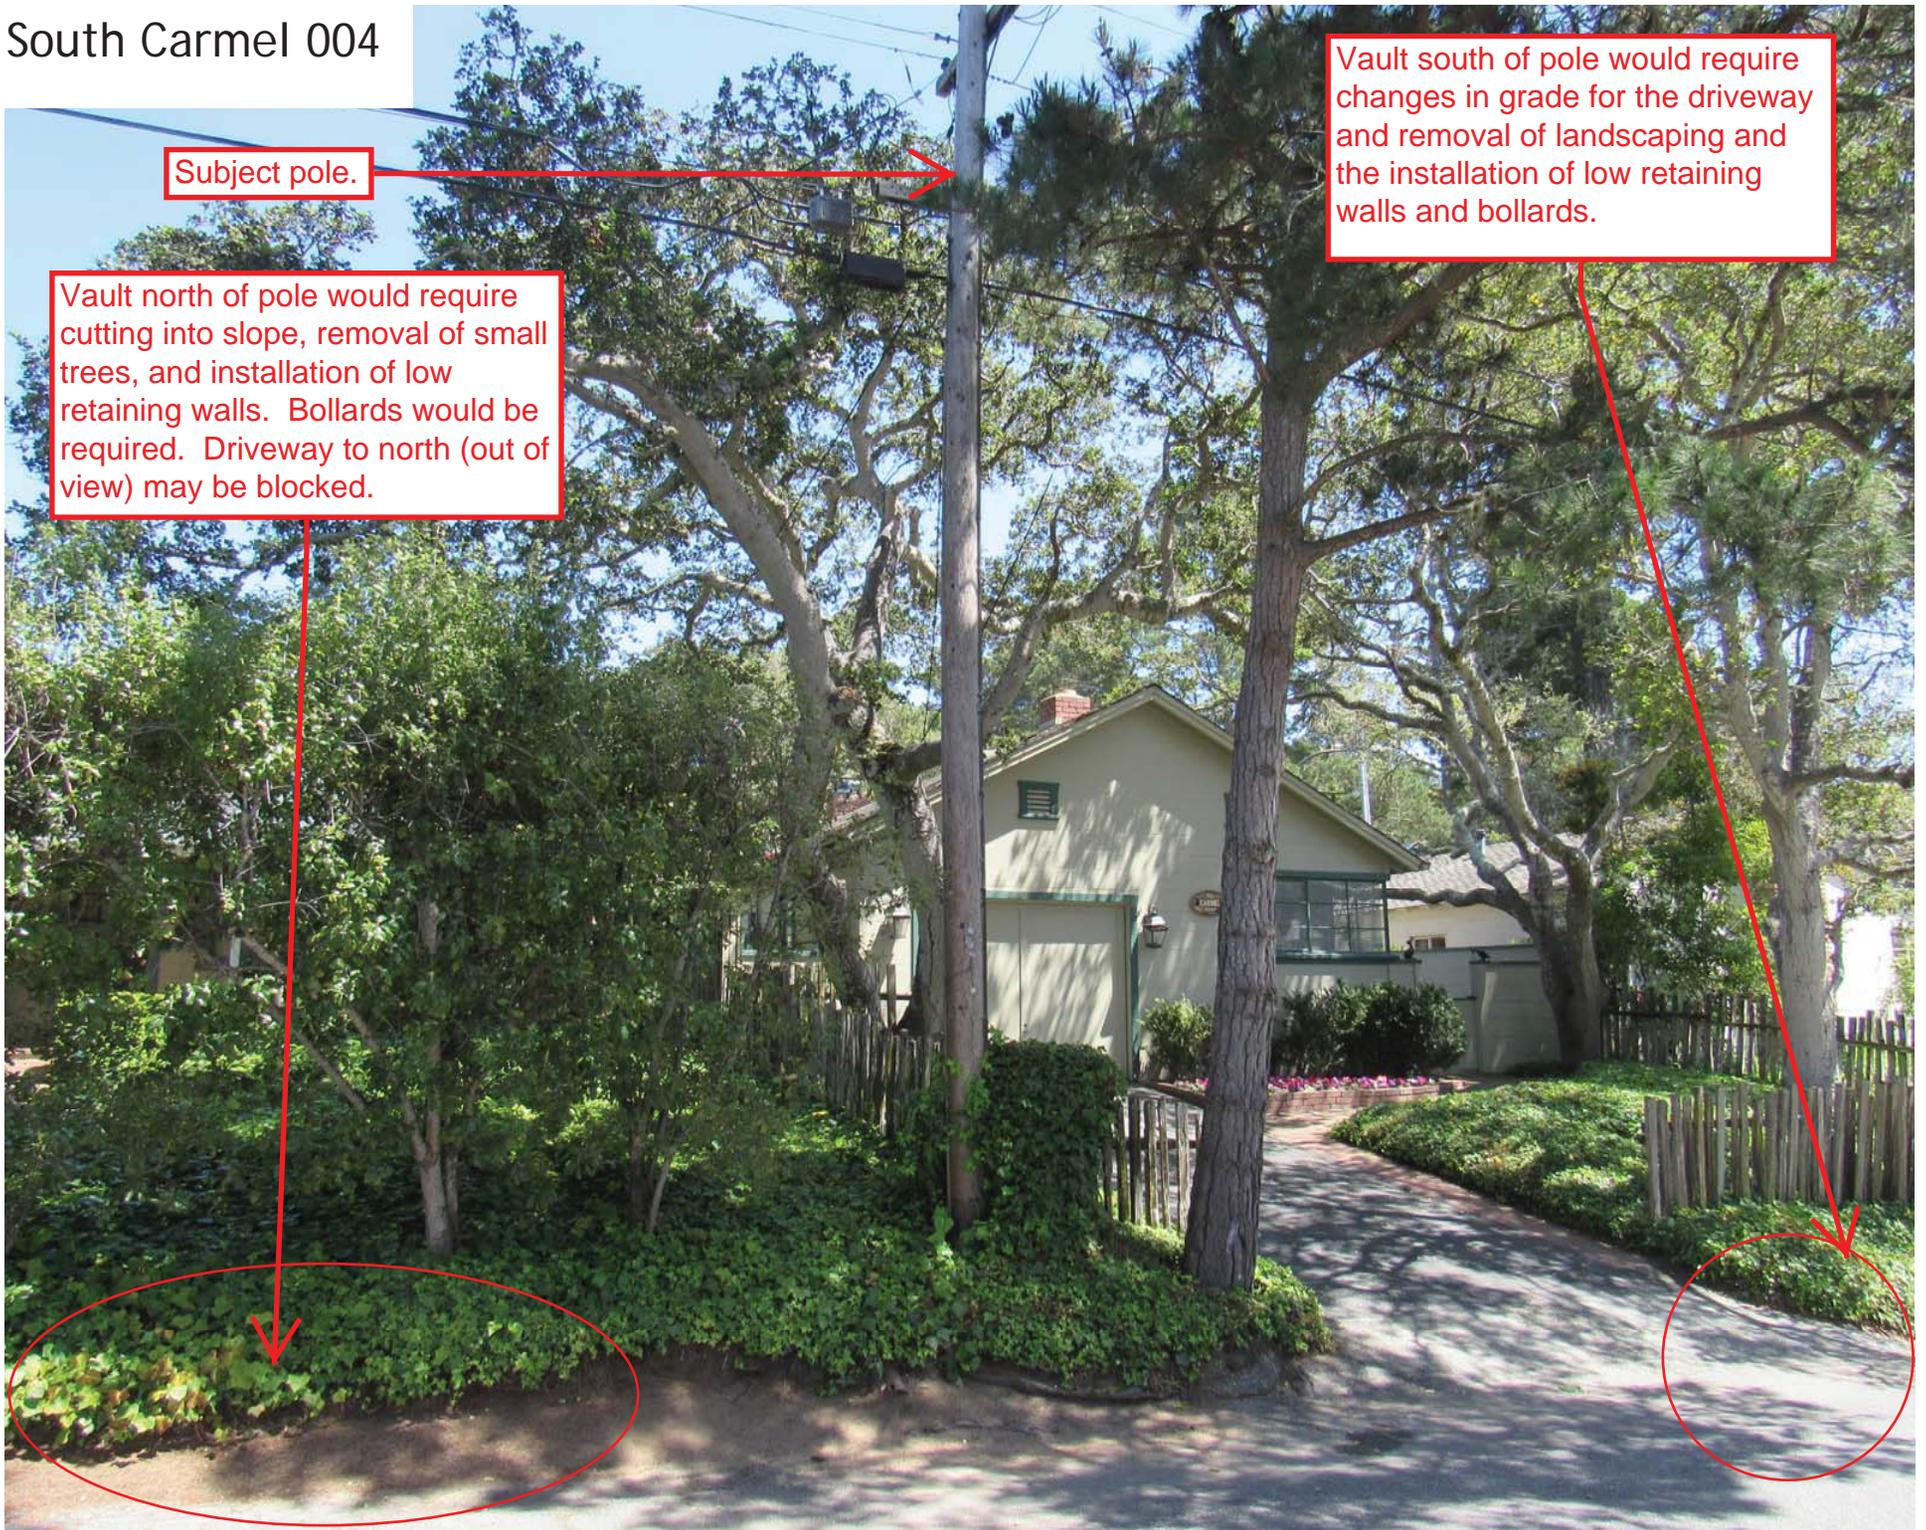
South Carmel 004

Subject pole.

Vault north of pole would require cutting into slope, removal of small trees, and installation of low retaining walls. Bollards would be required. Driveway to north (out of view) may be blocked.

Vault south of pole would require changes in grade for the driveway and removal of landscaping and the installation of low retaining walls and bollards.

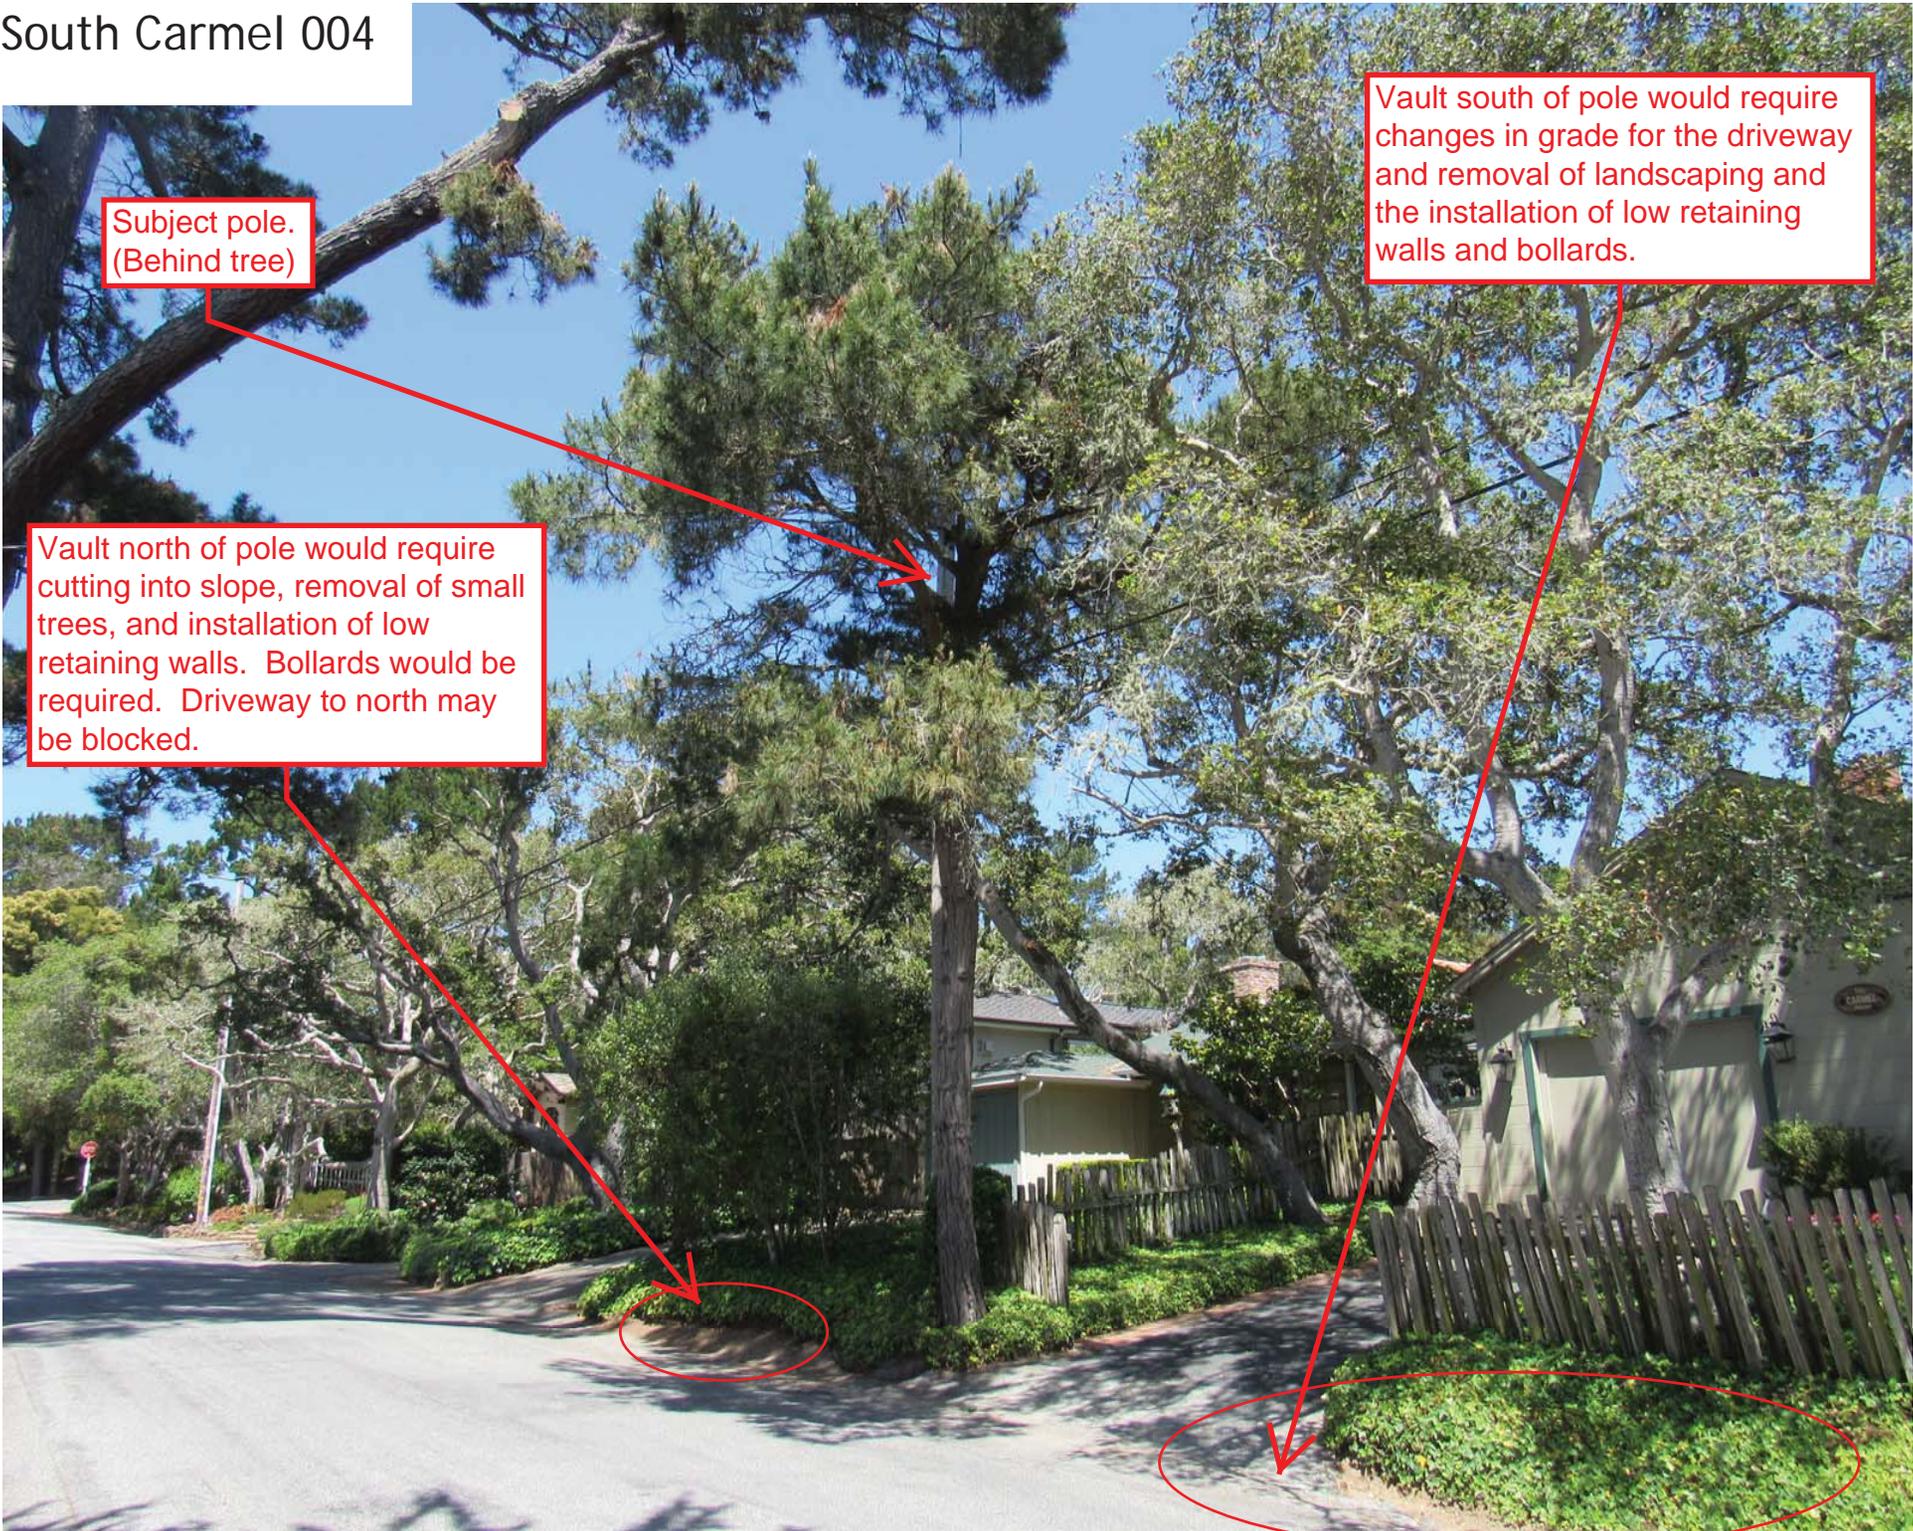
Subject pole.
(Behind tree)

Vault north of pole would require cutting into slope, removal of small trees, and installation of low retaining walls. Bollards would be required. Driveway to north may be blocked.

Vault south of pole would require changes in grade for the driveway and removal of landscaping and the installation of low retaining walls and bollards.

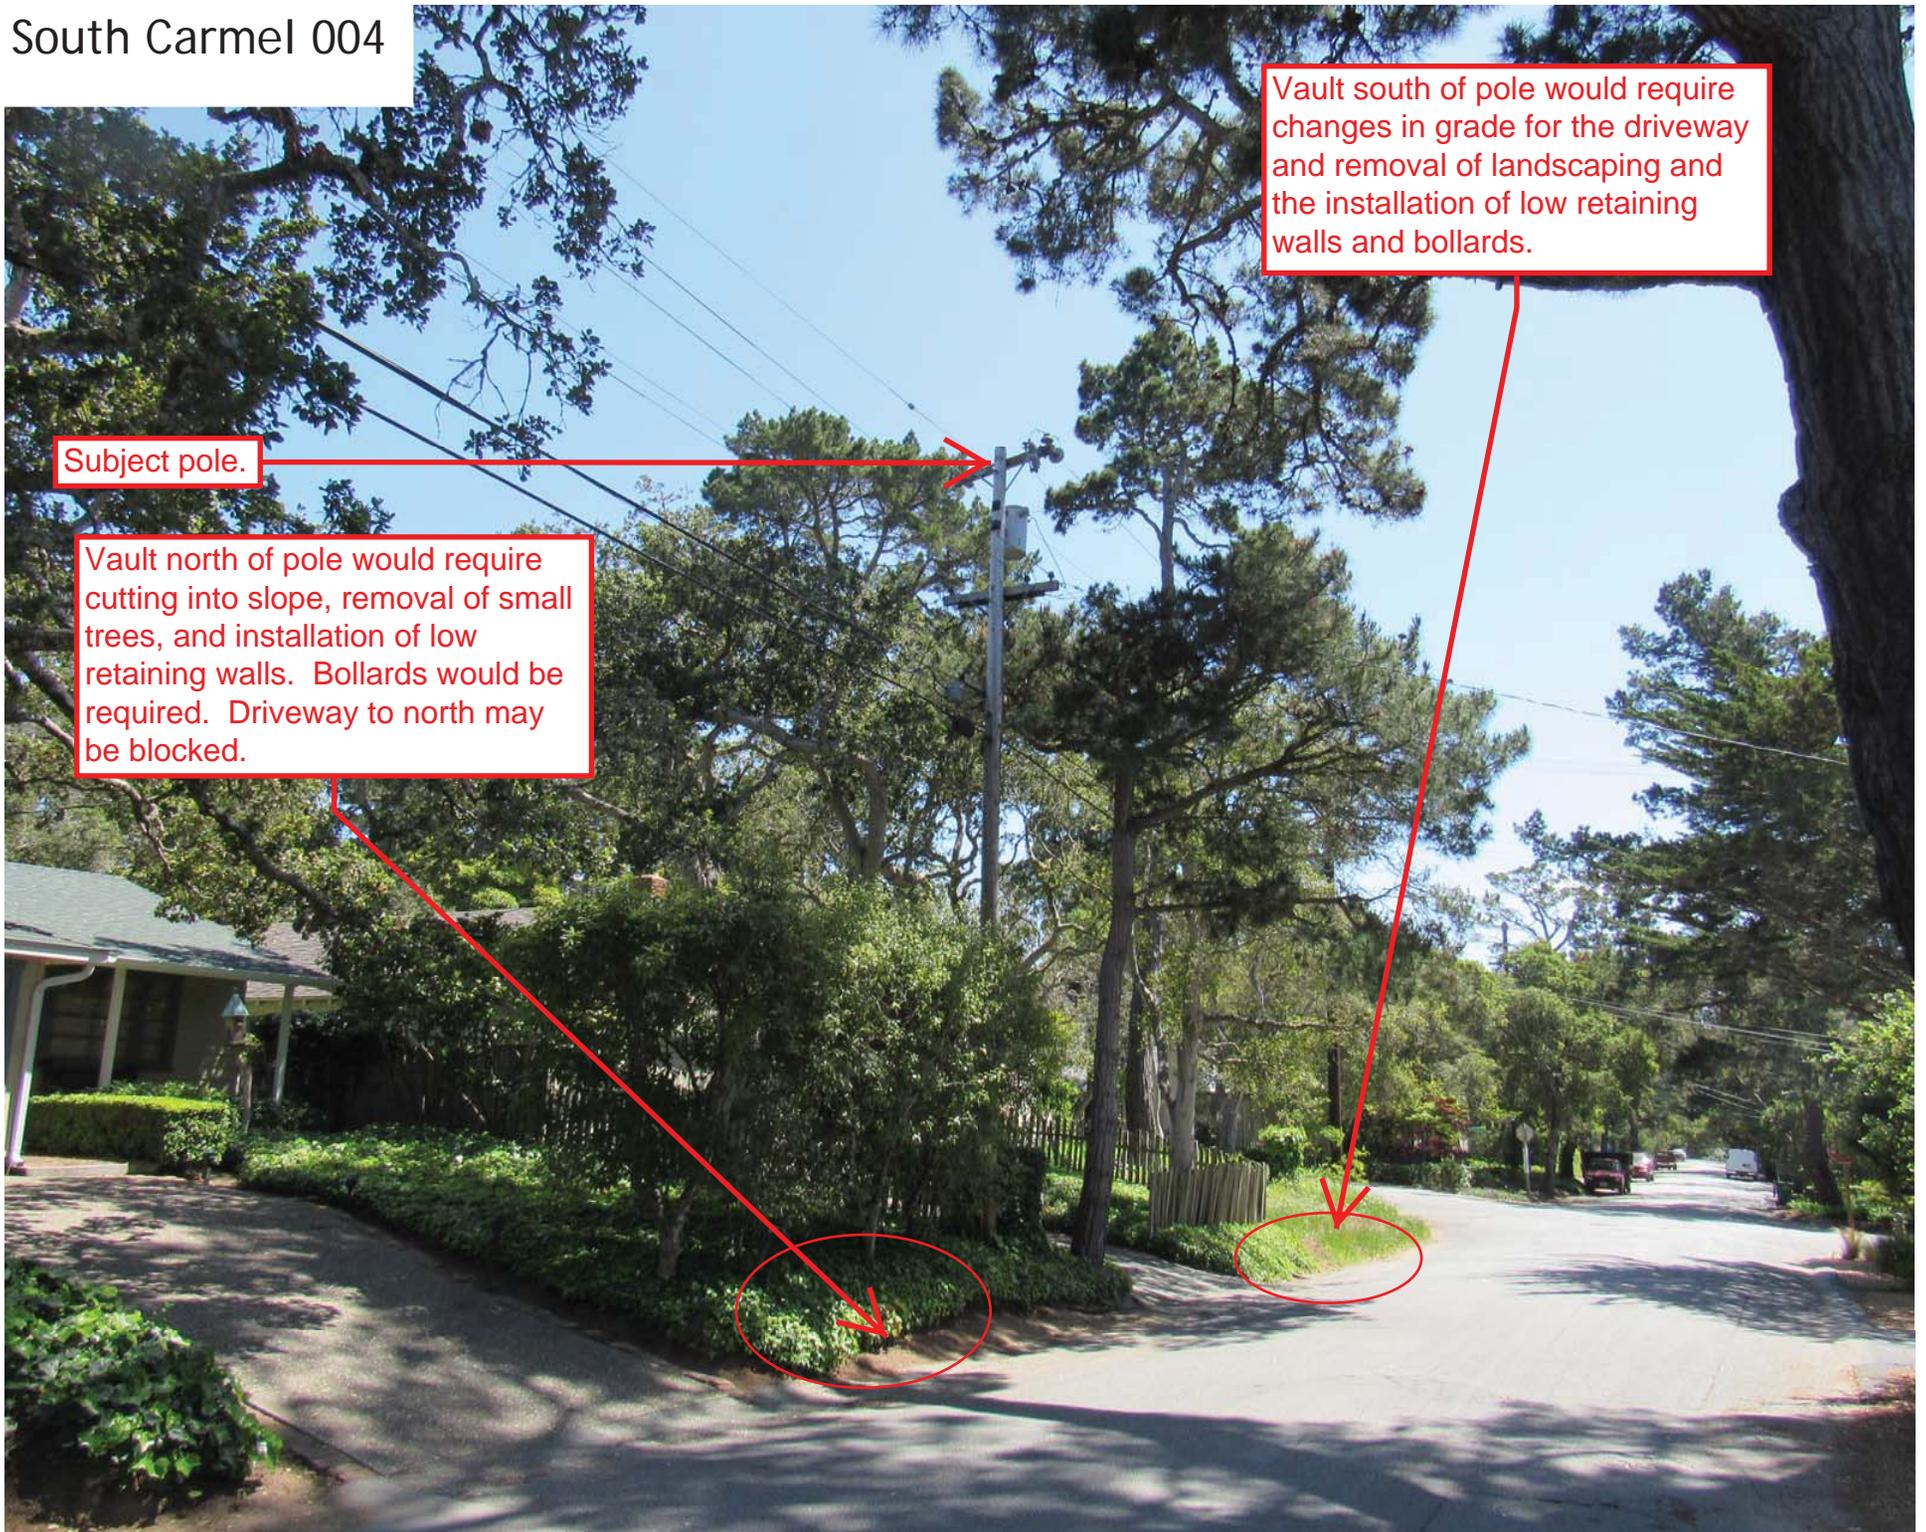
Vault south of pole would require changes in grade for the driveway and removal of landscaping and the installation of low retaining walls and bollards.

Subject pole.

Vault north of pole would require cutting into slope, removal of small trees, and installation of low retaining walls. Bollards would be required. Driveway to north may be blocked.
