Verizon Wireless South Carmel Polygon

Exhibit E: Vaulting Feasibility Analysis

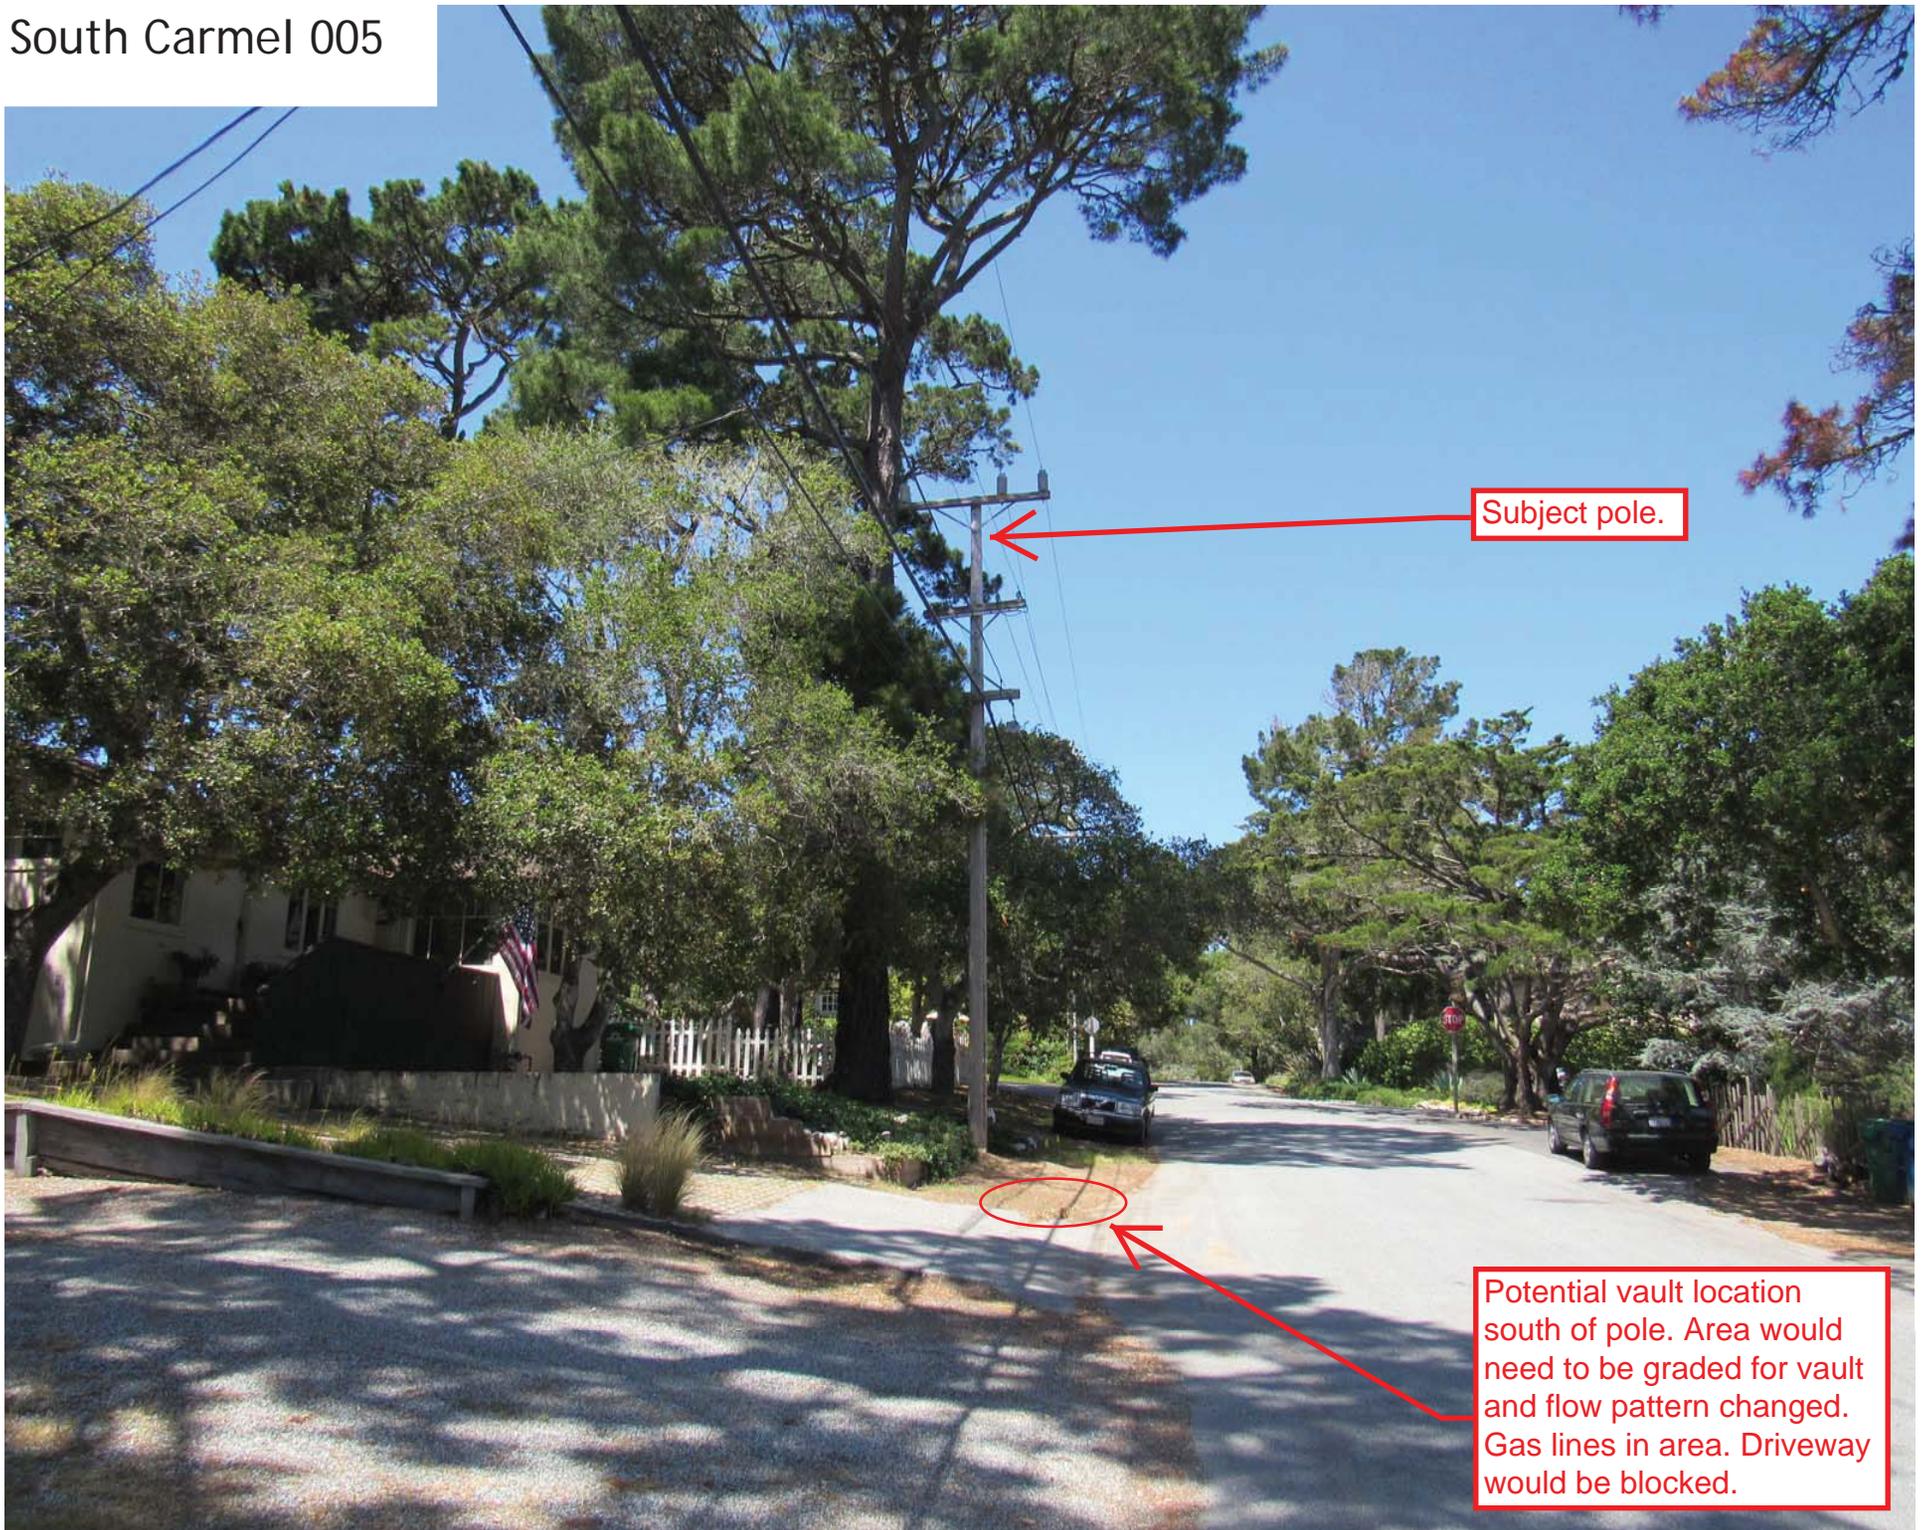
Subject pole.

Potential vault location south of pole. Area would need to be graded for vault and flow pattern changed. Gas lines in area. Driveway would be blocked.

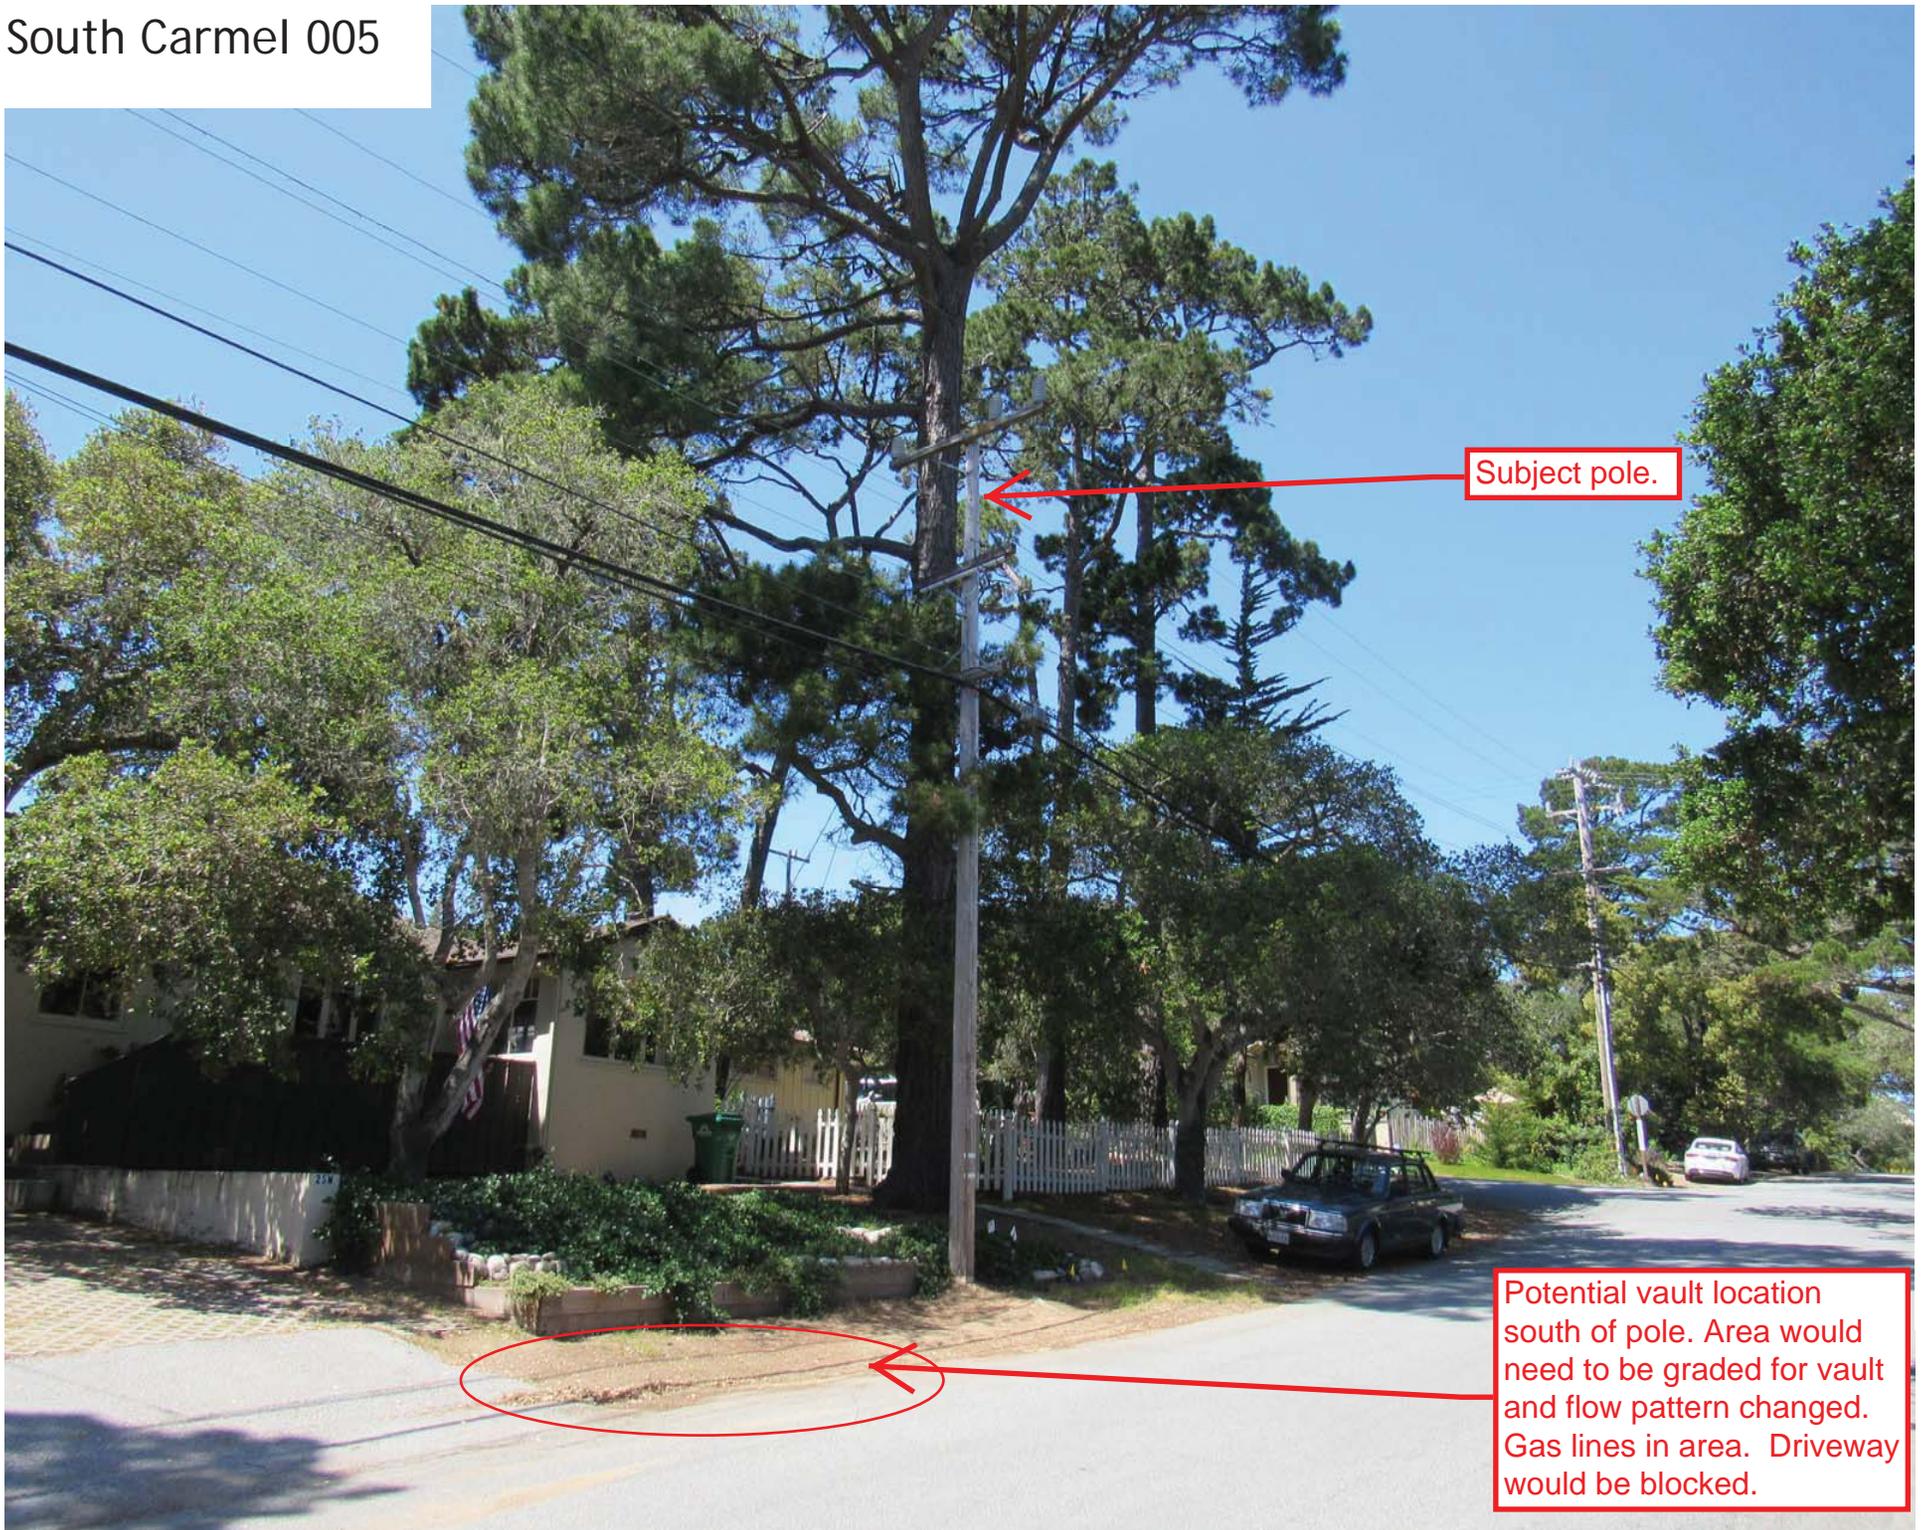
Subject pole.

Potential vault location south of pole. Area would need to be graded for vault and flow pattern changed. Gas lines in area. Driveway would be blocked.

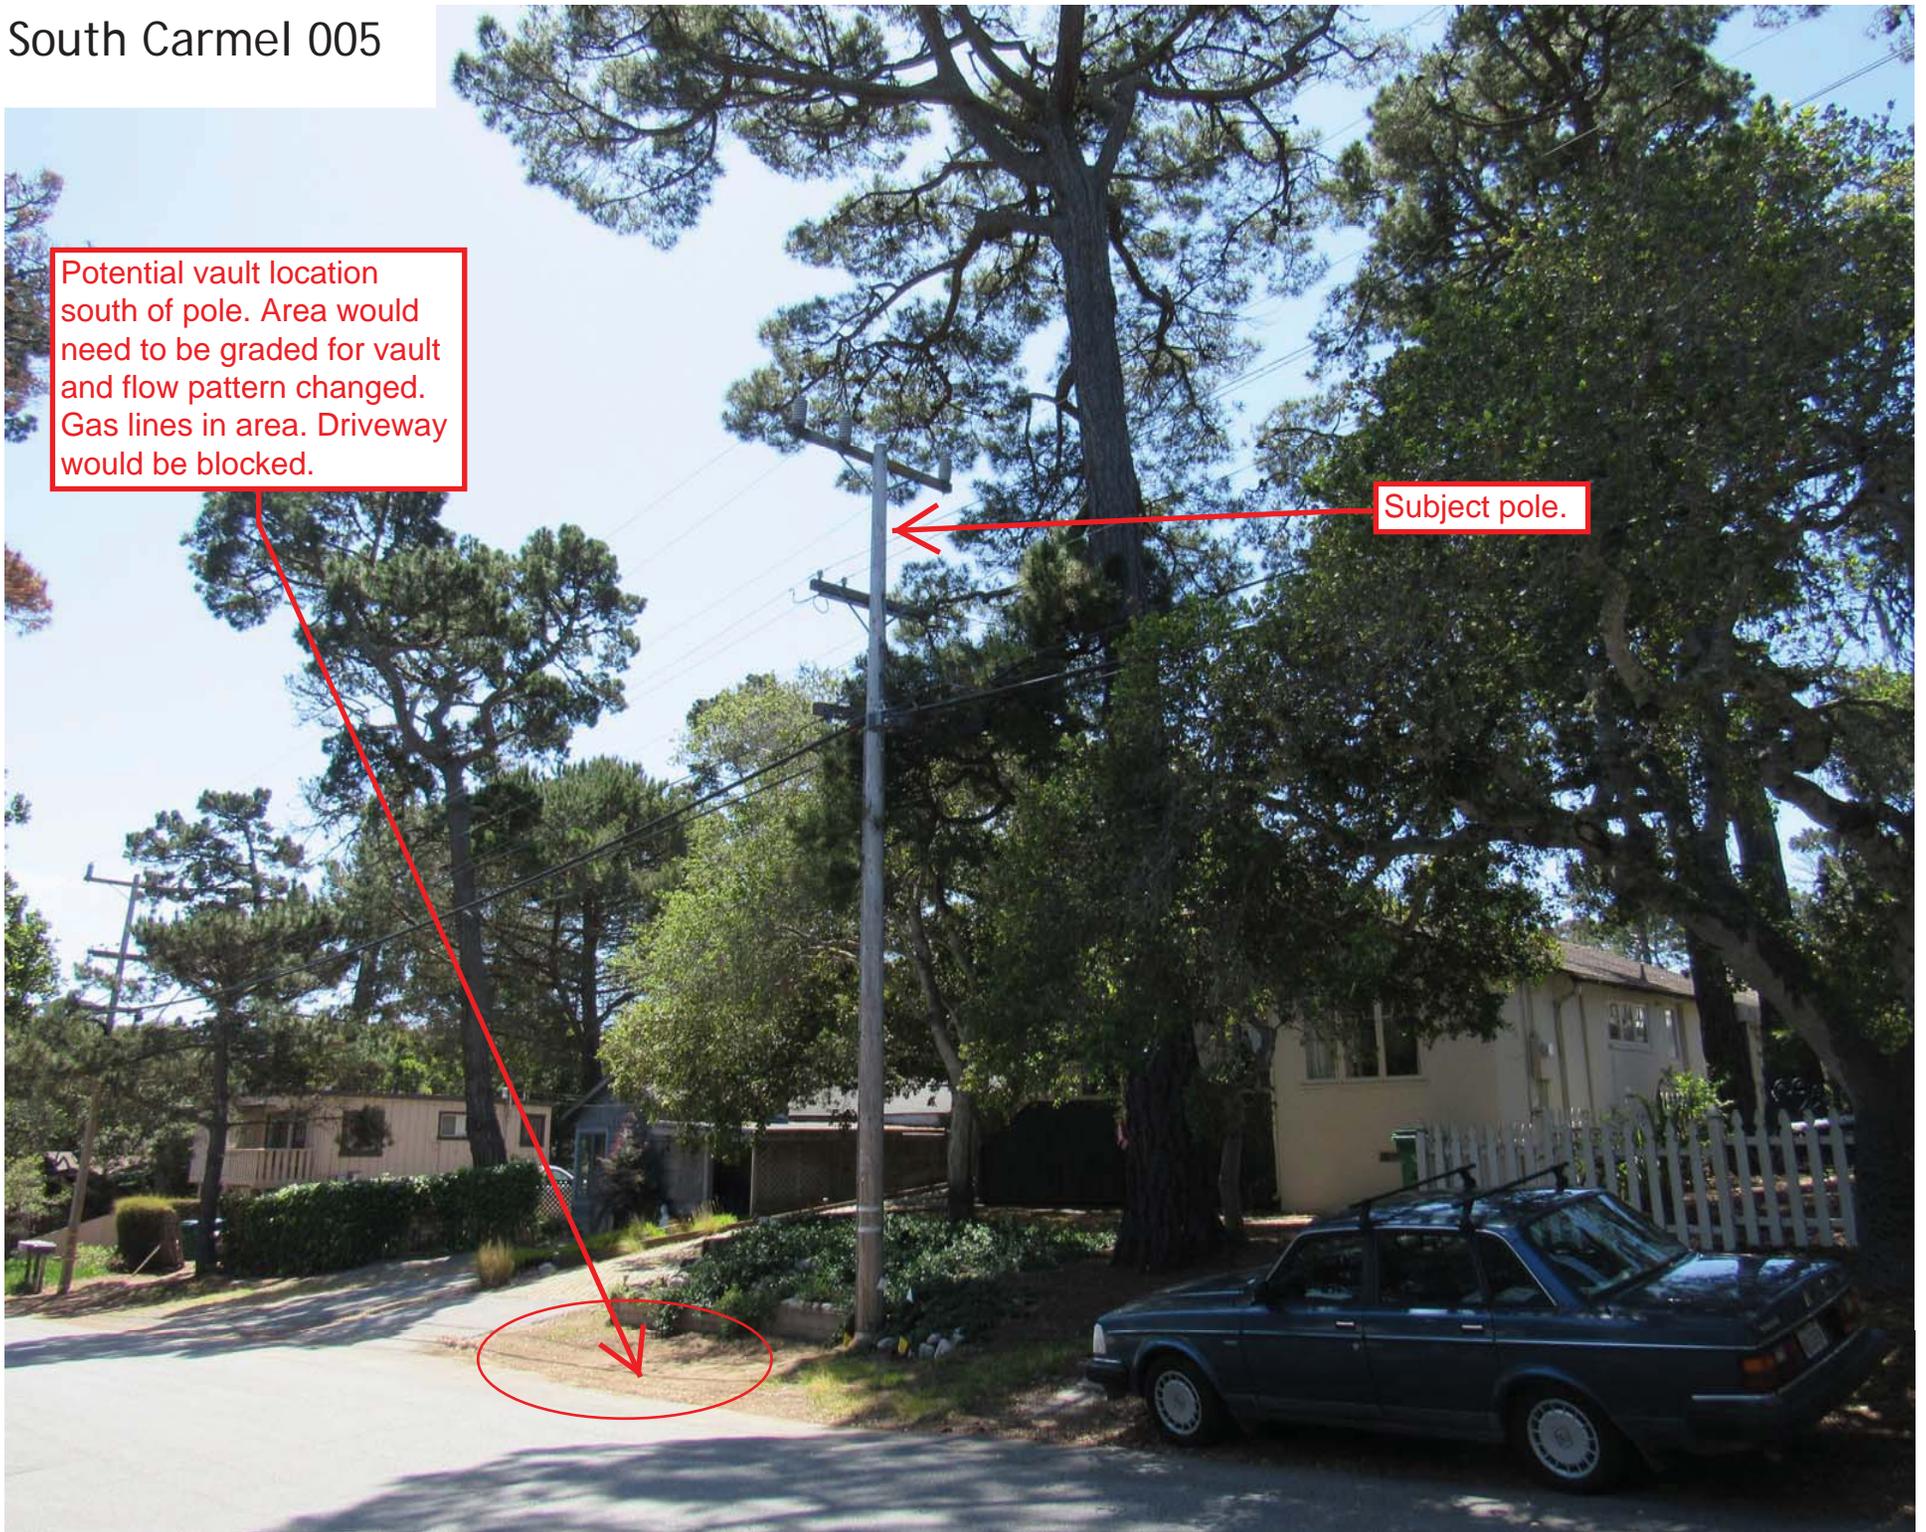
South Carmel 005

Potential vault location south of pole. Area would need to be graded for vault and flow pattern changed. Gas lines in area. Driveway would be blocked.

Subject pole.

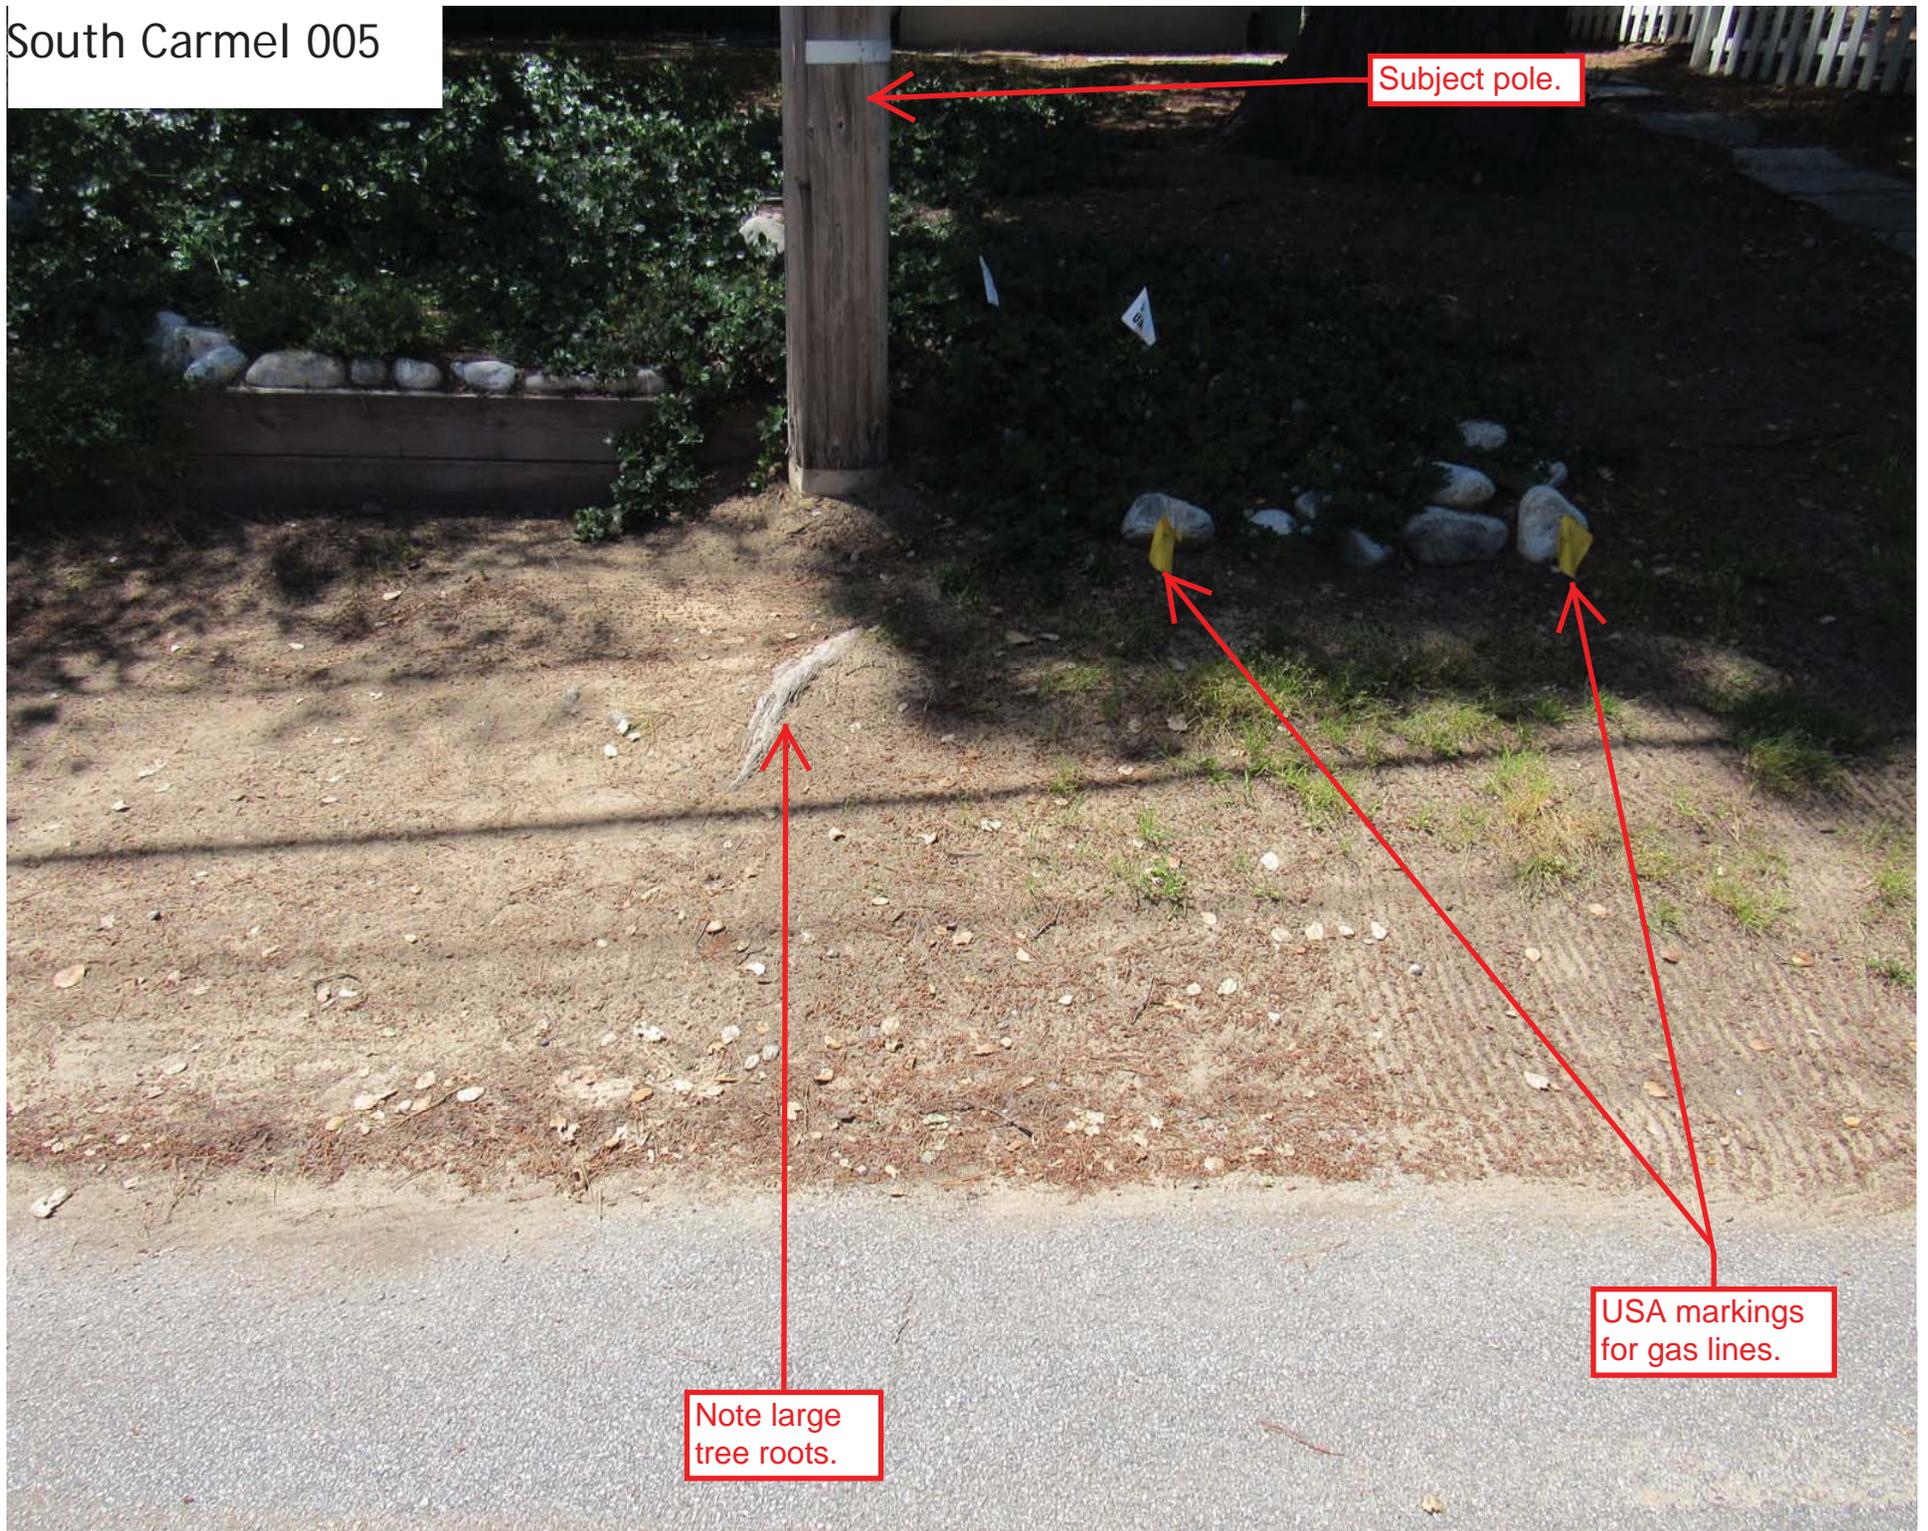
South Carmel 005

Subject pole.

Note large tree roots.

USA markings for gas lines.
