CITY OF CARMEL-BY-THE-SEA APPEAL FORM

**RE: APPEAL OF JANUARY 23, 2023 HISTORIC RESOURCES BOARD MEETING DECISION
7TH & DOLORES ANNEX BUILDING AND HISTORICAL RESOURCE BOARD PROCESS**

CITY OF CARMEL-BY-THE-SEA HISTORIC RESOURCES BOARD Staff Report

SUBJECT: Consideration of a Determination of Consistency for a Design Review Application (DR 20-395) for demolition of the Palo Alto Saving and Loan Community Room (Block: 91; Lot 6) and construction of a 16,898 square foot two story mixed-use development with a 11,371 square foot basement garage (Block 91; Lots 6, 8, & 10) in the Service Commercial (SC) Zoning District at Dolores 2 SE 7th; APN: 010-145-012.

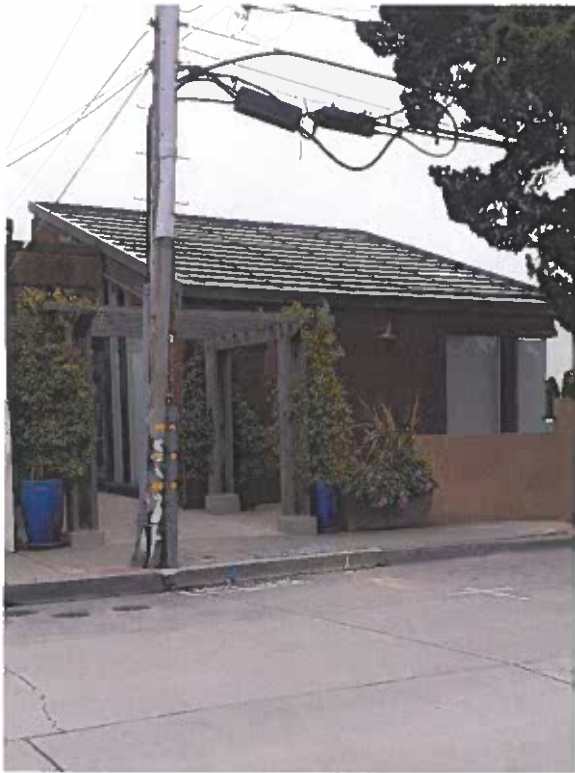
Front Elevation Facing Dolores Street, 2020

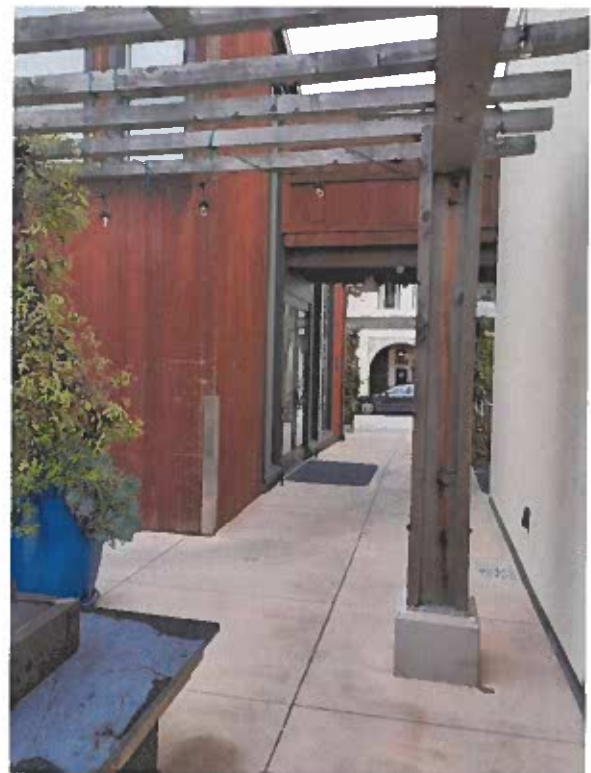
Looking towards Dolores Street, 2020

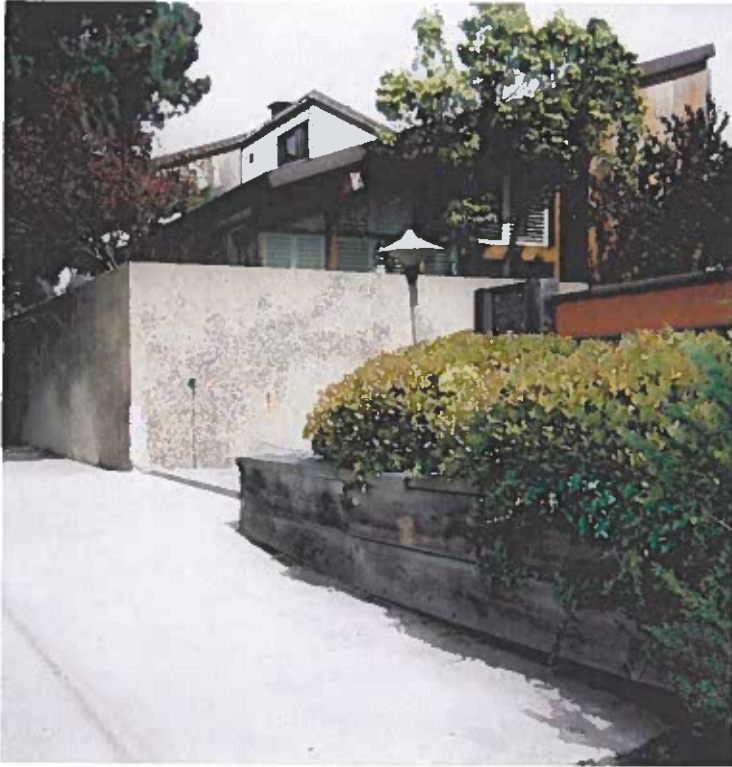
Views showing original window design, 1999.

The first remodel of the building took place in 1978³ and included the removal of the interior chair rails to accommodate plantation blinds. Eventually the exterior rails were removed from the upper and lower windows on the west and south elevations. Single panes of plate glass replaced the original windows. The wall surrounding the community room obscured much of the building but in 2013 a portion of the wall on the south elevation was removed and the entire wall was shortened by twelve inches. That same year new pergolas were added to the front and rear of the walkway.

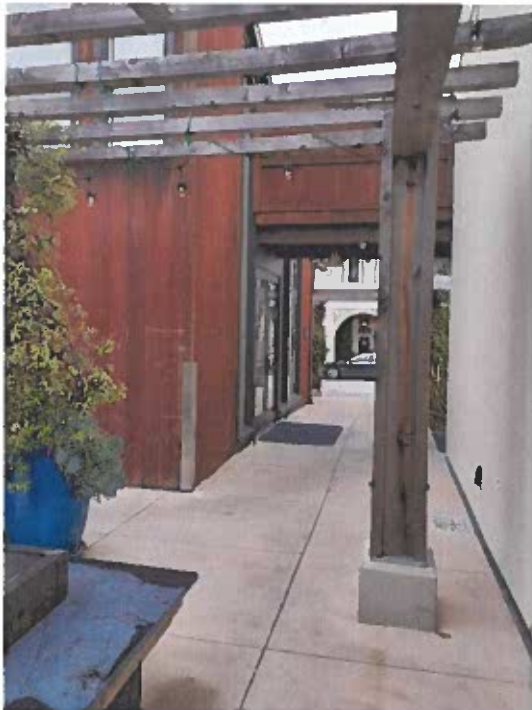
The community room will be demolished as part of this project. It is connected to the main bank building at the second-floor level by an elevated walkway. When the community room is demolished a gap will be created in the exterior wall of the bank building. The wall should be repaired by matching the original wall in design, color, texture, and if possible, materials. If this is clearly indicated on the construction plans, then the work will be consistent with Standard Five.

Phase II Response: "The community room will be demolished as part of this project. It is connected to the main bank building at the second-floor level by an elevated walkway. When the community room is demolished a gap will be created in the exterior wall of the bank building. The wall should be repaired by matching the original wall in design, color, texture, and if possible, materials. If this is clearly indicated on the construction plans, then the work will be consistent with Standard Five.
