City of Carmel-by-the-Sea

Overview of the Phase 1 Coastal Engineering and Hazard Assessment for Carmel Beach

March 26, 2024

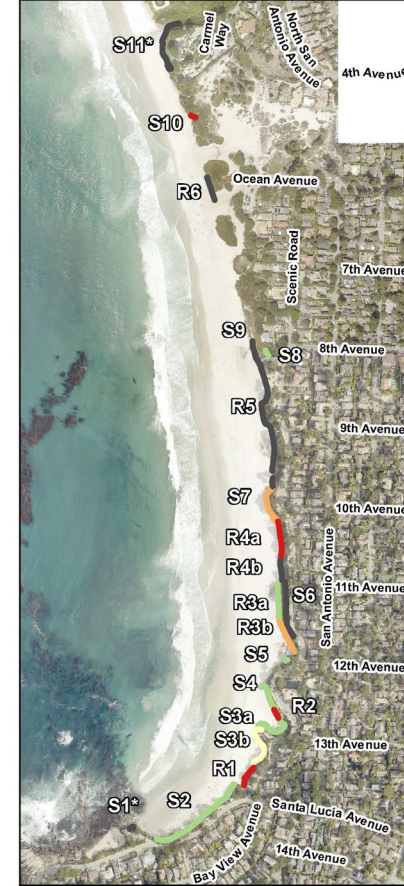
Coastal Armoring
Seawalls and Revetments

- **17** coastal armoring structures were assessed including **6 riprap revetments** and **11 vertical seawalls**.
- **11 coastal access stairways** were also assessed - *however conditions have changed significantly since the assessment*
- Seawalls are identified with an **S**, revetments **R**, and stairs **ST**.
- The map shows the priority of repair rankings from **very low to high**
- Of the **6** revetments, **4** are in need of repair; **one** in its **entirety** and the others in some portions
- Blue circles represent stairs that we damaged or undergoing repairs in 2024

Inspection dates: 12/22/2022 & 1/30/2023
This map represents preliminary results.

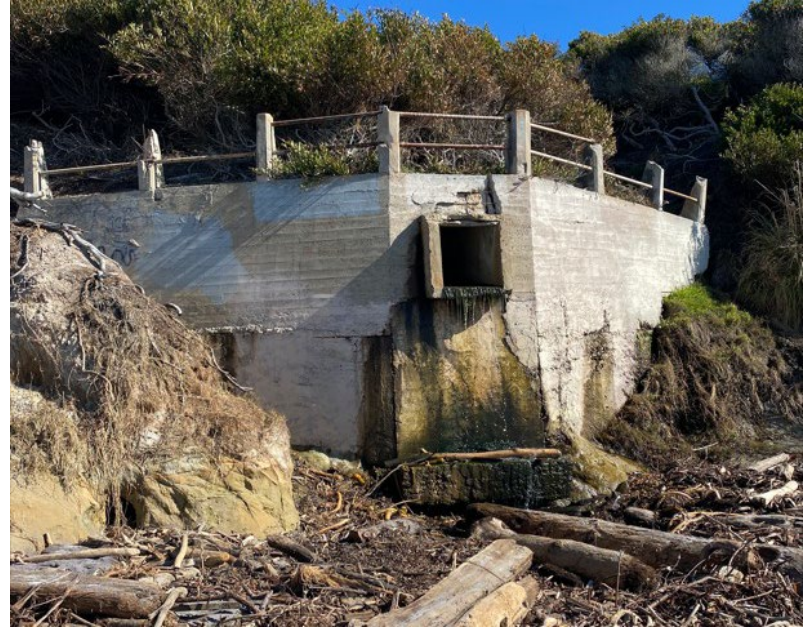
S10 between Carmel Way and Ocean Ave

- › Seawall just west of the beach volleyball courts between Ocean Ave and Carmel Way.
- › Structure is significantly deteriorated and is unstable.
- › Revetments R2 and R4 needed restacking to avoid potential toppling onto beach or beach goers

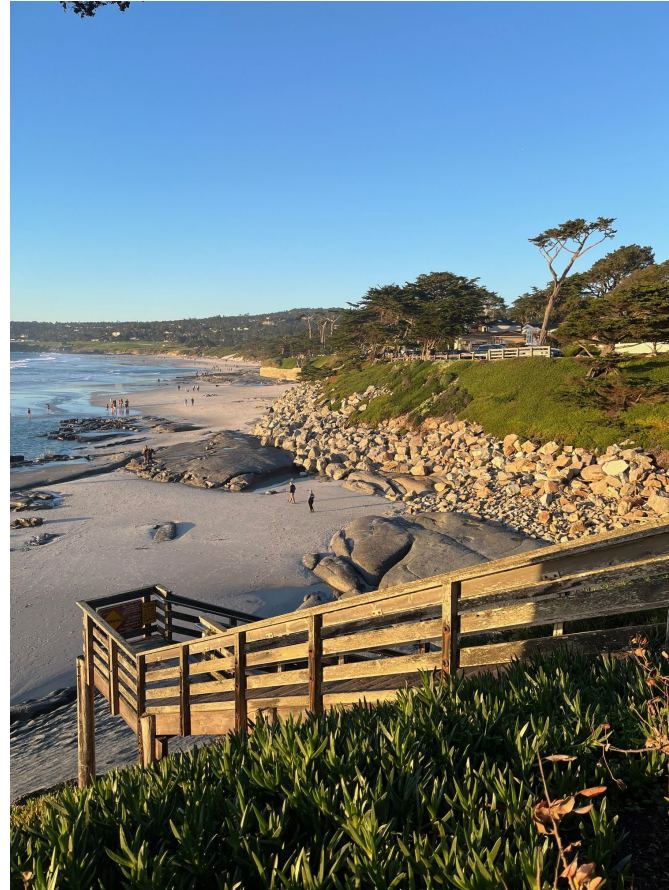
Beach Narrowing Methods

- › Project typical summer beach widths for each foot of sea level rise
- › Typical summer beach is based the CoastSat data presented in Task 2 (using 75th percentile from 1984-2021)
- › Winter beach varies widely and is often scoured completely in the south beach (like now)
- › This model can be considered a “*hold the line*” scenario and represents what may occur if **no adaptation** strategies are implemented in the future

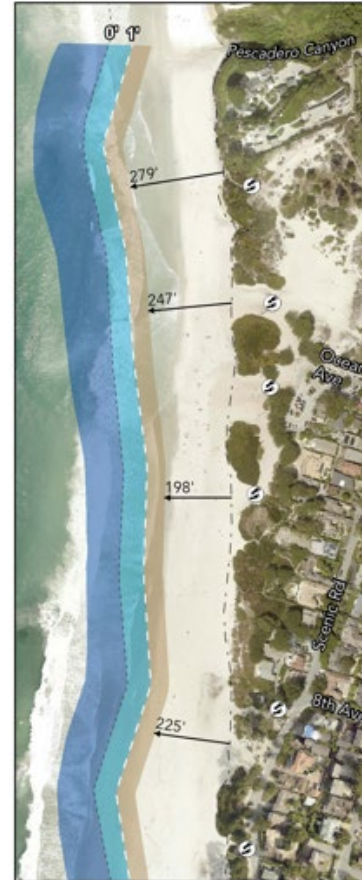
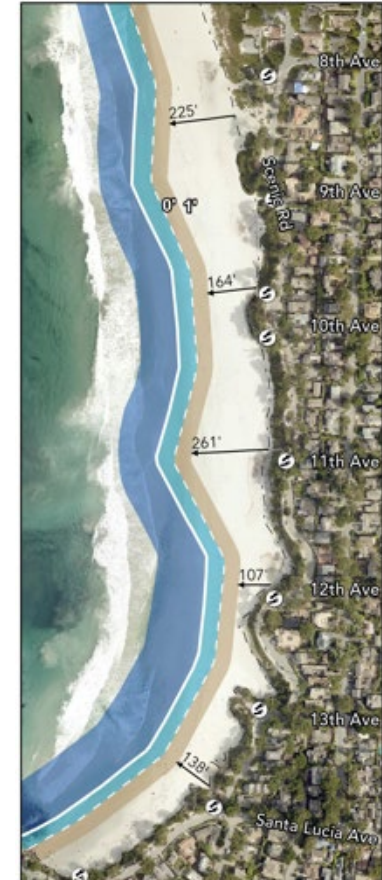
Beach Width Narrowing: Short term (2045 - 2060)

- › A typical summer beach still exists
- › Southern section becomes “squeezed” especially at 12th avenue headland
- › Summer beach widths narrow ~**50 - 60** feet for each foot of sea level rise
- › Beach widths generally higher in the north than the south
- › By **1 ft** of sea level rise, typical summer dry sand beach reduced by **20%**

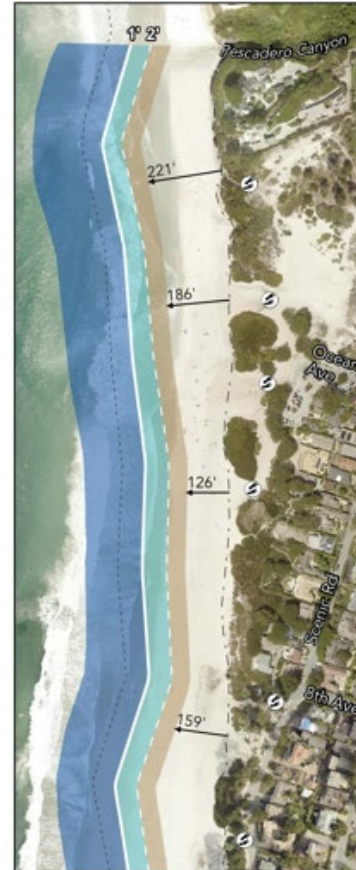
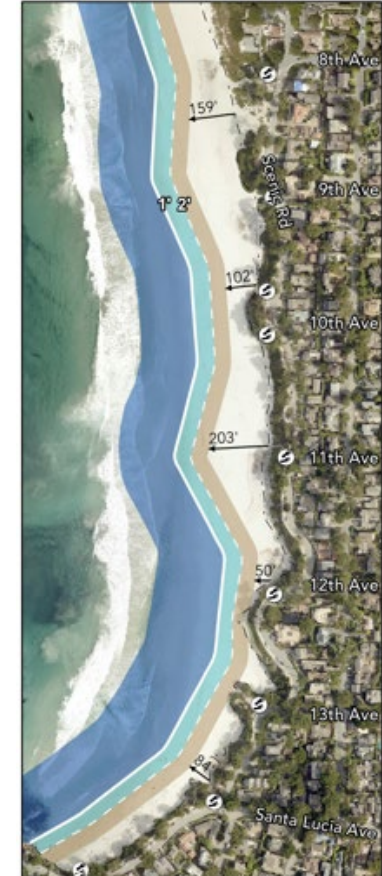
Beach Width Narrowing: Medium-term (2060 - 2080)

- The northern beach section remains connected laterally
- Lateral access to areas south of 12th Avenue headland may be restricted
- By **2 ft** of sea level rise, reduced by **39%**, with loss of lateral beach access to areas south of the 12th Avenue headland

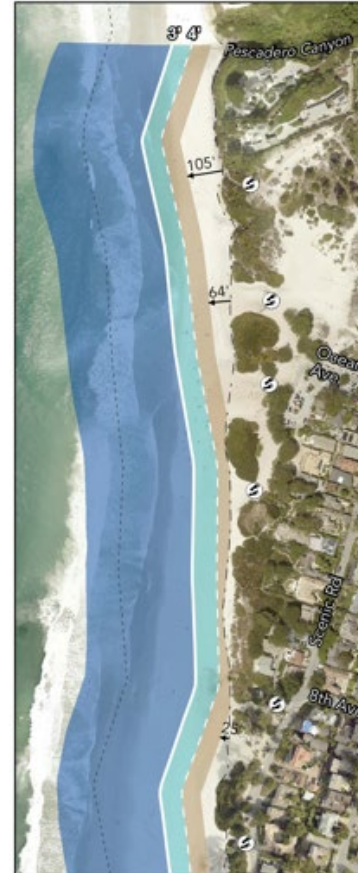
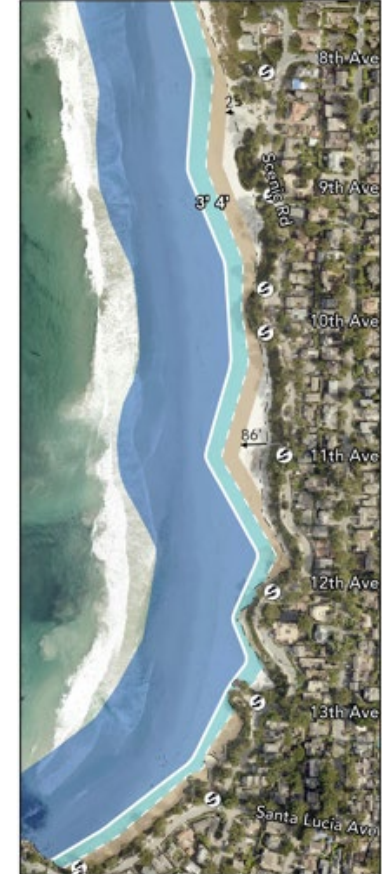
Beach Width Narrowing : Long Term (2080 – 2100)

- Only continuous dry sand beach is between the northern sand ramps to Pescadero Canyon
- Two small pockets between 8th avenue and 11th avenue (~1.5 acres each)
- By **4 ft** of sea level rise, reduced by **78%**, with two small pocket beaches remaining in the south, but dry beach remaining north of the sand ramps

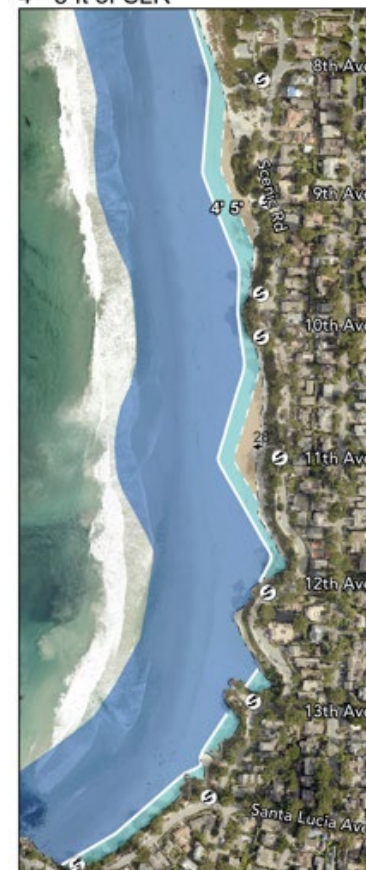
Beach Width Narrowing beyond 2100

- › Very little beach remains by 5 ft of SLR

Sea Level Rise Elevation (ft)	Acres of Dry Sand Beach (summer)	Percentage
0	34.2	100%
1	27.4	80%
2	20.7	61%
3	14.1	41%
4	7.6	22%
5	2.6	8%

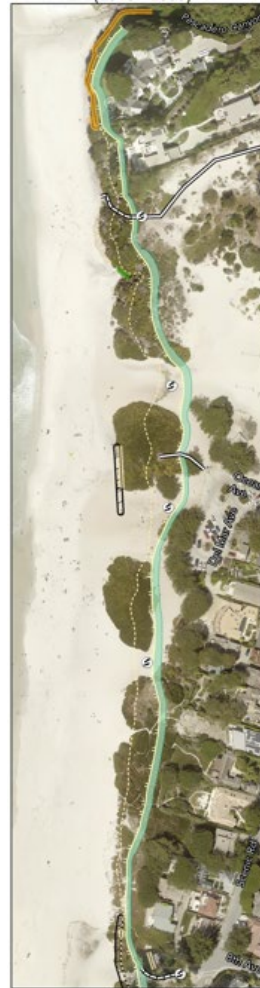
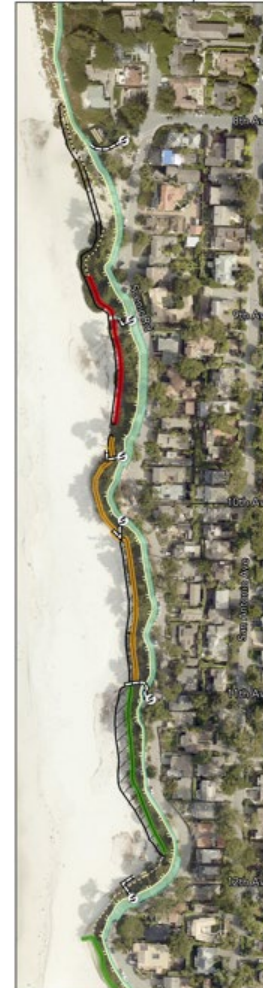
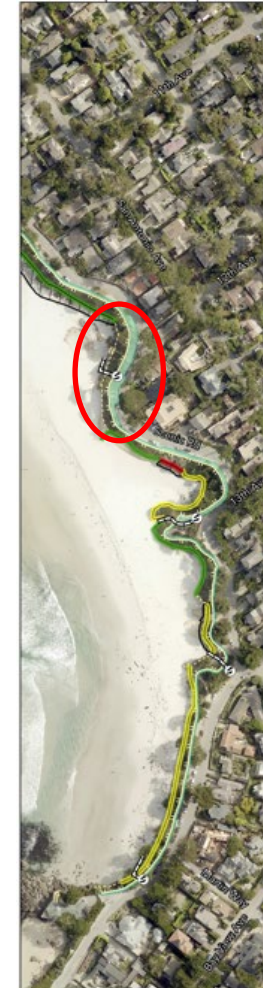
Erosion and Overtopping Short Term (2045 – 2060)

- Highest risk between 8th and 10th Avenues

- Most threatened area for erosion is at Central Carmel Beach between 8th and 12th Avenues
- Red circle indicates an unarmored area of shoreline at Scenic Dr. and 12th Avenue

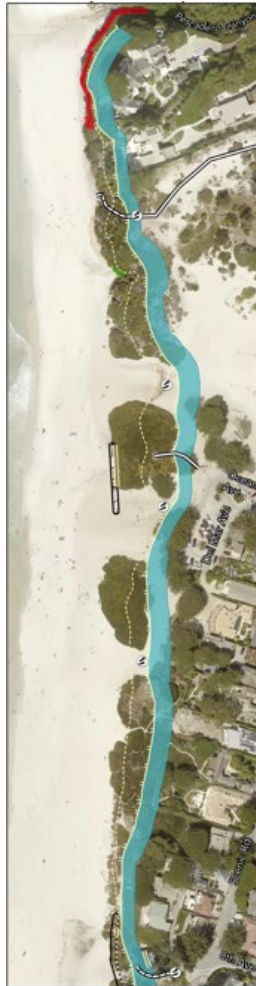
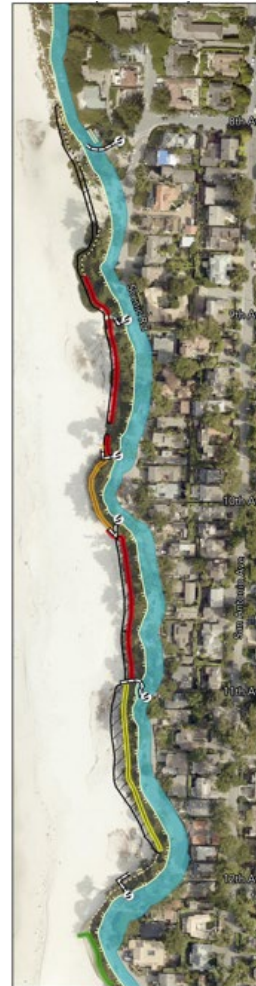
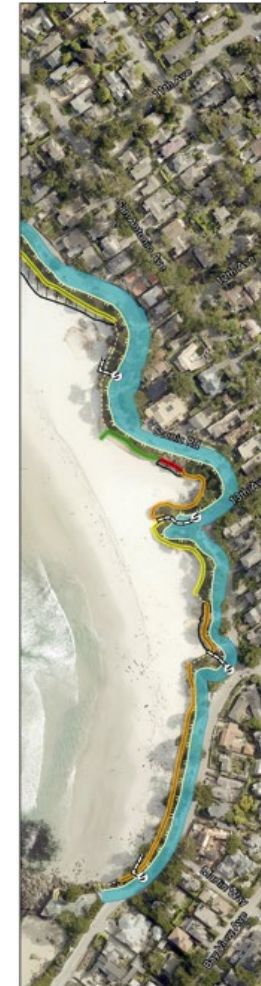
Cliff and Dune Erosion Medium Term (2060 – 2080)

- Overtopping potential highest between 8th and 12th Avenues

- Projected erosion hazards in areas behind seawalls range ~ 20-40ft
- Erosion hazard zones are slightly higher along the dune-backed shoreline

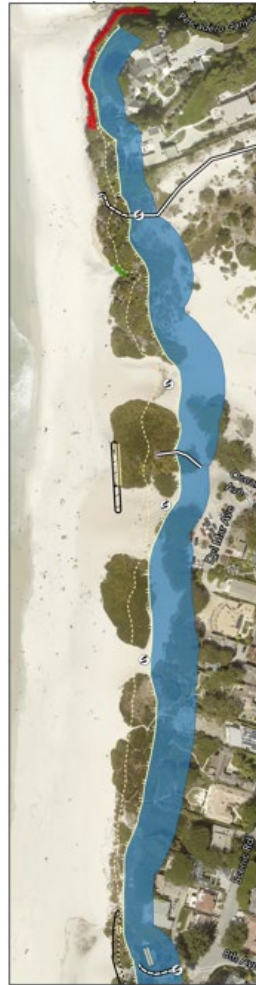
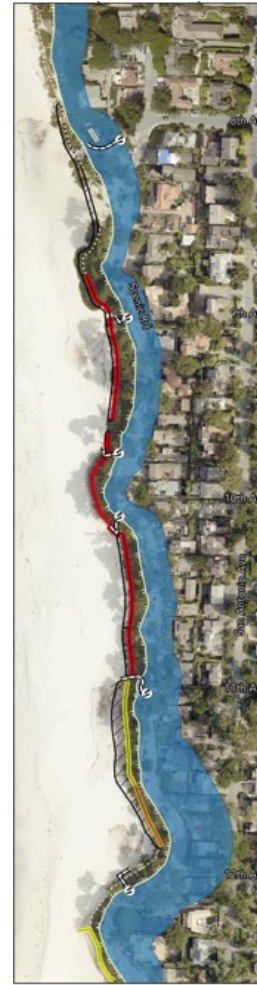
Cliff and Dune Erosion Long Term (2080 – 2100)

- › South Carmel Beach between Martin Way to 13th Avenue
- › North Beach near Pescadero Canyon

- › Highest erosion potential around 12th Avenue up to 150 ft (see red circle)

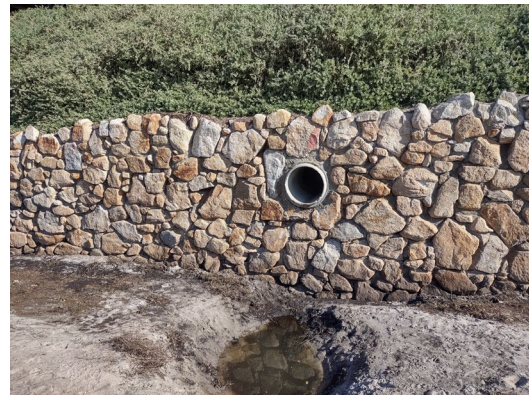
Stormwater infrastructure

- › **Stormwater** conveyance
- › All **beach access stairways** and the **beach overlook** at Del Mar
- › **Restroom** near Santa Lucia Avenue, located at ~24 ft NAVD 88, which is at the same elevation of the FEMA base flood elevation for this area
- › Wave splash (not green water associated with overtopping) may exceed the bluff crest of the armored coastline between 13th Avenue and Martin Way and the private seawall near Pescadero Canyon

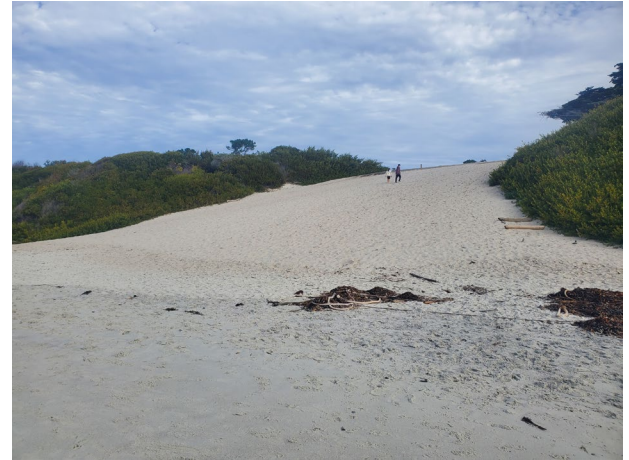
Sand ramp near the Del Mar Parking Lot

- › **Scenic Road** is exposed in 6 locations from 8th Avenue and 11th Avenue
- › **Wastewater mains** are exposed at:
 - Martin Way
 - Between 9th and 10th Avenues
 - Under dunes between 7th and 8th Aves
- › The integrity of the **sand dune ramps** may be at risk
- › 0.2 acres of **North Dunes Habitat** potentially eroded
- › During large storms wave splash could be more frequent between 8th Avenue and 11th Avenue

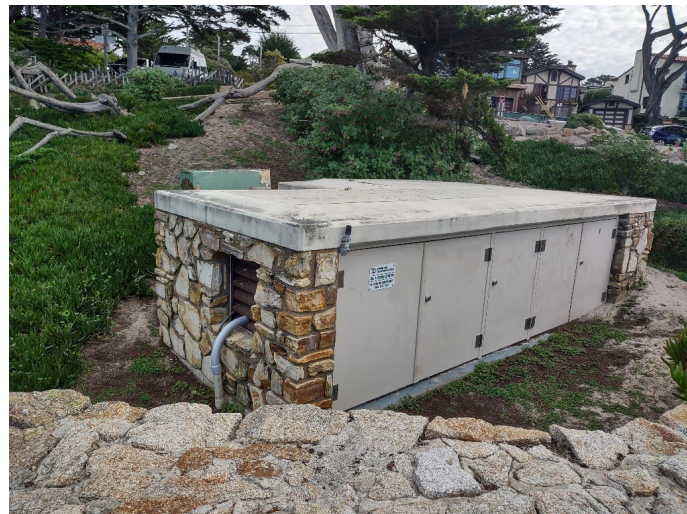
Wastewater lift station near 8th Avenue

- › **Scenic Road:** entire length exposed, including underground water and sewer infrastructure
- › **Water main** between 8th and 10th avenue
- › An additional 0.3 acres of dune habitat
- › During large storms, a **wastewater lift station** located at ~24.5 ft may be exposed to wave flooding
- › **5 homes** may be vulnerable under the *without armoring* scenario

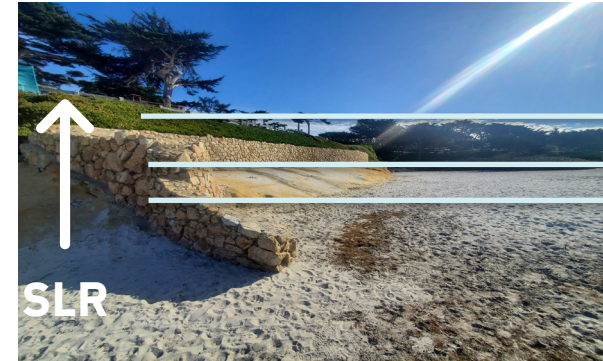
- › Multiple model approach similar to USGS cliff erosion tool that use historical erosion rates as a baseline
- › We modeled **unarmored** and **armored** conditions, and **high**, **medium**, and **low** assumptions on historical erosion rates.
- › For the **armored** scenario, the frequency of wave attack above the top of armoring leads to an acceleration of erosion rates into the future
- › For the **unarmored** scenario, a decreasing surf zone width and more wave energy on the cliff drives erosion

The light blue lines indicate the higher water level exposure with sea level rise

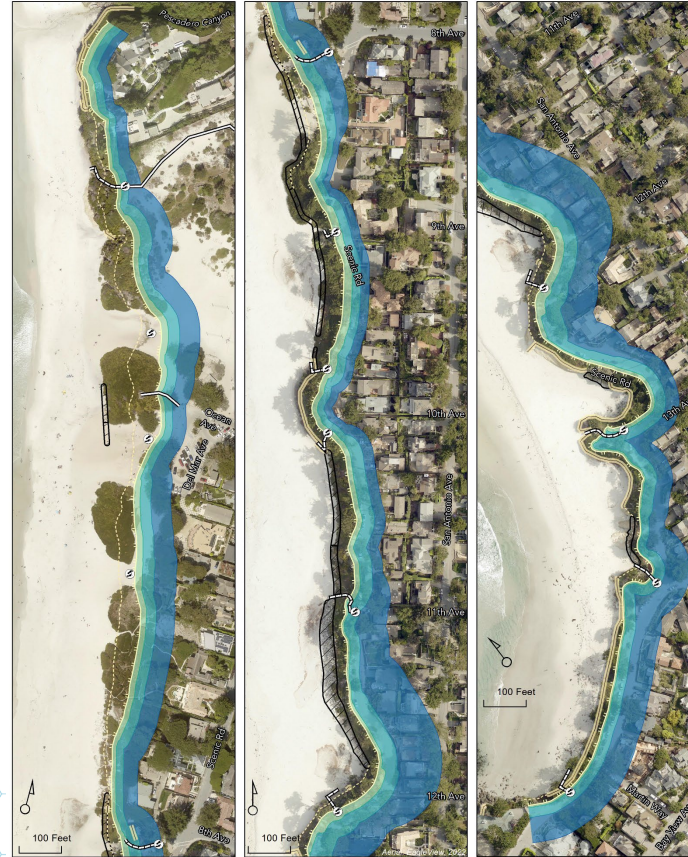
Coastal Cliff and Dune Erosion Projection With Armoring

Notes: Erosion distances represent projected long-term time-averaged trends in erosion with coastal armoring. Future erosion distances and bluff crest position may vary from these projections.

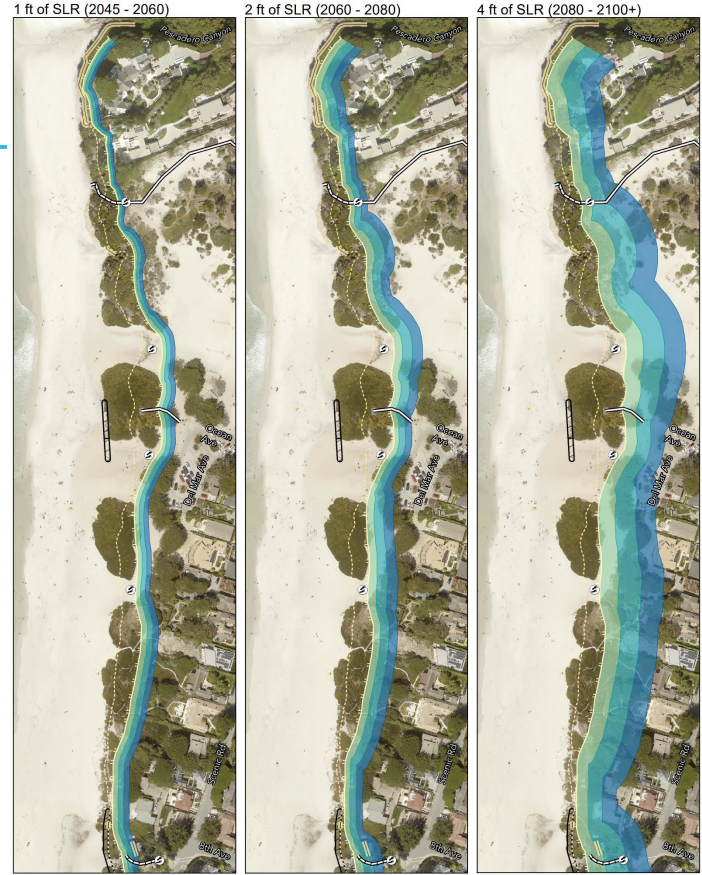
Coastal Cliff and Dune Erosion Projection Without Armoring - North Carmel Beach

Most Likely	Best	Worst Case
<p><i>Notes: Erosion distances represent projected long-term time-averaged trends in erosion without coastal armoring. Future erosion distances and bluff crest position may vary from these projections.</i></p> <p><i>Sea level rise elevations and time periods are based on 2018 IPCC guidance and refer to a high emissions scenario with 2020 as a baseline.</i></p>

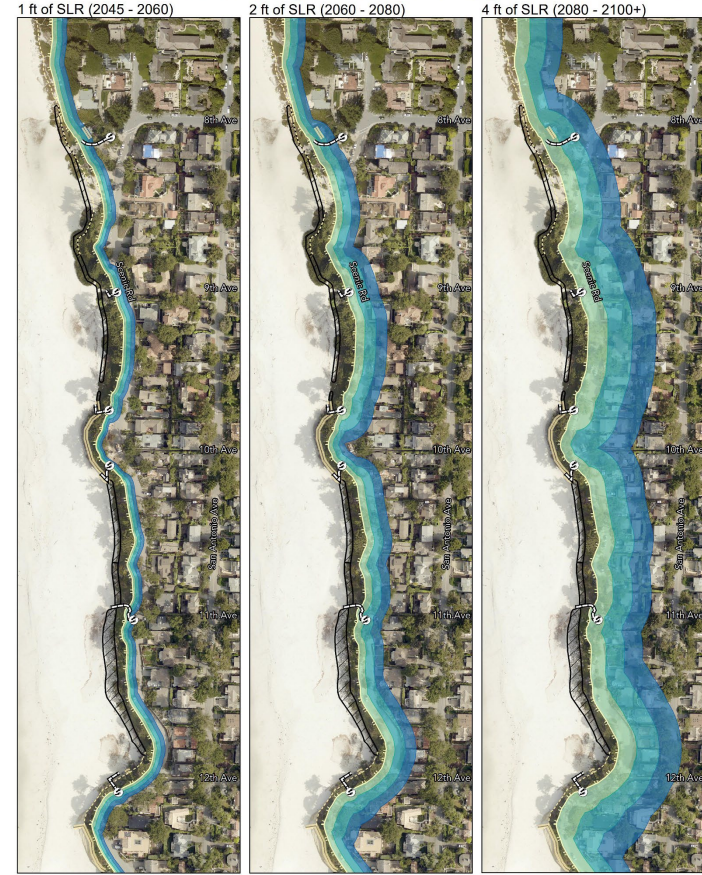
Coastal Cliff and Dune Erosion Projection Without Armoring - Central Carmel Beach

Most Likely	Best	Worst Case
<p><i>Notes: Erosion distances represent projected long-term time-averaged trends in erosion without coastal armoring. Future erosion distances and bluff crest position may vary from these projections.</i></p> <p><i>Sea level rise elevations and time periods are based on 2018 IPCC guidance and refer to a high emissions scenario with 2020 as a baseline.</i></p>

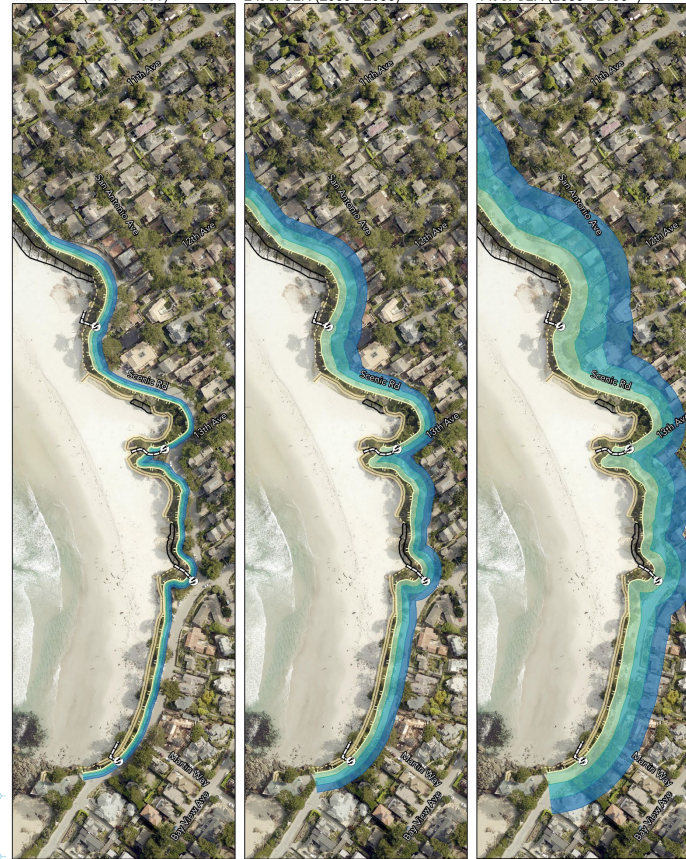
Coastal Cliff and Dune Erosion Projection Without Armoring - South Carmel Beach

Notes: Erosion distances represent projected long-term time-averaged trends in erosion without coastal armoring. Future erosion distances and bluff crest position may vary from these projections.
