Re: SE Corner Dolores St. and 7<sup>th</sup> Ave., Carmel-by-the-Sea, CA  
APN 010-145-022/023/024; DR 23-140: Northern California Savings & Loan

This letter evaluates the proposed alterations to the property located at the SE corner of Dolores Street and 7<sup>th</sup> Avenue, in Carmel-by-the-Sea, CA. PAST Consultants, LLC (PAST) completed a site visit to the property on June 20, 2023 to view the property's existing conditions and to evaluate project drawings for proposed alterations to the subject property.

The subject property contains the Northern California Savings & Loan Complex, constructed in 1972 in the Bay Region Modern style. Designed and executed by prominent local architects Walter Burde & Associates and Will Shaw & Associates, the building complex consists of a primary bank building located on the southeast corner of Dolores Street and 7<sup>th</sup> Avenue and a detached Community Room, whose shed-roofed design complements the larger bank building. An elevated walkway connects the bank building to the Community Room, creating a complex of two buildings integrated within the site. In 2023, the building was listed on the Carmel Historic Resources Inventory as an out

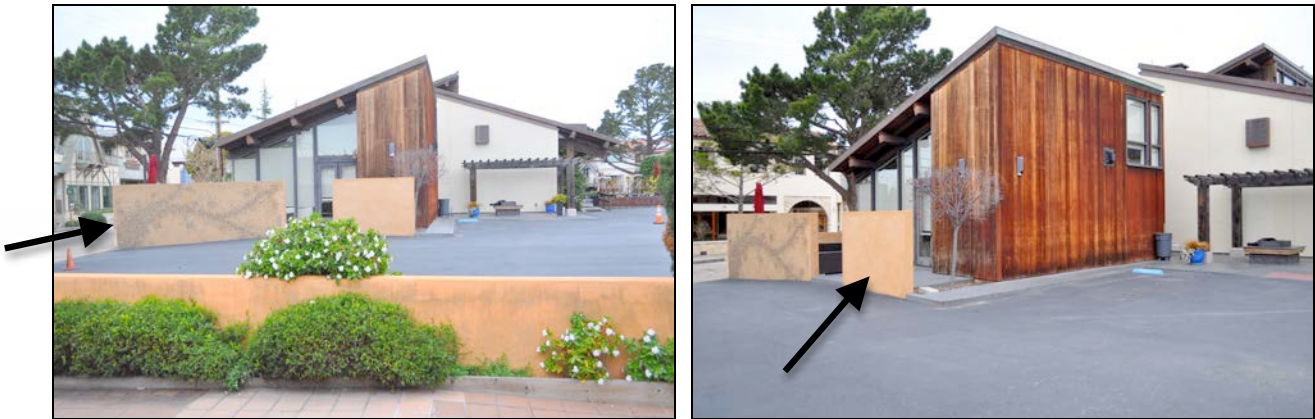
The ornamented concrete wall frames the Community Room and runs in an E-shaped pattern along Dolores Street and turns to the east within the lot. Designed by Brad Bowman and completed in 1972 by Ornamented Concrete, Inc. of Carmel-by-the-Sea, the wall was commissioned by Burde and Shaw as part of the overall project. Originally, the south section of the wall returned toward the Community Room. In 2014, the Dolores Street section of the ornamented concrete wall was cut down and the portion of the southern wall that returned toward the building was removed. A small stucco wall was also constructed (**Figures 1 - 3**).

**Figures 1 and 2.** Left image looks north at the site. Constructed in 2014, the wall in the foreground is not a historic addition to the site. The original ornamented concrete wall is shown with an arrow. Right image details the Community Room looking northwest, with the 2014 stucco wall shown.

In 2014, the ornamented concrete wall around the Community Room's southeast corner was altered with the Dolores Street-facing wall cut down and the south section removed where it returned toward the Community Room building. A poorly designed stucco wall was placed to the east of the original wall at this time (**Figures 1 and 2**).

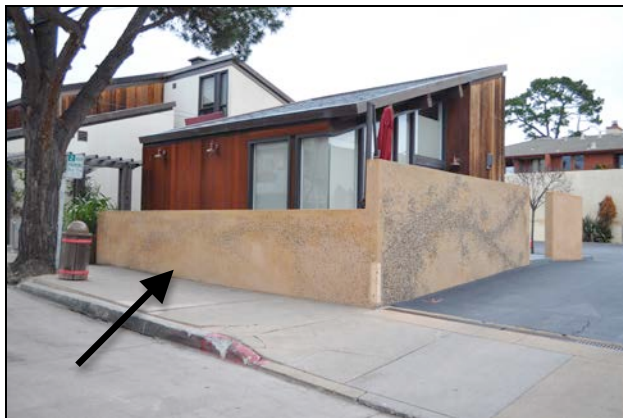
**Figure 3.** View of Community Room taken from Dolores Street, showing the wall cut down (arrow). The southern section retains its original height.

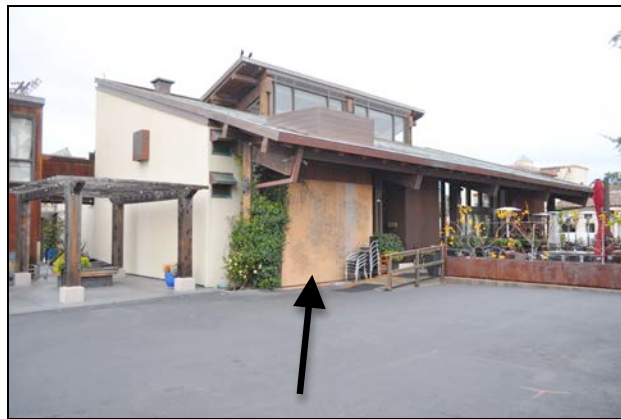
Ornamented Concrete, Incorporated was founded by Brad Bowman of Carmel Valley. The company specialized in handmade site alterations rendered in concrete and stucco. Ornamented concrete became popular with Mid-Century architects as Brad Bowman perfected his process in the late 1950s. On the Northern California Savings and Loan complex, the method was applied to the landscape walls framing the Community Room, and to the east wall of the Bank Building. The use of the ornamented concrete method on both the Bank Building and the site originally linked the building to its surroundings (**Figure 5**).

**Figure 5.** Looking northwest at the east elevation of the Bank Building, the ornamented concrete wall shown.

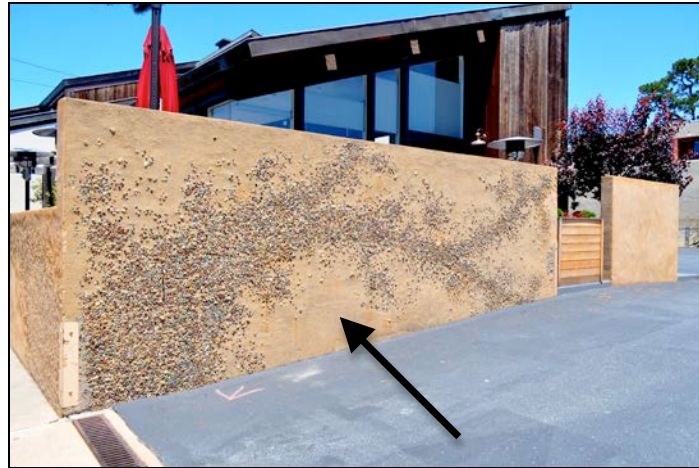
Based on the numerous alterations to the site and the original Burde/Shaw landscape design, this report concludes that the original landscape design south and east of the Community Room has lost substantial historic integrity. However the south portion of the ornamented concrete wall remains intact enough to reveal the original stone pattern.

**Figure 7.** Remaining intact section of the ornamented concrete wall.

The remaining intact section of the Bowman-designed ornamented concrete wall is shown above (**Figure 7**). This section still reveals its original stone pattern and sand finish. This report recommends that the removed section of the wall be preserved and replaced at another location on the site. A potential location would be in the parking lot within proximity of the ornamented concrete wall on the east elevation of the Bank Building. This location would allow interpretation of the removed feature on the original site and provide a link to the original Burde/Shaw design.
