CITY OF CARMEL-BY-THE-SEA

APP 24117 (Rodriguez)

Consideration of an Appeal of the Historic Resources Board's decision to add an individual property known as the "Henry J. Ohloff House" located at Camino Real 4 northwest of 11th Avenue to the Carmel Inventory of Historic Resources. APN: 010-275-006.

“J. Henry Ohloff House”

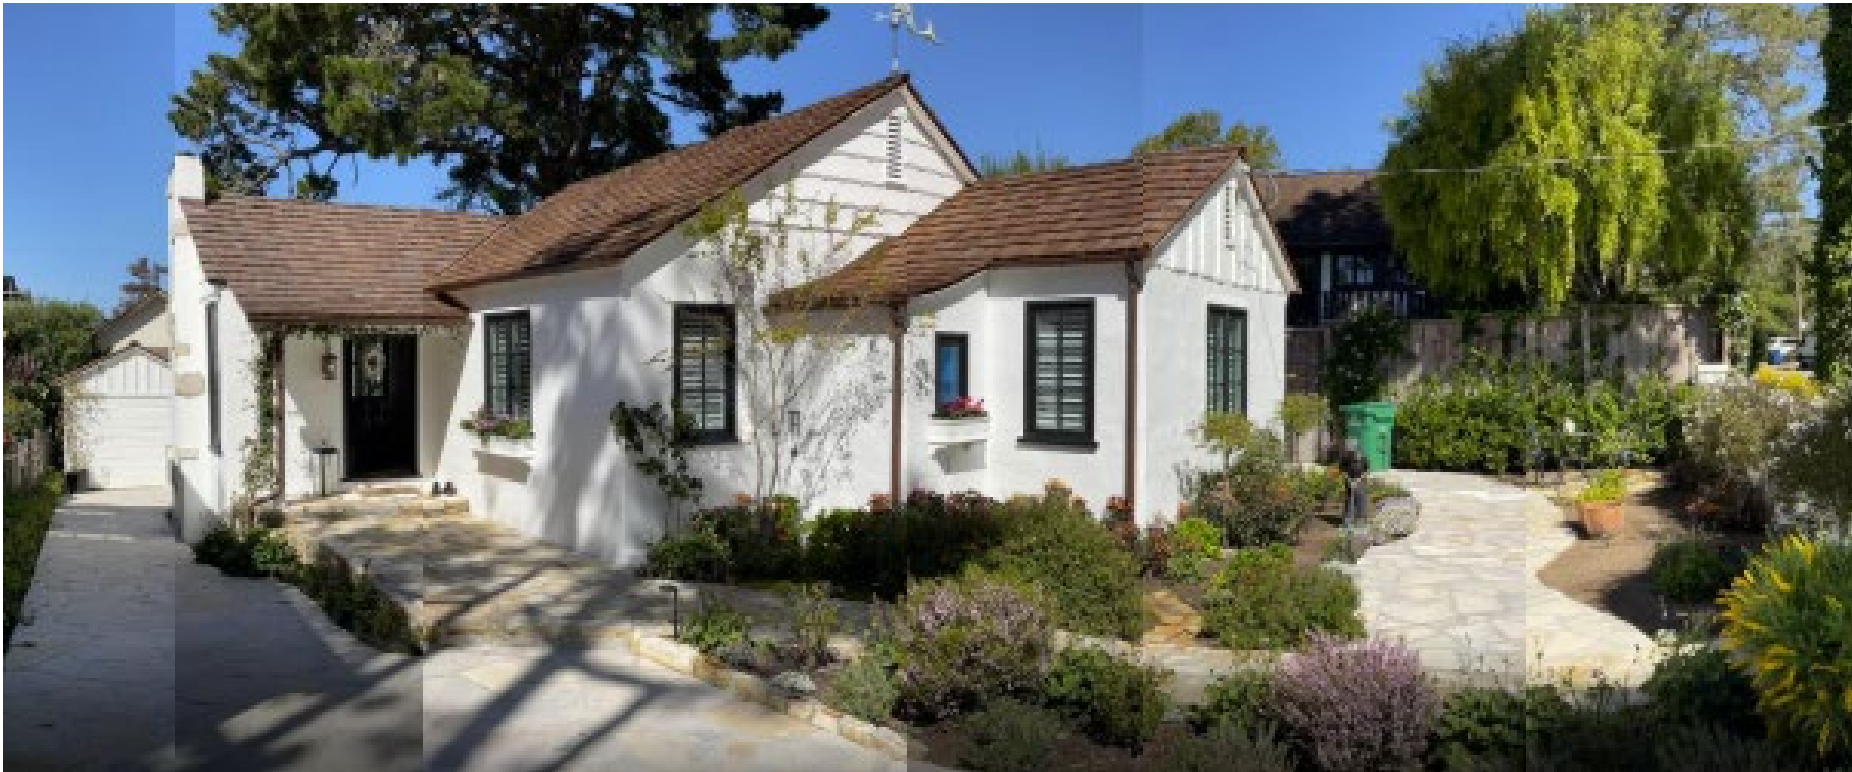
- 1933 Tudor Revival cottage by master builder Ernest Bixler, rebuilt in 1940 by master builder Miles Bain to original design, after a fire
- 1941 small rear addition by Miles Bain
- Original owners: J. Henry Ohloff and wife, Dorothy

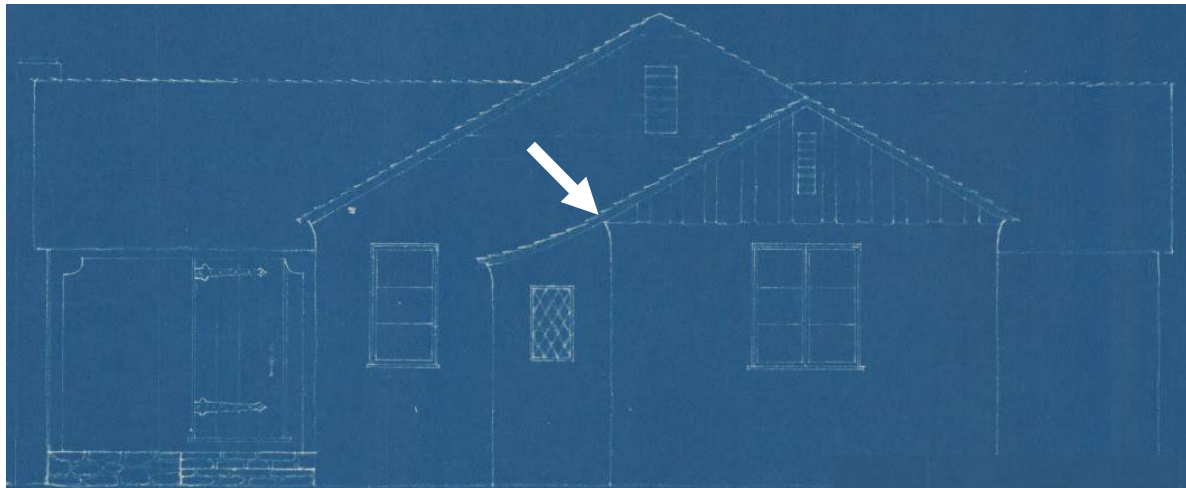
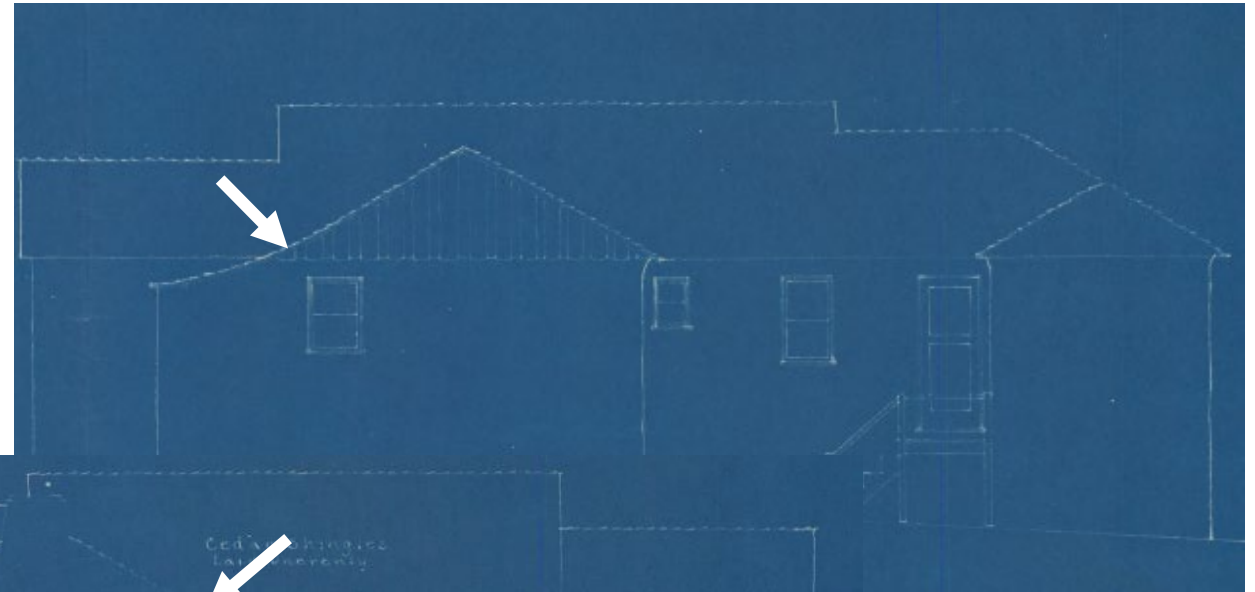
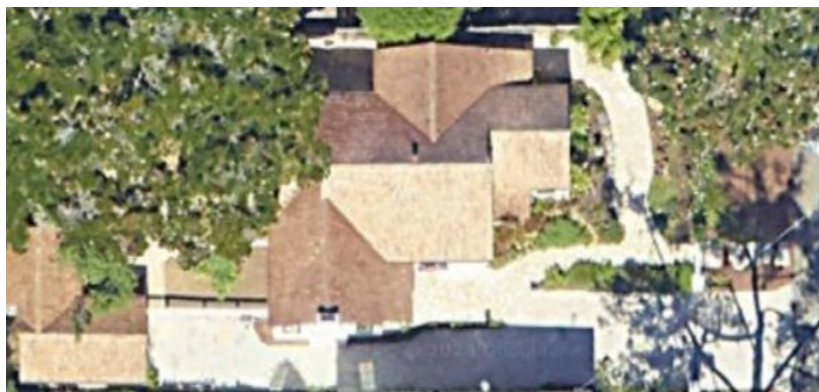
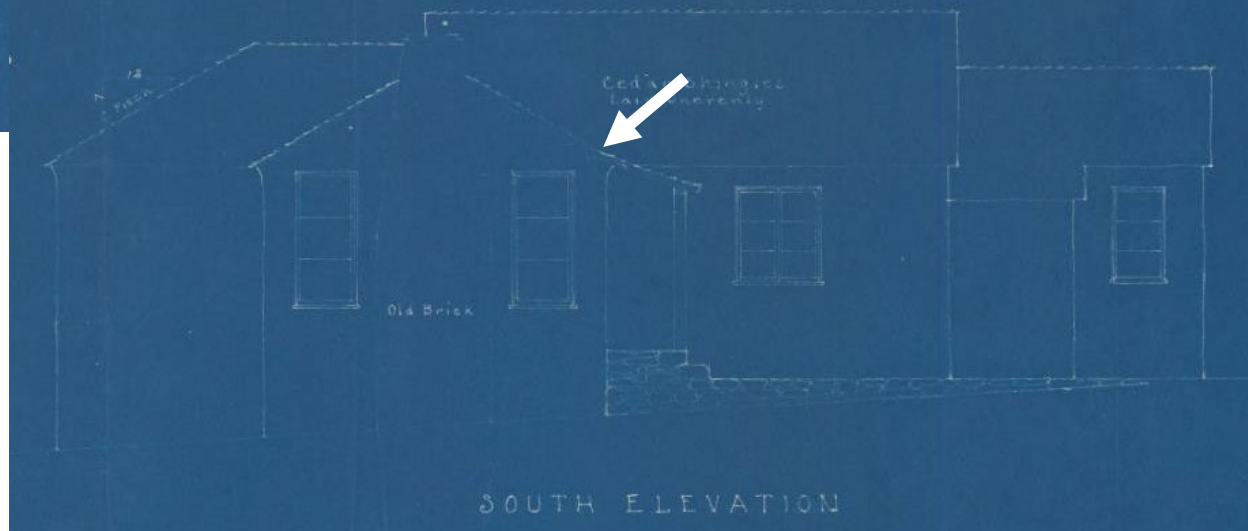
- Cross gabled roof system with (3) sloping rooflines, compound floor plan

EAST ELEVATION

SOUTH ELEVATION

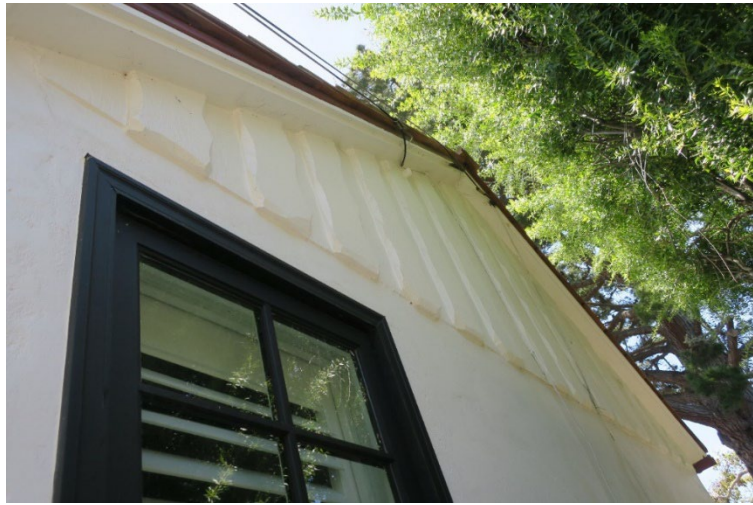
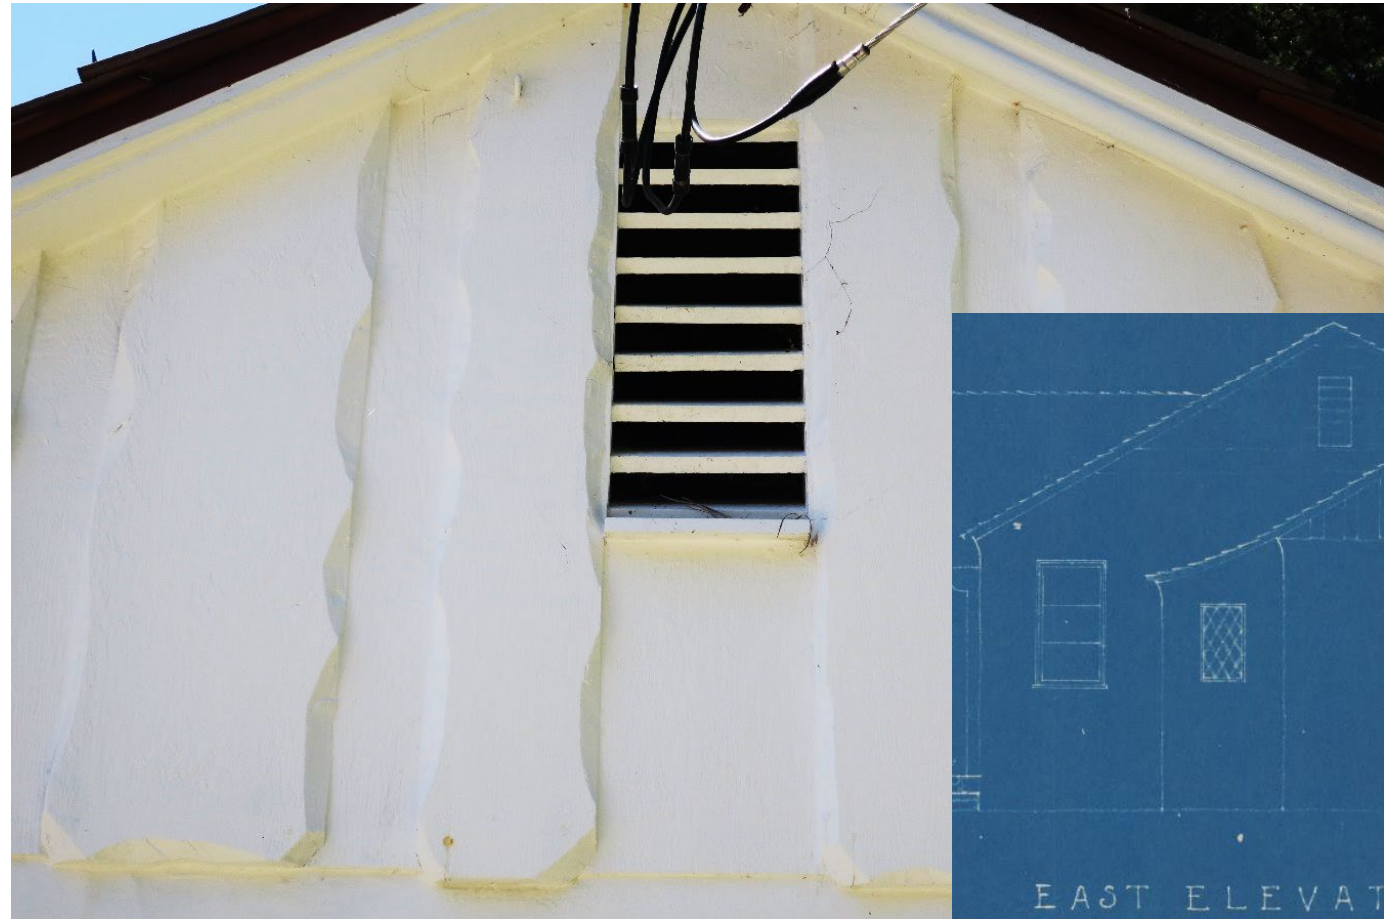
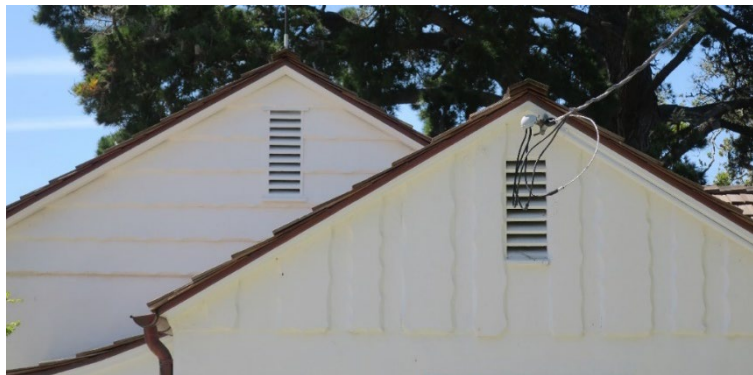
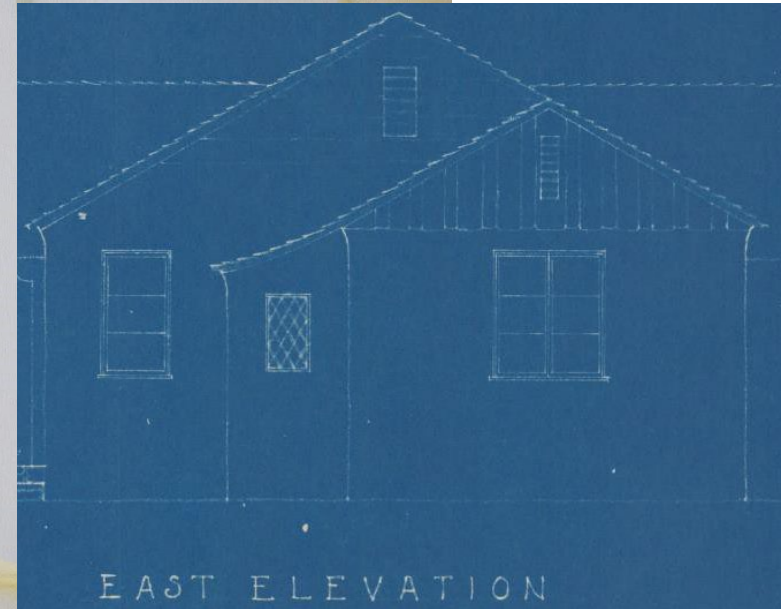
- Horizontal and vertical boards in gable apexes, and louvered vents

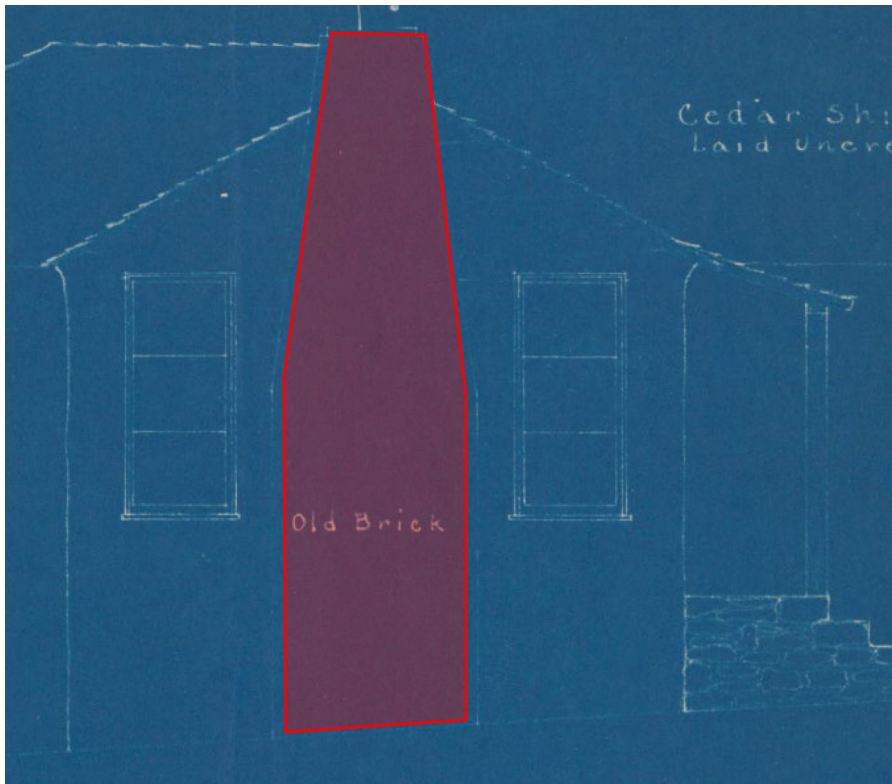
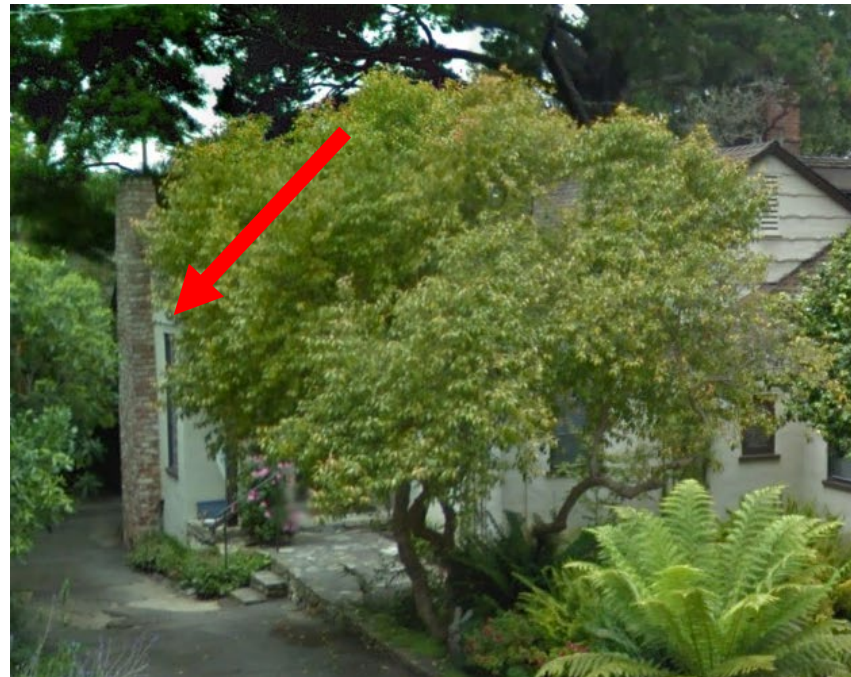
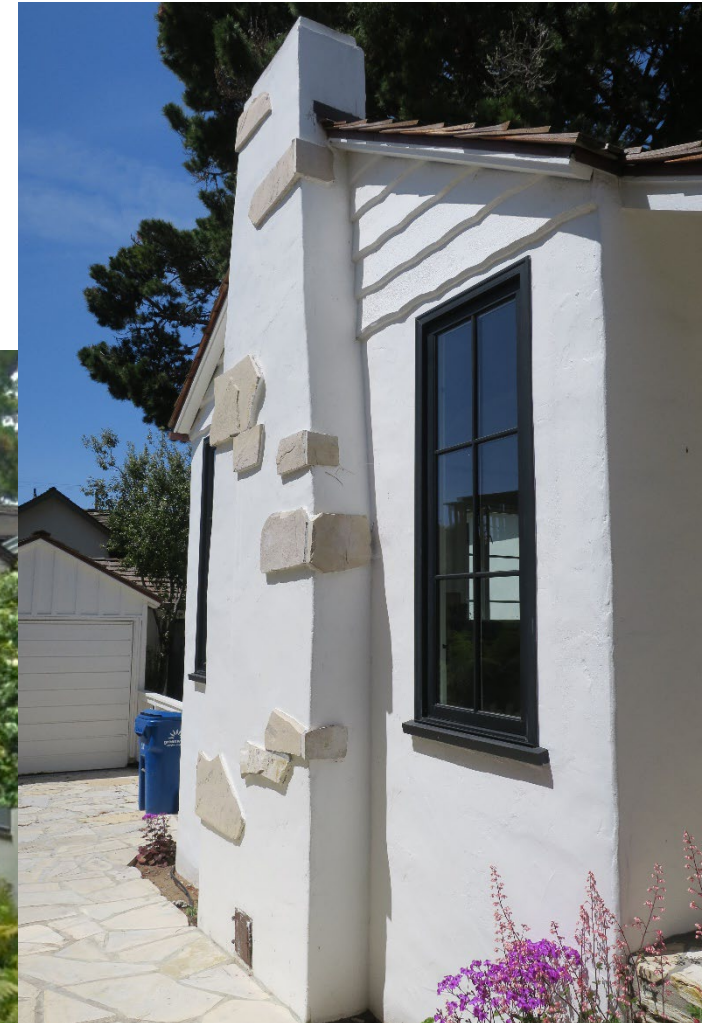
- “Old brick” chimney

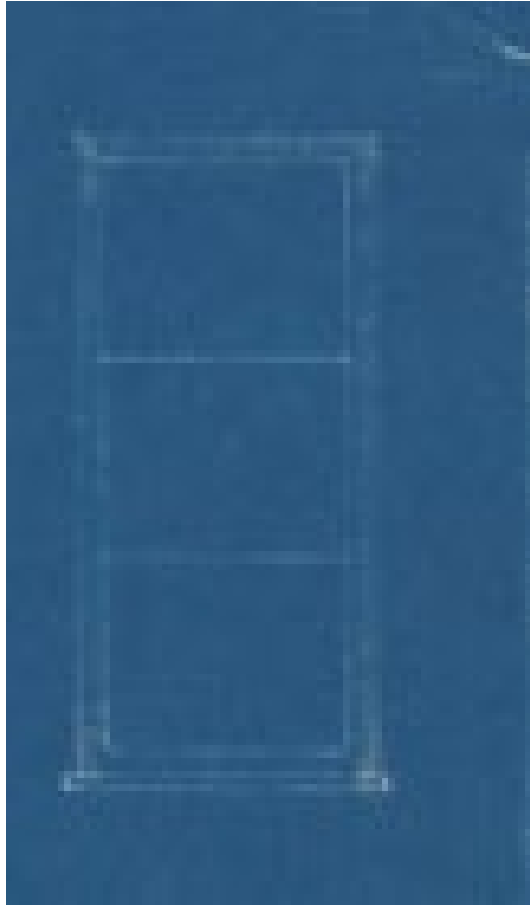
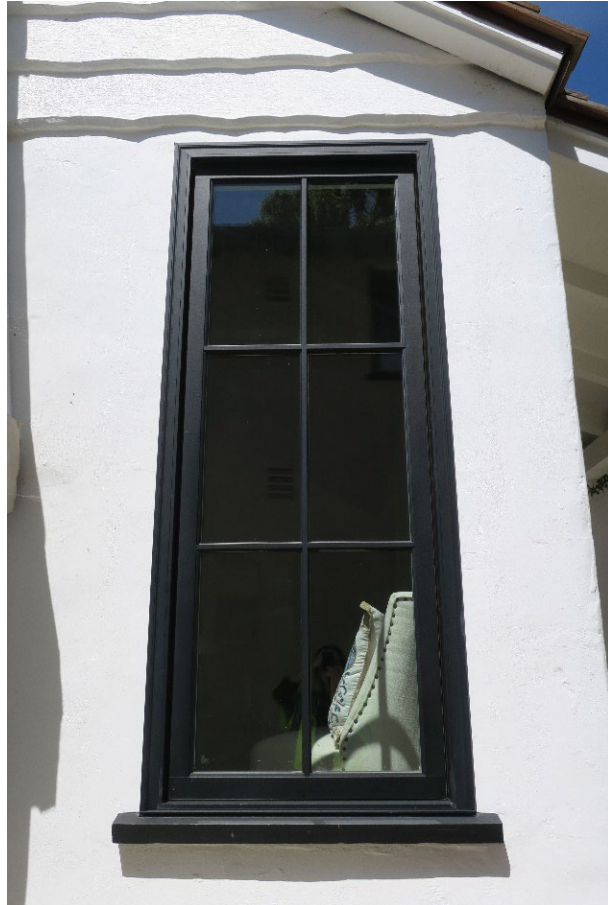
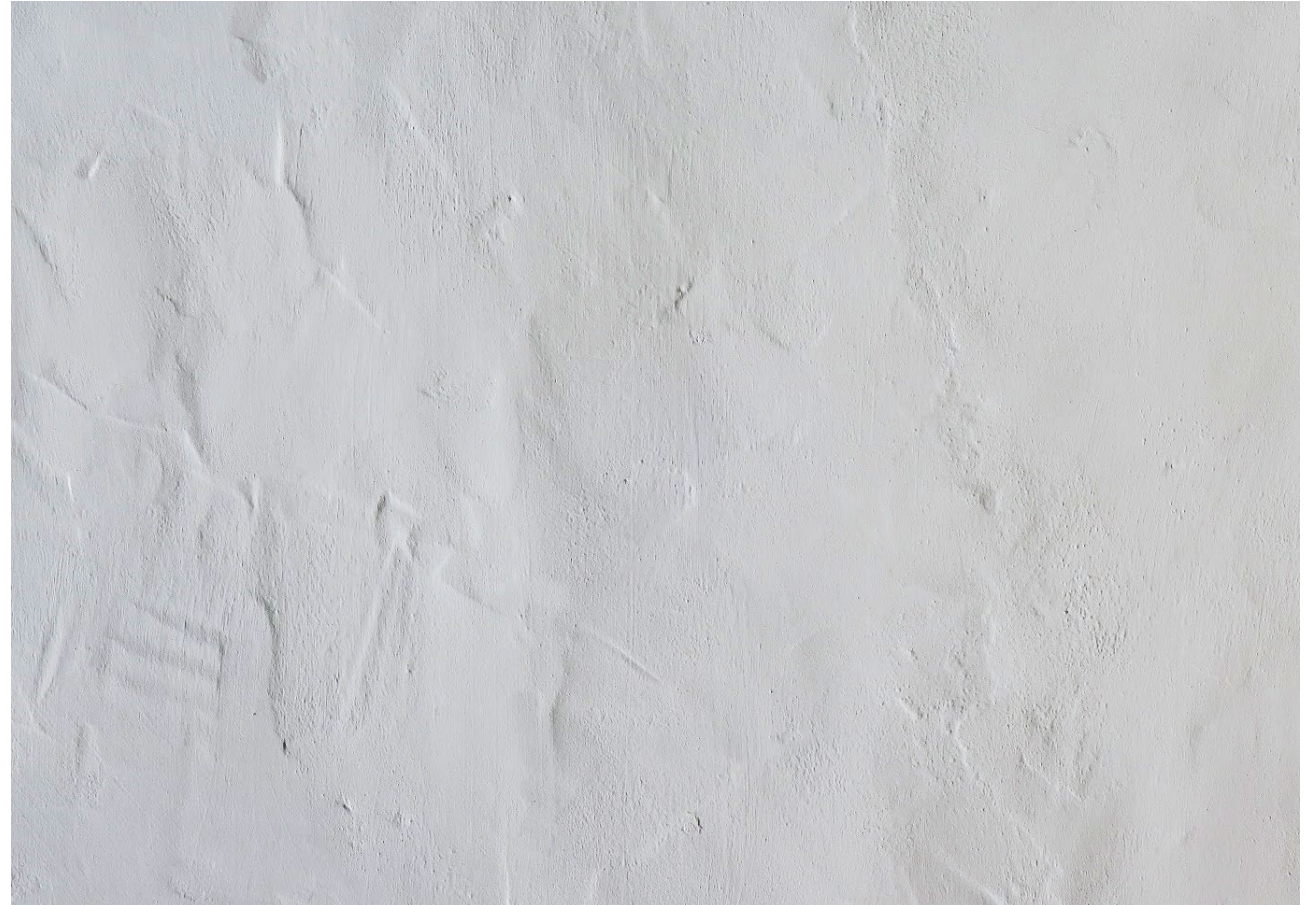
- Multi-paned casement windows, stucco walls

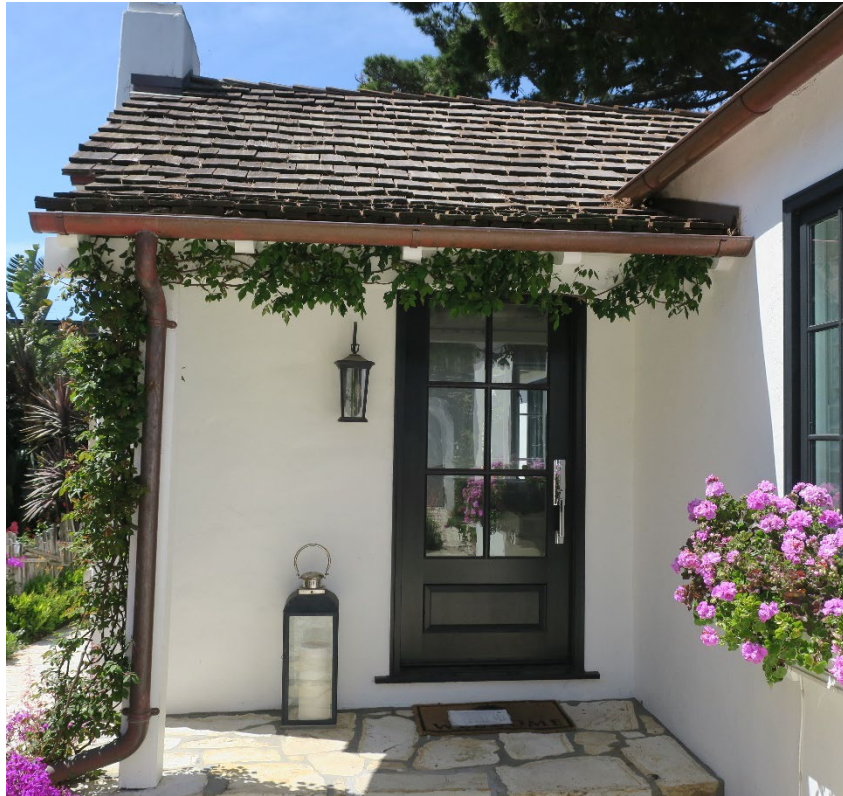
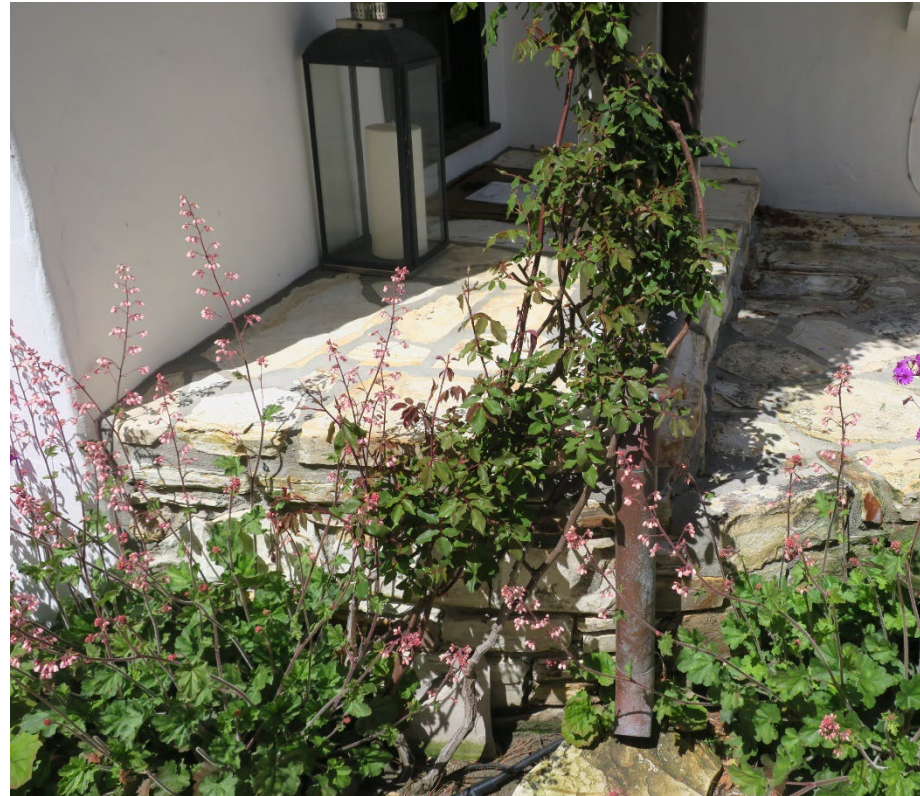
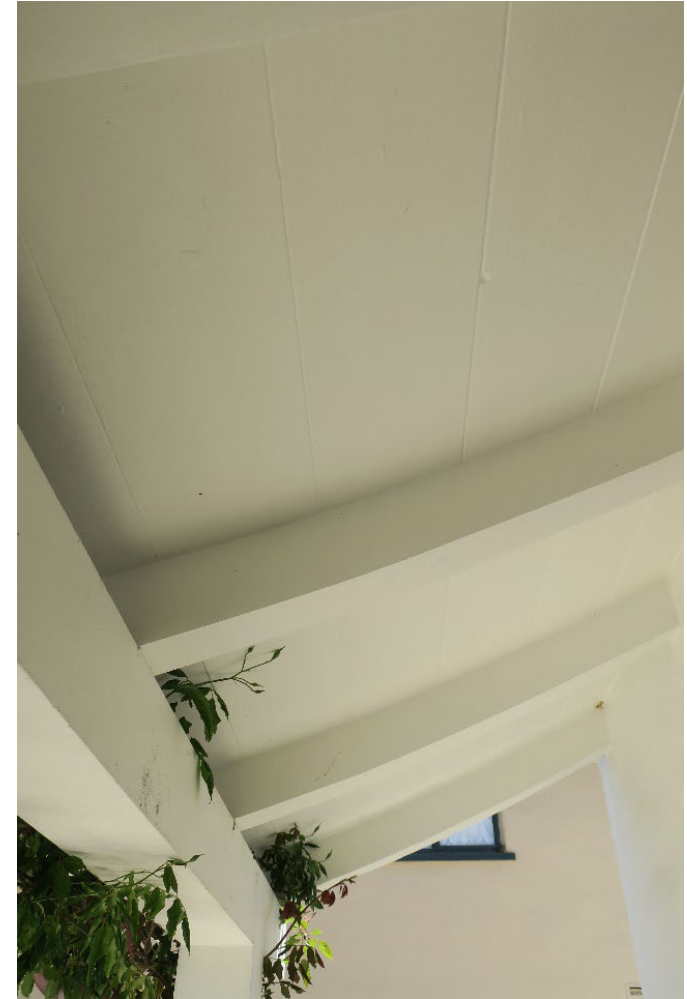
- Partial-width porch

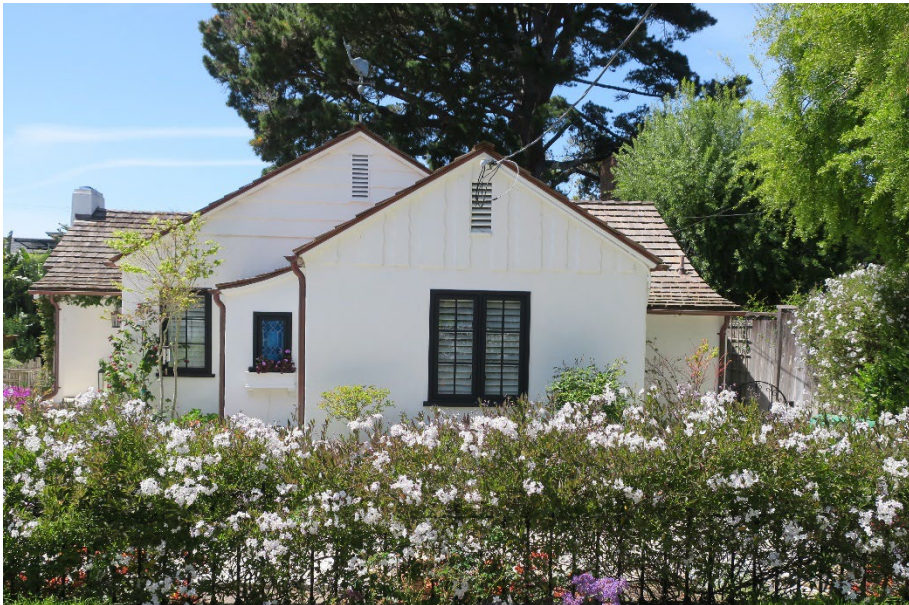
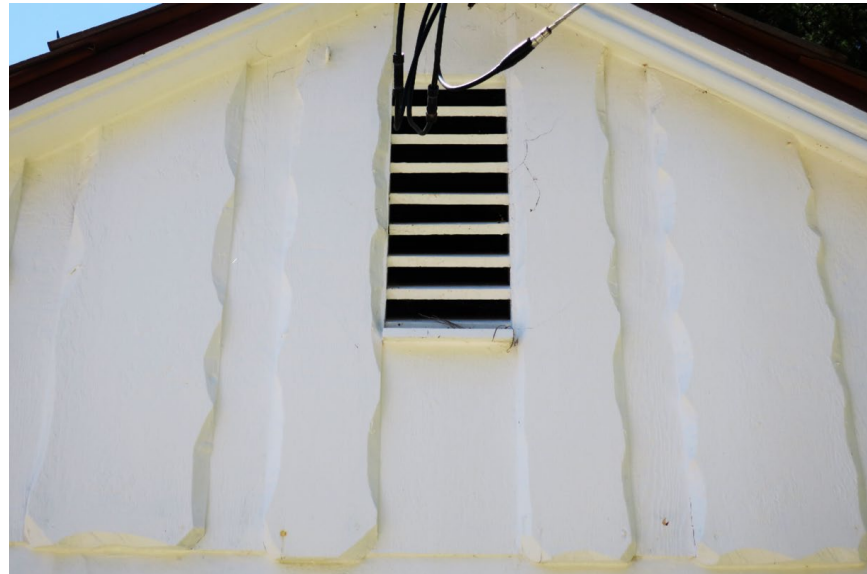
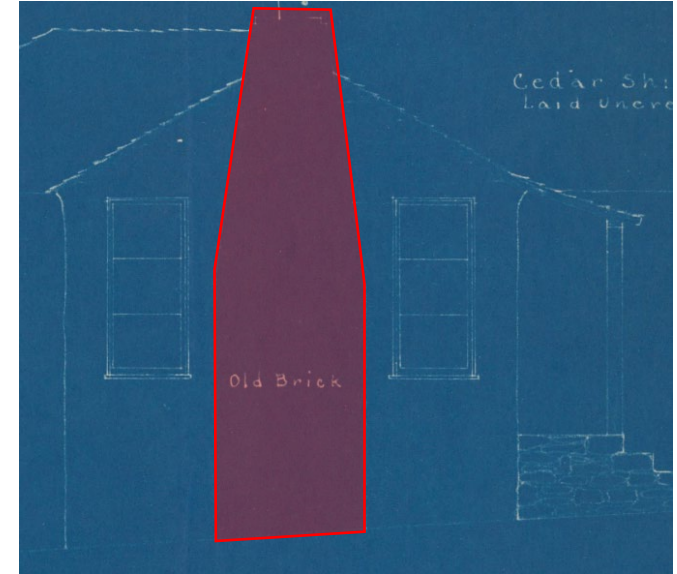
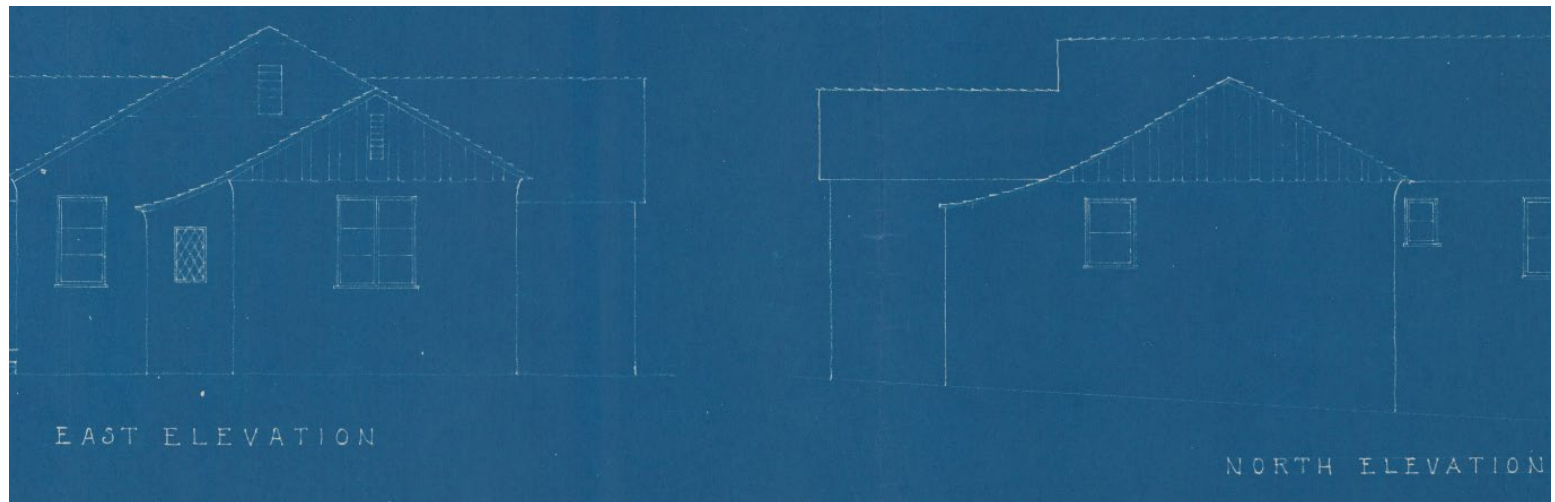
J. Henry Ohloff House – a modestly employed yet cohesive Tudor style

- (3) Sweeping roof slopes
- Rough-hewn “half timbering”
- Prominent chimney
- Entry porch
- Stucco, wood, stone

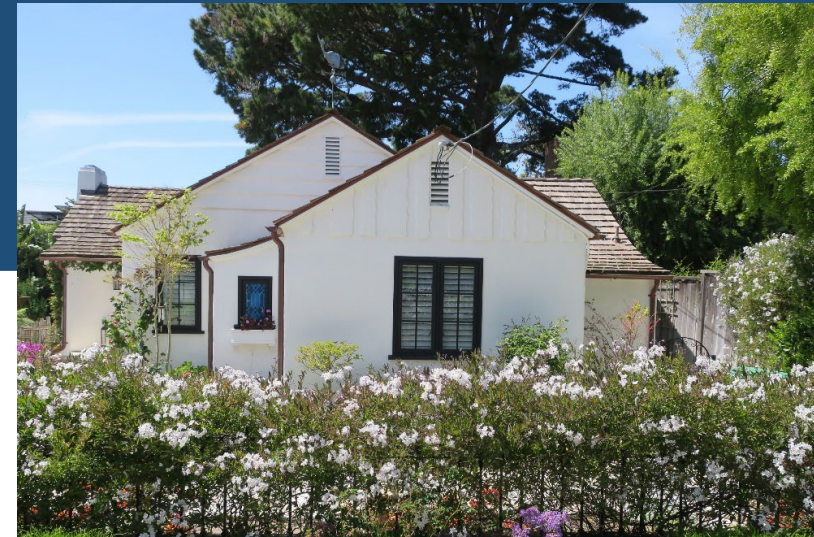
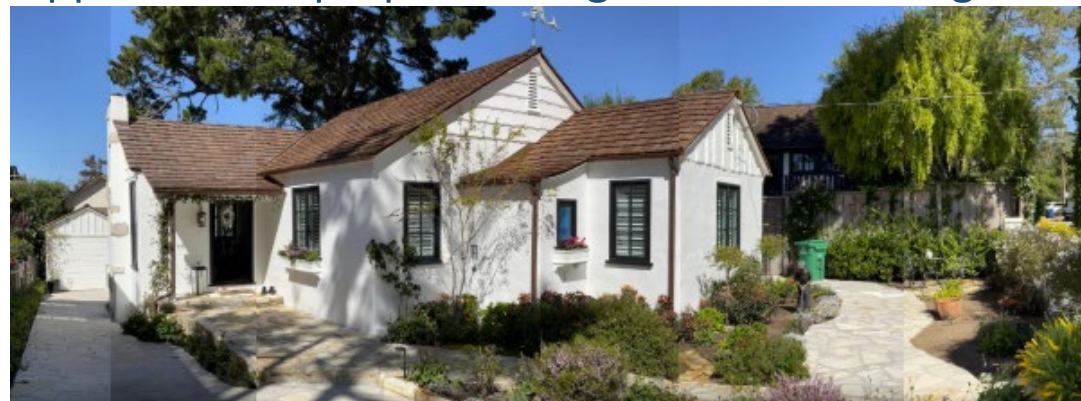
Does it Retain Integrity?

- Location: still in original location.
- Design: Tudor revival design, original roof configuration. Modest rear addition. Original window and door openings. Original window configuration (casement)
- Setting: still located in a residential setting.
- Materials: retains stucco siding, wood board detailing, wood window frames, stone porch and front path.
- Workmanship: wood board detailing.
- Feeling: retains the physical features that convey its historic character, i.e., a 1930's Carmel cottage.
- Association: association is only applicable for properties eligible under CA Register Criteria 1 and 2.

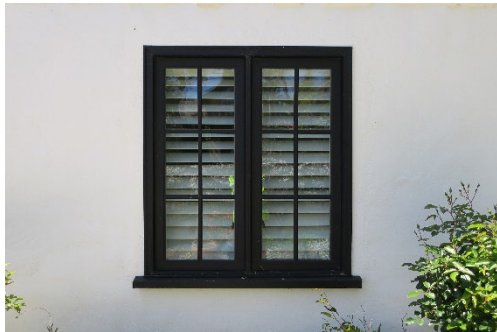
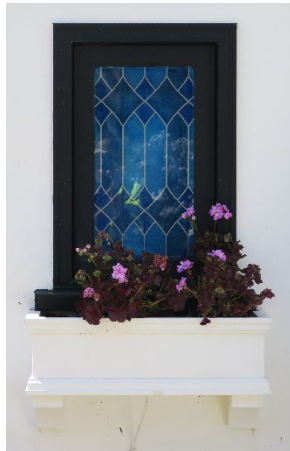
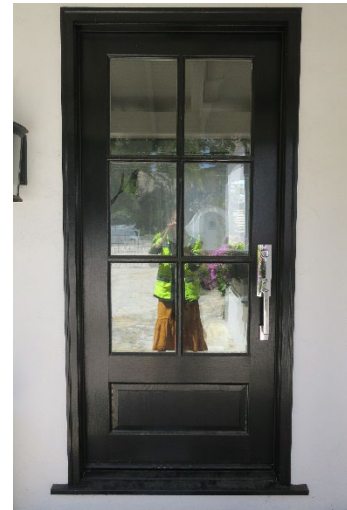
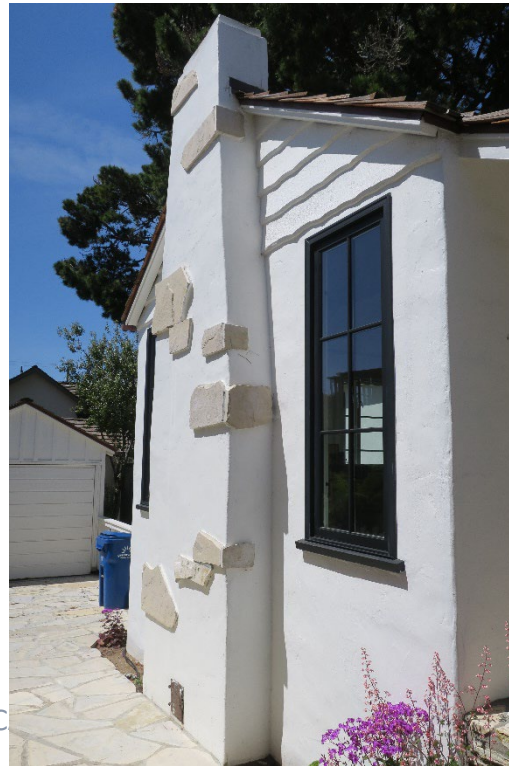
Alterations:

- Rear addition
- Wood windows and doors
- Wood roof
- Front fence & arbor
- Stucco/stone over brick chimney
- Stone driveway & pathways
- Driveway gate
- Rear deck
