IDENTIFYING AND AVOIDING RISKS FROM ADJACENT CONSTRUCTION

Tech Notes

TEMPORARY PROTECTION

Protecting a Historic Structure during Adjacent Construction

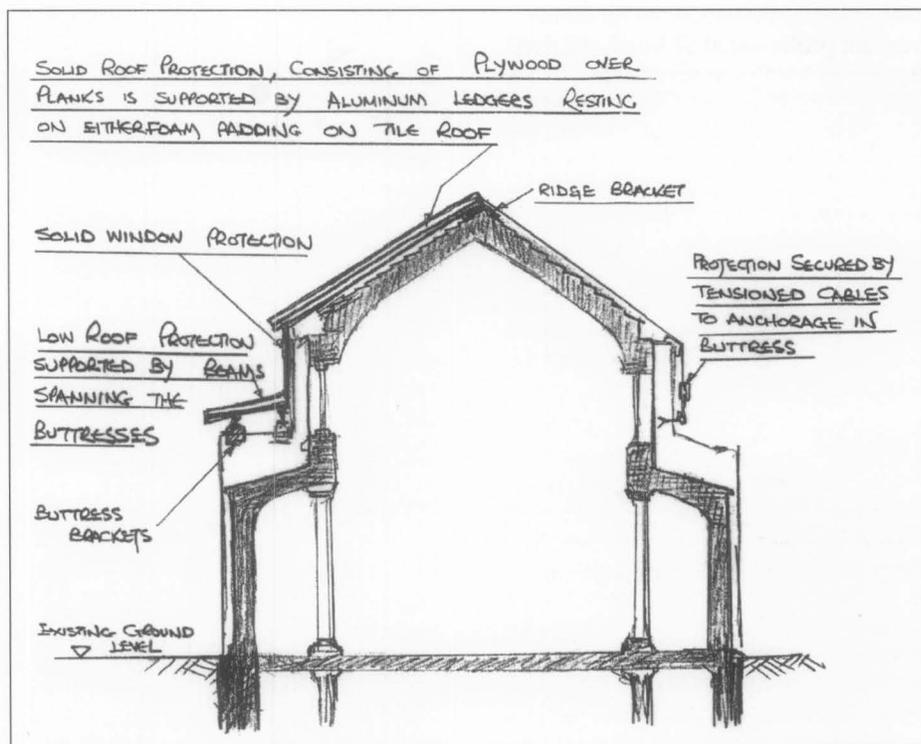
Figure 1. Before new construction was undertaken to the left of this church, a subcontractor was hired to design a protective system for the tile roof and clerestory windows. Drawing: Alan Shalders, Universal Builders Supply, Inc.

Generally, to counter these occurrences, protective barriers are placed over any area of the historic structure deemed at risk. If the new construction will rise above the historic building, plywood sheets should be placed over the roof to distribute the force of dropped materials (see figure 4). Plywood covers should also be placed over decorative roof embellishments such as finials and balustrades. Alternately, horizontal netting can be rigged to shield vulnerable rooftop features.

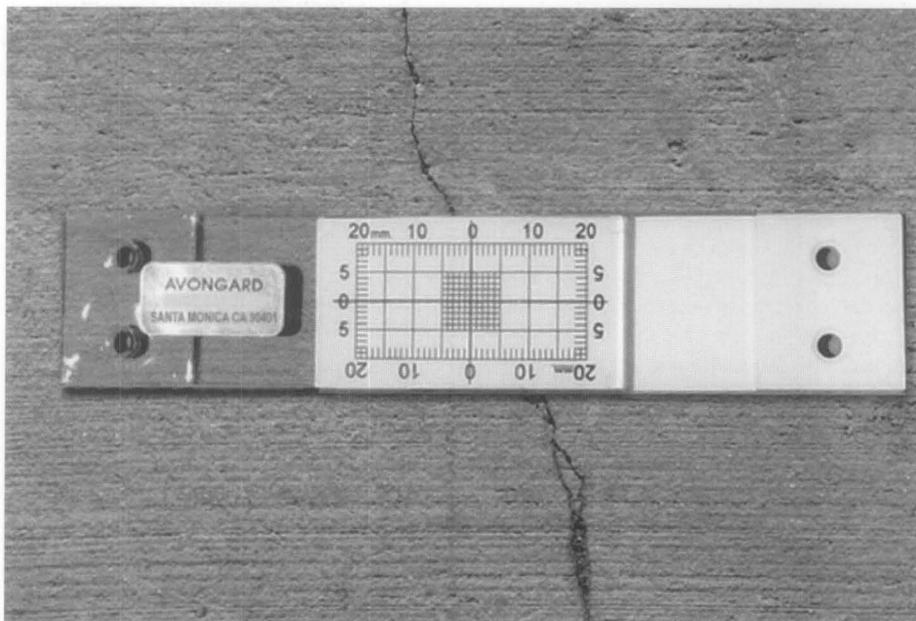
Figure 2. With advanced notice of adjacent construction activity, a crack monitor can be used to determine whether existing cracks in the historic building are stable or still experiencing movement. Compared with measurements taken during the monitoring phase, such information can help determine if subsequent movement resulted from work on the neighboring site. Photo: Avongard Products U.S.A., Ltd.

close-up images of cracks, staining, indications of settlement or other fragile conditions. A complete interior and exterior crack survey should be undertaken to identify and characterize existing cracks (see figure 2). Their locations can then be plotted on a drawing of each wall or ceiling surface. While identifying every hairline crack may be impractical in a large building or one that exhibits a great deal of preexisting damage, the more thorough the documented record, the better. The condition of features such as arches, chimney stacks and parapet walls determined by the engineer to be particularly susceptible to distress should also be recorded even when no damage is apparent.

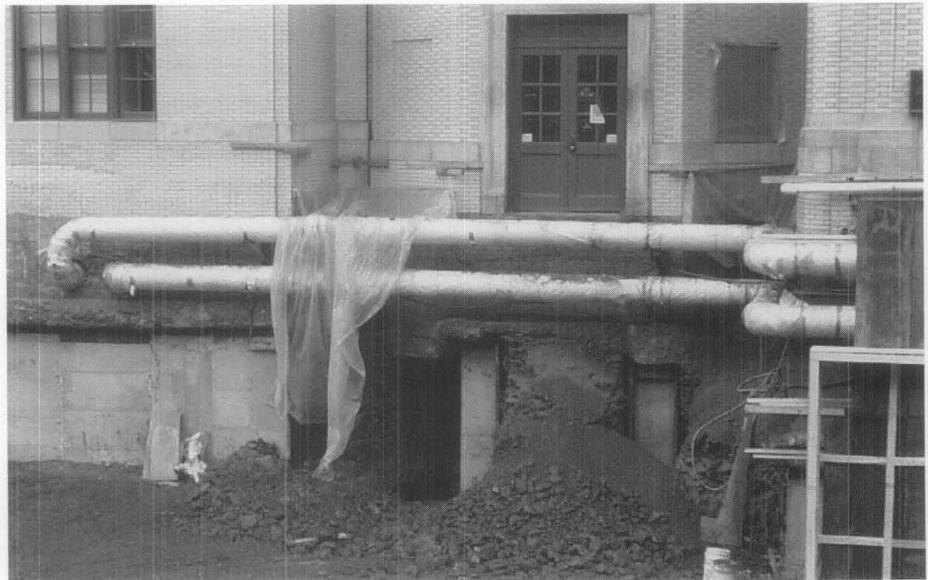
Figure 3. Concrete pier underpinning to an existing building may be necessary when adjacent construction occurs. In this example, pits are hand dug beneath the foundation of the historic building to provide space for wood forms. After concrete is poured into the forms, the space between the top of the pier and the bottom of the original foundation is packed with a quicksetting grout. The historic building owner should retain an independent engineer to ensure that the underpinning plan adequately protects the historic structure. Photo: Professor Arpad Horvath, Department of Civil and Environmental Engineering, University of California, Berkeley.

Efforts to control movement should begin during the consultation phase. Whether the developer's engineer selects underpinning or strengthened excavation walls with tie backs as the means to resist movement of the adjacent structure, the historic building team should retain its own engineer to review the plans (*see figure 3*). The consulting engineer should ensure that the selected approach addresses the unique characteristics and vulnerabilities of the historic structure and that even incidental movement is restricted.

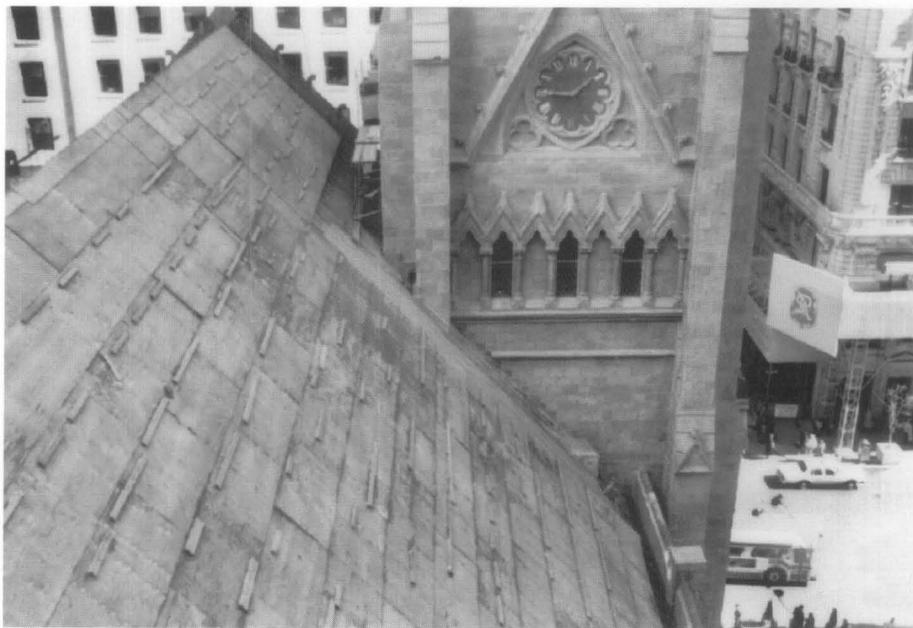
Figure 4. Dropped equipment, tools, and materials all present risks when new construction rises above neighboring historic structures. In this case, the historic slate roof was completely covered with sheets of exterior grade plywood. Photo: National Park Service files.

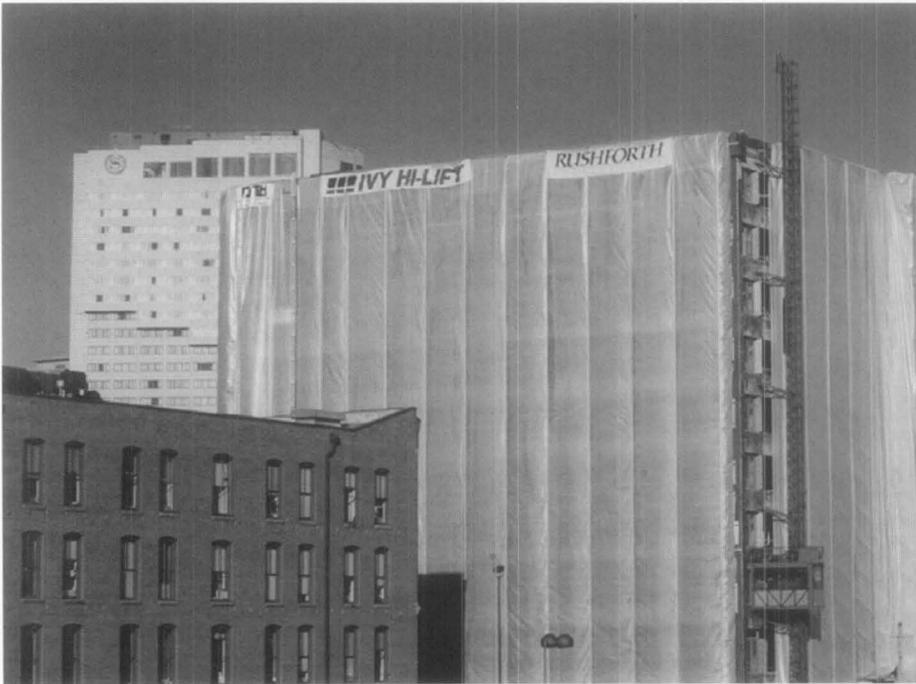
Figure 5. The historic building on the left is partially protected from debris and dust generated by the renovation of the structure to the right. Such temporary enclosure systems consist of a polyethylene or other fabric shell stretched between an aluminum frame. Photo: Walton Technology, Inc.

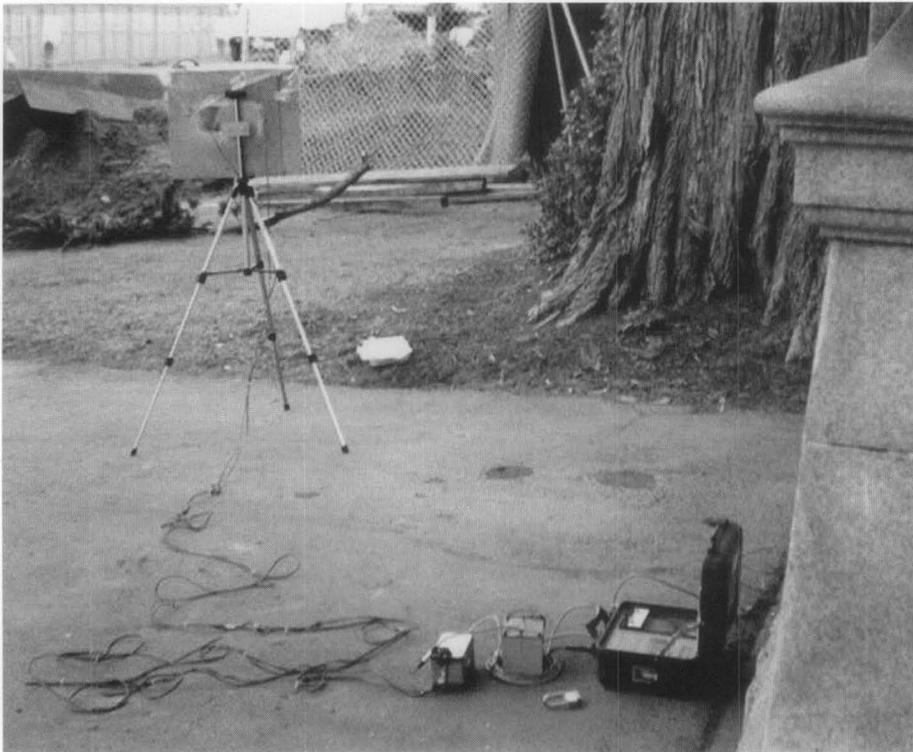
Figure 6. A seismograph records vibrations transmitted at the ground level of an historic building. The instrument is wired to a light and siren designed to warn the excavation crew that vibration levels are approaching preset limits. Additional sensors are often installed in the basement and on sensitive features such as stained glass windows. Photo: Wilson, Ihrig & Associates, Inc.

The extent of the monitoring program and the tools used will depend upon the scope of the adjacent activity. A basic plan to address concerns over vibration levels may include a single seismograph placed on the structure's

basement floor. More comprehensive measurements can be obtained by locating sensors at several points throughout the structure and the ground immediately adjacent to the historic building foundation (see figure 6).

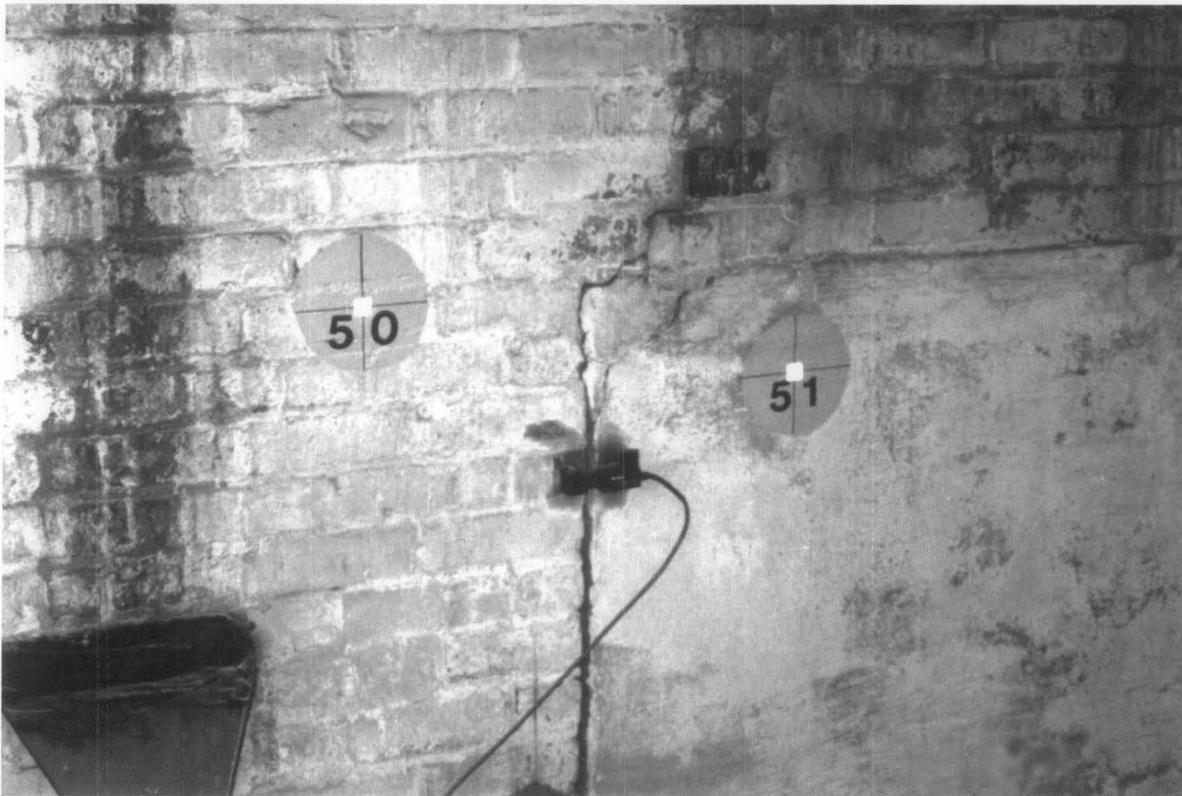
Figure 7. Electronic crack monitor and survey targets are shown installed on an existing wall. The crack monitor feeds movement data to a laptop computer. The targets are aligned and measured with optical survey equipment to determine the degree and direction of movement. Photo: McMullan and Associates, Inc.

Structural movement as described in the preceding section is detected and recorded using a number of different tools. Electronic monitors that feed precise movement measurements to laptop computers can be placed across existing cracks (see figure 7). When budgets are tight or a large number of cracks are involved, inexpensive tell-tales made from two sheets of overlaid plastic with a grid can be used to track changes.

Optical survey instruments provide another means of detecting vertical and lateral movement within a historic building. Control points are established and marked by targets or reflectors on the historic structure facade and interior walls before adjacent construction begins. The location of each of these markers is precisely measured at regular intervals. Engineers then use the resulting information to determine whether the markers have shifted from their original positions and, if so, the rate and direction of movement.
