# J.B. PASTOR BUILDING-DOLORES HISTORIC BUILDING PROTECTION & MONITORING PLAN

March 26, 2001

HISTORIC BUILDING PROTECTION PLAN KEY NOTES

SITE DEMOLITION PLAN

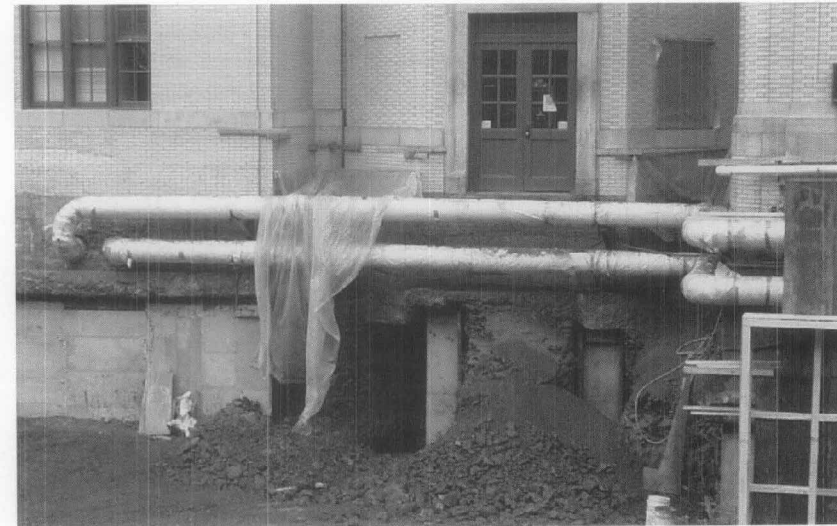
Figure 3. Concrete pier underpinning to an existing building may be necessary when adjacent construction occurs. In this example, piles are hand dug beneath the foundation of the historic building to provide a secure base for new columns. After the concrete is poured into the holes, the top of the pier and the bottom of the original foundation is packed with a quicksetting grout. The historic building owner should retain an independent engineer to ensure that the underpinning plan adequately protects the historic structure. Photo: Professor Arpad Horvath, Department of Civil and Environmental Engineering, University of California, Berkeley.

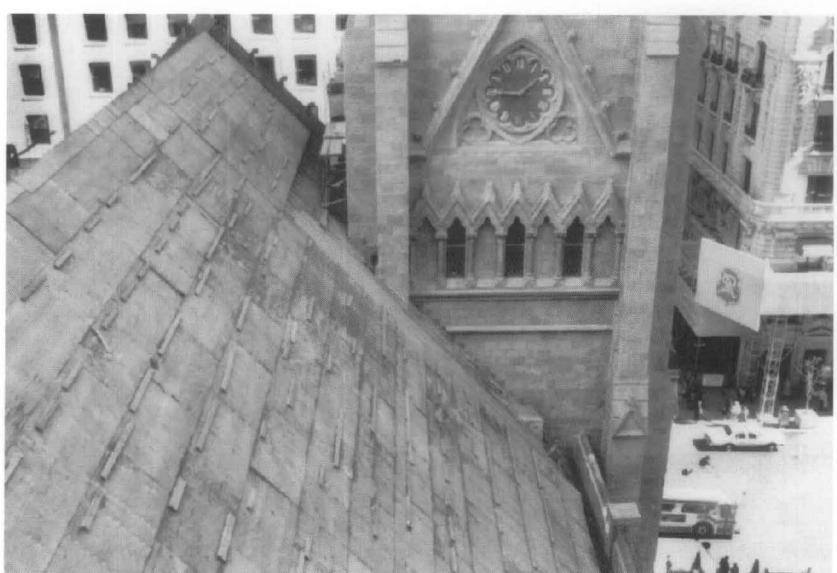
Figure 4. Dropped equipment, tools, and material all present risks when new construction rises above neighboring historic structures. In this case, the historic slate roof was completely covered with sheets of exterior grade plywood. Photo: National Park Service files.

Generally, to counter these occurrences, protective barriers are placed over any area of the historic structure deemed at risk. If the new construction will rise above the historic building, plywood sheets should be placed over the roof to distribute the force of dropped materials (see Figure 4). Plywood covers should also be placed over decorative roof embellishments such as finials and balustrades. Alternately, horizontal netting can be rigged to shield vulnerable rooftop features.

age, windows should be covered with plywood. Layers of cushioning material can be placed between the plywood covering and particularly fragile windows, such as stained glass. If interior walls and surfaces are vulnerable, scaffolding should be erected against the facade and debris netting placed on the outside of the scaffolding. Plastic sheeting can provide added protection in areas where acidic cleaning solutions may splash onto historic facades, windows and other surfaces.

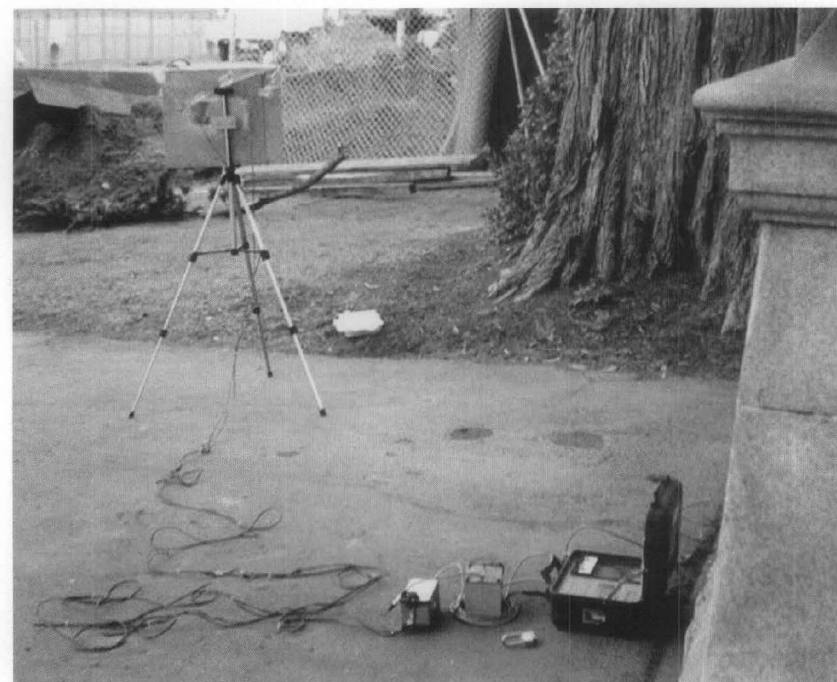
Figure 6. A seismograph records vibrations transmitted at the ground level of an historic building. The instrument is wired to a light and siren designed to warn the excavation crew that vibration levels are approaching preset limits. Additional sensors are often installed in the basement and on sensitive features such as stained glass windows. Photo: Wilson, Harg & Associates, Inc.

basement floor. More comprehensive measurements can be obtained by locating sensors at several points throughout the structure and the ground immediately adjacent to the historic building foundation (see Figure 6).
