CITY OF CARMEL-BY-THE-SEA FOREST AND BEACH COMMISSION

REGULAR MEETING Thursday, November 14, 2024

SUBJECT: Consider the Conditional Release of a Stop Work Order at the Northwest Corner of Fifth Avenue and Carpenter Street.

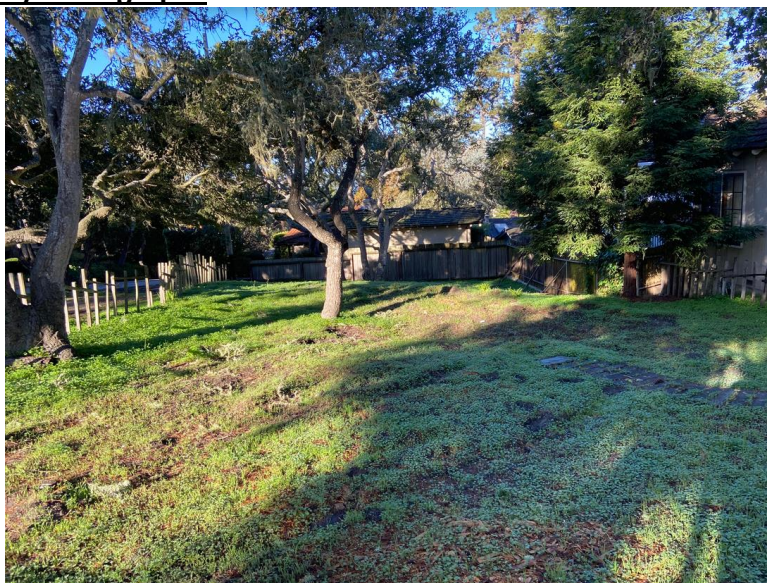
Photo 1. Front View of the lot facing west

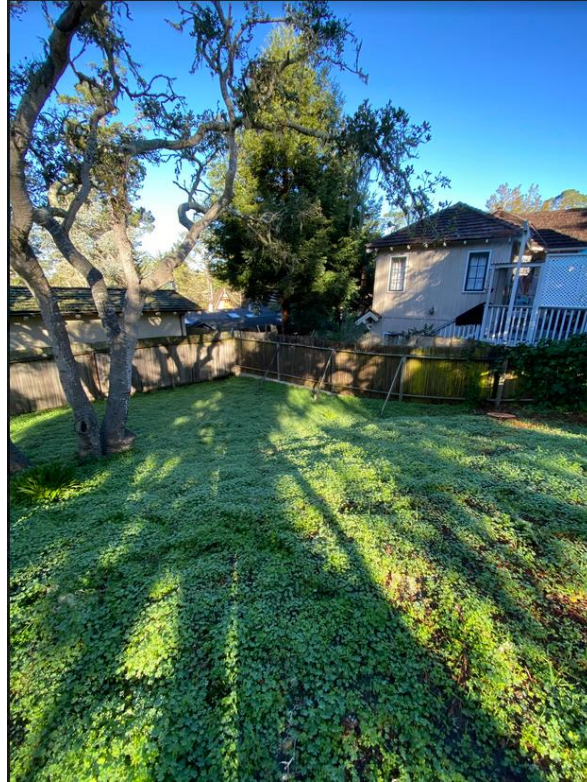
Photo 2. View of the lot facing northwest

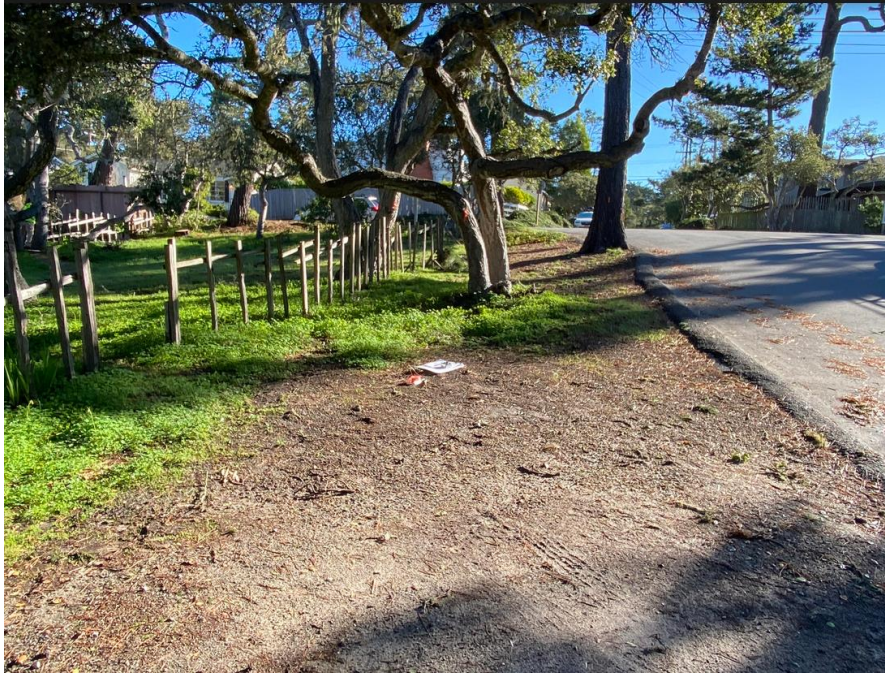
Photo 4. View of the right-of-way to the south of the property along 5th Avenue (facing east).

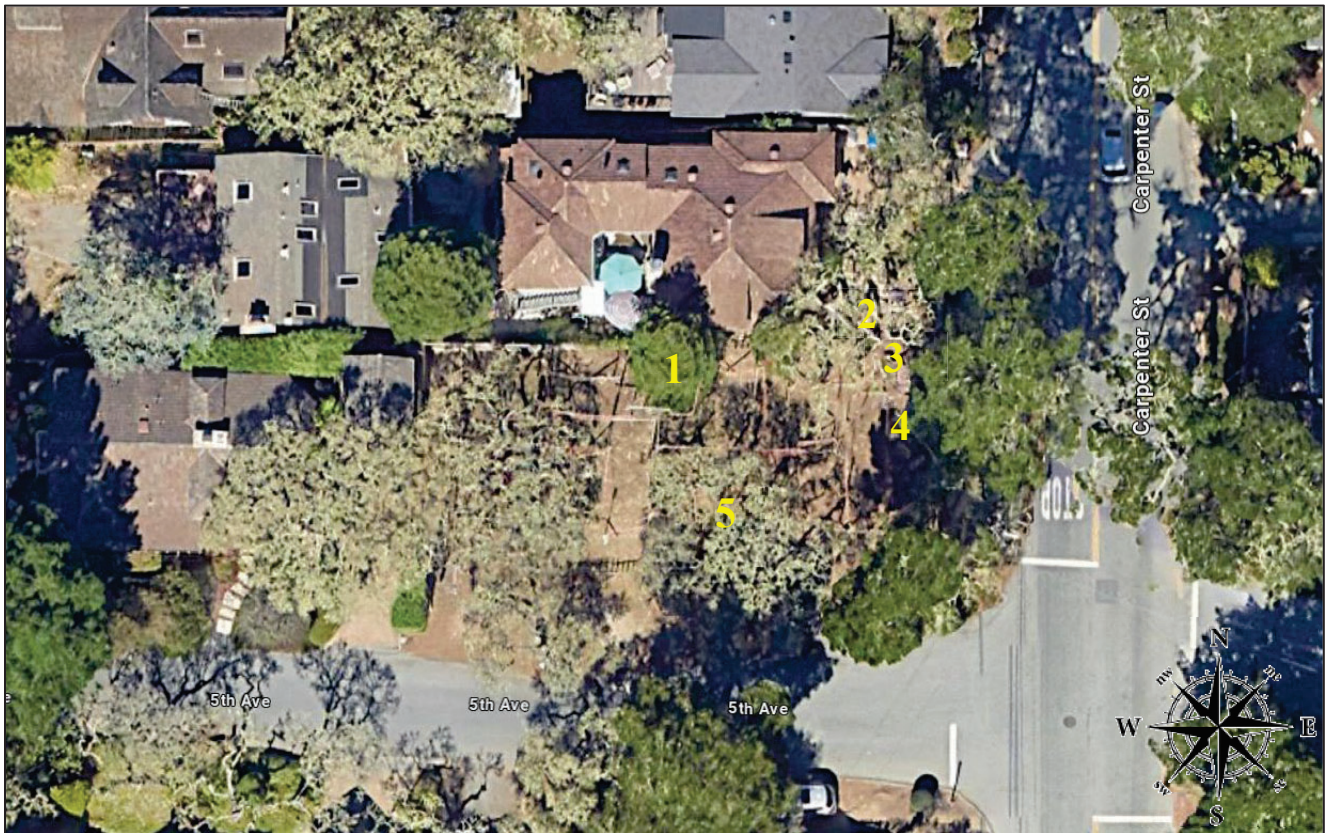
Appendix A Map

The subject trees are numbers on the above map.

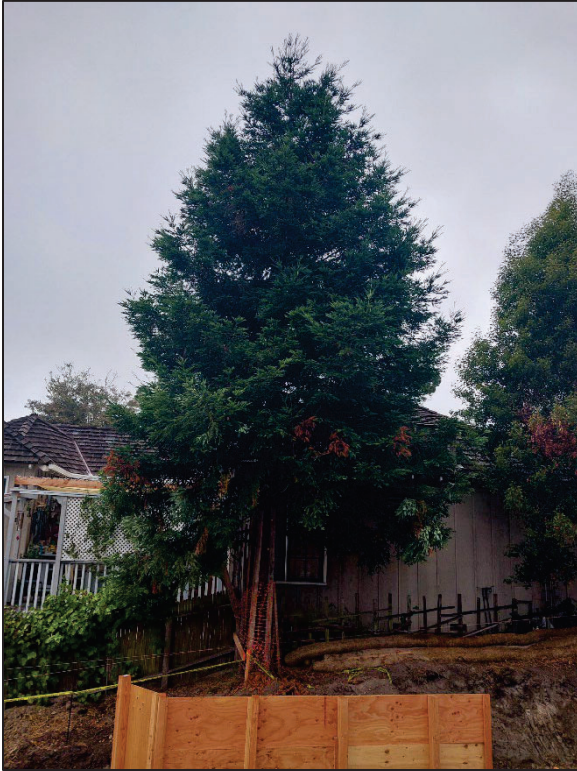
Photo 1 (Top Left): Coast redwood tree #1 growing on the north perimeter of the lot. It has healthy foliage throughout the canopy.

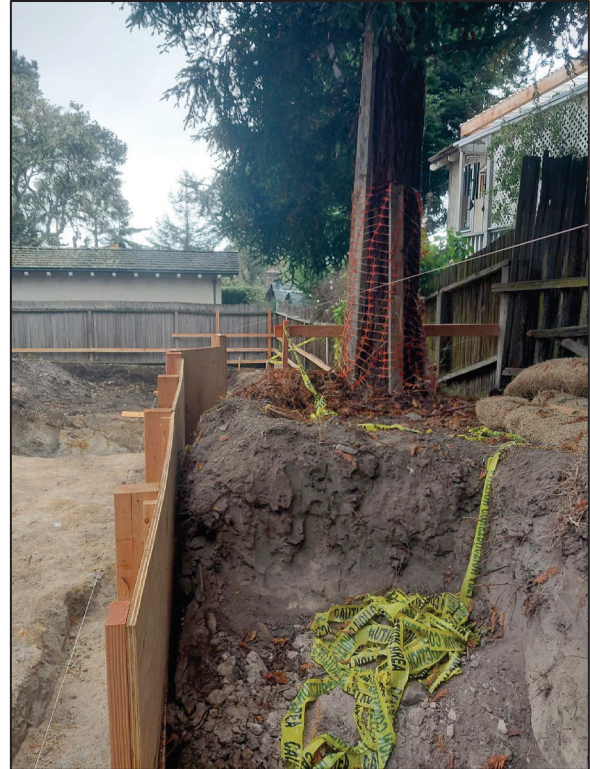
Photo 2 (Top Right): Excavation has taken place 3.5-feet from the base of the tree on the south side and 4.5-feet on the east side.

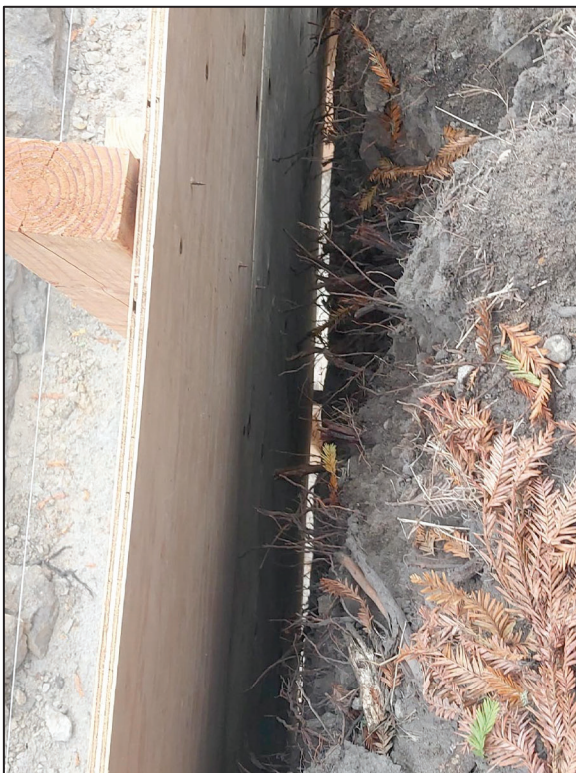
Photo 3 (Bottom Left): Torn roots behind the soil support. Numerous roots were damaged during this excavation activity.

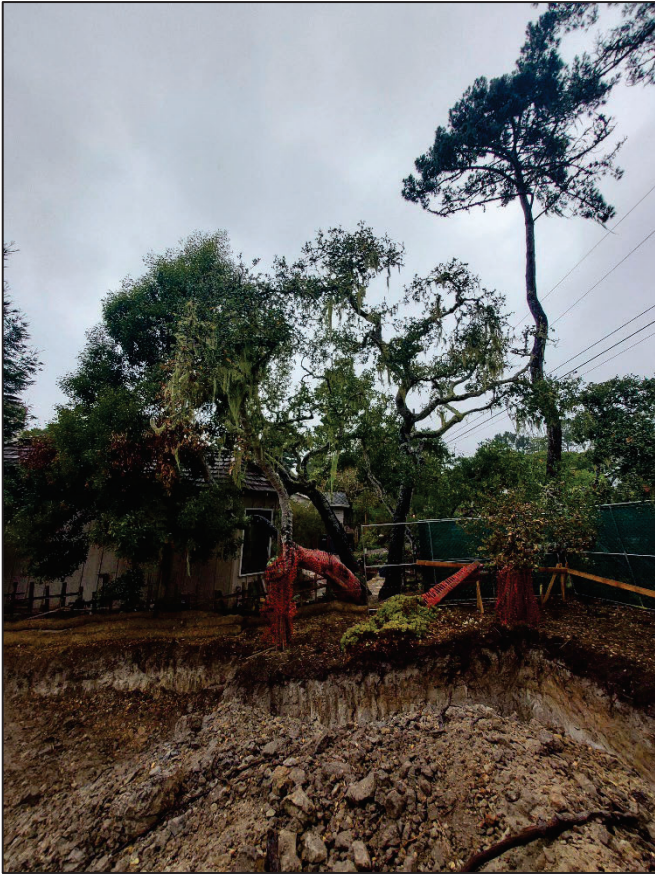
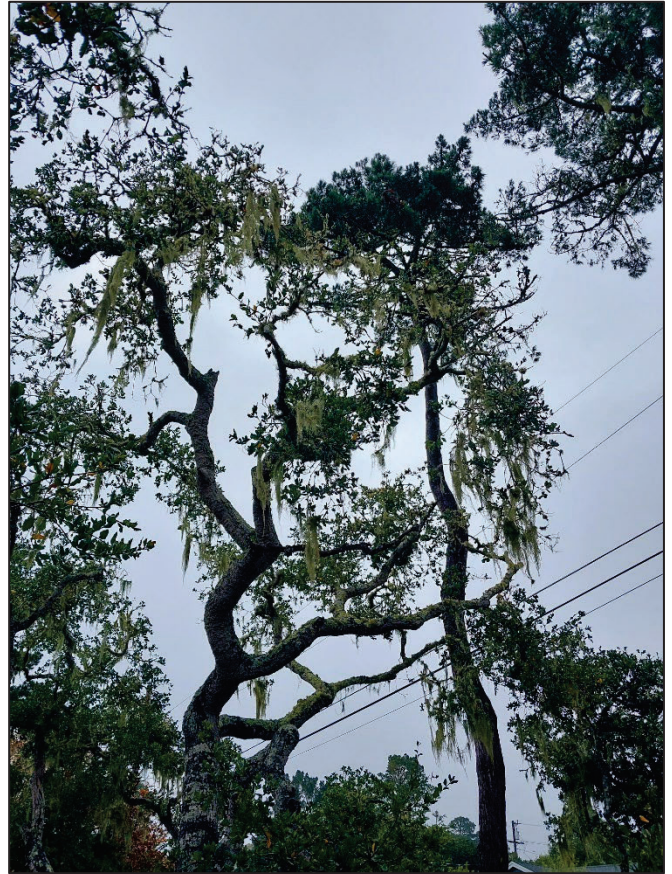
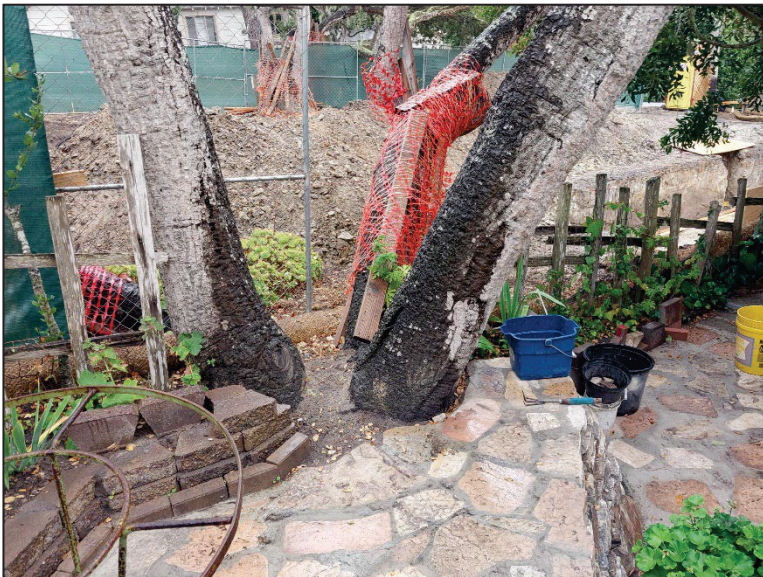
Photo 4 (Top Left): Coast live oak #2 growing north of the subject property on the neighboring property.

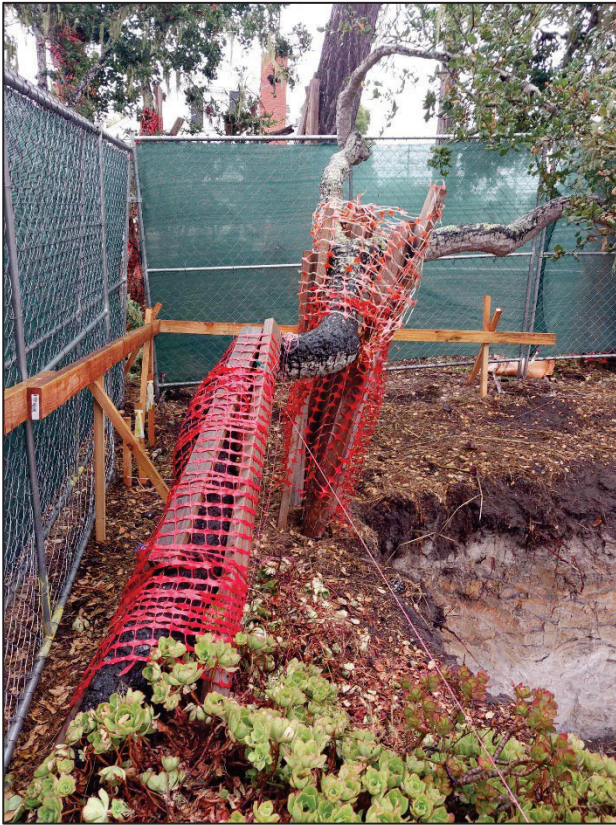
Photo 7 (Top Left): Coast live oak #3 growing along the northeast perimeter of the property. It has a significant eastward lean and is crowded by tree #2.

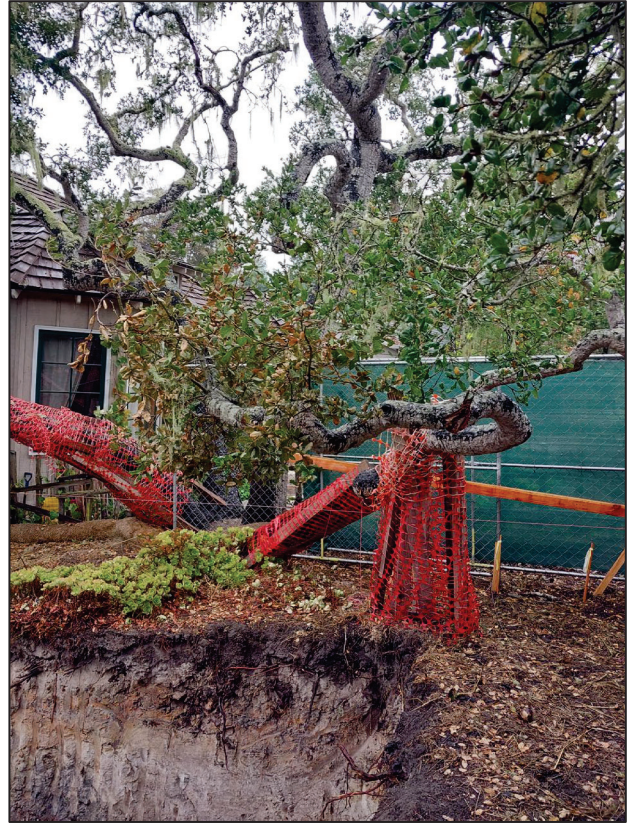
Photo 8 (Top Right): Browning foliage is present in the tree canopy. Excavation activity has taken place 3.5-feet from the tree base.

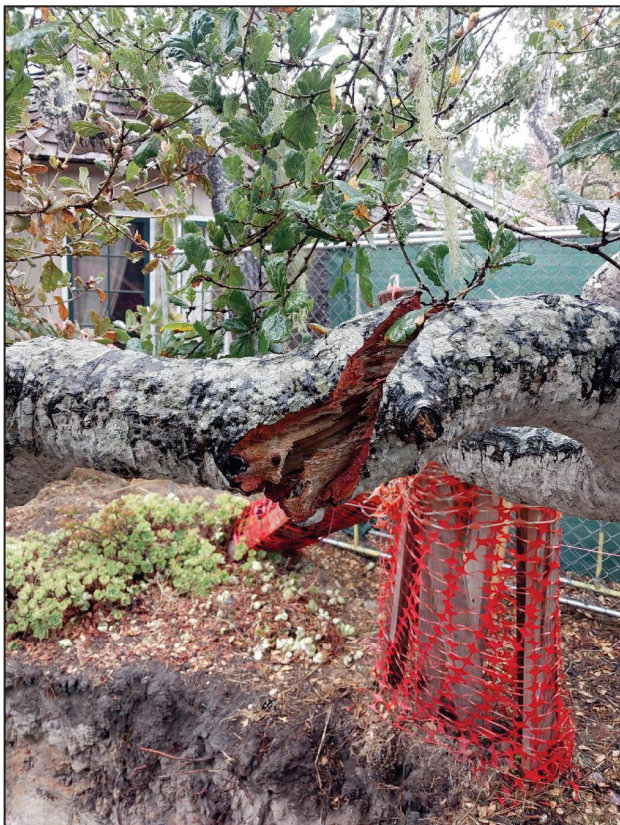
Photo 9 (Bottom Left): A severe mechanical wound on the main scaffold limb. This wounding will likely require removal, and the tree will lose the majority of its canopy.

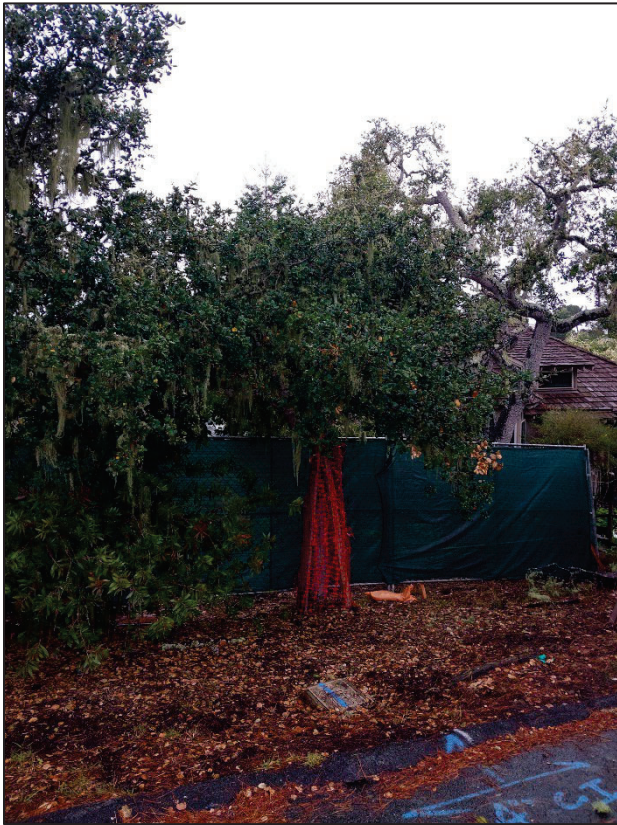
Photo 10 (Top Left): Coast live oak #3 growing on the east perimeter of the property outside the construction area. It is a City tree. Healthy foliage is present throughout the canopy.

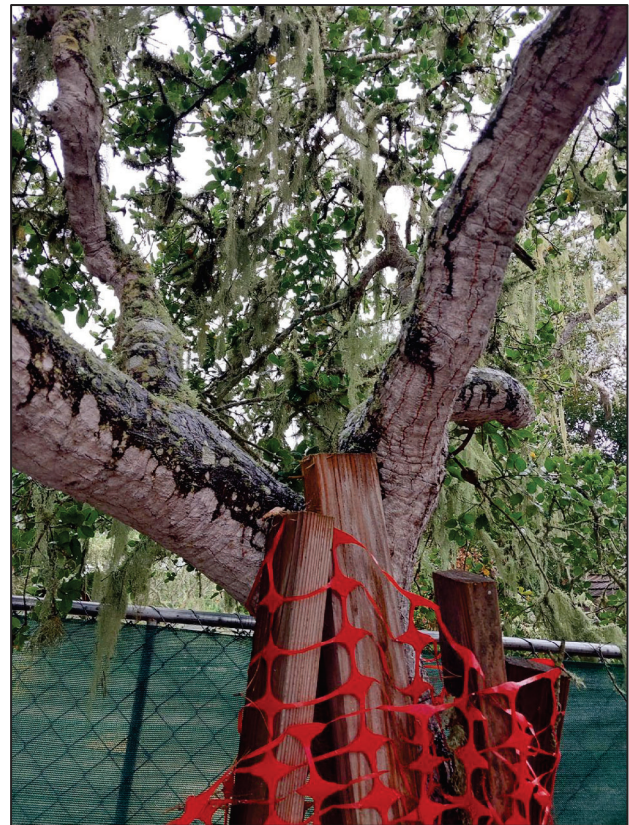
Photo 11 (Top Right): Multiple codominant attachments at 6.5-feet from the tree canopy.

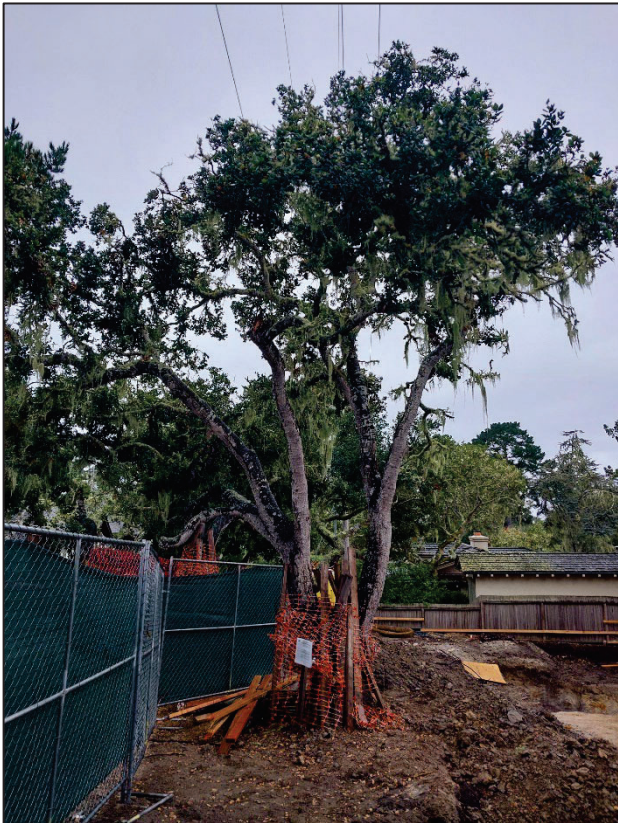
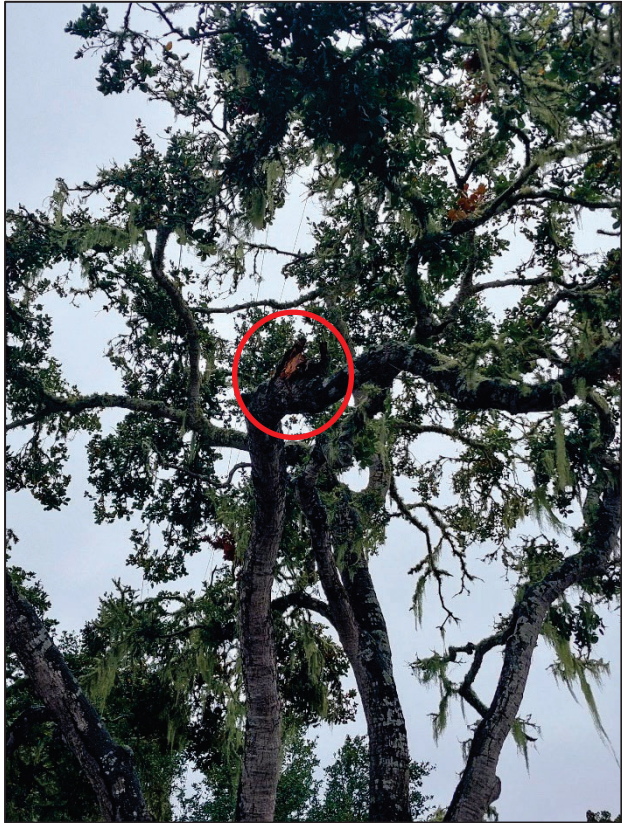
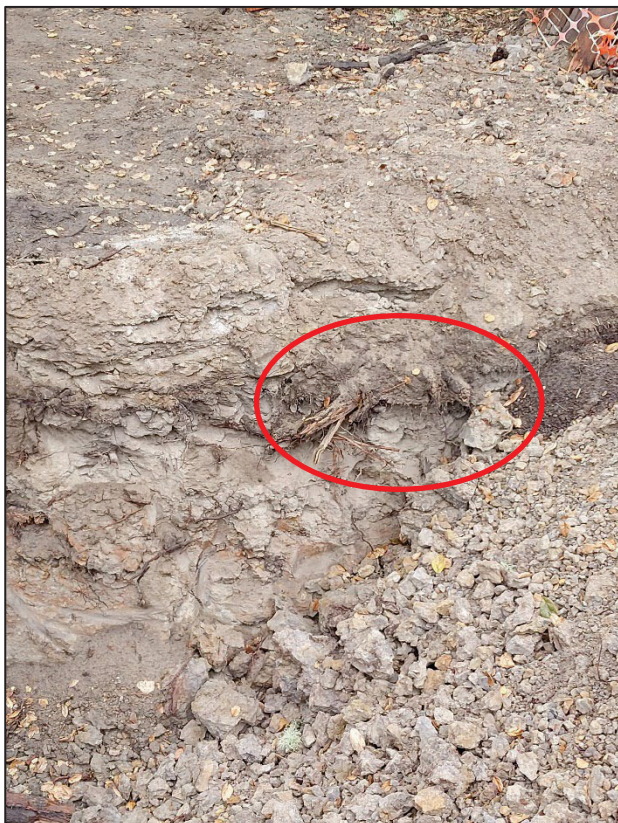
Photo 12 (Bottom Left): Excavation activity on the east side of the tree is 6-feet away from the base of the subject tree.

Photo 13 (Top Left): Coast live oak #5 growing on the south side of the property. It is growing directly beneath powerlines.
