CITY OF CARMEL-BY-THE-SEA FOREST AND BEACH COMMISSION

REGULAR MEETING Thursday, November 14, 2024

SUBJECT: Consider the Conditional Release of a Stop Work Order at the Northwest Corner of Fifth Avenue and Carpenter Street.

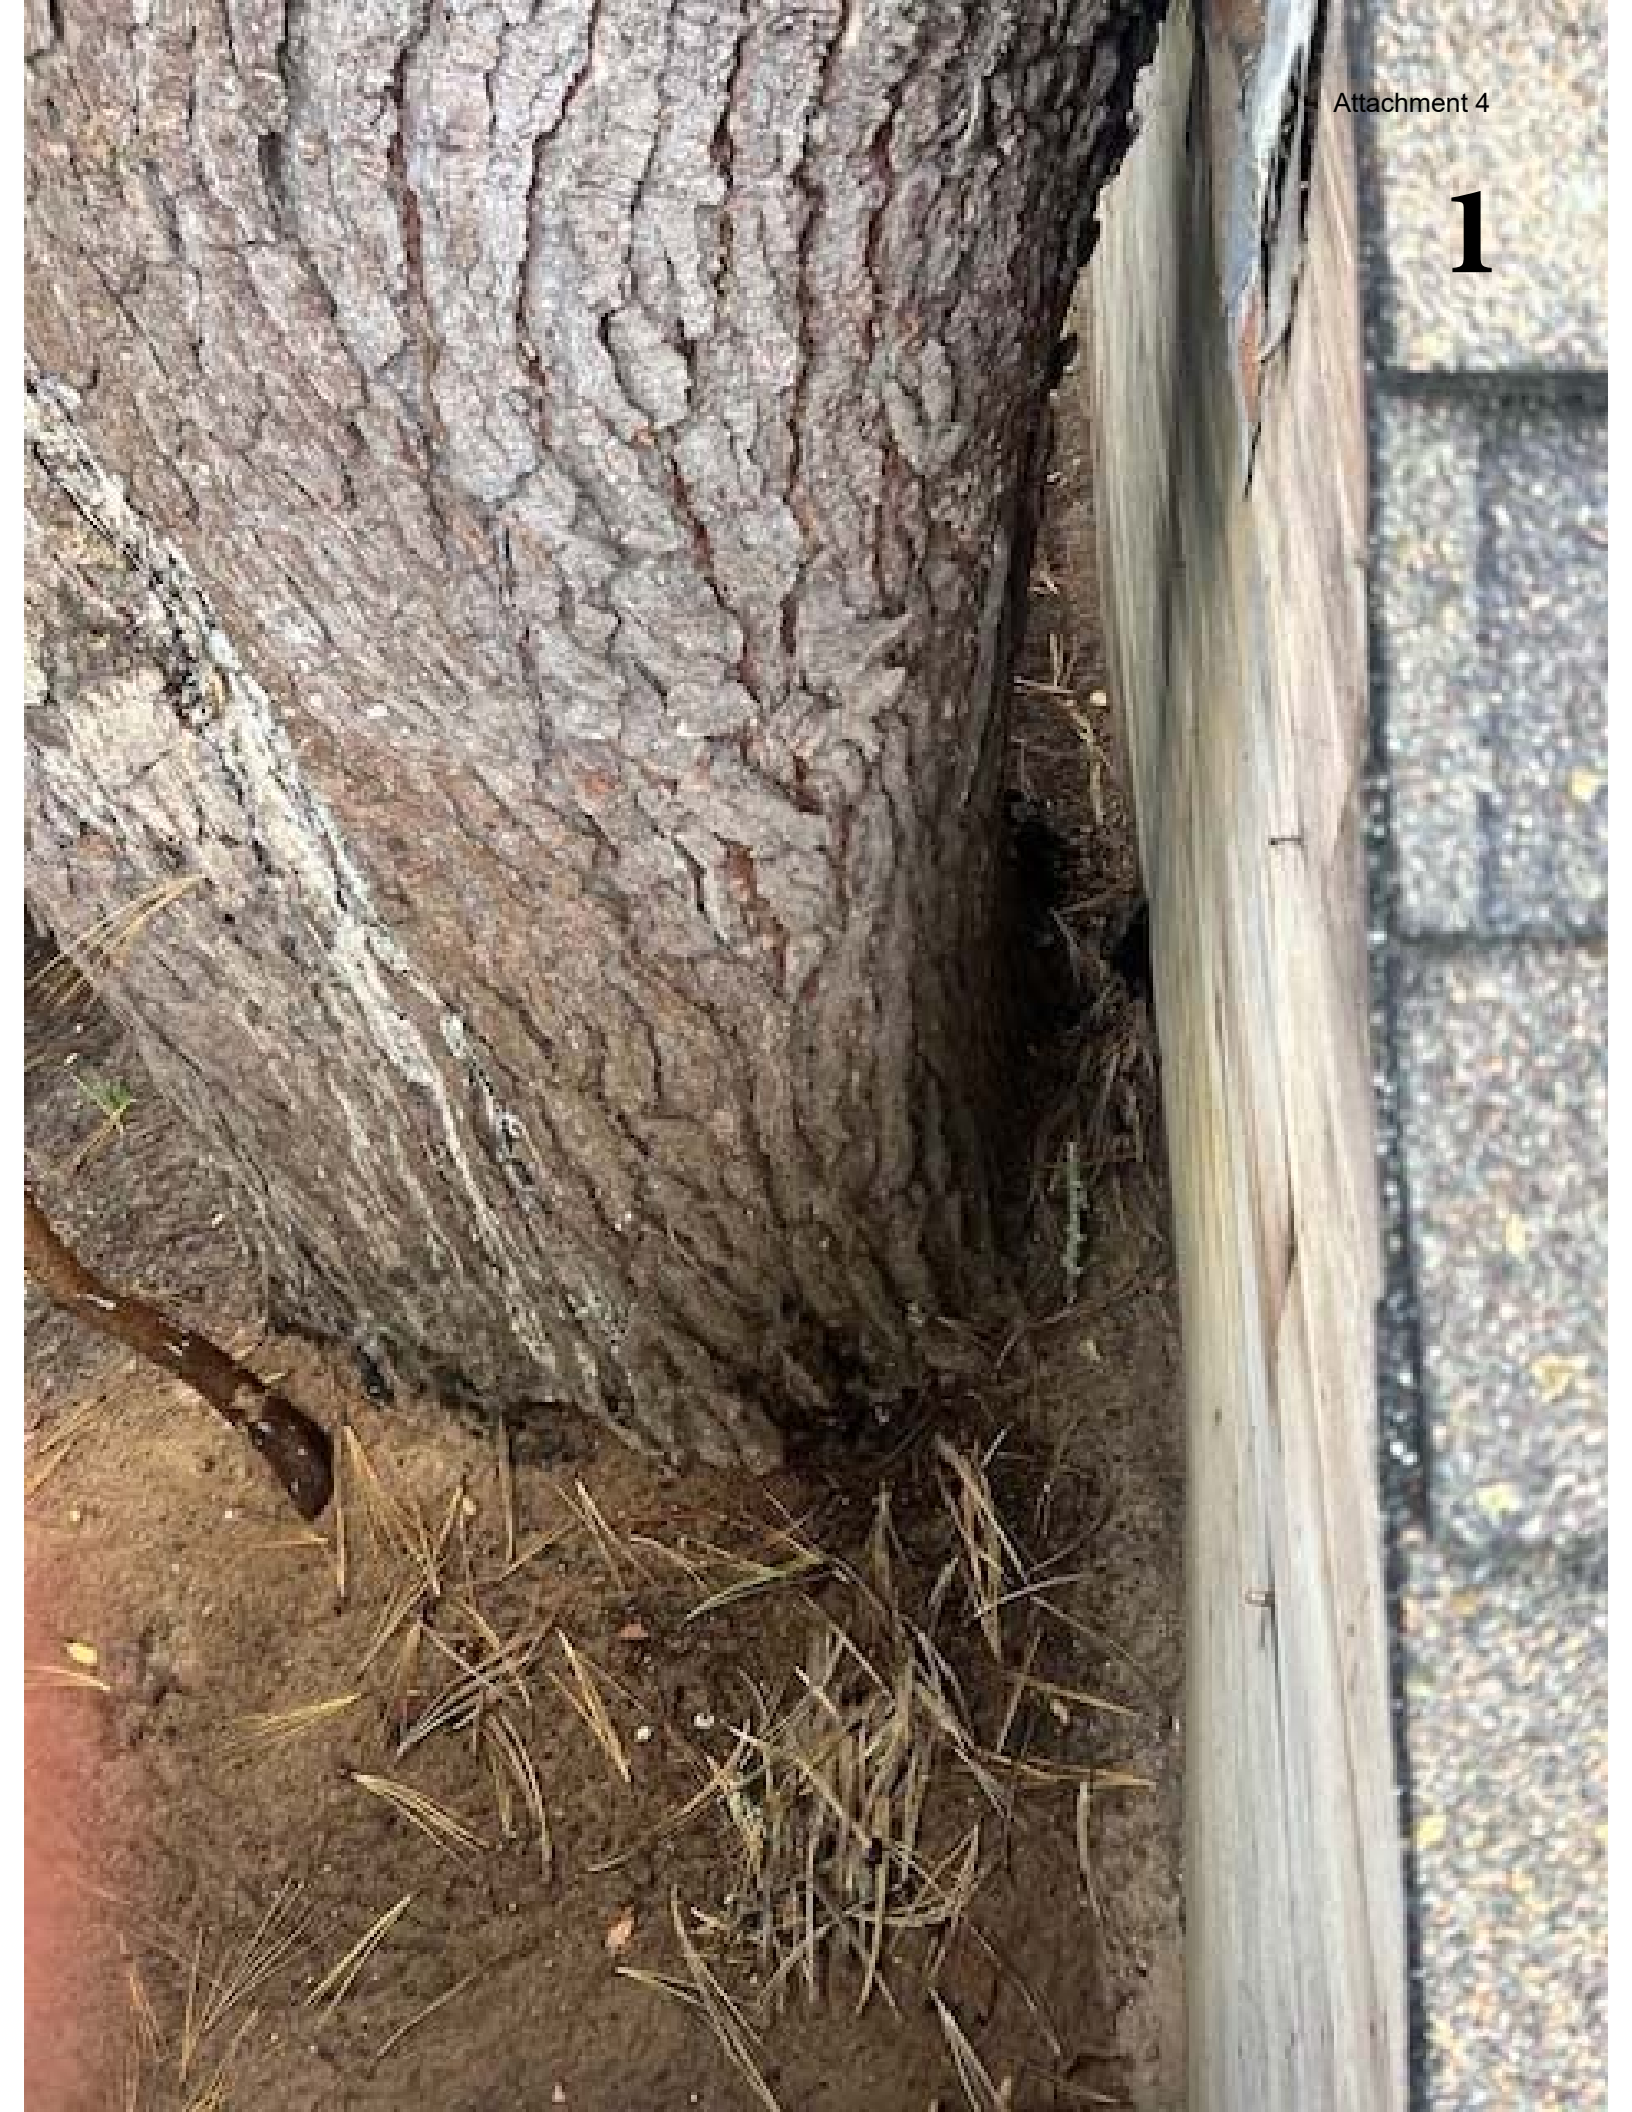
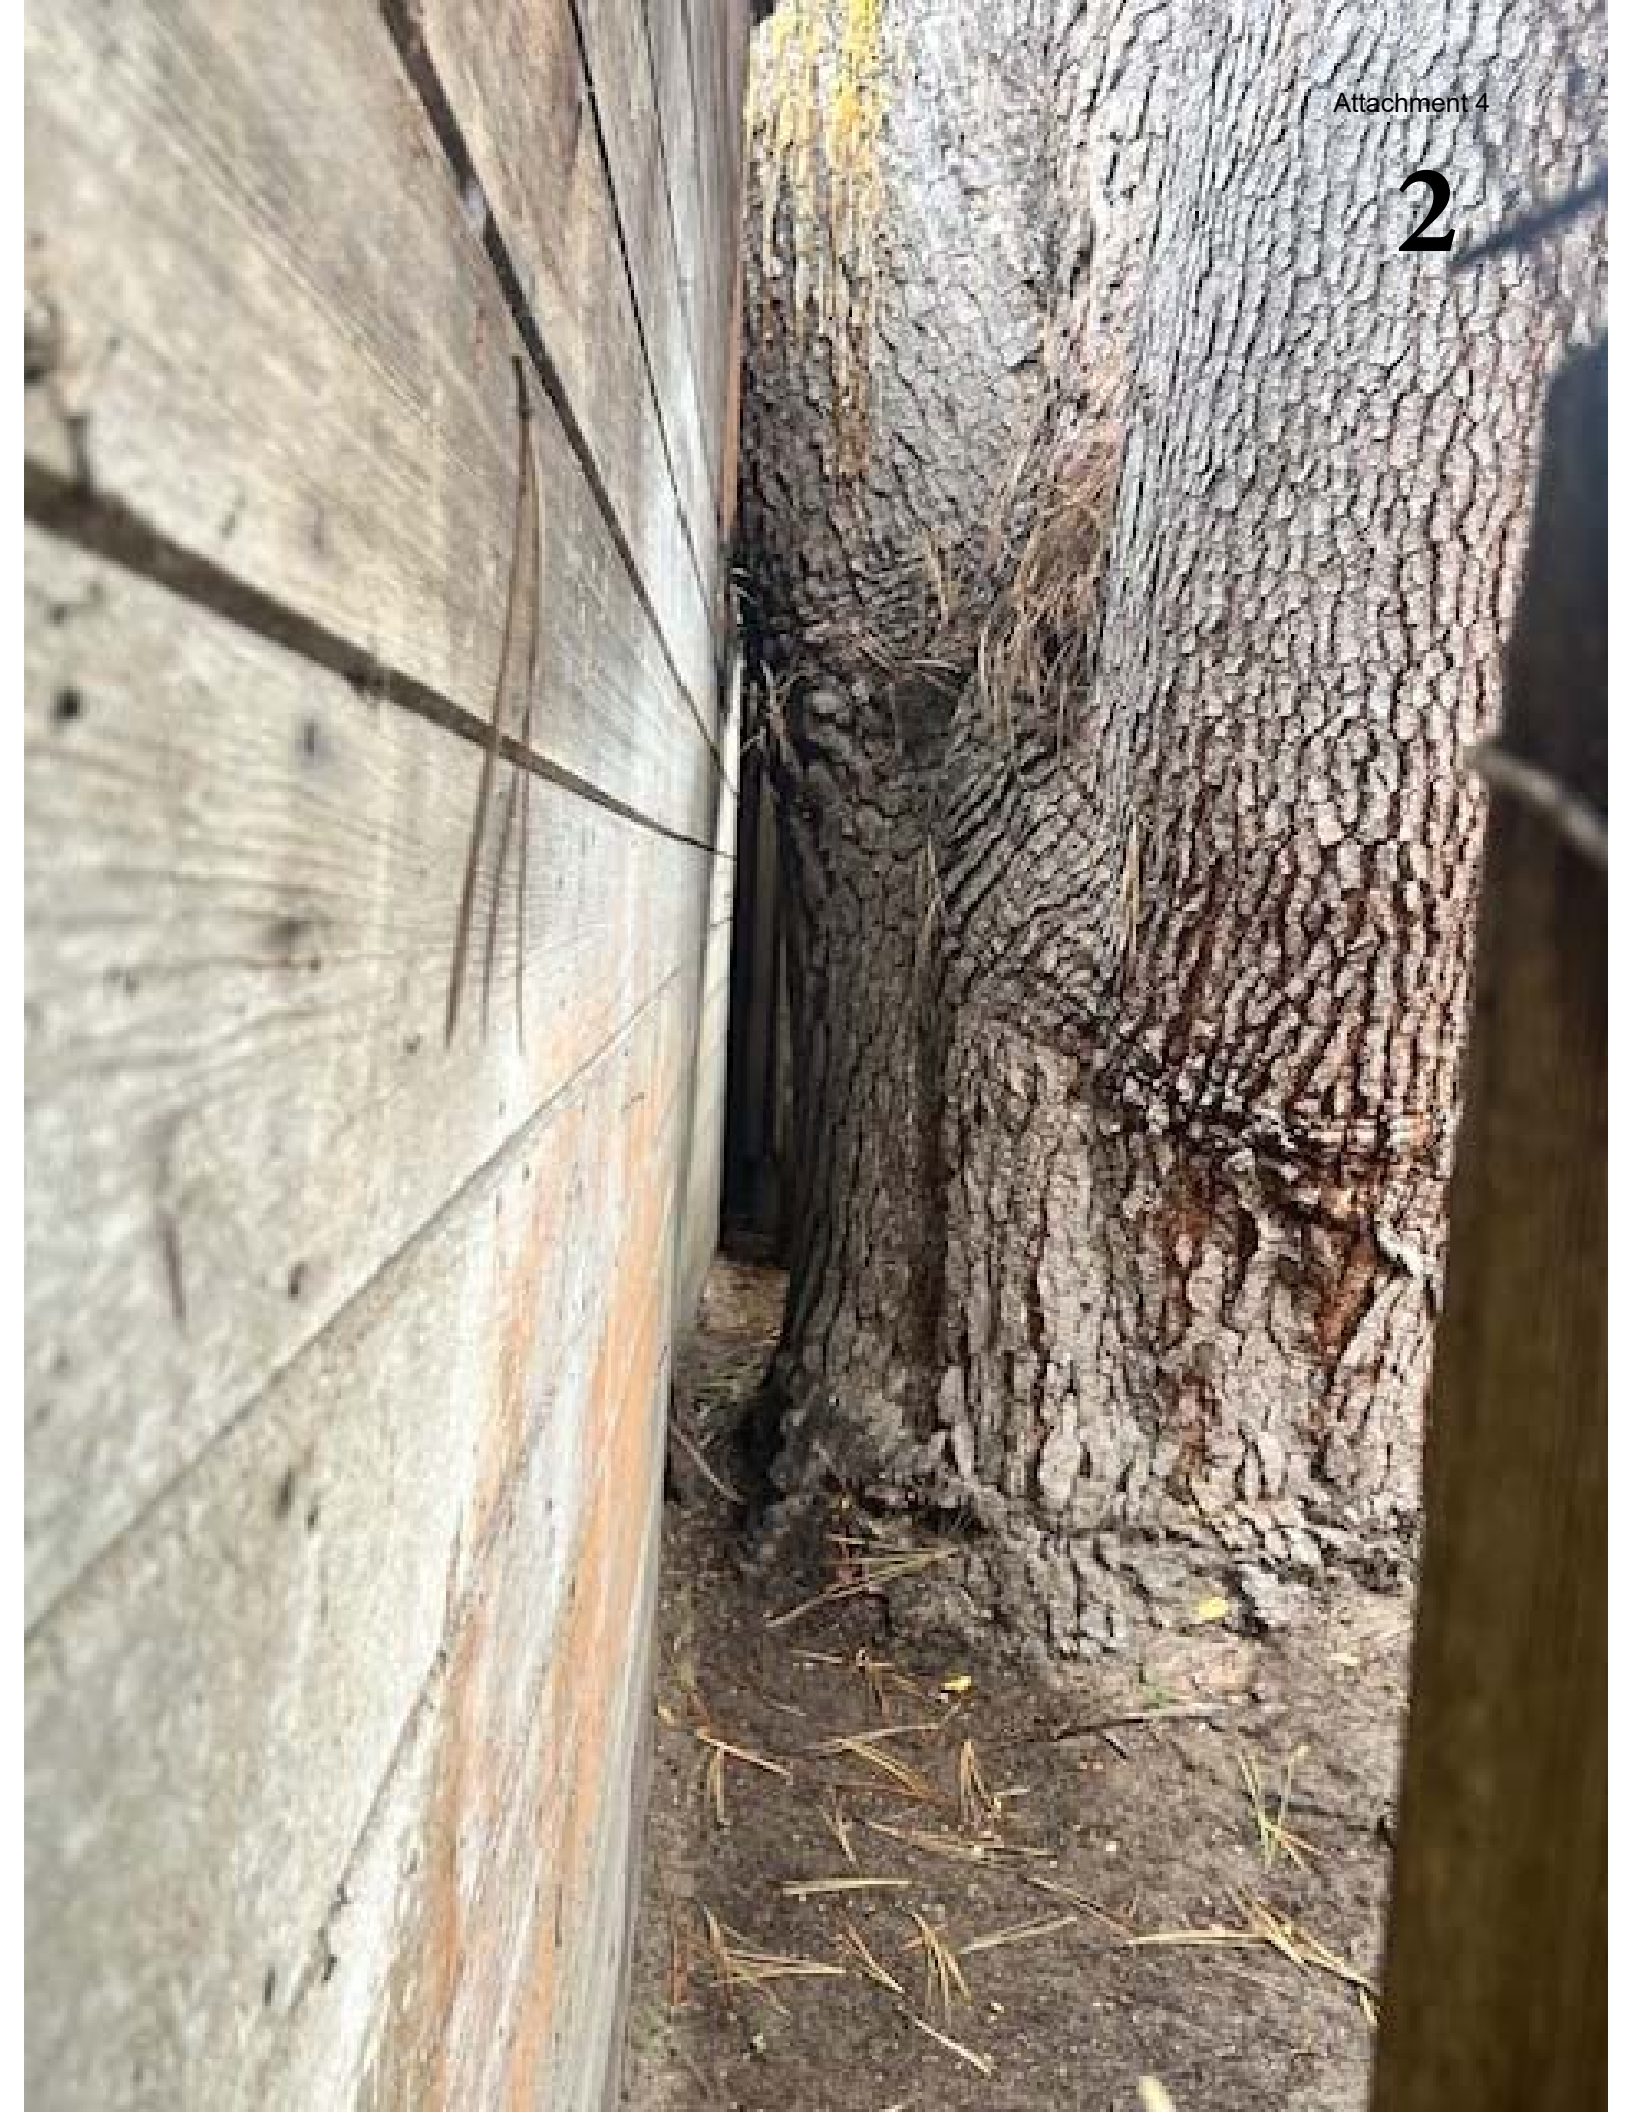
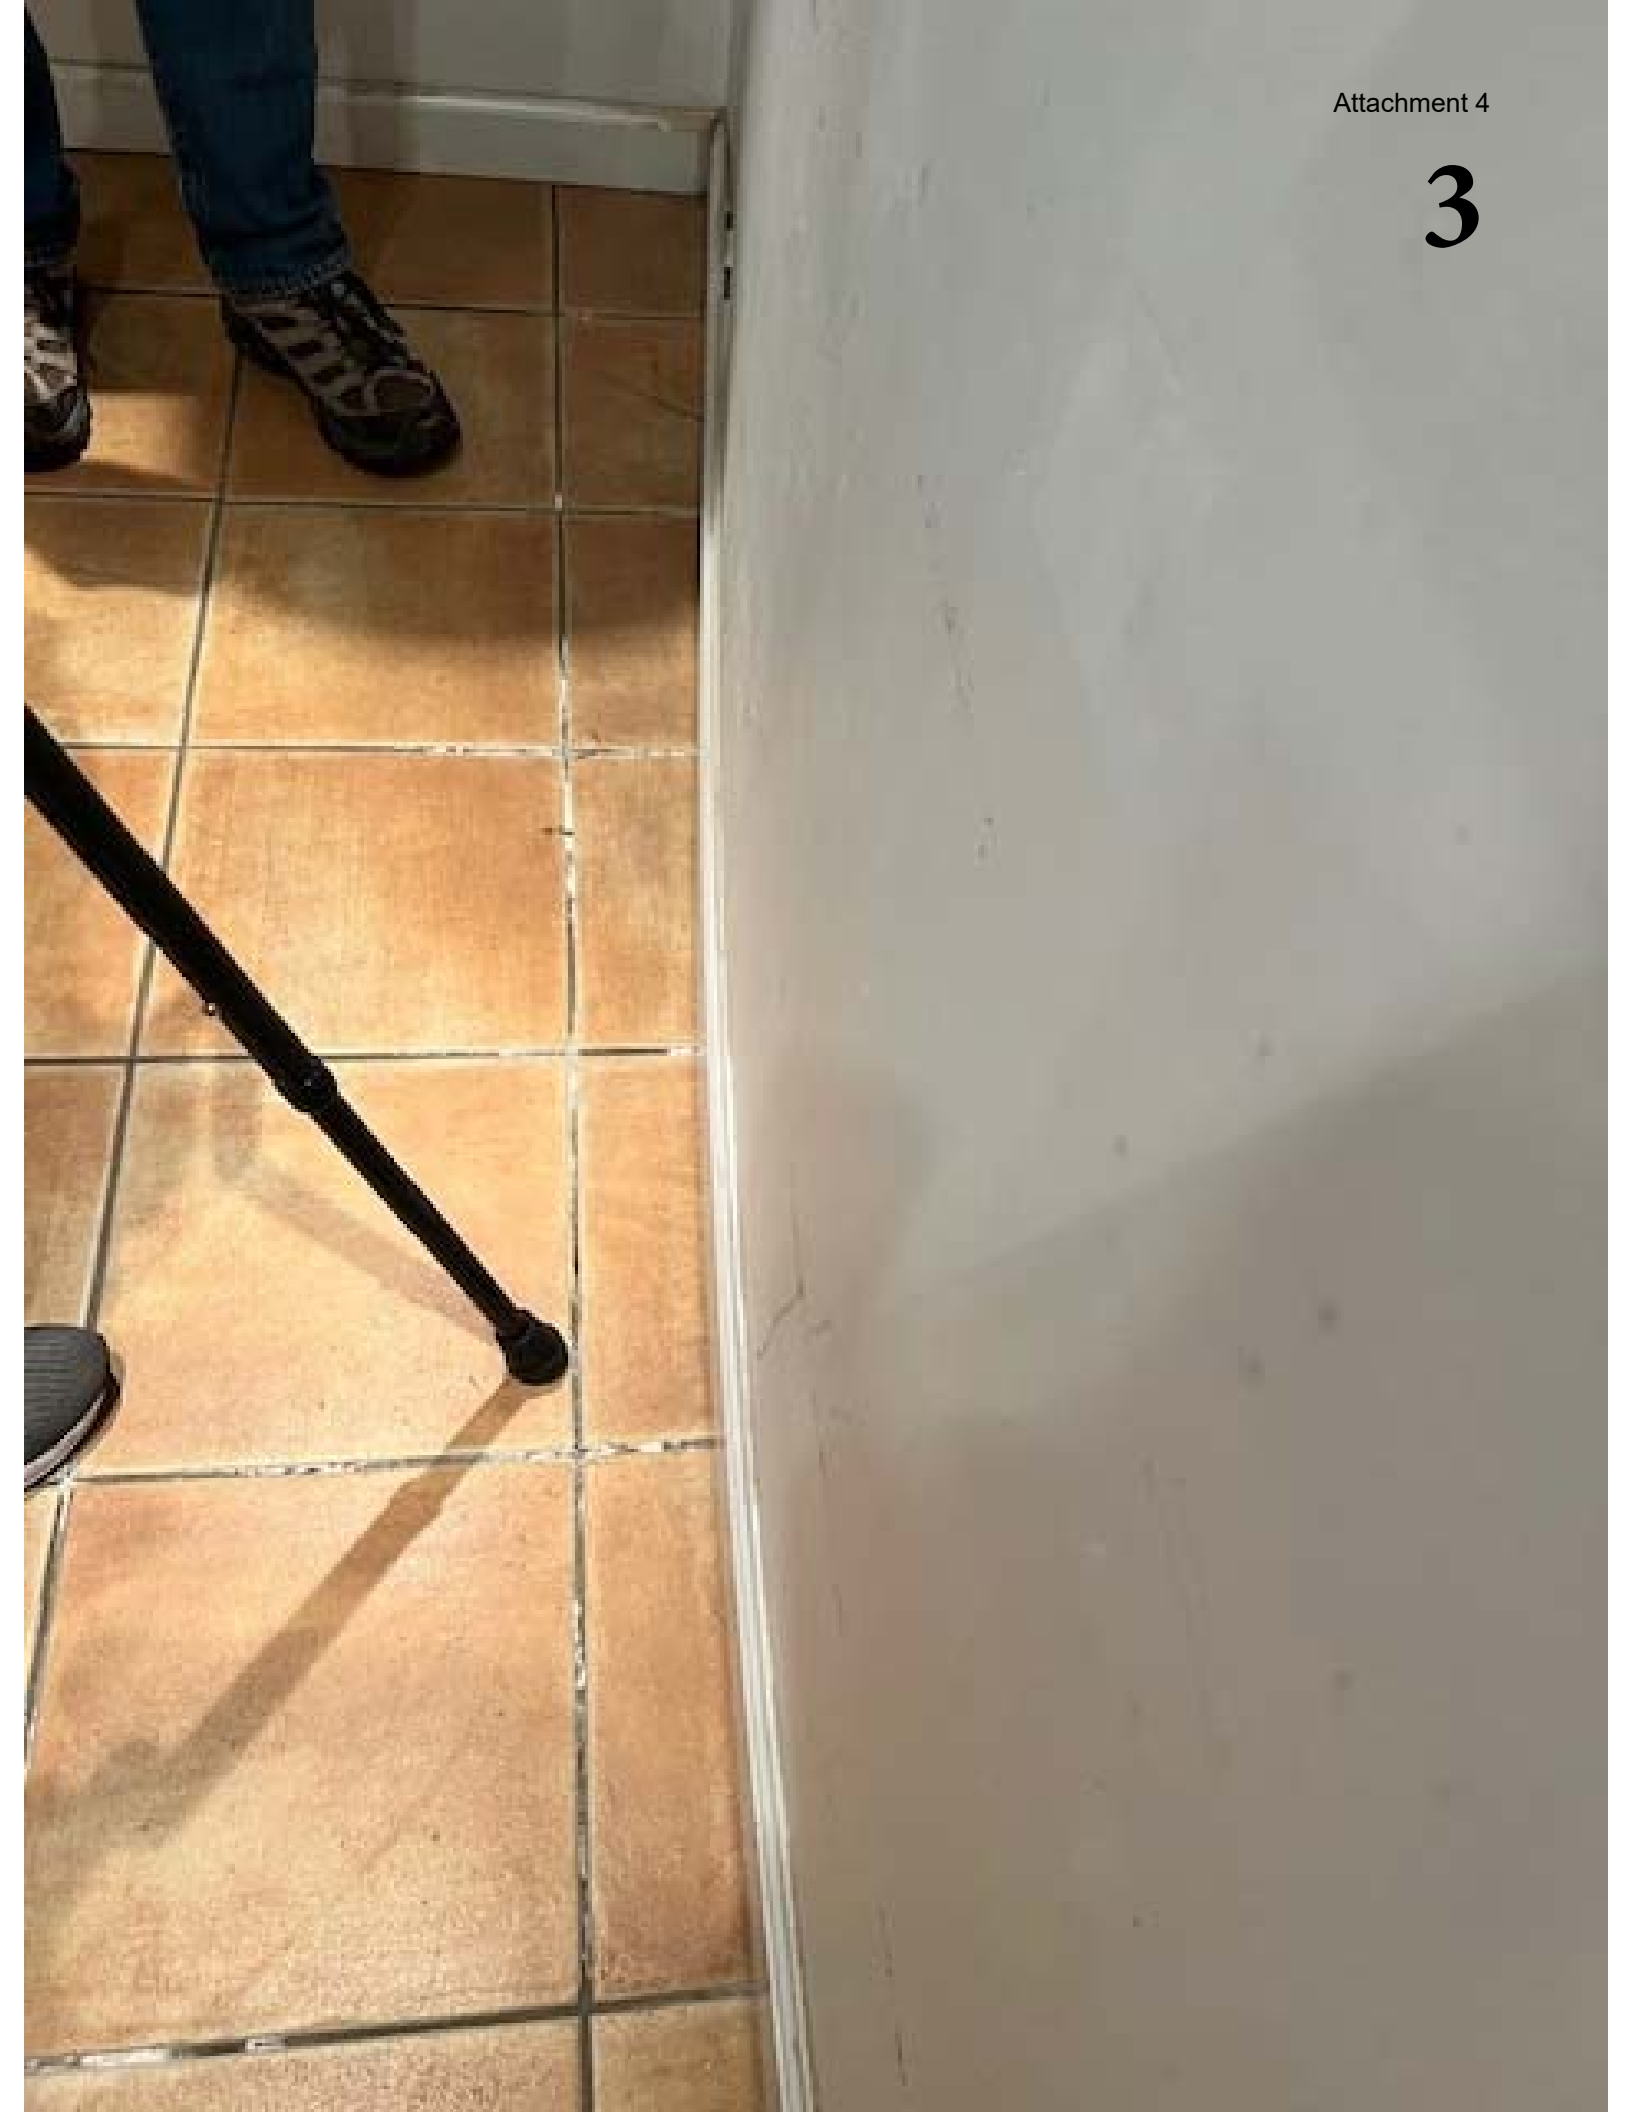
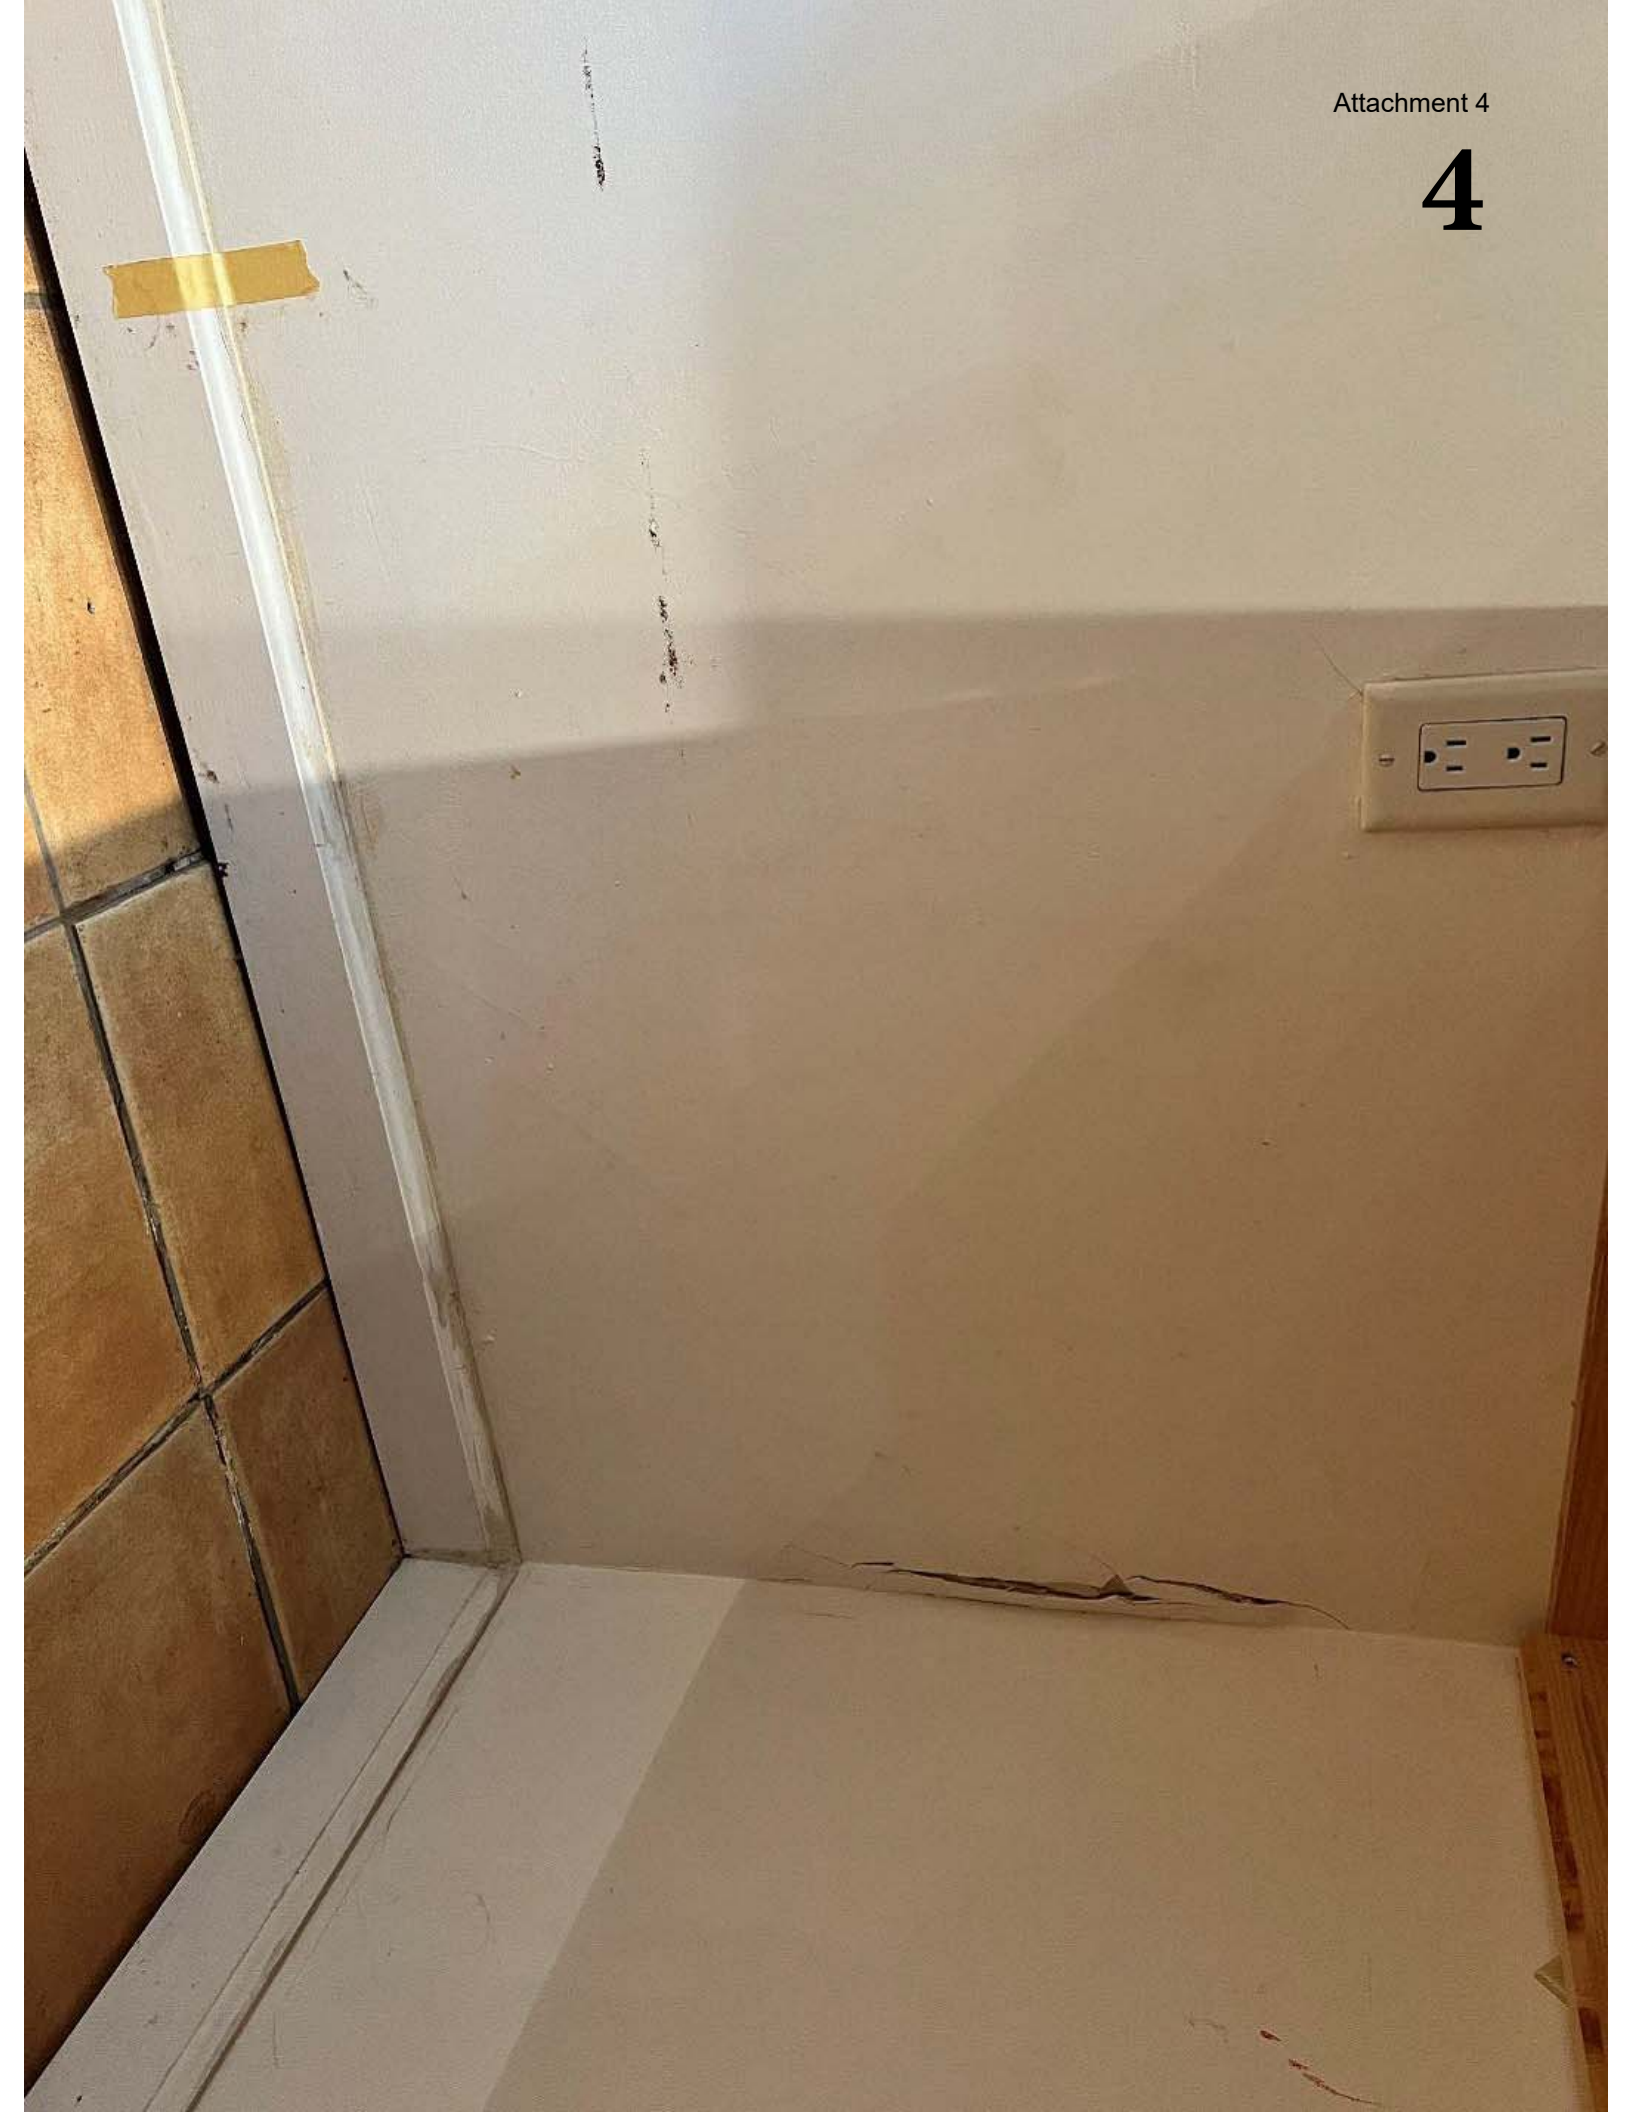
- Photo 1: looking down from the roof at the base of the tree near the east wall
- Photo 2: taken from the southeast, exterior corner of the structure facing north
- Photo 3: interior floor tile along the curved east wall in the vicinity of the tree
- Photo 4: ruptured interior wall finish at junction of east wall and interior wall
- Photo Sheets 5 & 6: broken and displaced floor tile along east-to-west crack

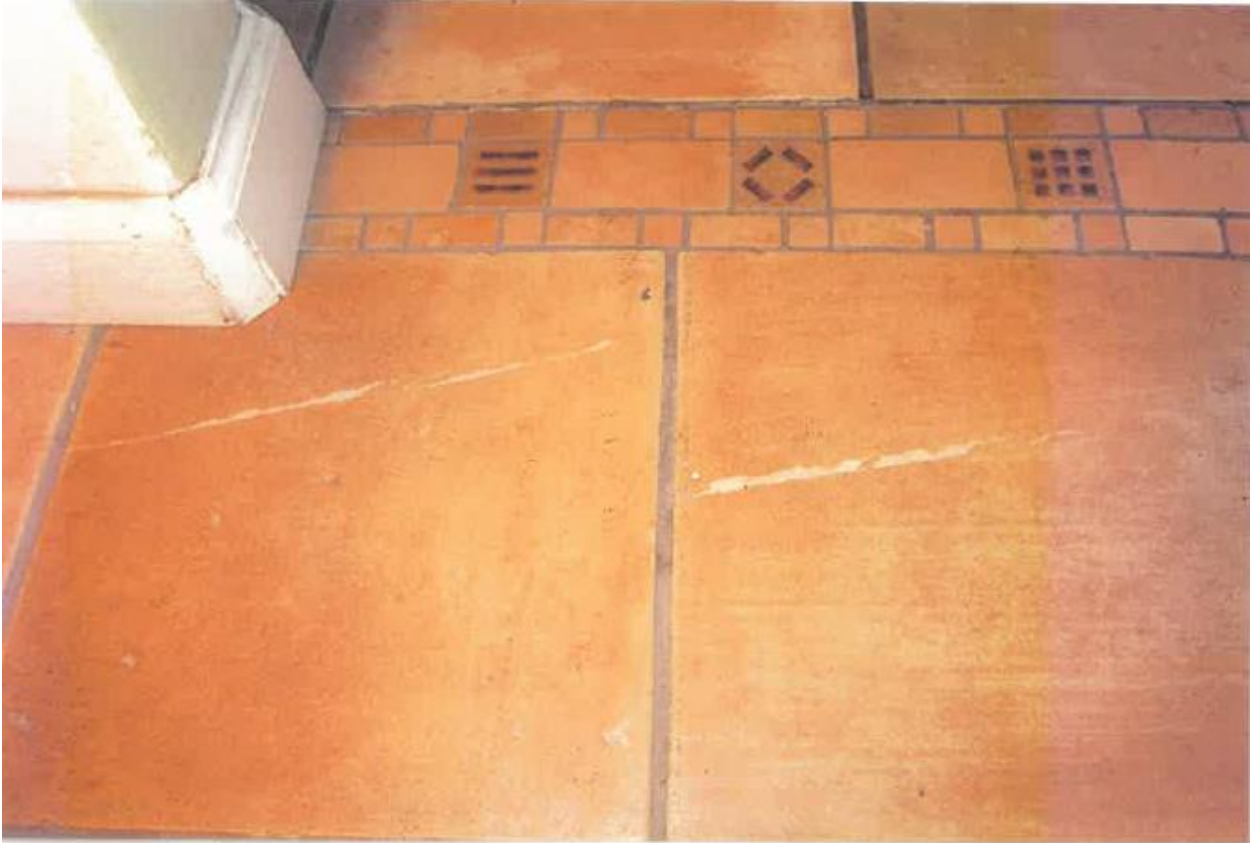
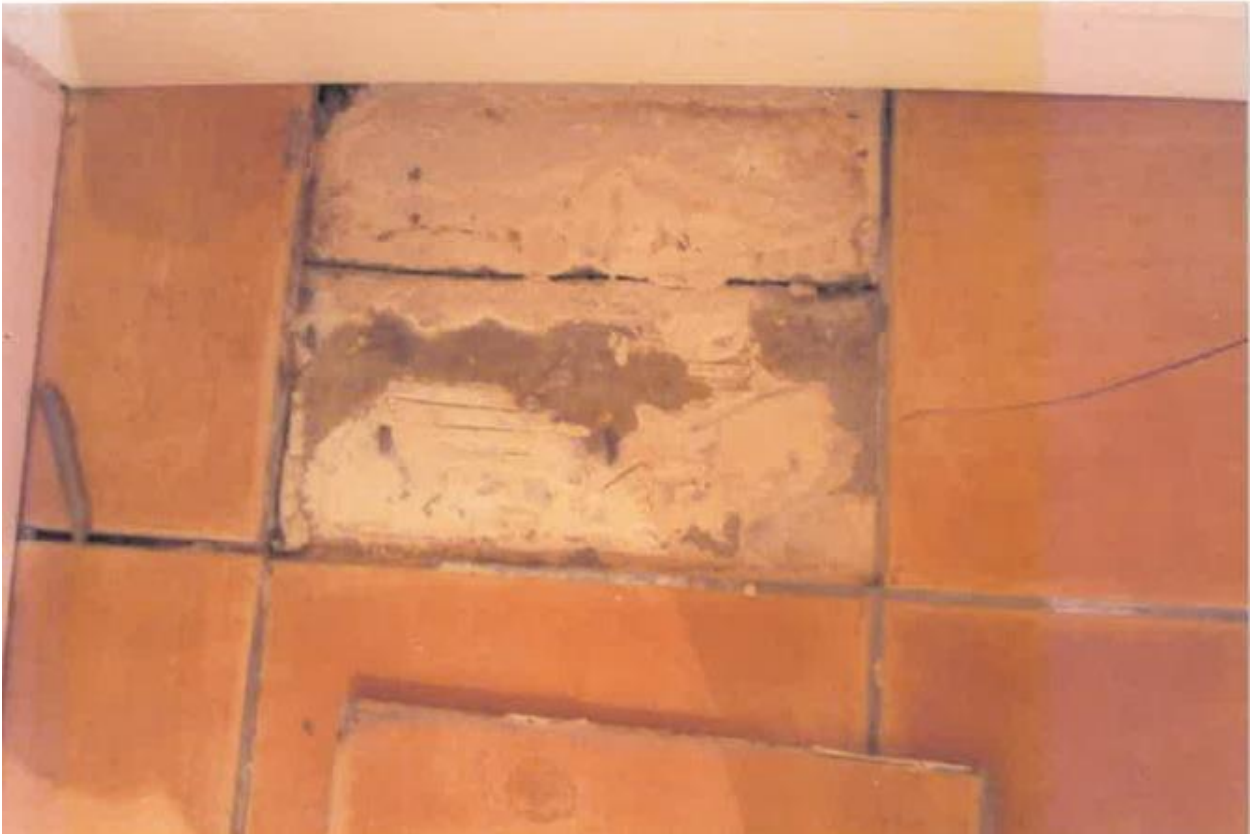
6

The floor of the structure is a concrete slab finished with ceramic tile. At the curved portion of the east wall, the floor tile are cut to match the curve. [Photo 3.] The tile and slab are cracked in two general locations, and many pieces of tile are broken off and displaced. The most prominent crack runs east-to-west, located near the center of the structure. This crack runs through the entire ADU. [Photo Sheets 5 & 6: broken and displaced floor tile along east-to-west floor crack full length of ADU.]
