Carmel Legacy Hotel Response to Appeal to the City Council and Recommended Evidence for a Class 32 Categorical Exemption

This report presents the findings of the visual assessment and evaluation of the Hofsas House Hotel, located in Carmel, California. The objective of this study was to perform a visual conditions assessment, noting deficiencies encountered, and a qualitative structural review of the buildings along with a civil assessment of the site.

SITE & STRUCTURAL SCREENING and EVALUATION

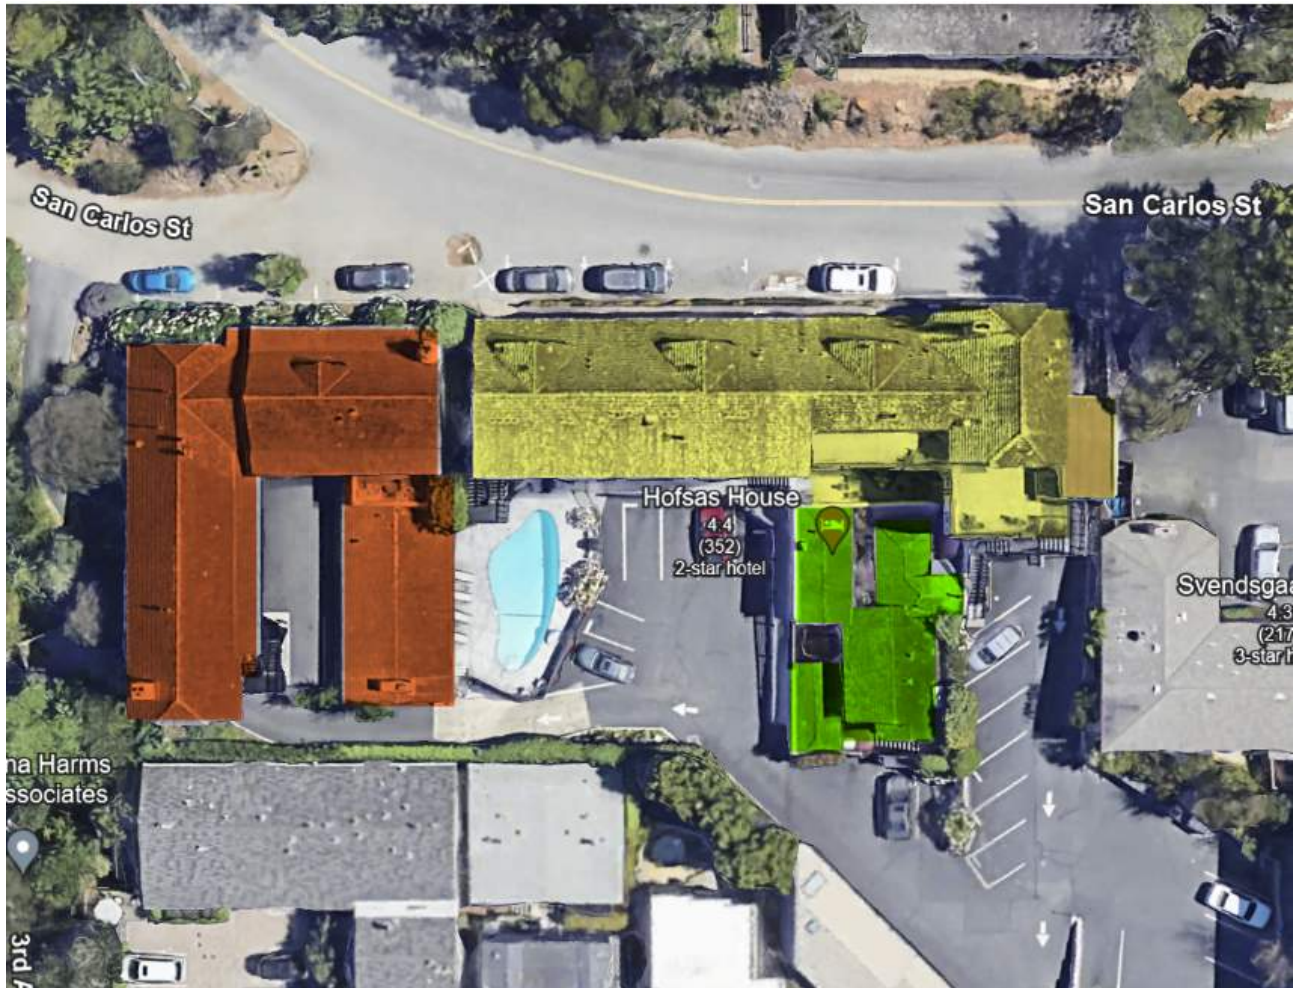
Figure 1- Aerial View

- 4.9 Fractured CMU at Cantilevered Beam: There is a 6x12 beam that cantilevers off the CMU wall at the north end of the building highlighted yellow in Figure 1. This beam supports the elevated walkway framing and the stair landings. The CMU support wall has cracked underneath beam and should be repaired.

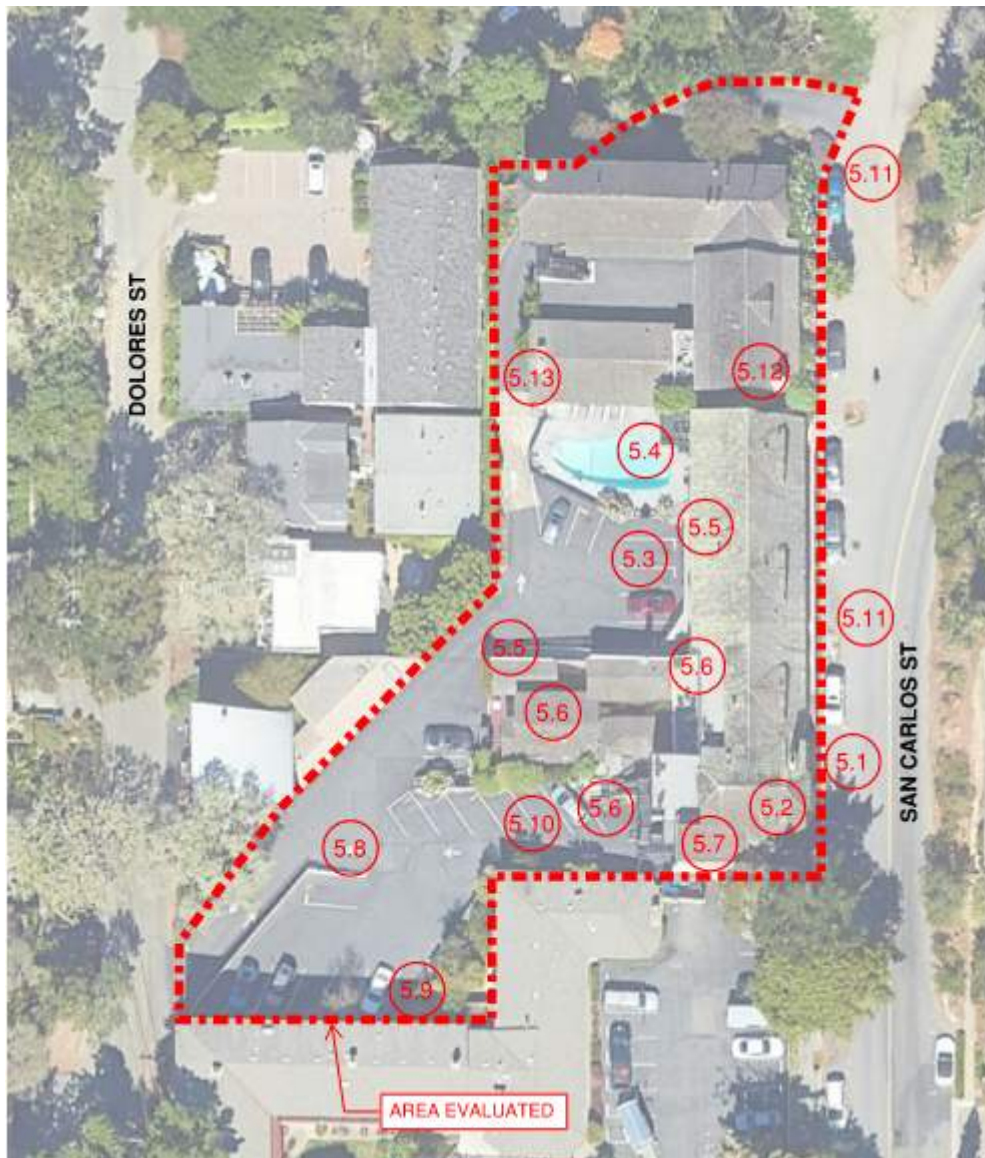
Figure 14 – Civil Site Observations Key Map

The following sections note a variety of field observations made upon our May 2024 site visit. The comments listed below are primarily focused on site accessibility, but also cover other site features including site structures, drainage, and utilities. The key map below, Figure 14, provides the general location of the following listed items.
