Date: 27 April 2023  
Client: City of Carmel  
Subject: Carmel Beach Coastal Protection Assessment  
Reference: Carmel Beach Adaptation Plan  
Project No.: 12176

## CARMEL BEACH COASTAL PROTECTION ASSESSMENT REPORT

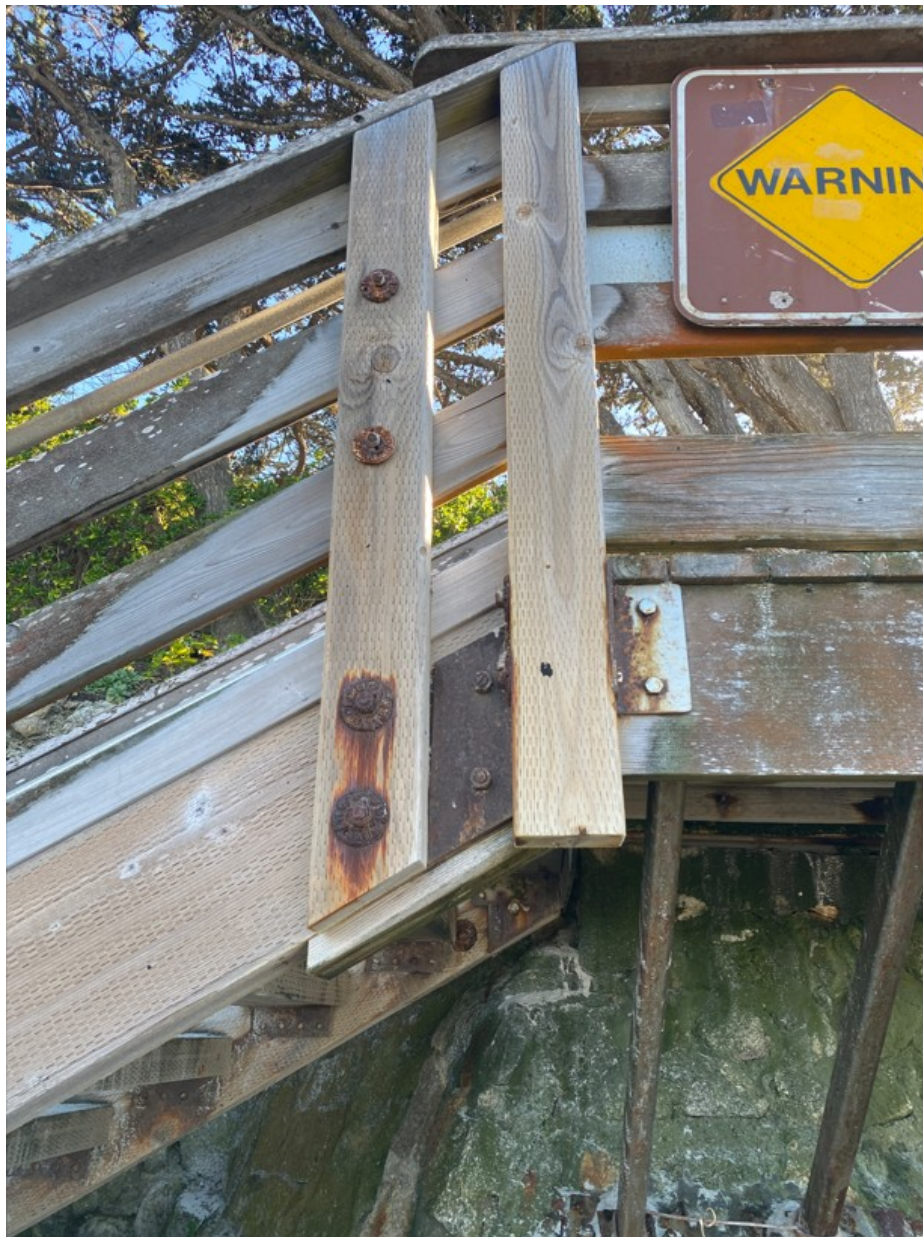
**Photograph 5: Public Access Stairway ST1 on December 22, 2022**

Photograph 5 shows Public Access Stairway ST1 on December 22, 2022. Corrodible fasteners and brackets were used on this stairway and those are deteriorating. At some point it will need maintenance and/or repair. Visually it appears satisfactory to us at this time. Further evaluation of the structure by an independent licensed structural engineer (and if need be a licensed corrosion engineer) should be scheduled to verify the structure is safe for public use, and recommend any needed repairs.

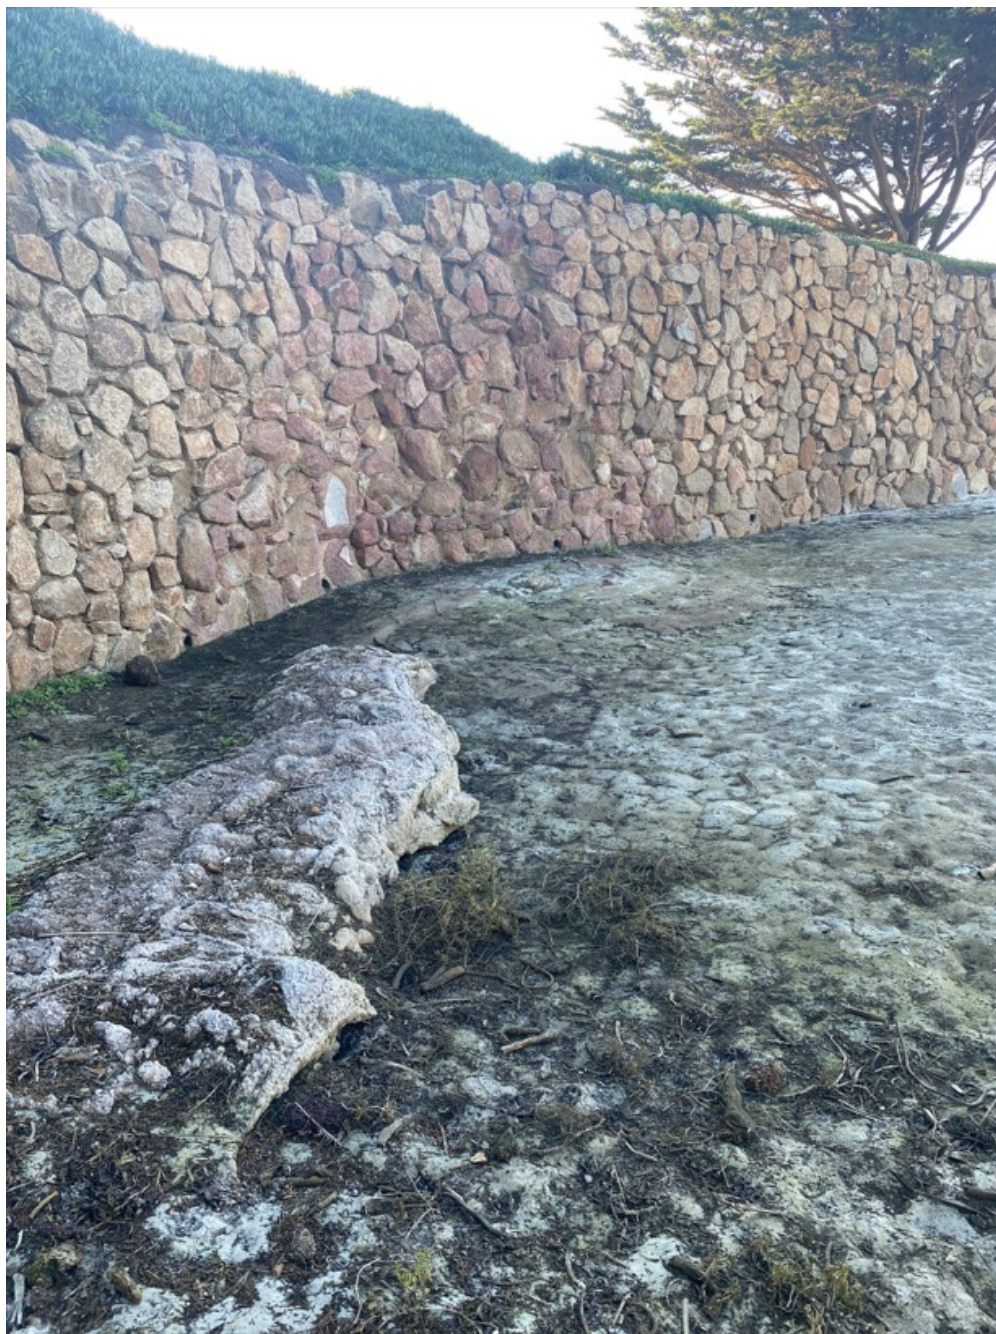
**Photograph 23: Concrete Debris on Beach at Base of Seawall S3 on December 22, 2022**

Photograph 23 shows Seawall S3 on December 22, 2022 which has pumped concrete debris located on the beach at base of the seawall. Easton Geology inspected Seawall S3 in February 2016 and again in June 2016 for the City. Photograph 24 from Easton Geology shows that the beach was more scoured then than during our 2022 and 2023 inspections.

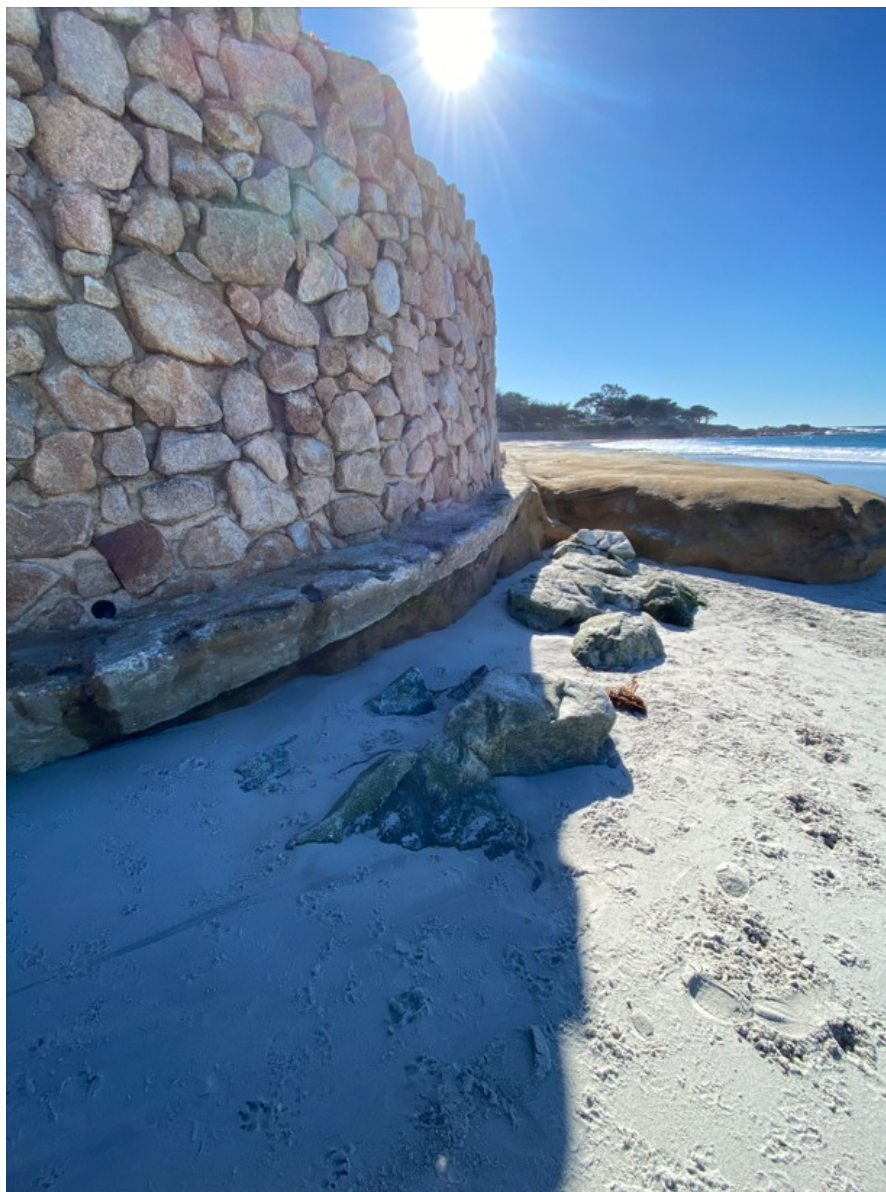
**Photograph 31: Looking South at Seawall S3 Adjacent to ST3 on January 30, 2023**

Photograph 31 shows Seawall S3 at the south end of Cooks Cove, adjacent to ST3, showing its foundation is still bearing on a sandstone bedrock platform, and the footing remains slightly undermined. It is still performing well, and we have no recommended maintenance at this time. We note that when beach sand levels are naturally higher, the footing is buried and naturally protected from wave impact, resulting in no undermining occurring during those time periods, which are typically present in most years all year long. We recommend the undermining shown in Photographs 30 and 31 be photographically monitored whenever it is exposed, to verify the that undermining is occurring at over time.

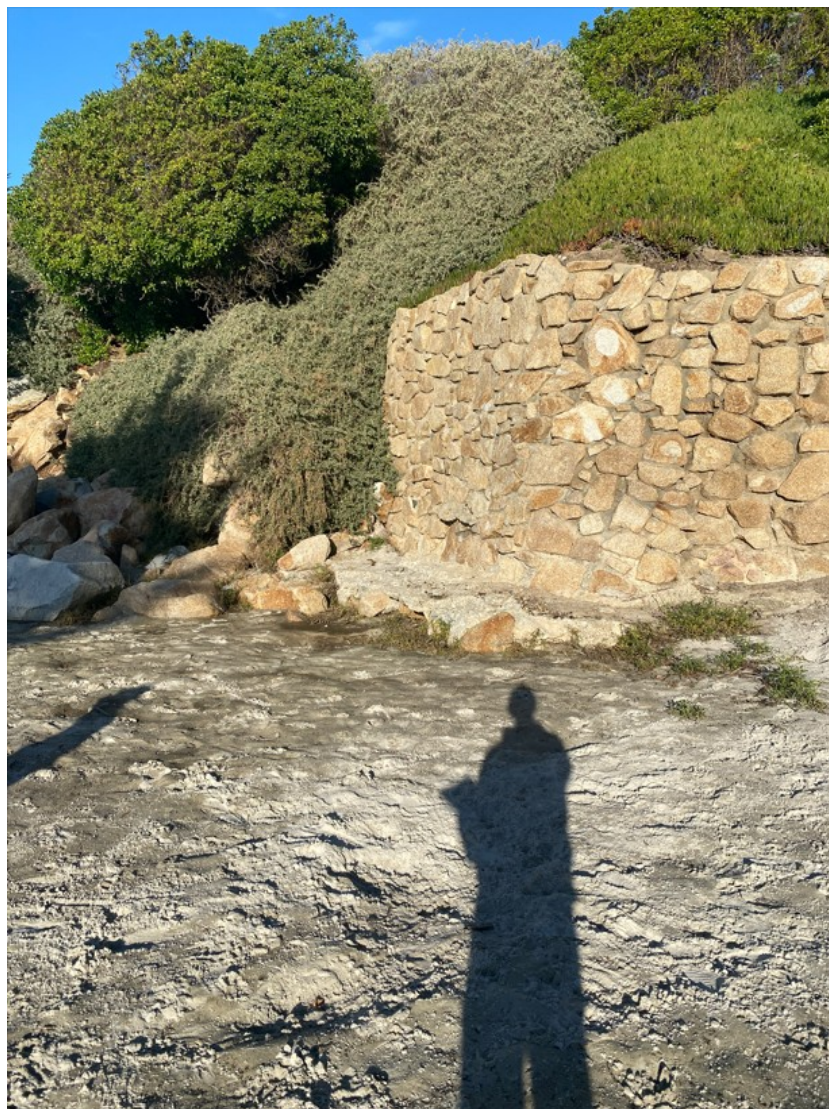
**Photograph 32: North End of Seawall S3 on December 22, 2022**

Photograph 32 shows the north end of Seawall S3 where it adjoins Revetment R2 on December 22, 2022. The north end of Seawall S3 was historically slightly undermined, and the resultant cavities have been repaired with concrete patchwork, and or grouted riprap. The north end of Seawall S3 appears to be stable.

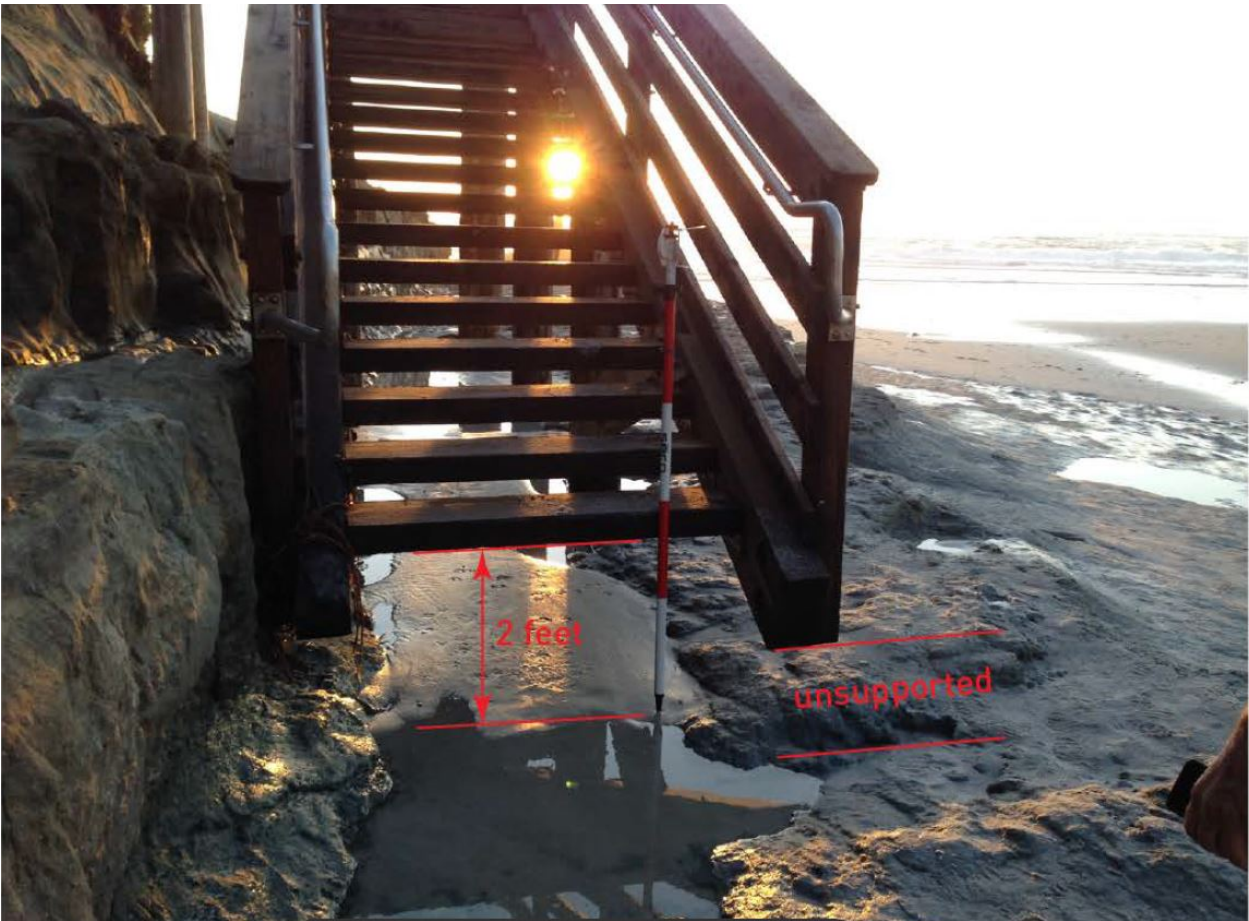
**Photograph 39: Undermined Stairway ST4 in February 2016 (Easton Geology)**

Photograph 38 Shows Public Access Stairway ST4, located at 12th Avenue, on December 22, 2022. This stairway was undermined as shown in Photograph 39 (below) contained in a letter from Easton Geology dated February 8, 2016

The undermined portion of Stairway ST4 that was visible in 2016 was not visible during our December 2022 inspection but was subsequently exposed by beach scour and visible in our January 2023 inspection. The metallic hardware for the railing is severely corroded and is expanding and splitting the timber framework of these stairs, which are located at 12th Avenue.

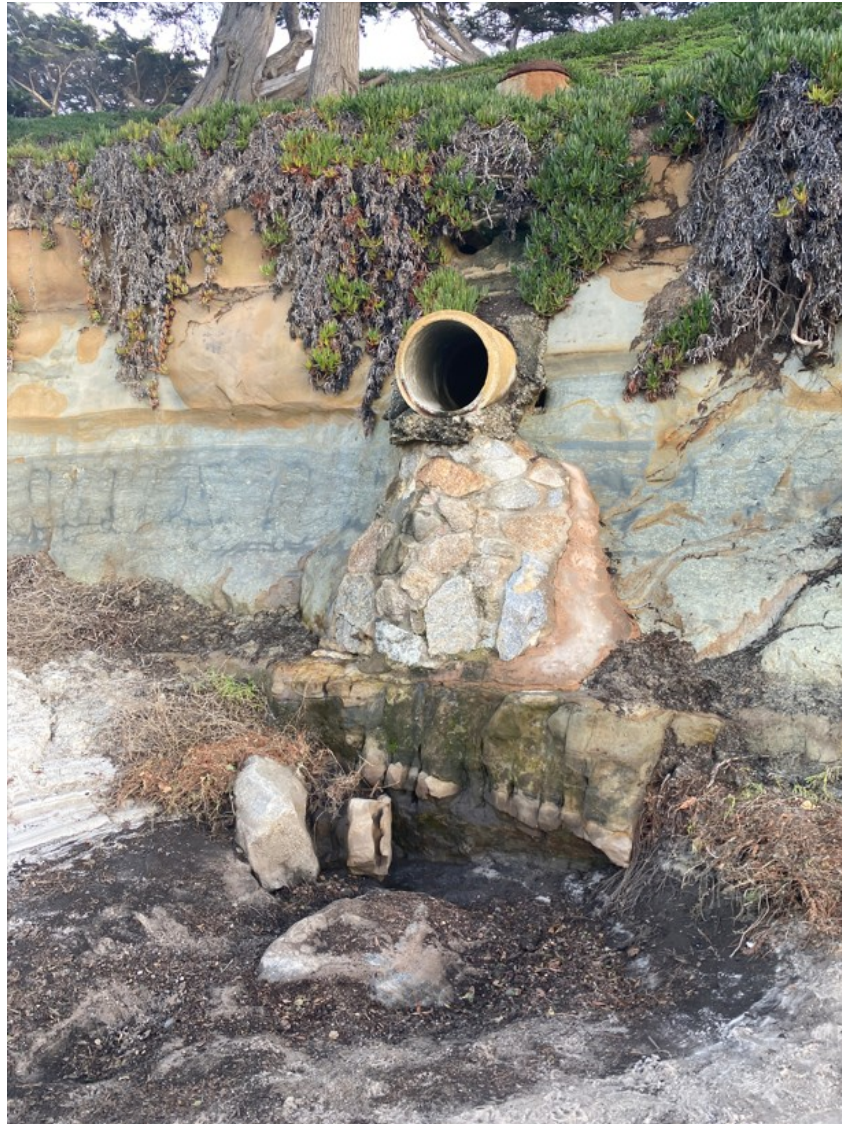
**Photograph 43: Storm Drain Outfall and Seawall S5 Northeast from Stairway ST4 on December 22, 2022**

Photograph 43 (below) shows a storm drain outfall just northeast of Stairway ST4 with a rock and mortar seawall that armors the bluff face below the outfall that is Seawall S5. A small amount of riprap below the outfall and Seawall S5 was barely visible during our December 2022 inspection.

Seawall S5 is immediately below the storm drain outfall near 12th Avenue.

Photograph 43 shows a storm drain outfall with minor armoring (Seawall S5) south of Revetment R5 and Stairway ST4 on December 22, 2022. Photograph 44 shows the same outfall and Seawall S5 after during January 2023 when considerable additional sand scour had occurred, exposing the grouted riprap energy dissipater placed on the bedrock platform below the outfall. About 75% of the coastal bluff height consists of erosion resistant bedrock, and appears to be in good shape. A seawall may be needed to slow bluff retreat in the future. Photograph 45 by Easton Geology (above) shows the conditions in February 2016, and includes their recommendations regarding extending the culvert and restacking the rip-rap they made at that time. Seawall S5 has no maintenance recommended by HKA at this time. It appears to have at least 30 years remaining life.

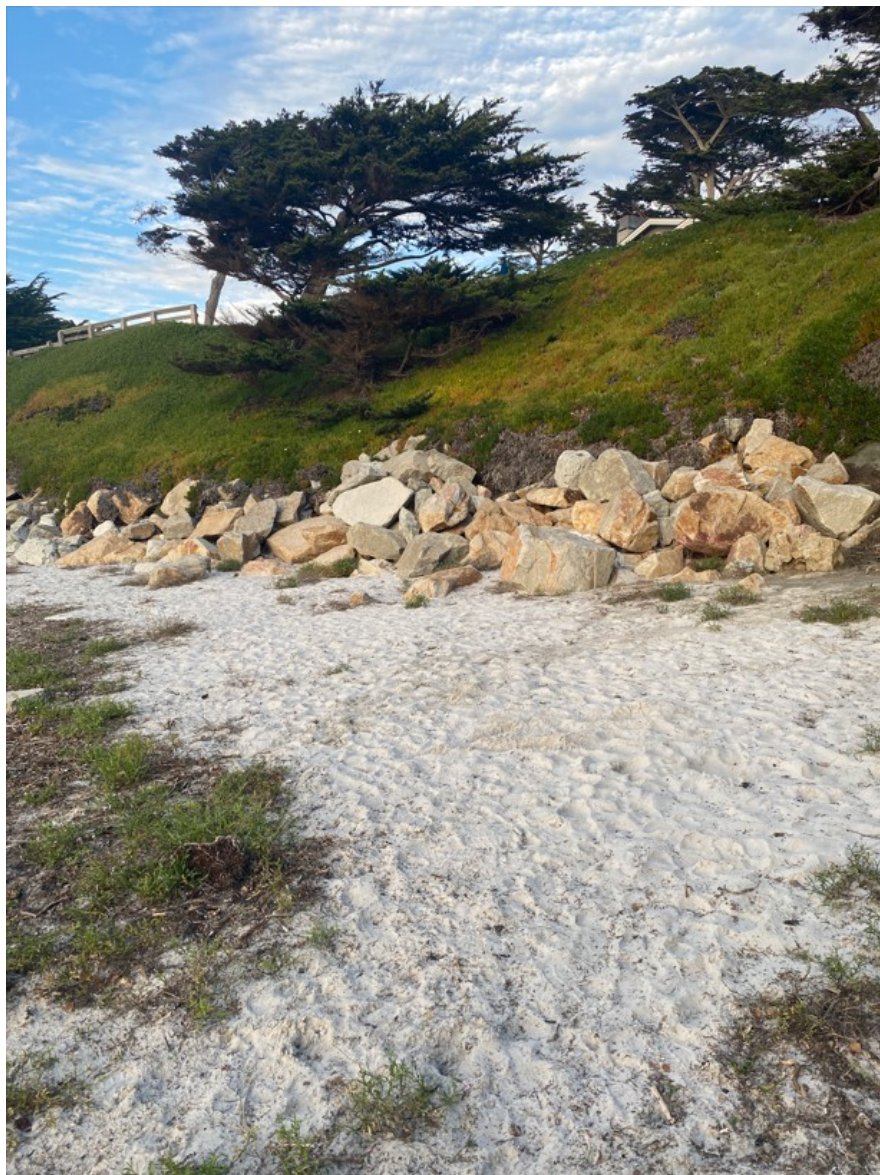
**Photograph 47: Revetment R3 Showing Scattered Rip-rap Boulders on December 22, 2022**

Photograph 47 shows Revetment R3 with scattered rip-rap boulders on December 22, 2022. We recommend that Revetment R3 be restacked to increase coastal protection and reduce the revetment footprint.

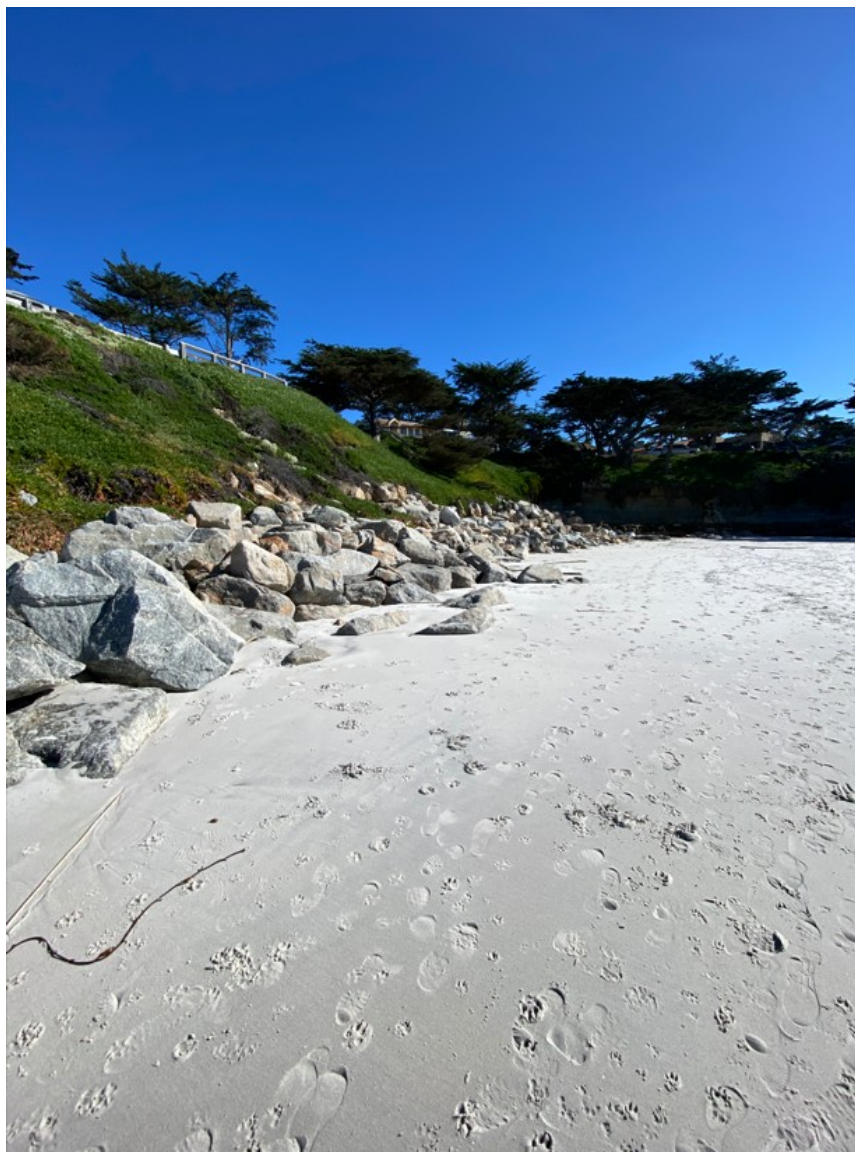
**Photograph 49: Showing Revetment R3 Looking South on January 30, 2023**

Most of the portion of R3 shown in Photograph 49 has begun to slump and requires routine maintenance. needs to be re-stacked. The portion of R3 shown in Photograph 48 appears to have been constructed at a different time using smaller rock that may have been dumped into place rather than placed boulder by boulder, perhaps due to emergency conditions during construction. There is displaced undersized rock at the toe of the revetment at a lower gradient, and the revetment appears to be founded on the sandstone bedrock platform and we expect it will continue to provide service for 10 to 20 years. However, the rip-rap boulders are subject to displacement from wave impact. We recommend a vertical reinforced concrete seawall with rock fascia be designed and planned for and considered as a replacement for this portion of the R3 Revetment. The public coastal access at the top of the bluff is reliant upon bluff toe stability, which is currently provided by the R3 rip-rap armoring.

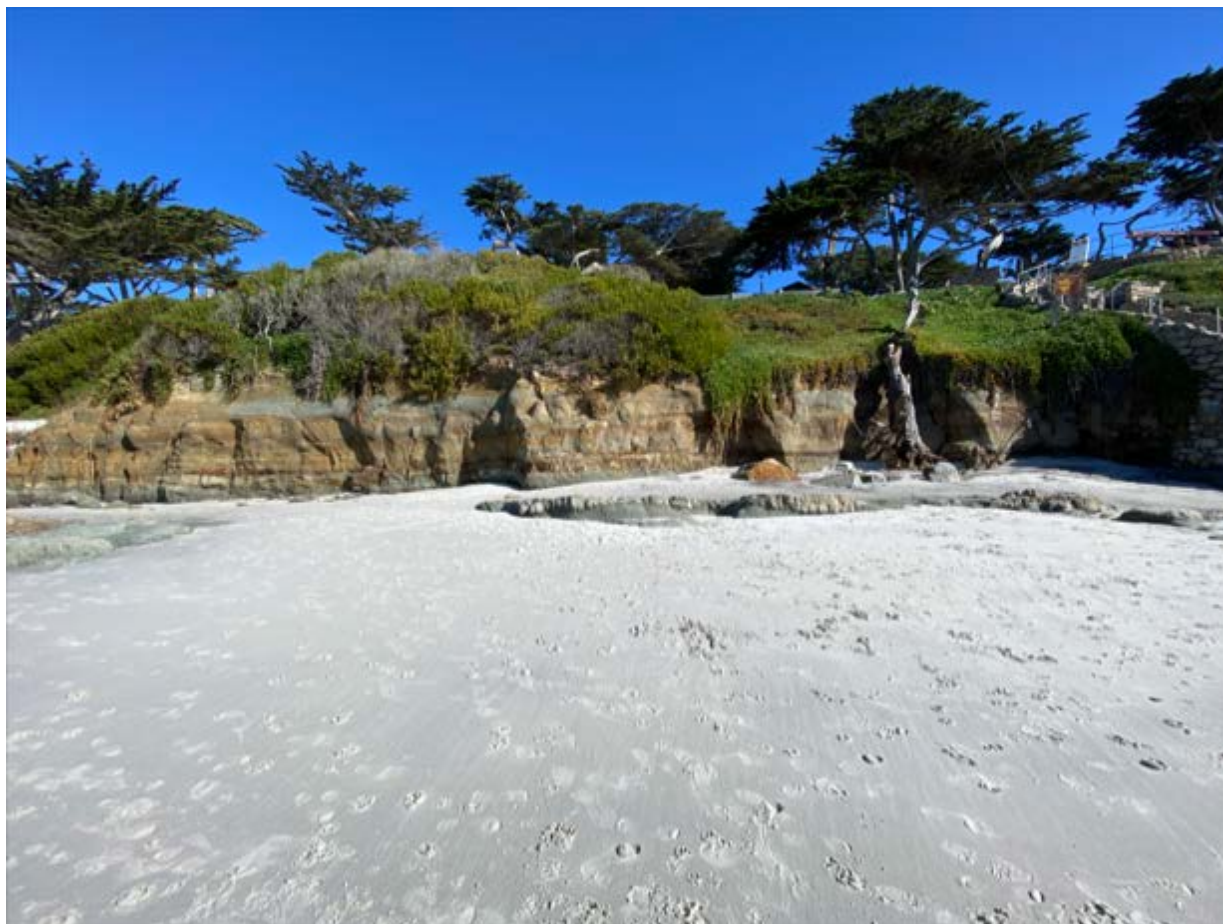
**Photograph 59: Showing Bluff South of Revetment R4 on January 30, 2023**

At the time of our inspection along the bluff face between Stairway ST5 and Revetment R4, a sandstone bedrock platform was discontinuously exposed, with very few fugitive riprap boulders exposed along the toe of the bluff at beach level. The bedrock exposed in the vertical lower bluff face appears to be erosion resistant and in good shape. No maintenance or armoring is necessary now. However, a future bluff face seawall with artificial rock fascia may be needed in the future to retard long-term erosion.

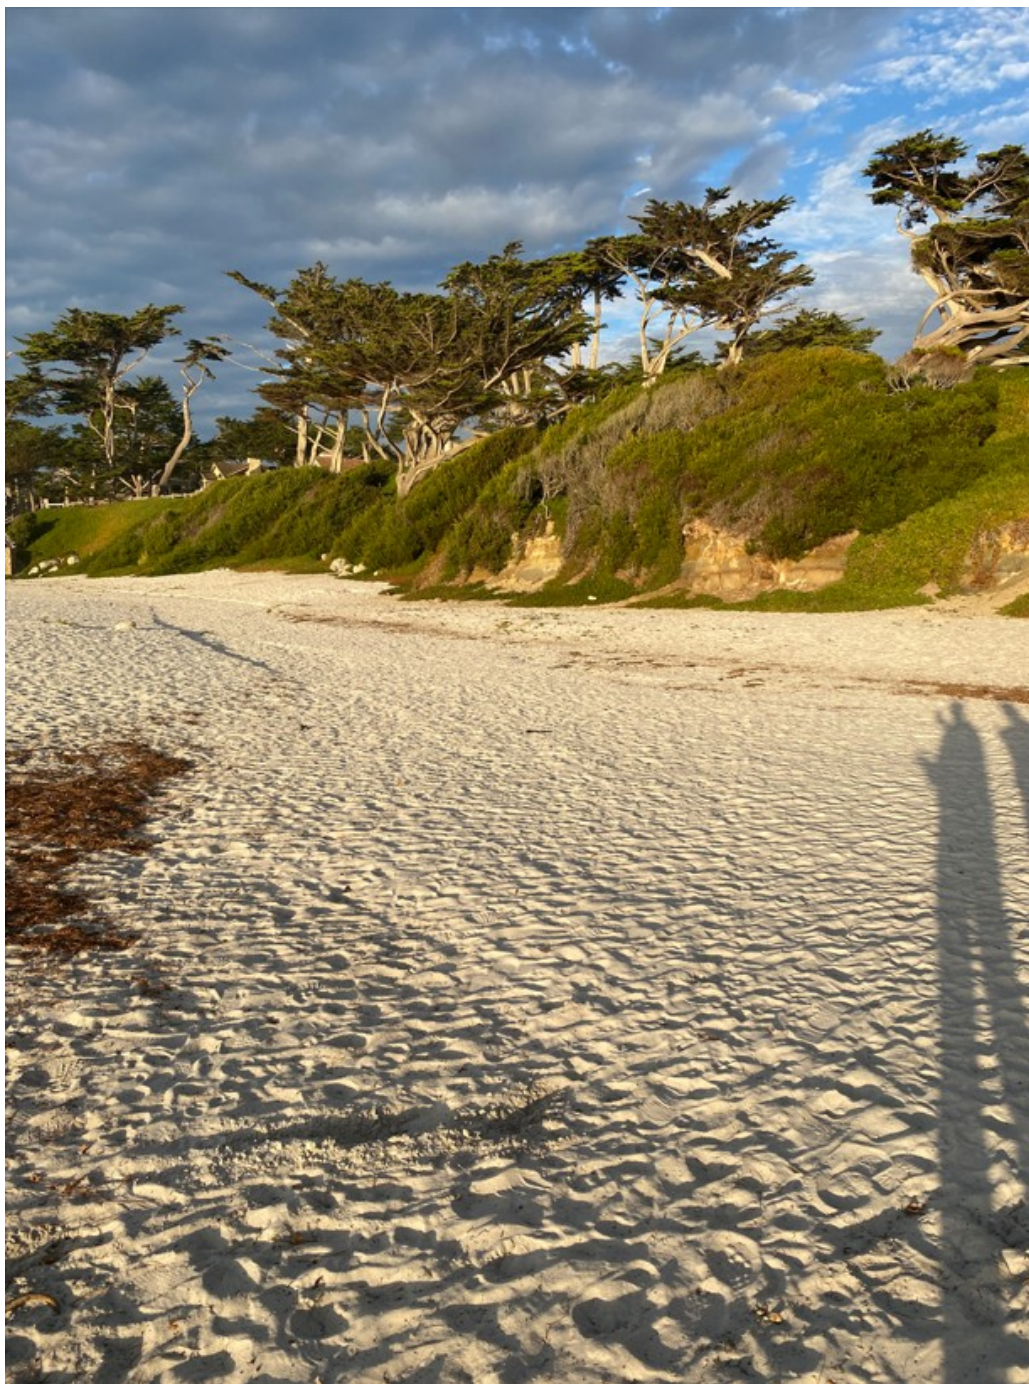
**Photograph 60: Showing Very Few Boulders Exposed in Revetment R4 Area on December 22, 2022**

Revetment R4 is located between 9th Avenue and 10th Avenue and was mapped by Integral Consulting extending from Stairway 5 and Stairway 6.

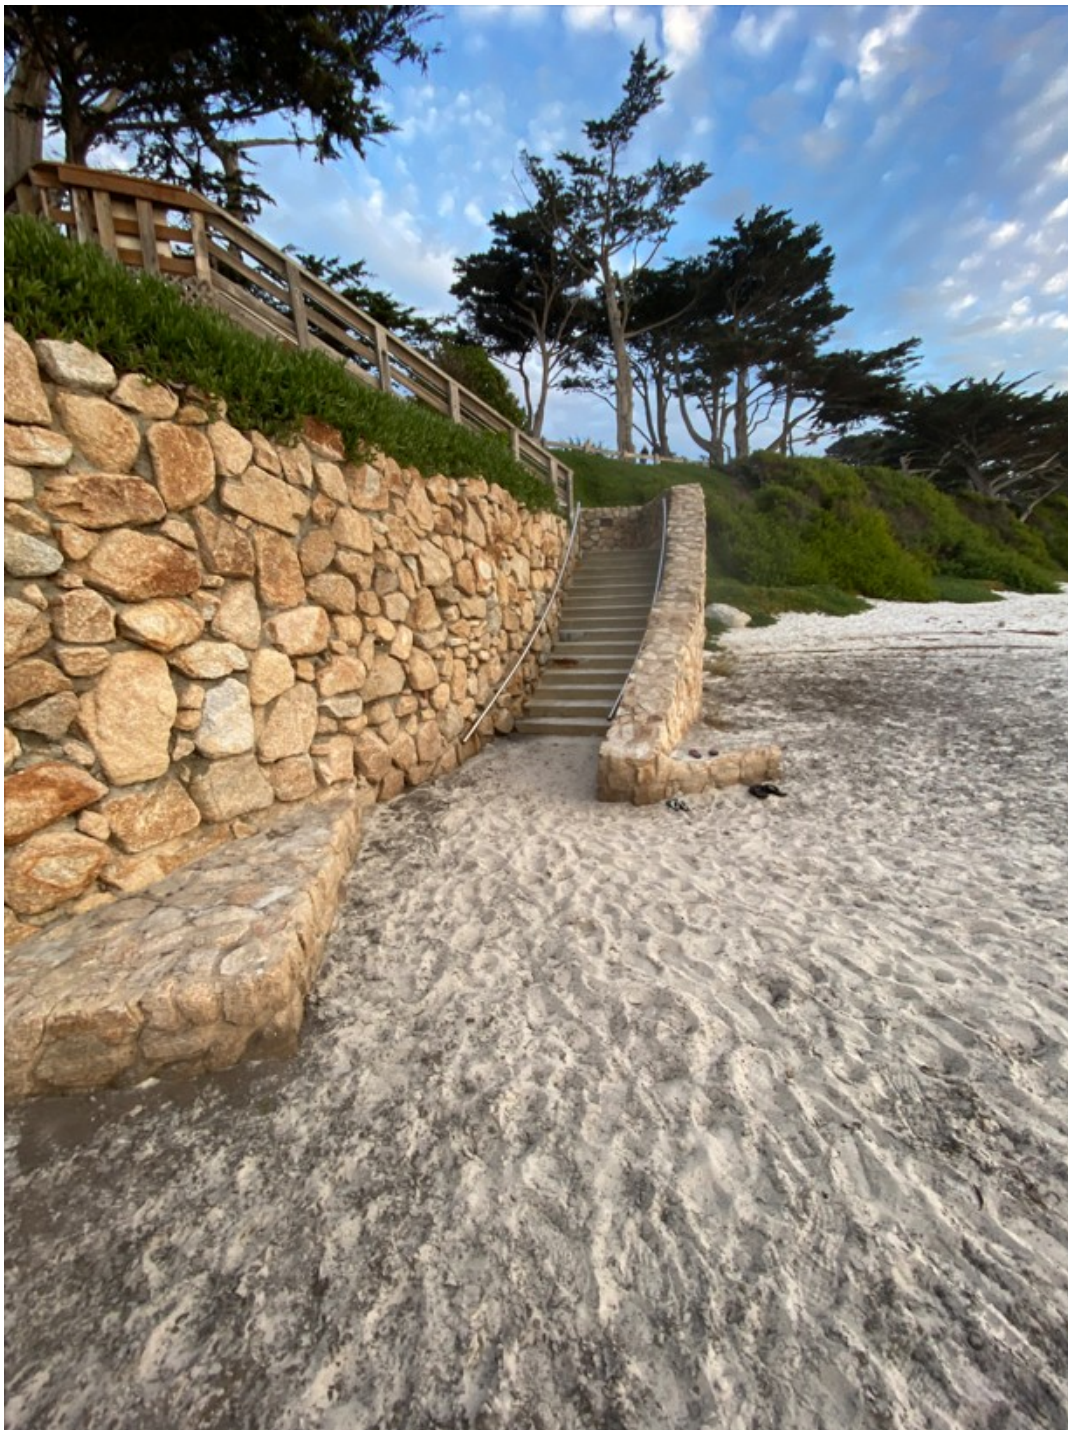
**Photograph 64: Showing Stairway ST6 on December 22, 2022**

Photograph 64 shows Stairway ST6 is located south of 10th Avenue. The base of the stairs was buried in beach sand.

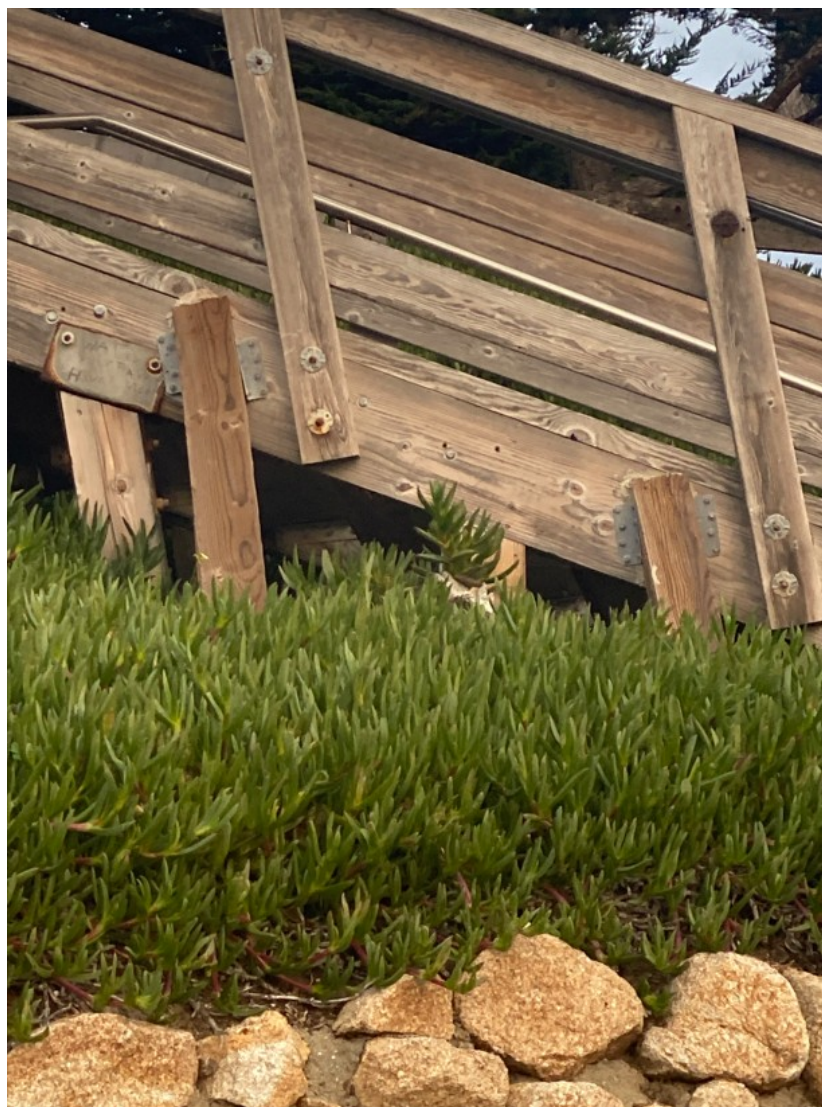
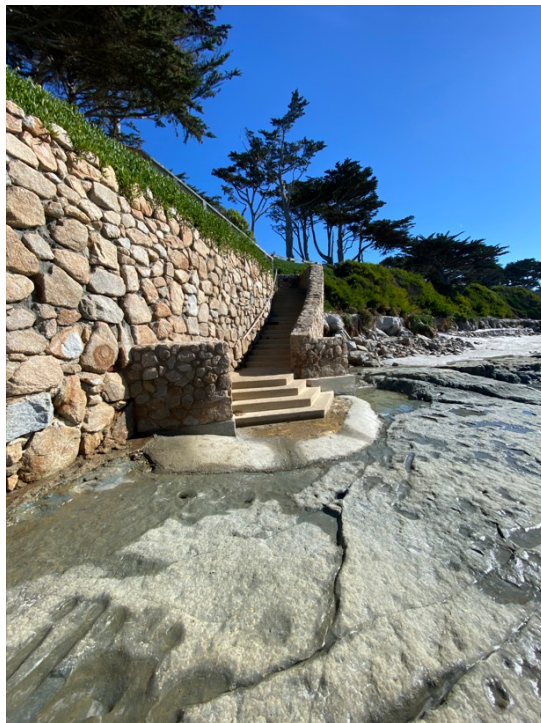
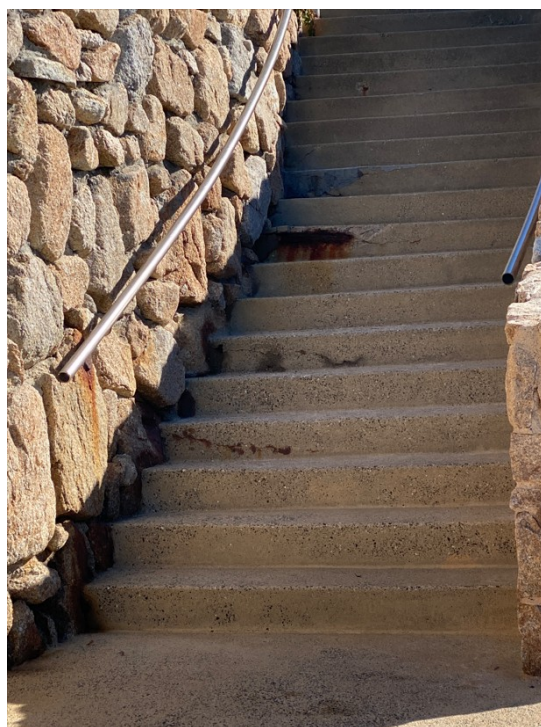
**Photograph 65: Showing Recent Maintenance on Stairway ST6 on December 22, 2022**

Photographs 65, 66 and 67 show Stairway ST6, which is a combination reinforced concrete (lower portion) to wooden (upper portion) public beach access staircase. The base of the staircase is founded on the sandstone bedrock platform below the beach sand. Several stair treads have spalled concrete areas, exposing highly corroded rebar, which is expanding, resulting in internal pressures within the concrete, which causes the stair treads to spall. This spalling creates a hazardous condition, and we recommend it be repaired and maintained to a safe standard for public use, using corrosion resistant reinforcing bar such as ChromX 4100 or 9100. Stairway ST5 repairs are needed due to corrosion of the concrete reinforcing, concrete spalling, and worn irregular concrete tread surfaces. We rank the concrete repair as a medium priority to abate slip and fall hazards.

**Photograph 66: Stairway ST6 Well Founded in Bedrock on January 30, 2023**

**Photograph 67: Stairway ST6 with Tread Deterioration on January 30, 2023**

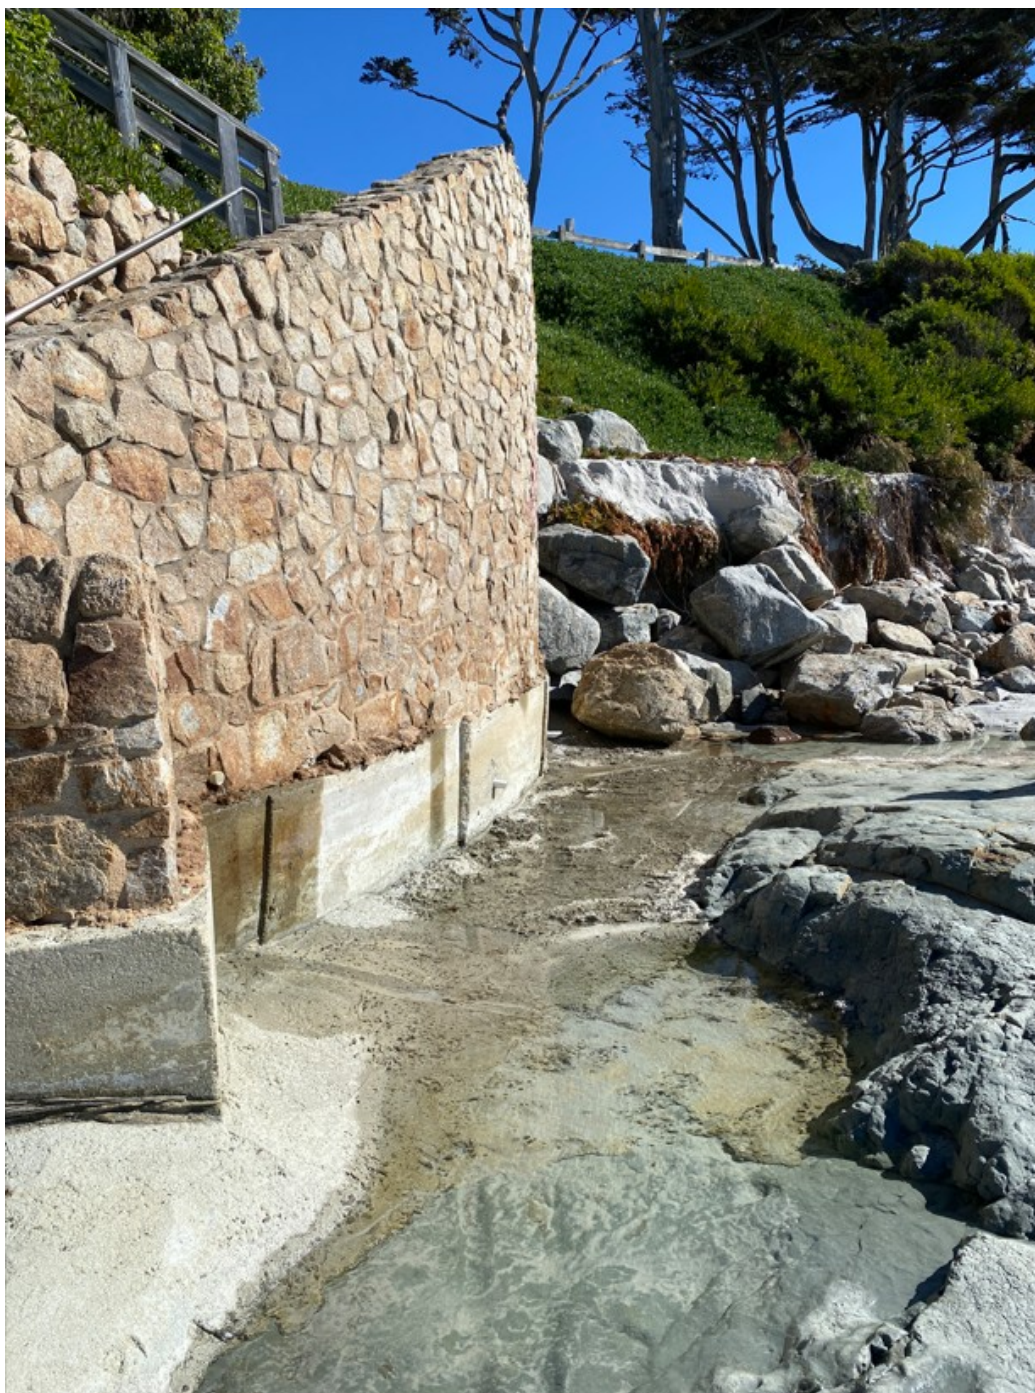
**Photograph 68: South Foundation of Seawall S7 on January 30, 2023**

Photograph 68 shows the south foundation of Seawall S7, located between Stairways ST6 and ST7, is bearing on the sandstone bedrock platform. The foundation is in good condition. Seawall S7 is flanked by the north end of R6.

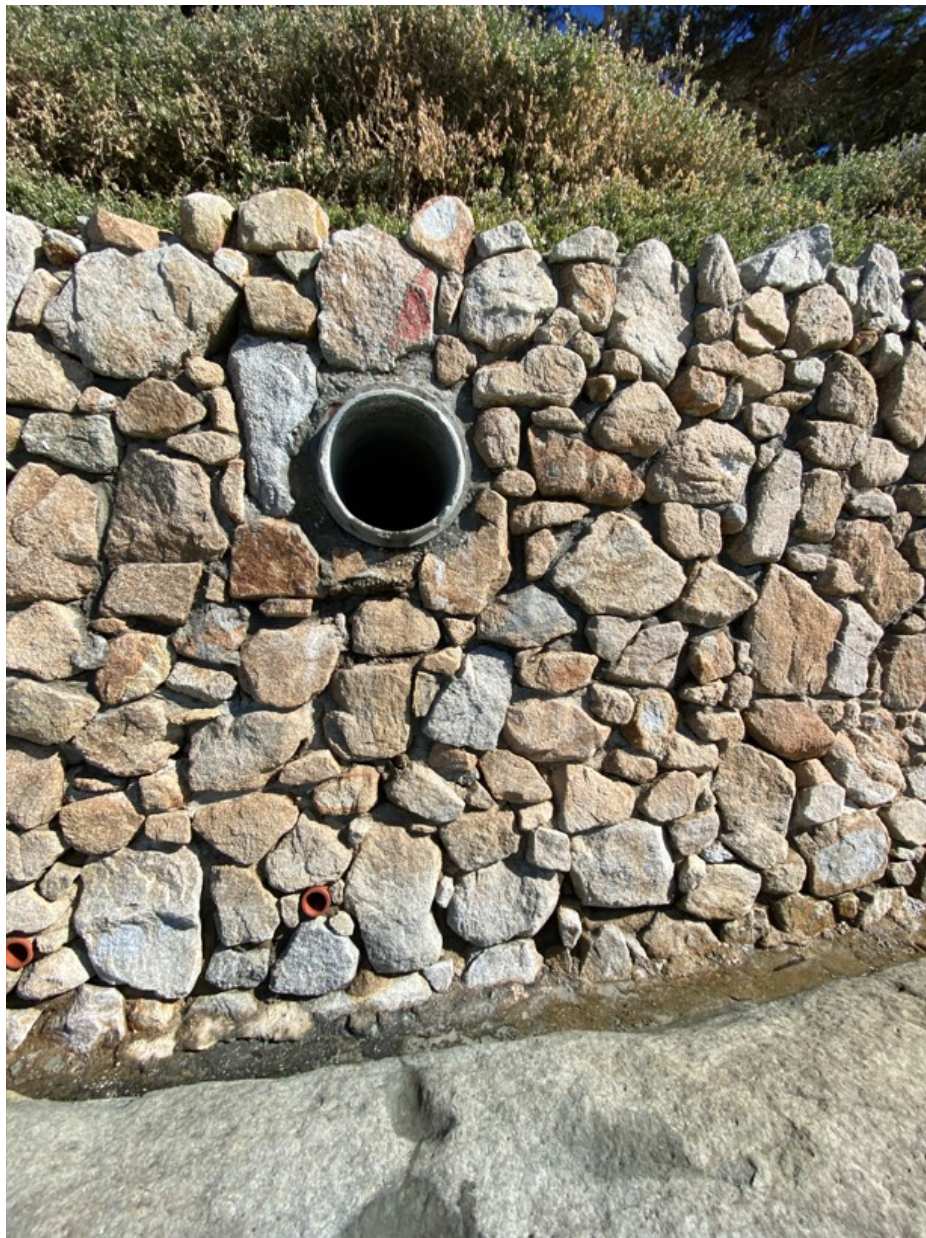
**Photograph 69: Storm Drain Outfall near South End of Seawall S7 on January 30, 2023**

Photograph 69 shows the south end of Seawall S7 where a 24-inch diameter concrete storm drain culvert outfall is in good condition. No maintenance is recommended here.

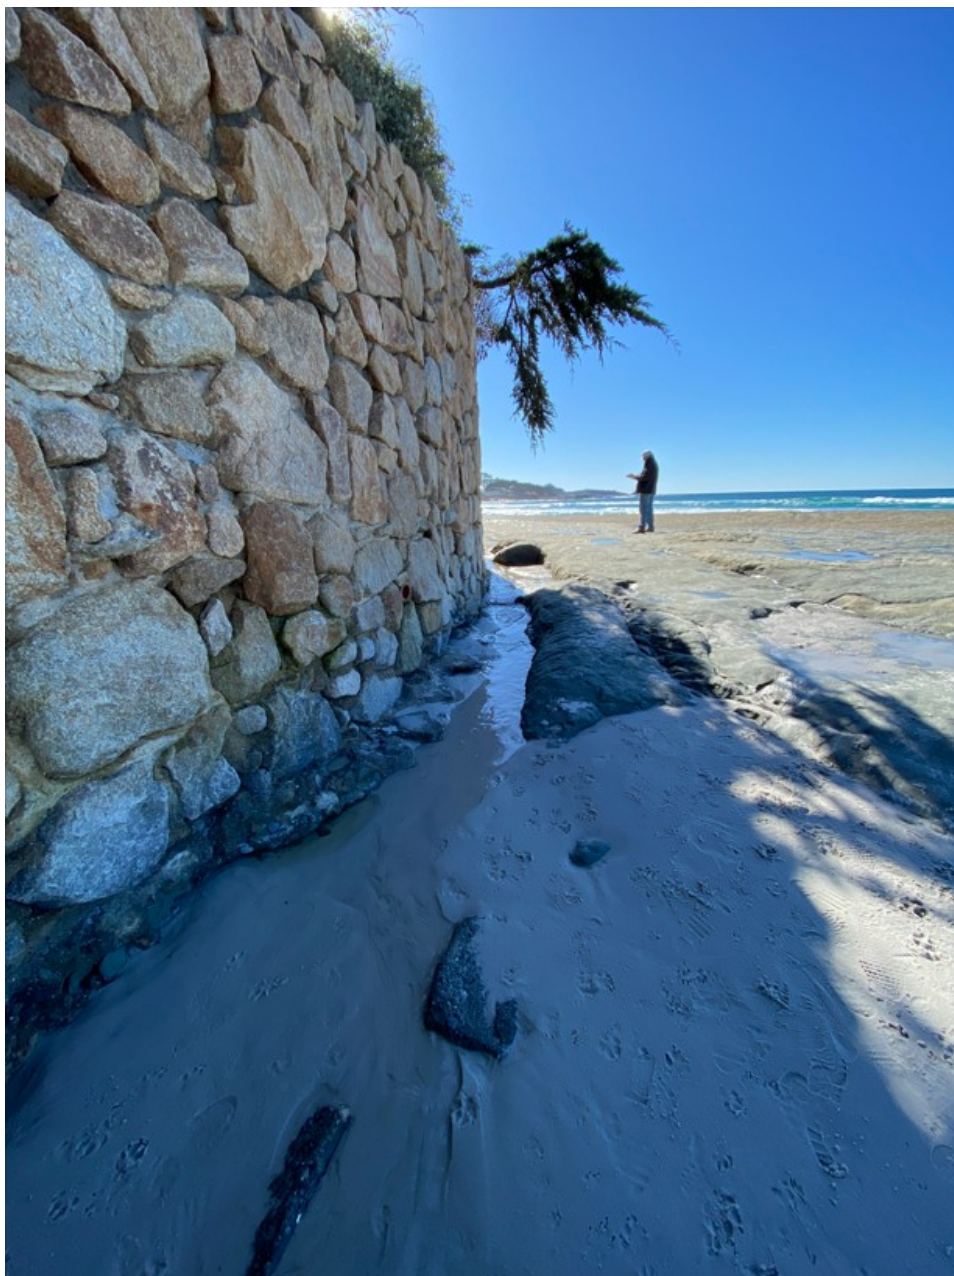
**Photograph 70: Seawall S7 Foundation on January 30, 2023**

Photograph 70 shows the Seawall S7 foundation, which was partially exposed during our inspection. This foundation appears to be a conventional spread footing foundation, approximately 20 inches wide at its toe and embedded in bearing upon the sandstone bedrock platform. The seawall above grade has slowly deteriorating mortar between individual rocks that form the wall face. The seawall foundation appears to be in good condition, and no maintenance is recommended at this time.

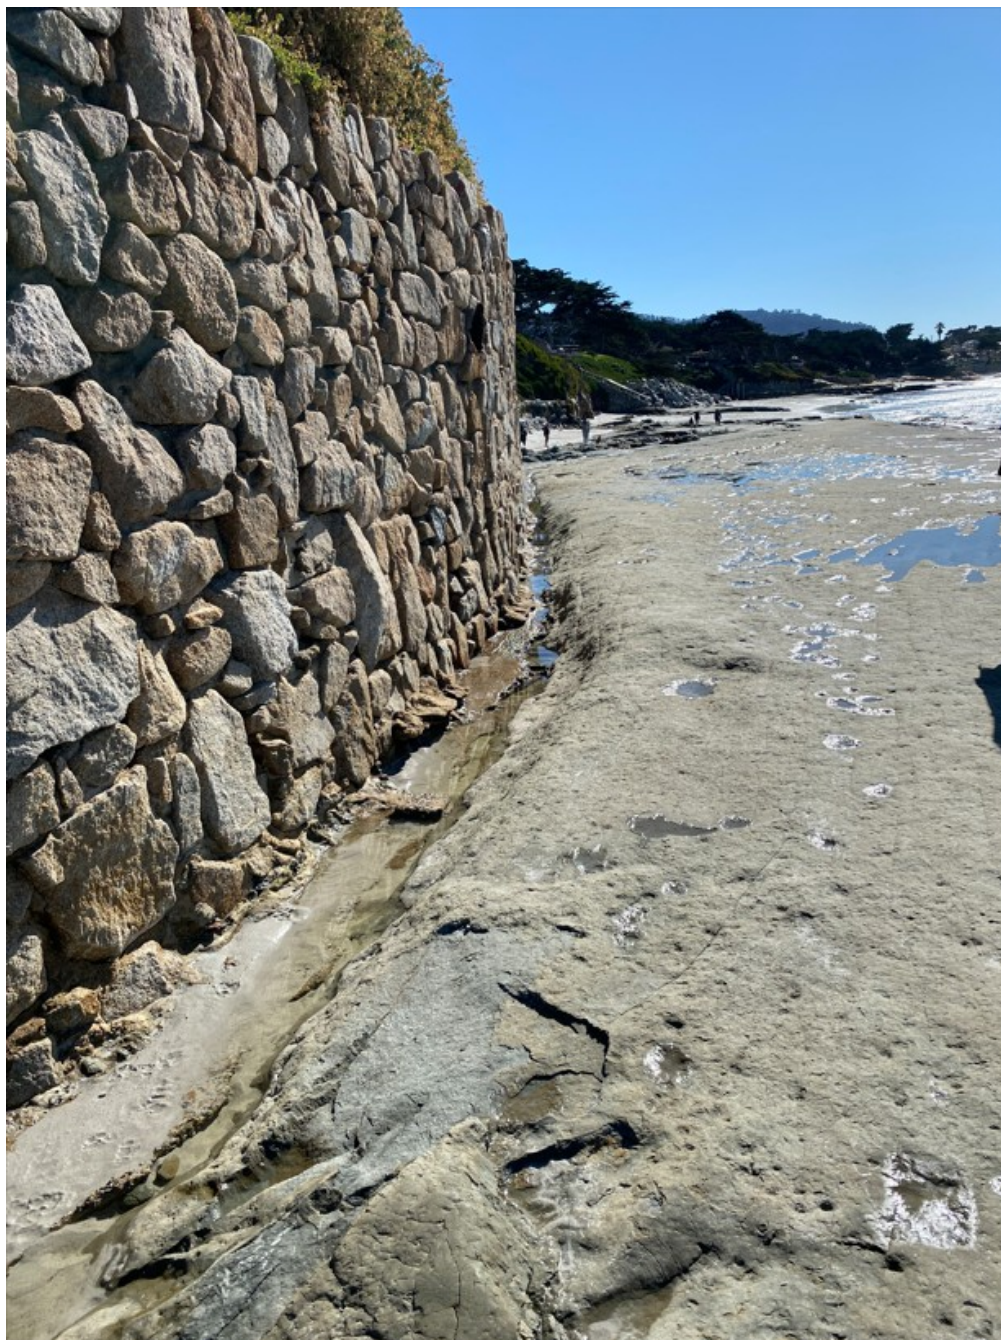
**Photograph 71: Seawall S7 Foundation on January 30, 2023**

Photograph 71 shows a view looking down coast at Seawall S7, showing additional exposed foundation area that is bearing on the sandstone bedrock platform.
