Date: 27 April 2023  
Client: City of Carmel  
Subject: Carmel Beach Coastal Protection Assessment  
Reference: Carmel Beach Adaptation Plan  
Project No.: 12176

## CARMEL BEACH COASTAL PROTECTION ASSESSMENT REPORT

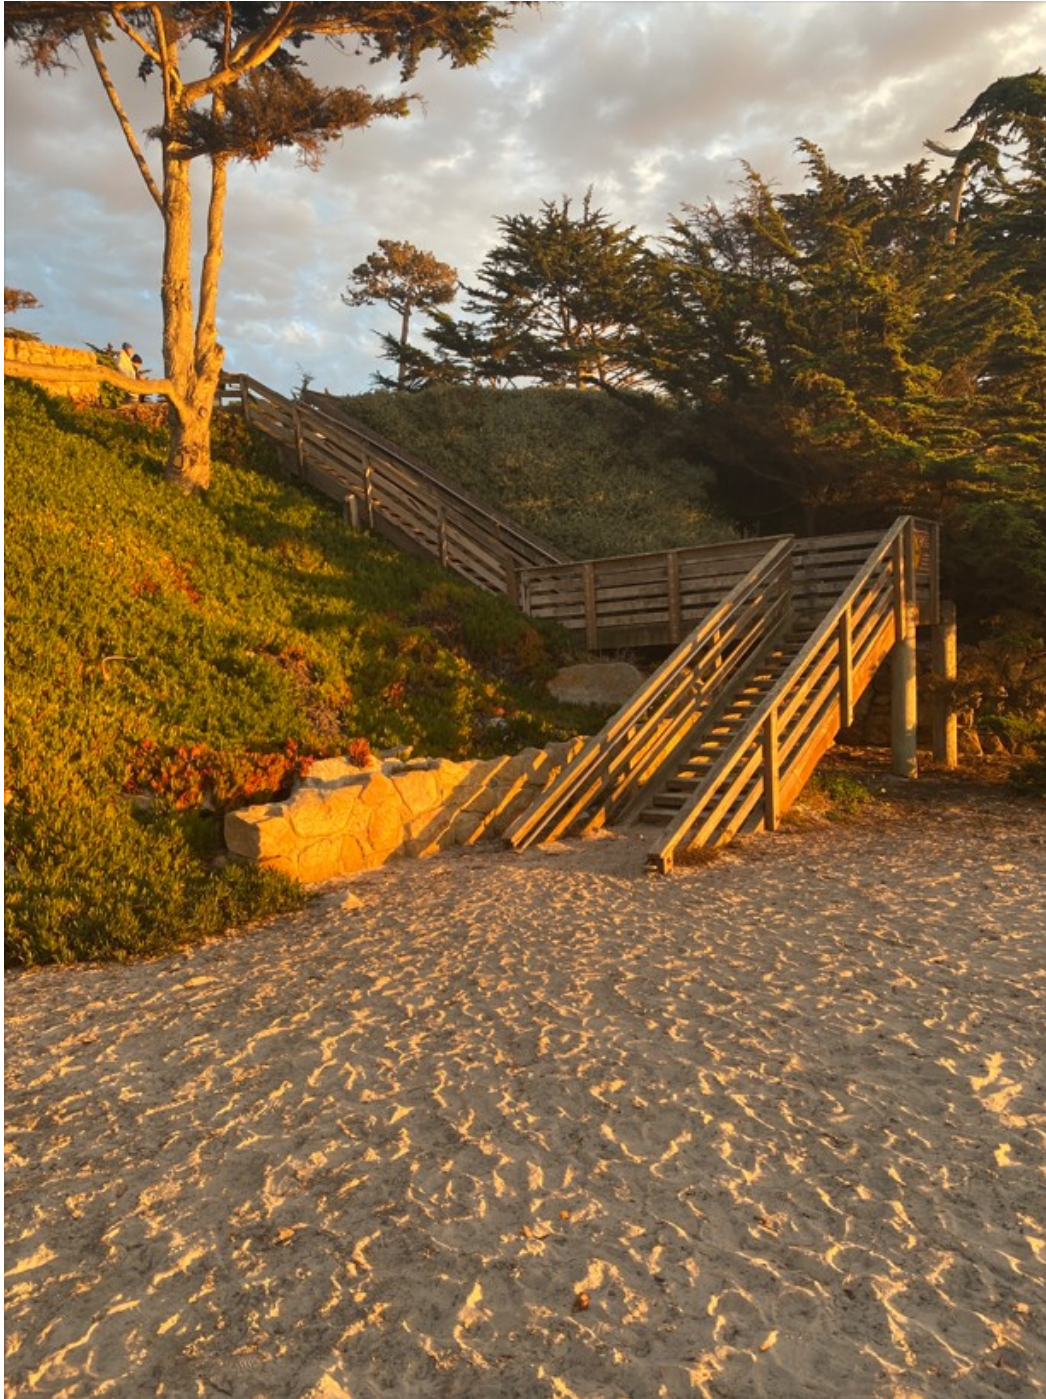
**Photograph 72: Stairway ST7 on December 22,2022**

Photograph 72 shows Stairway ST7, which is located north of 10th Avenue.

Photographs 72 and 73 show Stairway ST7 at different beach scour conditions. Photo 73 shows the lower end of the stairs ending in mid-air at the time of our January inspection. Stairway ST7 repairs are needed due to corrosion of fasteners and hardware, and the vertical drop off and lack of foundation support at the base of the stairs during times of low beach surface elevations from scour. We rank the repair as a high priority and recommend prompt structural and corrosion inspection. There is a high risk to users of the stairs.

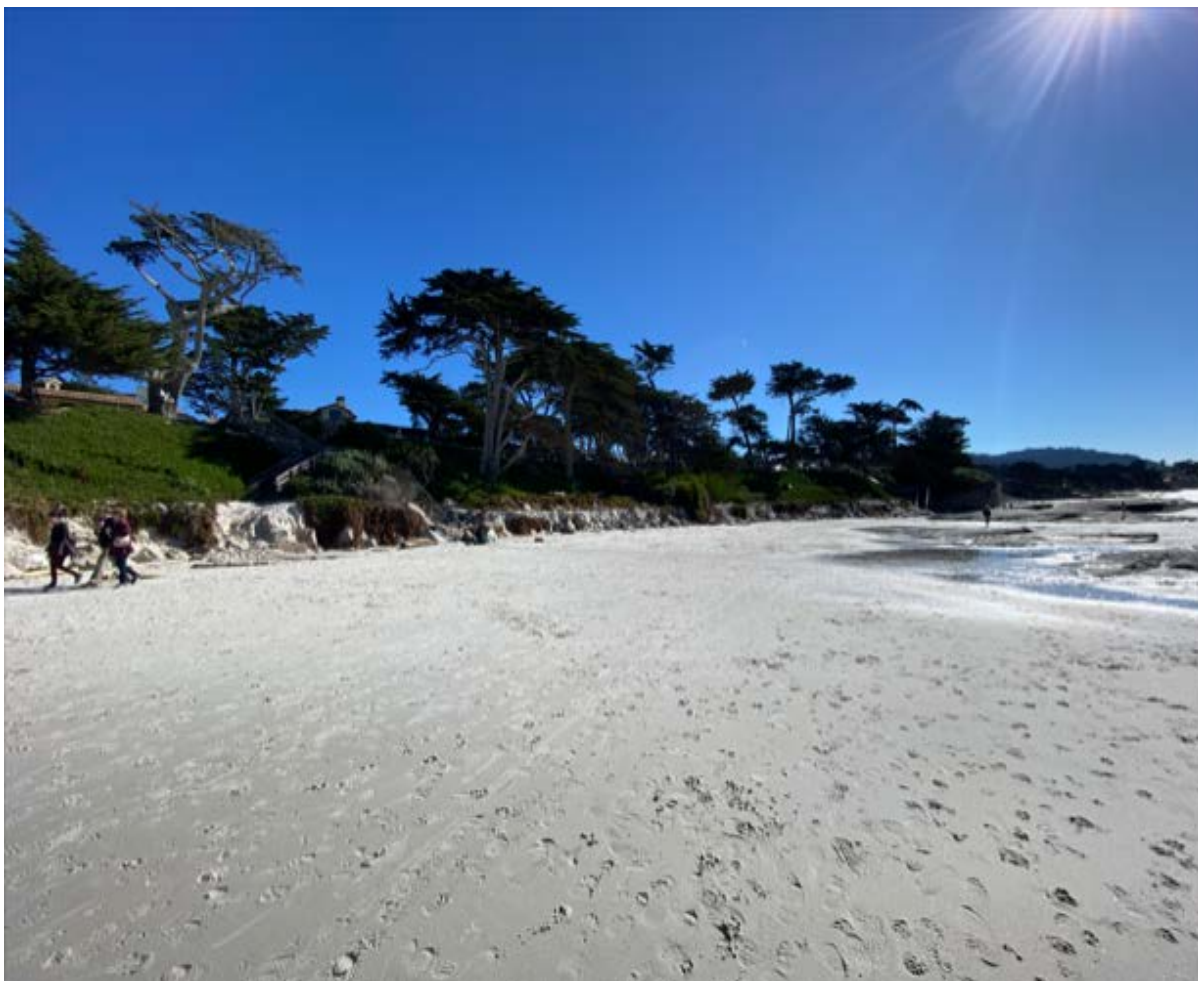
**Photograph 78: Central Portion of Revetment R5 on January 30, 2023**

Photograph 78 shows the central portion of Revetment R5, where the coastal access path at the top of the bluff is dependent on bluff toe armoring and stability. A riprap revetment structure which is armoring the toe of the bluff is barely visible. About 3 to 5 feet of the revetment height is visible. The total height of a revetment is unknown, but estimated at 12 to 15 feet. Future wave action could cause the steep slope below the path to slump, undermining the large cypress trees, and public pathway along Scenic Road. A vertical concrete seawall at the toe of the bluff would be a preferred alternative here, as opposed to the riprap revetment structure, which requires more maintenance, and takes up a larger footprint.

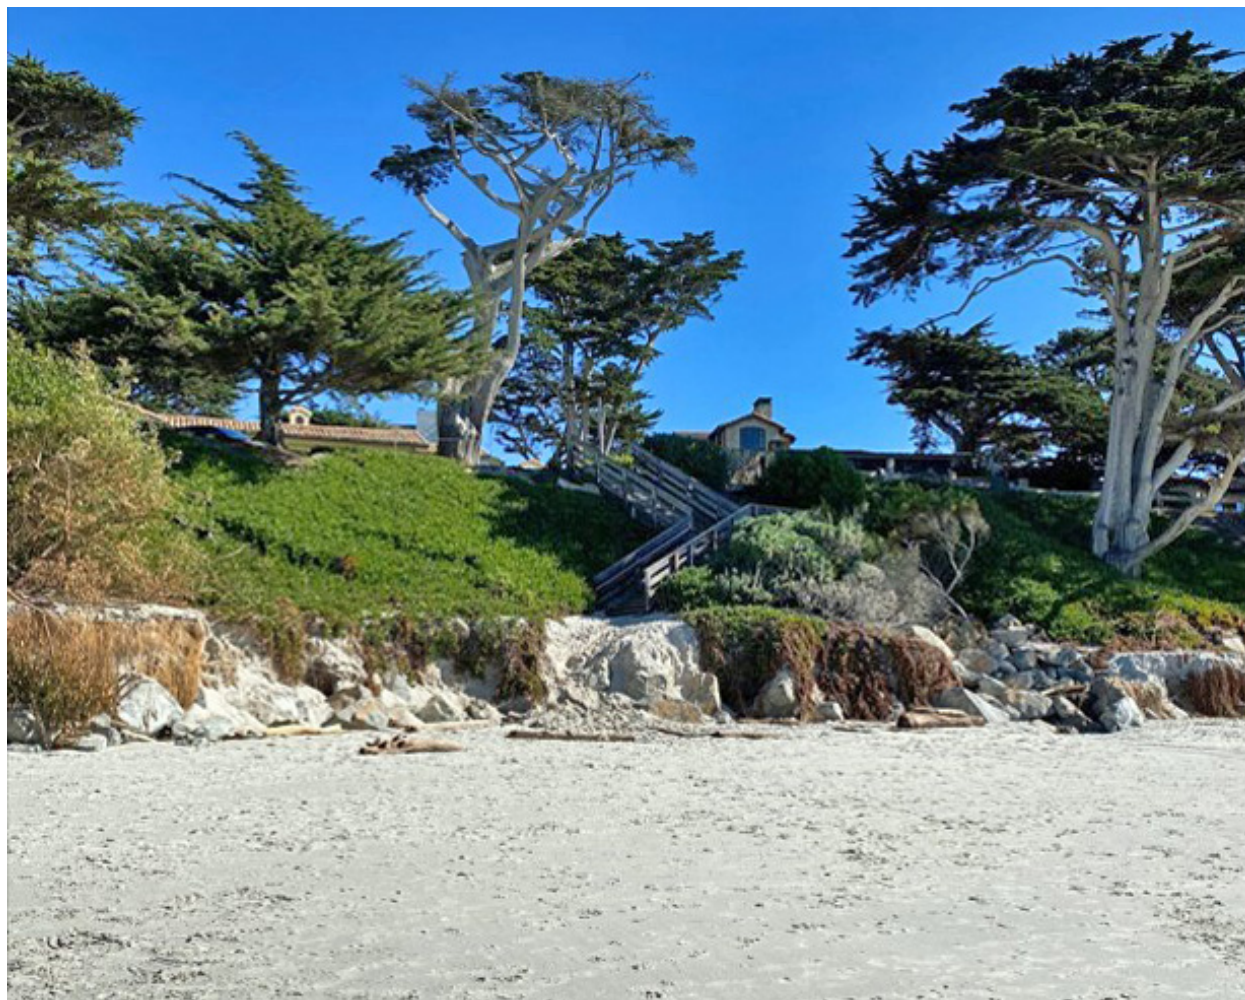
**Photograph 79: Showing Beach Access Stairway ST8 on January 30, 2023**

Photograph 79 shows Beach Access Stairway ST8, which is near 9th Avenue just south of the central part of Revetment R5. It is a wooden stairway that is in good condition; however, it terminates before reaching the beach when the beach sand levels are seasonally low. We recommend that that the stairway be extended approximately 12 vertical feet down to the bedrock platform (which is presently buried by beach sand) at beach level. The existing beach access path across the R5 rip-rap below these stairs is hazardous and poses risk to stair users attempting to cross the revetment. Extension of the stairs is a high priority. This stairway does not have any other maintenance recommended at this time. Extending the stairway across the rip-rap revetment should be done carefully. A detailed design study will be necessary to properly found the stairway in and seaward of Revetment R5.

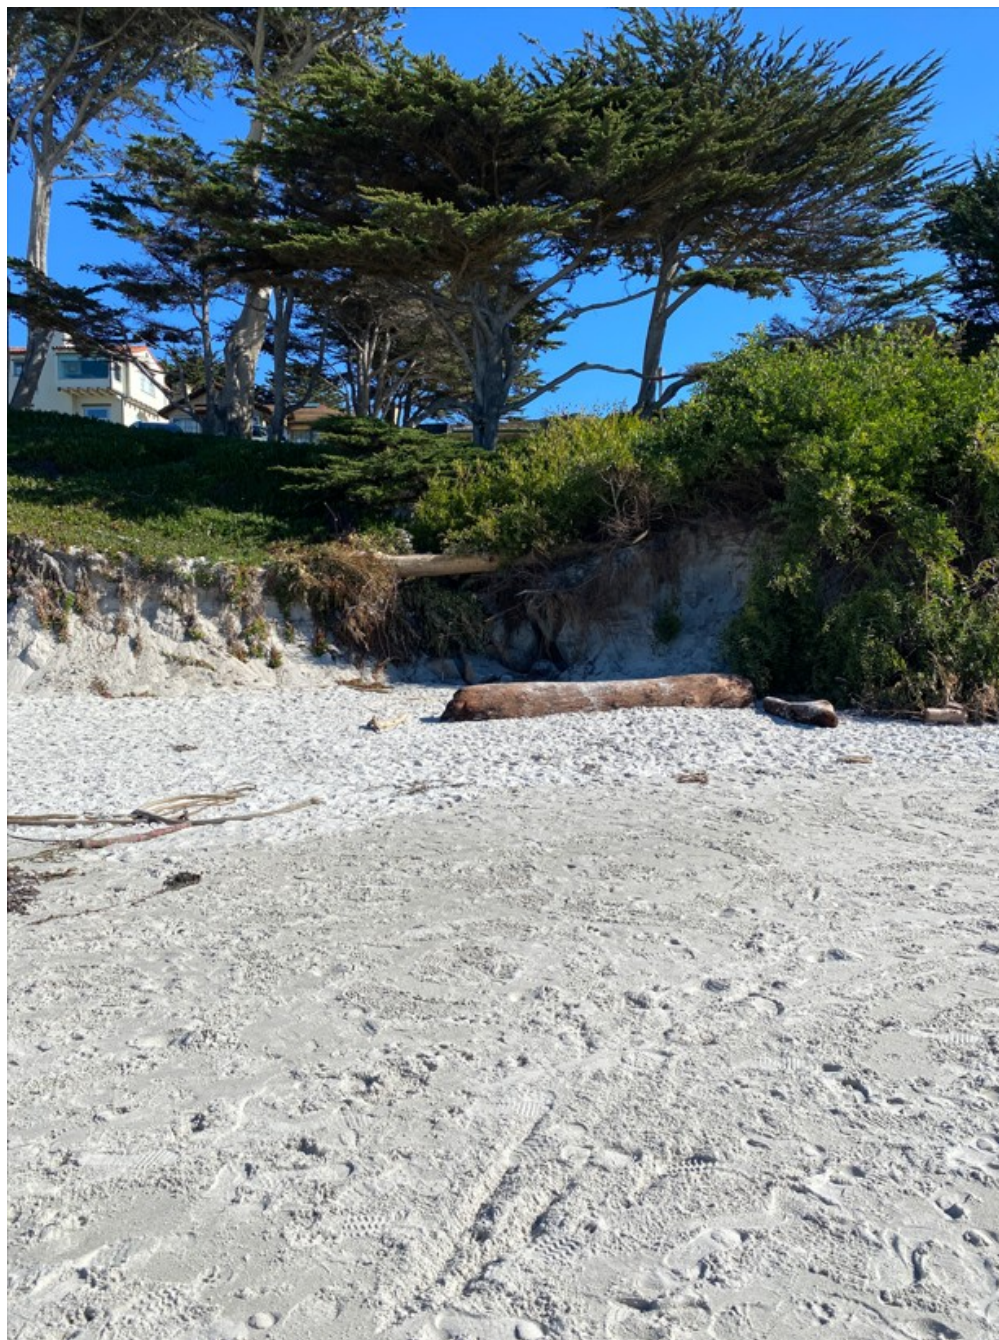
**Photograph 81: Small Amount of Revetment R5 Riprap on January 30, 2023**

As shown in Photograph 81, in the center portion of Revetment R5 we observed a small amount of visible riprap which was approximately 12 feet long and 6 feet tall. It was not possible to see enough riprap to draw meaningful conclusions regarding the extent, dimensions, condition and need for repair (if any) of this reported structure.

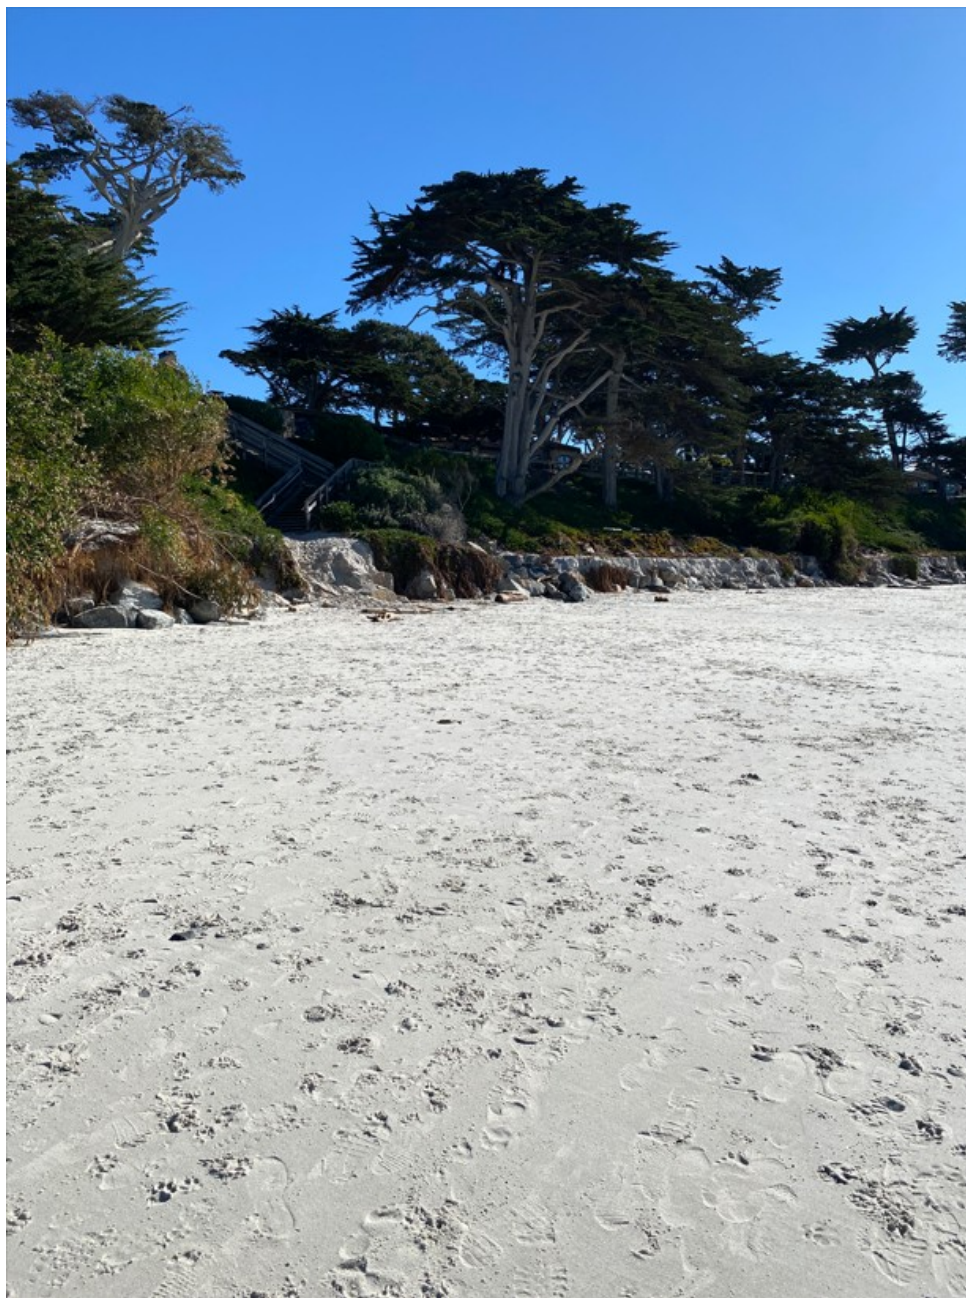
**Photograph 83: Showing Additional Revetment R5 Rip-rap on January 30, 2023**

**Photograph 84: Showing a Small Amount of Revetment R5 Riprap on January 30, 2023**

Photographs 82, 83 and 84 show the location of the center portion of Revetment R5 where we observed approximately 100 linear feet of 3- to 5-foot-high rip-rap that was exposed. It was not possible to see enough riprap to draw meaningful conclusions regarding the extent, dimensions and condition of this reported structure. We suspect most of this revetment structure is below sand level, not visible during our inspection.

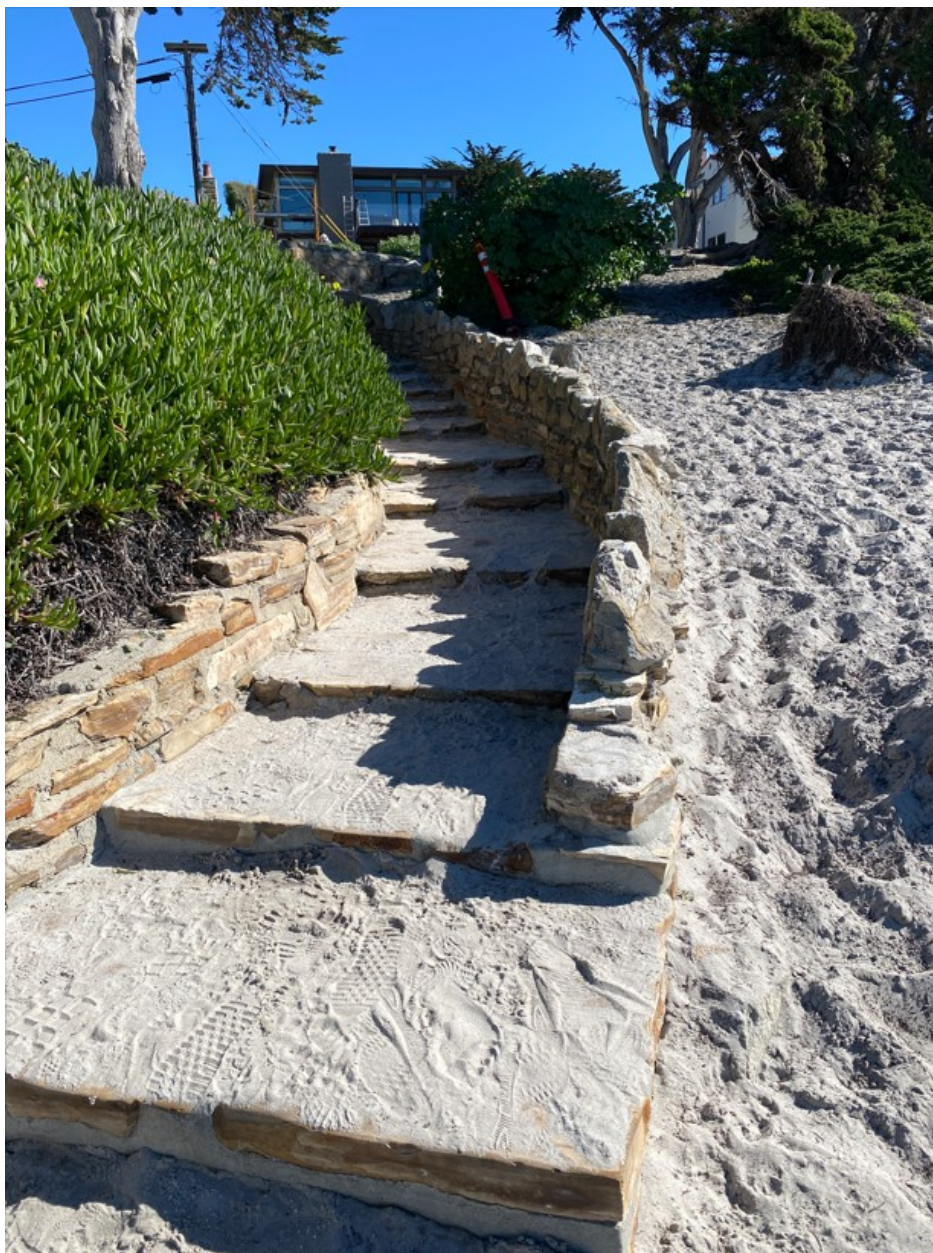
**Photograph 86: Stairway ST9 on January 30, 2023**

Photographs 86 and 87 show Stairway ST9, which is near 8th Avenue, is a set of rock and mortar landscape or decorative steps. No recommended maintenance at this time is needed. The natural rock (Carmel Stone) treads are becoming worn, and their irregular surface should be evaluated for safety and code compliance by a qualified professional. A detailed study would be required to assess how to protect the stairs from being undermined.

Because the treads of Stairway ST9 are worn and have an irregular (bumpy) surface that poses some slip and fall risks to stair users, we recommend they be repaired and classify that as a medium priority.

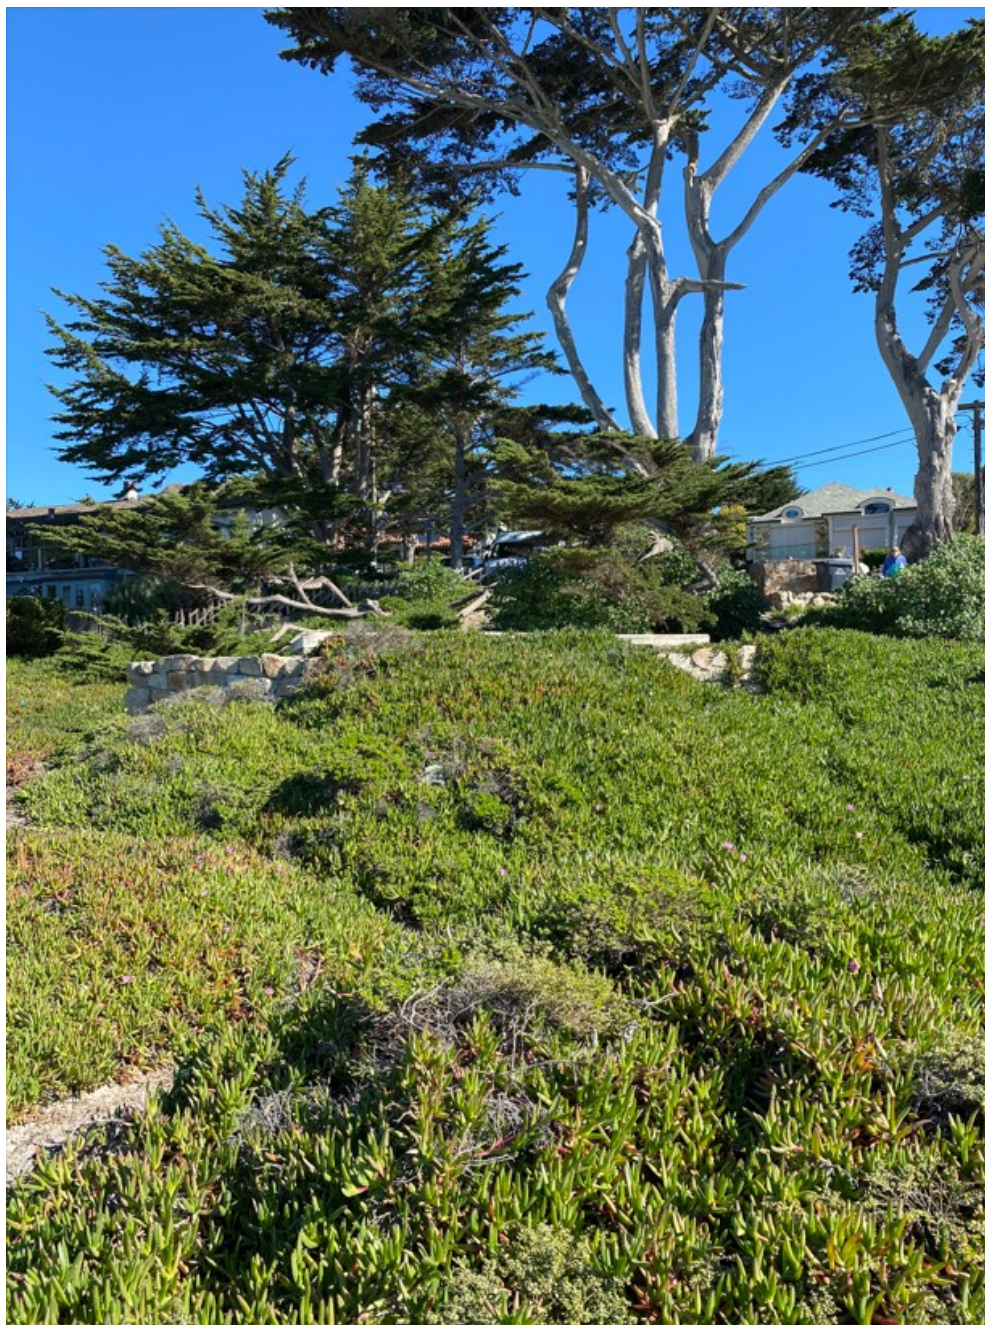
**Photograph 88: Seawall S8 on January 30, 2023**

Photograph 88 shows Seawall S8 on January 3, 2023. It is a retaining wall (not a seawall) near 8th Avenue and Stairway ST9 and appears to be supporting a cut slope created to construct a municipal infrastructure system. It is not influenced by ocean wave impact. Seawall S8 appears to have at least 30 years of remaining life and no repairs are needed now.

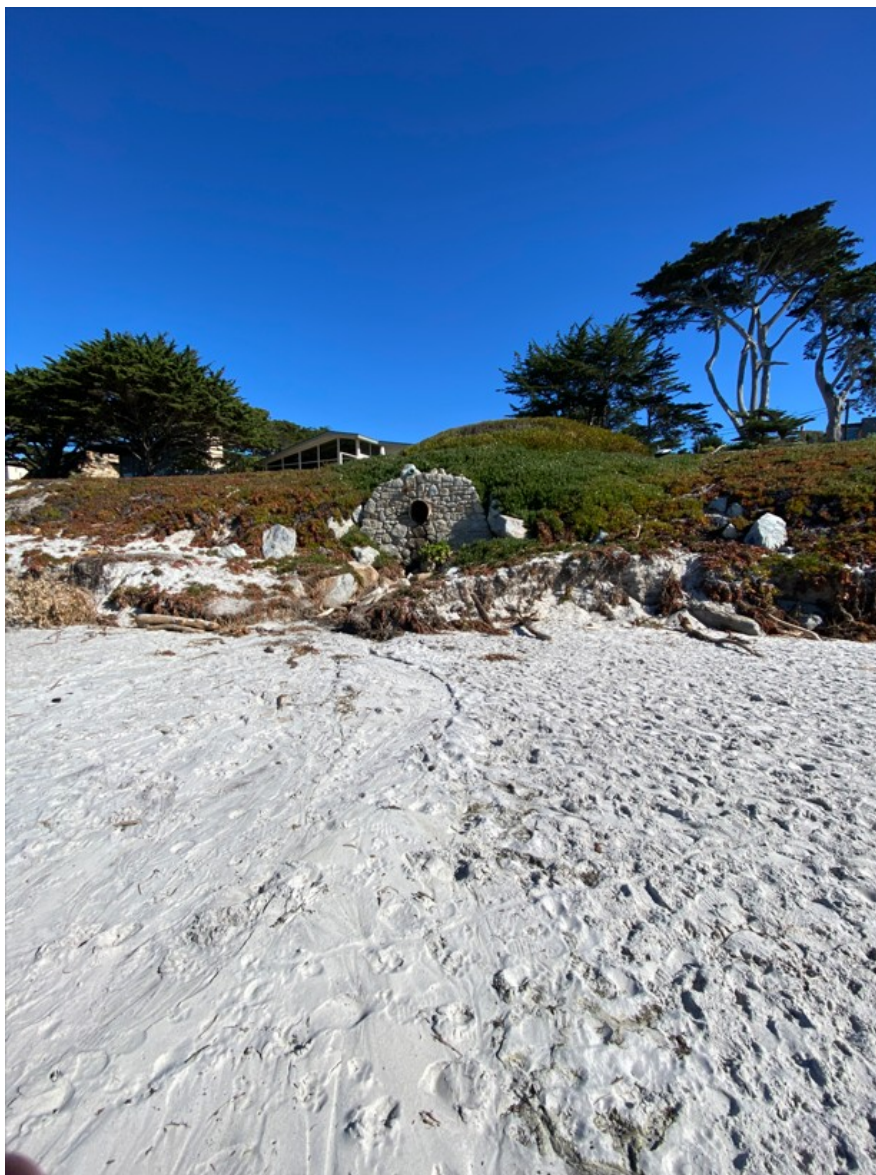
**Photograph 89: Revetment R5 and Seawall S9, Showing Small Amount of Riprap Boulders on January 30, 2023**

Photograph 89 shows that Seawall S9 is a storm drainpipe headwall just north of 8th Avenue. No noticeable maintenance is recommended at this time. As exposed during our inspection, the north end of Revetment R5 has scattered riprap in this location and it does not seem laterally continuous. During our inspection, only the crest of the revetment structure was visible during inspection. Seawall S9 appears to have 20 years of remaining life and no repairs are needed now.

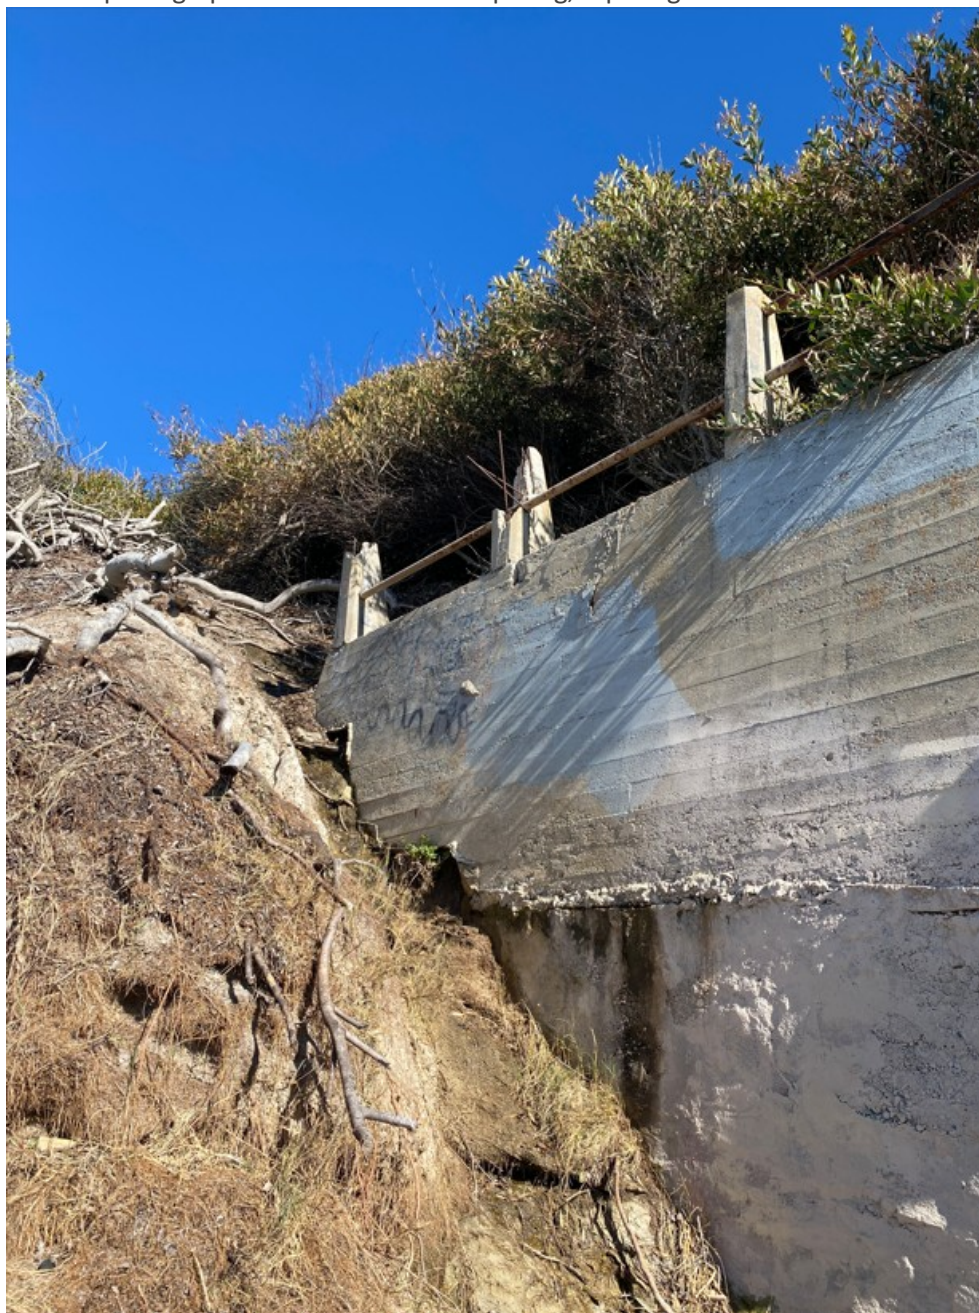
**Photograph 94: Seawall S10 on January 30, 2023**

Photograph 94 is a photograph that shows Seawall S12 being undermined where it steps up the coastal bluff on the north side. Also visible is that the guard at the top of the wall is broken creating an unsafe condition there that needs to be remedied.

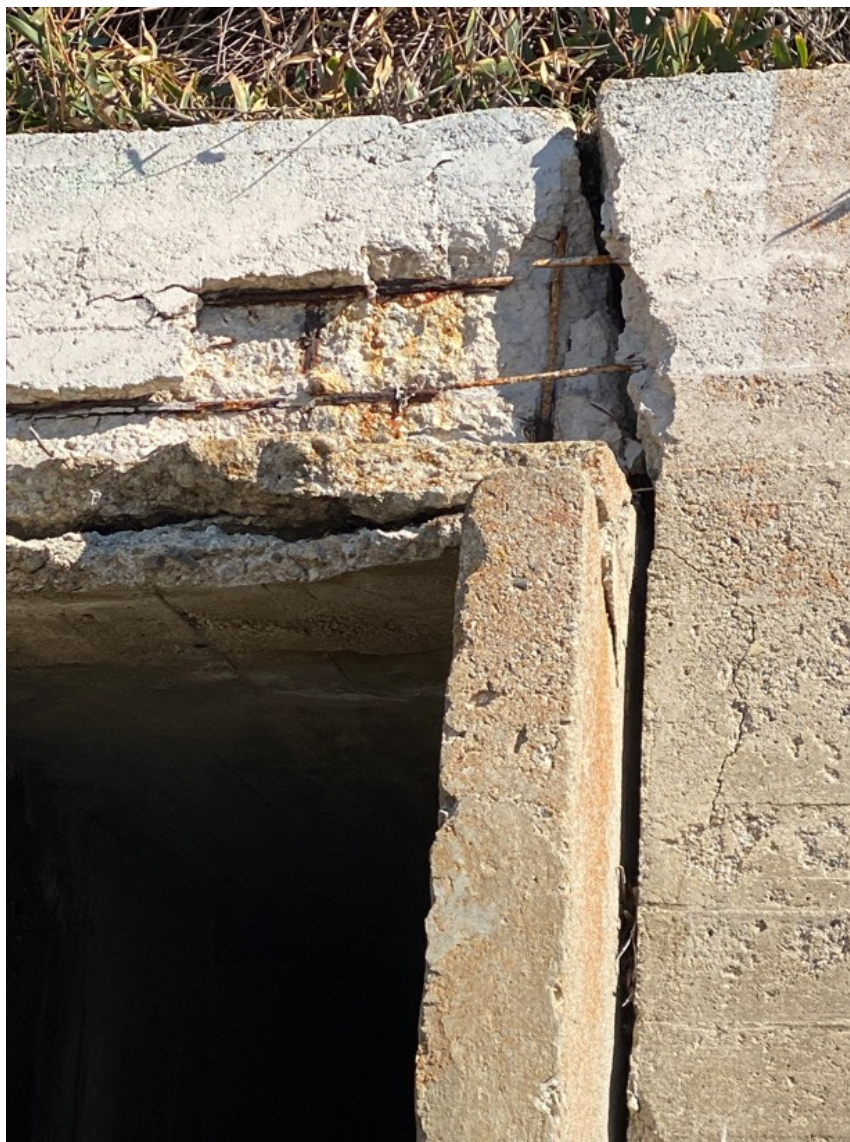
**Photograph 95: Seawall S10 on January 30, 2023**

Photograph 95 is a photograph that shows a large structural crack in Seawall S12 above the box. The crack is wider at the top than the bottom and the wall has been displaced. Reinforcing bars have been exposed by spalling concrete. It appears the south side of the seawall has rotated out in the seaward direction. The north side of the seawall appears to be vertical (plumb) and straight. Most of the rebar of the structure is corroded and not salvageable. We recommend reconstruction of the box culvert and seawall in its entirety. The down coast end of the seawall is outflanked and has been partially undermined, contributing to instability on that side of the structure. This structure has 0 to 10 years of remaining service life before it may collapse. It could collapse catastrophically this year. We do not expect it to survive 10 years. We recommend the City budget for and construct a new structure as soon as possible. This structure poses risks to beach users, and we recommend it have a high priority for replacement

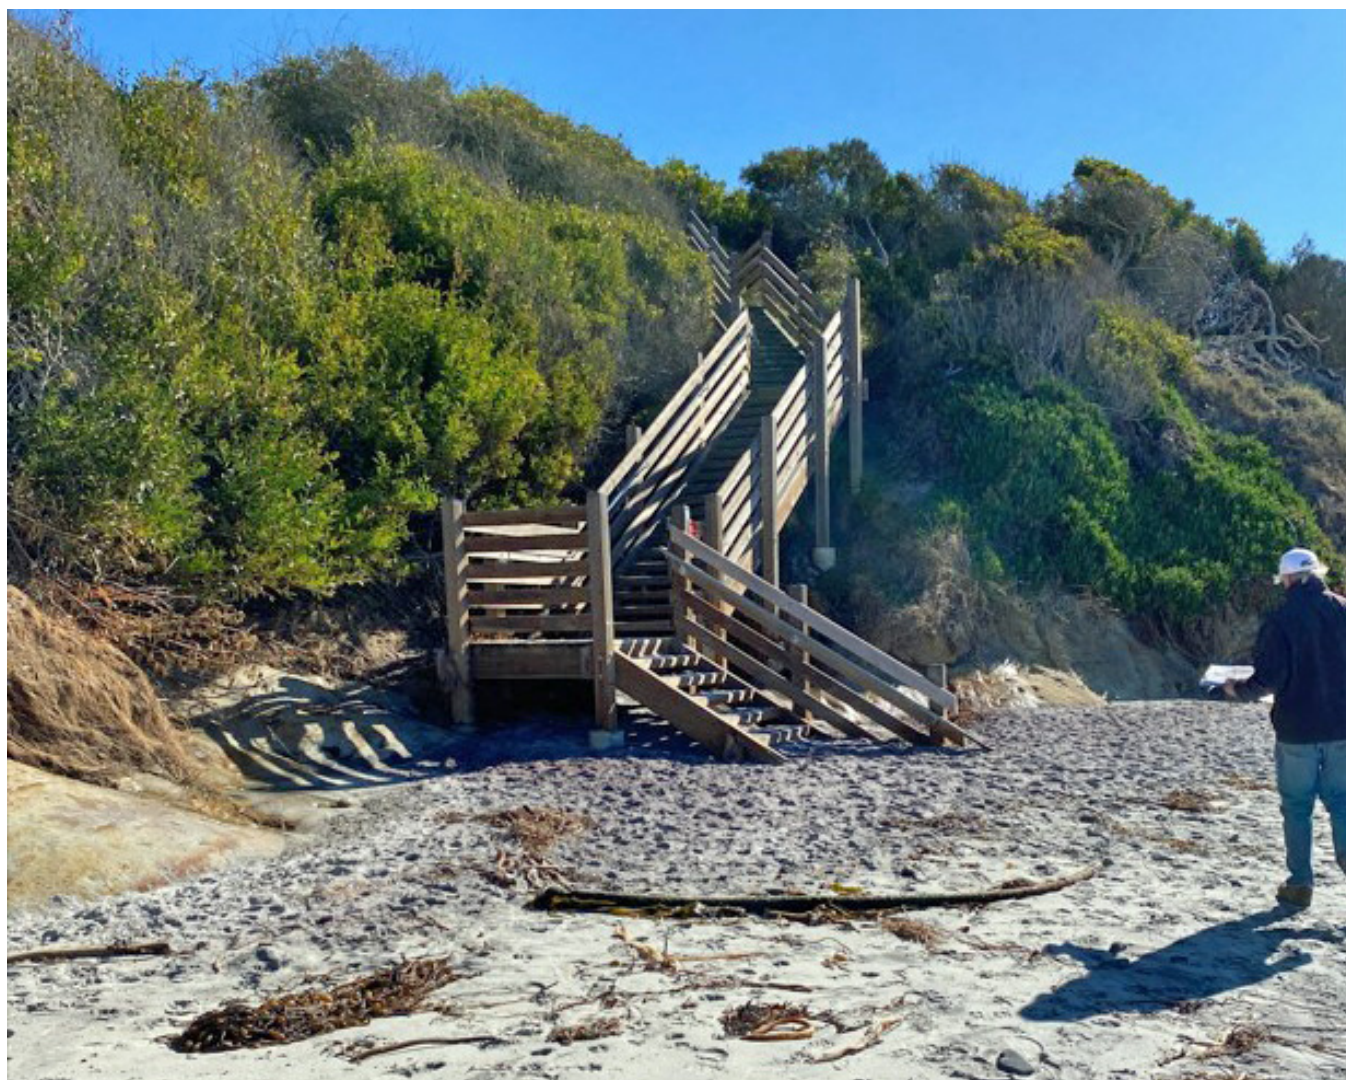
**Photograph 96: Stairway ST11 on January 30, 2023**

Photograph 96 shows Public Beach Access Stairway ST11, located in the dunes area north of Ocean Avenue, on January 30, 2022. Our firm (Haro Kasunich and Associates Inc.) designed this stairway. The lowest elevation run of the stairway has a damaged handrail, minor corrosion in a few spots along the handrail, a broken wooden guard and handrail on the north side of the lowest flight of stairs. The bottom 3 or so feet of the stairs were buried in beach sand at the time of our inspection. We recommend re-inspection during the next natural beach scour event that exposes the lowest portion of the stairs which were founded on bedrock at the time of initial construction. Further evaluation of the structure by an independent licensed structural engineer (and if need be, a licensed corrosion engineer) should be scheduled to verify the structure condition is safe for public use. We recommend the broken guard and handrail be repaired or replaced for the sake of pedestrian safety, and rank that as a high priority, since the current conditions pose slip and fall risks to stair users.

ST11	Dunes	1/30/2023	NA	NA	NA	NA	NA	NA	NA	NA	YES	YES	HIGH	Regular Maintenance is Essential	Hazardous; Broken Guard and Handrail on Upcoast Side of lowest Run	Maintenance is Essential for Pedestrian Safety

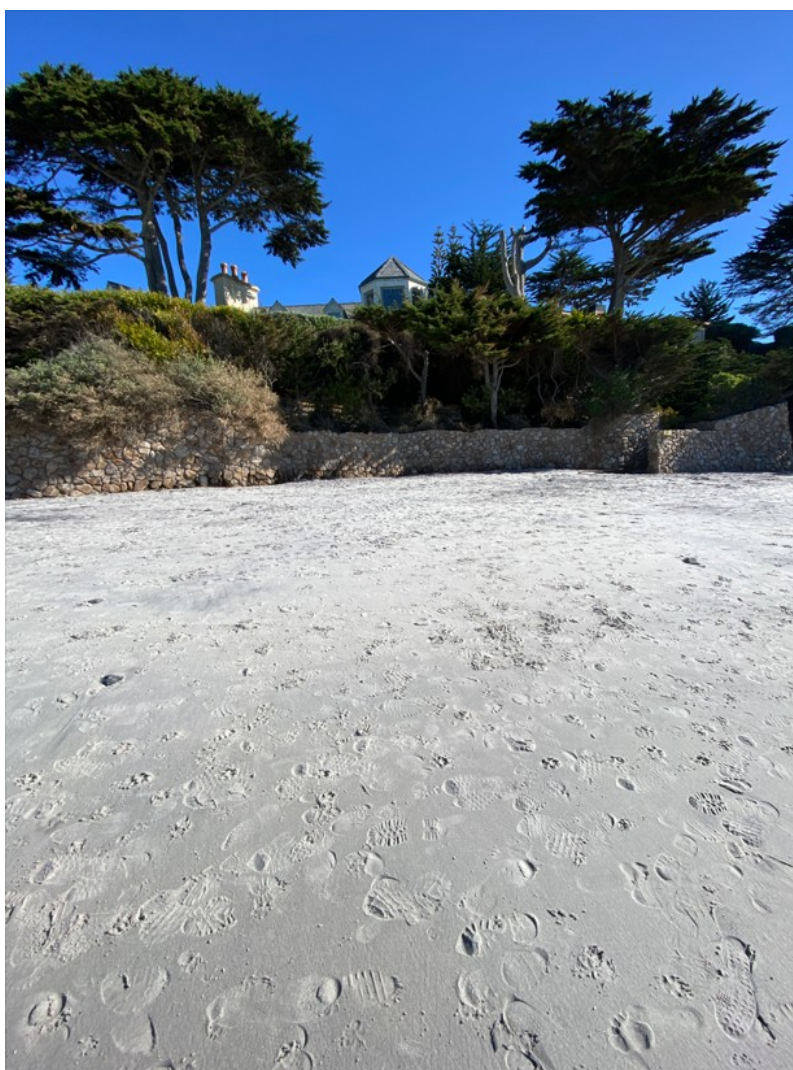
**Photograph 97: South Portion of Privately Owned Seawall S11 on January 30, 2023**

Photograph 97 shows the south part of Seawall S11 on January 30, 2022. The south portion is approximately 6 feet high. This portion includes a private access stairway at the south end. The seawall appeared to be in good condition, and we did not observe any maintenance or repair that was needed.
