Verizon Wireless South Carmel Polygon

Exhibit E: Vaulting Feasibility Analysis

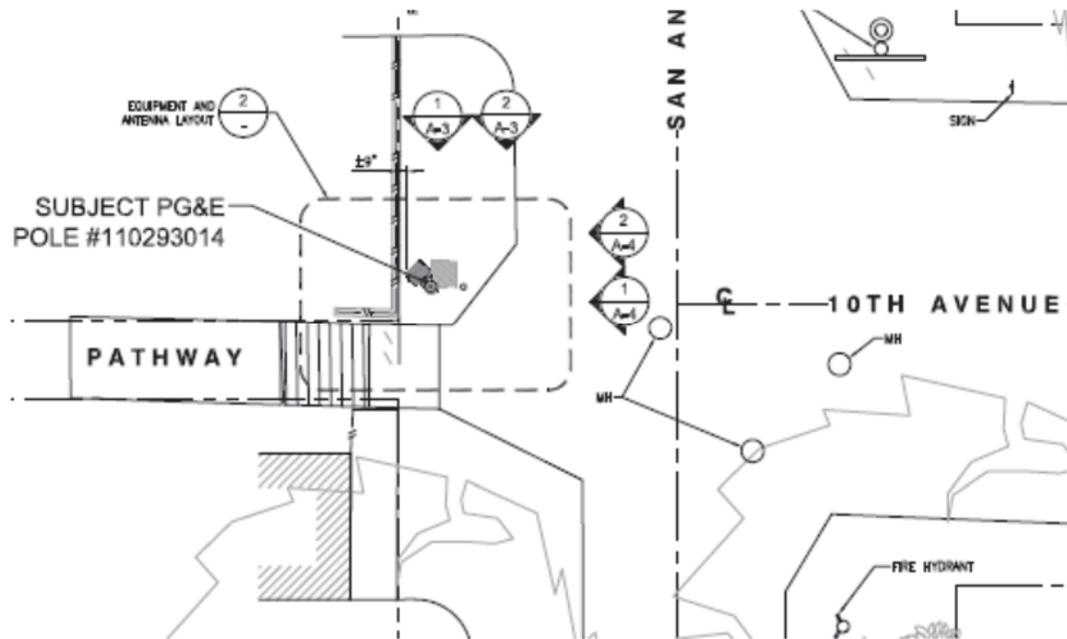
South Carmel 001

Pole is located on the west side of San Antonio Avenue at 10th Avenue. The P-ROW is relatively flat at this location and drops off in grade immediately to the west outside the P-ROW into a residential front yard. There are storm drains that cross San Antonio Avenue diagonally then turning west just south of the subject pole. There is also evidence of utilities in the middle of the P-ROW of San Antonio evidenced by trenching repairs in the street. The P-ROW here drains to the site apparently down a paved foot path between the two lots adjacent to the pole. The lot immediately west and north west of the pole had sandbags to protect water flow onto the lot from the street and a raised bump to prevent the draining of the P-ROW down the driveway. A vault in close enough proximity to the pole to function would need to be place in the path of the front walk to a residence and would require changing the grade and existing flow pattern of the street in the area to prevent water flow into the vault and vents. The location appears to currently be used for parking which would be prohibited by a vault. Locations of utility laterals serving the residence are unconfirmed. Locating the vault south or north of the location immediately adjacent to the subject pole would place it in residential driveways impacting the grade of the driveways and/or immediately adjacent to large trees. Vaulting here is not feasible without substantial reconstruction of the street and changing its character.

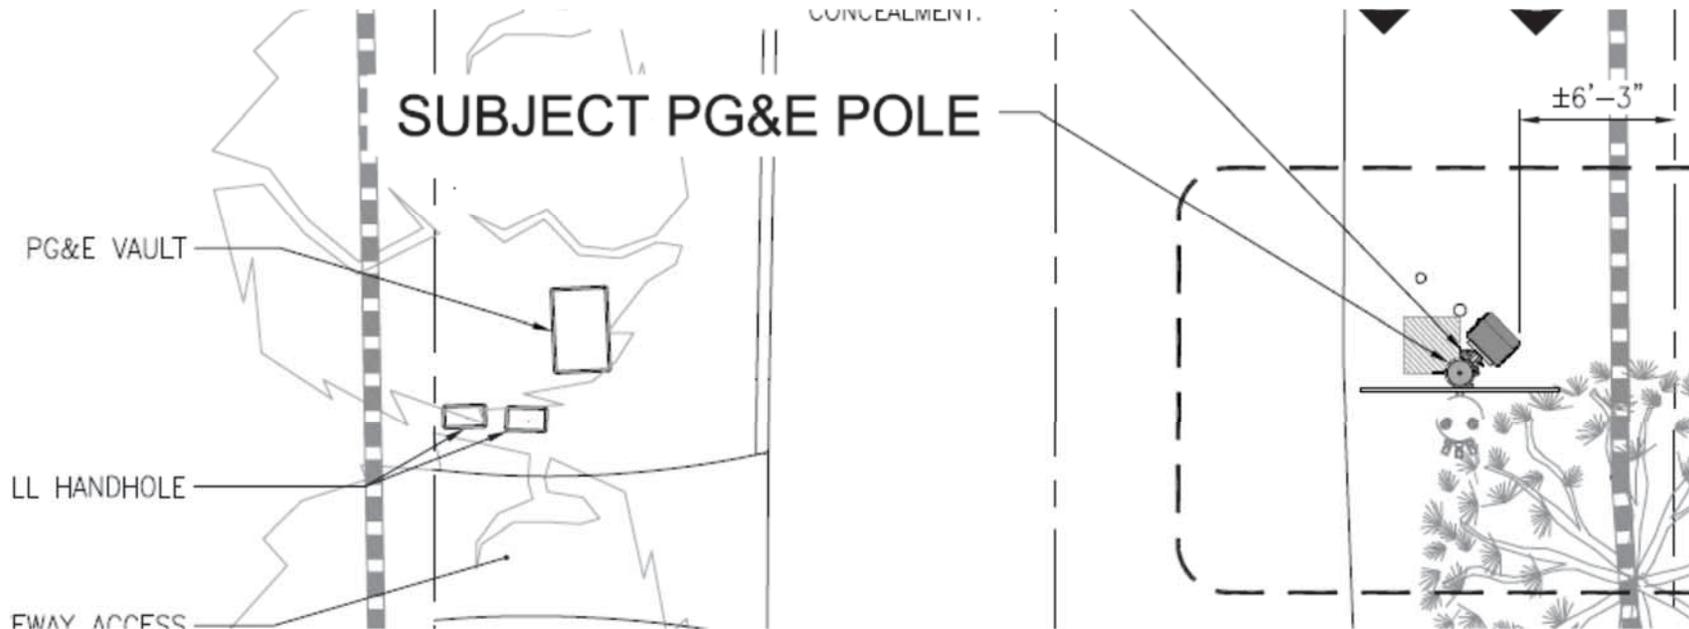
South Carmel 002

Pole is located on the east side of San Antonio Avenue south of 13th Avenue. The P-ROW is relatively flat at this location. There are no curbs or gutters. The unpaved P-ROW here is flat, dirt, slightly lower in grade than the adjacent paving, and used for parking. Parking is marked "Reserved Parking Guests Only" and would be prohibited by a vault. Utilities from the pole are routed west to vaults across the street. Locating a vault south of the pole would be immediately adjacent to a large tree. Locating a vault north of the pole off pavement would require the area to be raised and paved to have water flow away from the vault. The existing flow pattern of the street would be altered by the vault blocking flow as surface flow currently flows off pavement. A minimum of four additional bollards would be required to prevent parking over the vault. Impacts of vault installation are far greater than mounting the equipment on the pole.

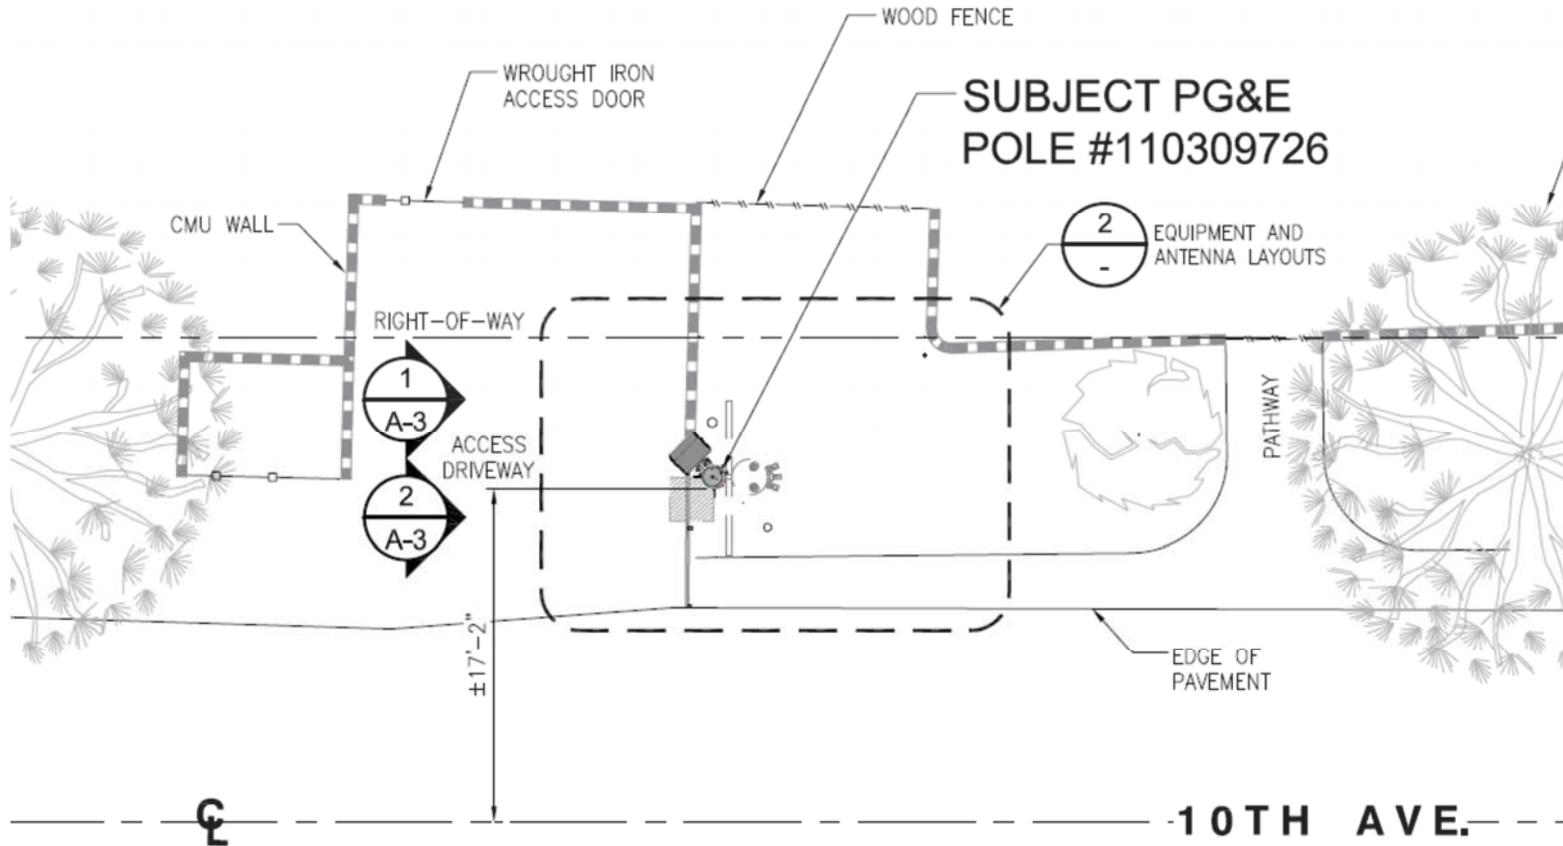
South Carmel 003

Pole is located on the north side of 10th Avenue between Lincoln and Dolores Streets. 10th Avenue slopes down to the west at this location and the street, adjacent driveway to the west, and the landscaping to the east of the pole are all sloped. Placing a vault west of the pole would require changing the grade of the of the driveway rendering it unusable. Placing a vault east of the pole would require removal of a tree, regrading the landscaped area in front of the residence, and installation of low retaining walls and bollards. USA marking and trench repairs in the P-ROW immediately south of the pole are evidence of underground utilities that would most likely need to be relocated for a vault. Vaulting here is not feasible without substantial reconstruction of the street and changing its character.

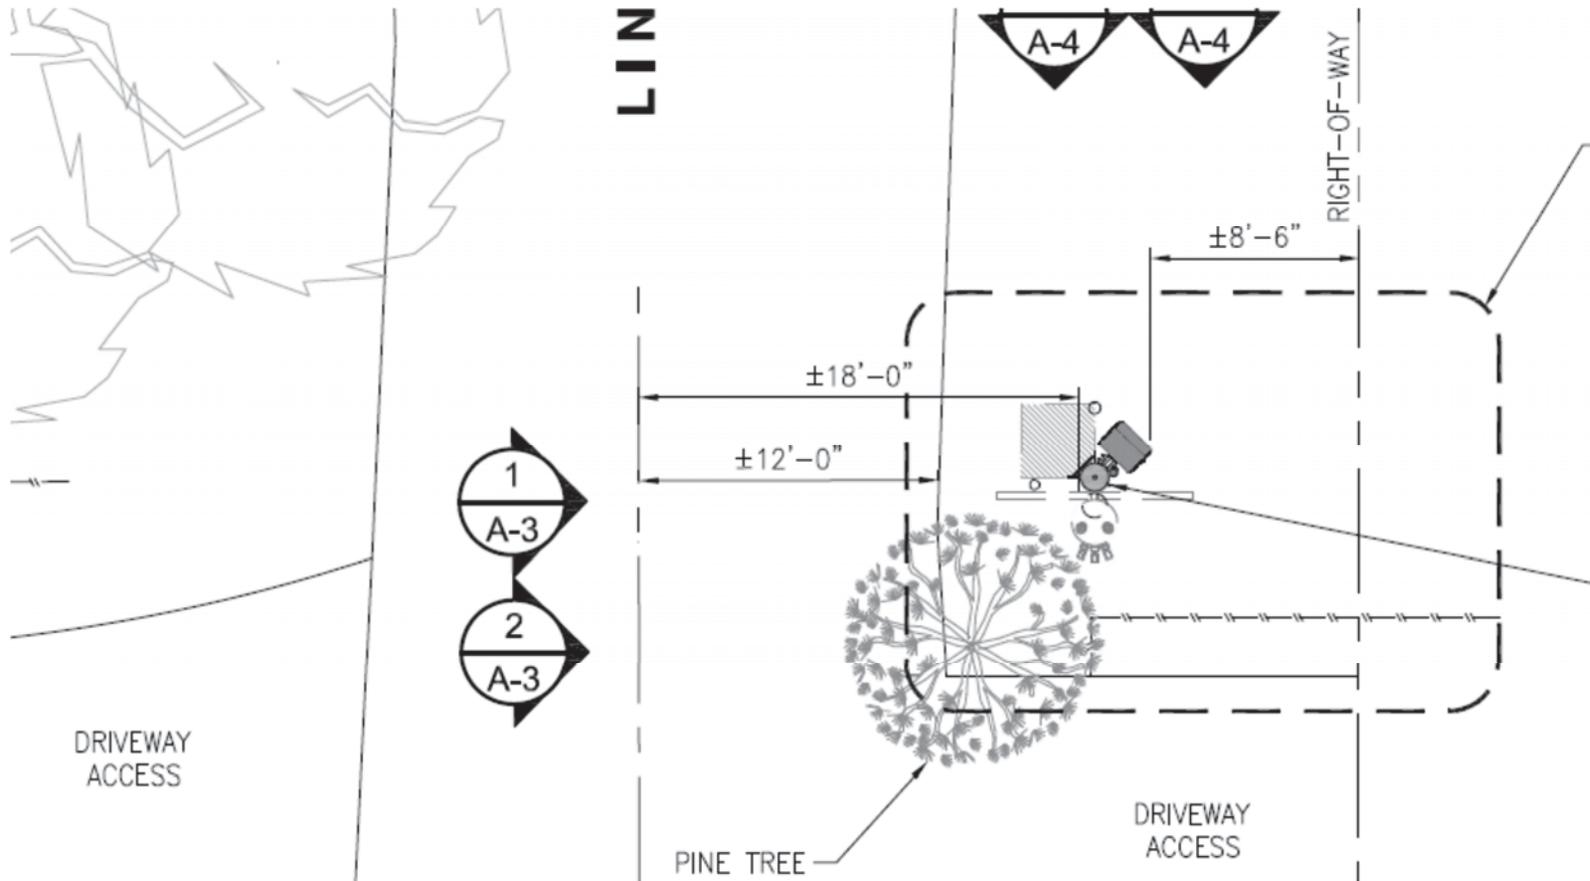
South Carmel 004

Pole is located on the east side of Lincoln Street between 11th and 12th Avenues. The location slopes down to the street pavement towards the west. The location is heavily landscaped and occupied by a sloped driveway to the south. A vault north of the pole will require cutting into the slope, removal of small trees and landscaping and the installation of retaining walls. A vault south of the pole would require removal of a tree and changing the grade of a driveway and its relationship to the street and or removal of substantial landscaping. If the vault was placed in the paved portion of the street surface flow patterns would need to change to allow for flow around the vault. Vaulting here is not feasible without substantial reconstruction of the street and changing its character.

Subject pole.

Vault north of pole would require cutting into slope, removal of small trees, and installation of low retaining walls. Bollards would be required. Driveway to north (out of view) may be blocked.

Vault south of pole would require changes in grade for the driveway and removal of landscaping and the installation of low retaining walls and bollards.

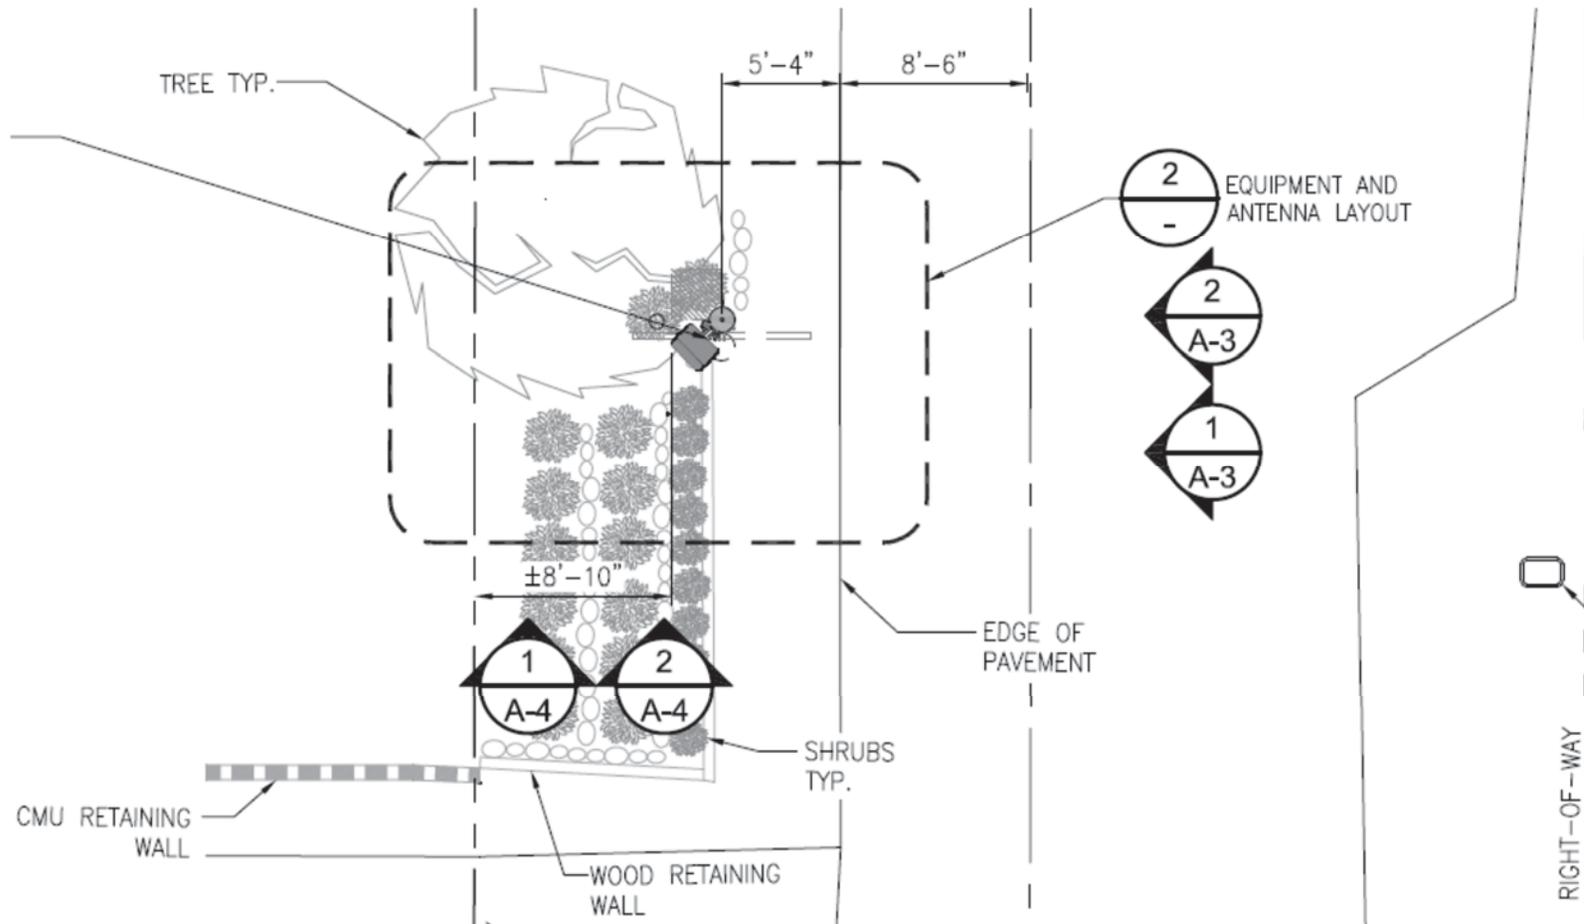
South Carmel 005

Pole is located on the west side of Mission Street between 12th and 13th Avenues. Mission Street slopes down towards the south here and the slots slope down towards the street to the east. Any vault placed north of the pole would be under the canopy of a large oak tree and require removal of a street parking space. Any vault placed south of the pole would require regrading of the location, changing the surface flow pattern of the street, and elimination of street parking and blocking of the driveway. Existing USA markings show the existence of gas lines that would be impacted by any vault installation. Impacts of vault installation are far greater than mounting the equipment on the pole.
