**SCOPE OF INSPECTION:** The limited, visual inspections, evaluations and reports for this building are intended for the exclusive use of the City of Carmel-by-the Sea / Historic resources Board only. The inspection is NOT an engineering evaluation of the property or structures.

**CLAUSEN RESIDENCE**  
DOLORES ST. 5 NW SECOND AVE.  
CARMEL-BY-THE-SEA, CALIFORNIA

**A-1.0.2**

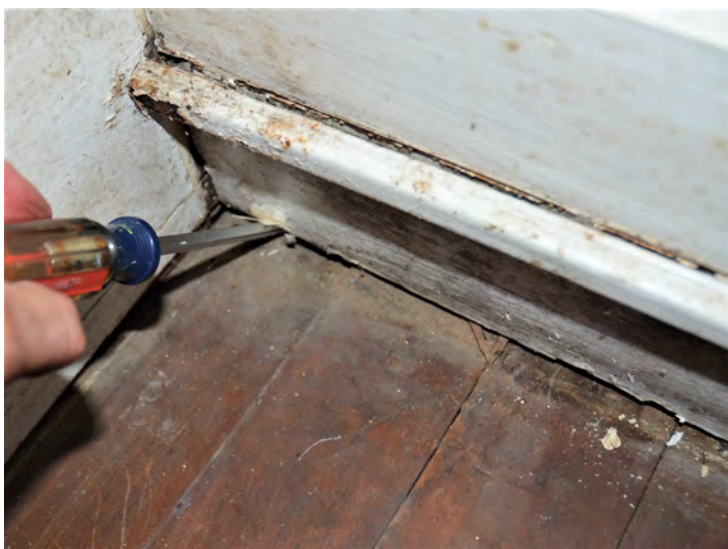
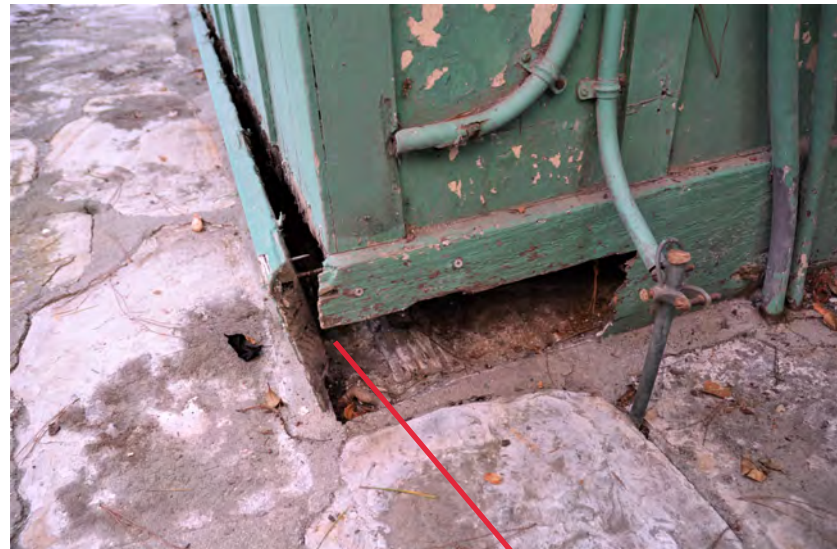
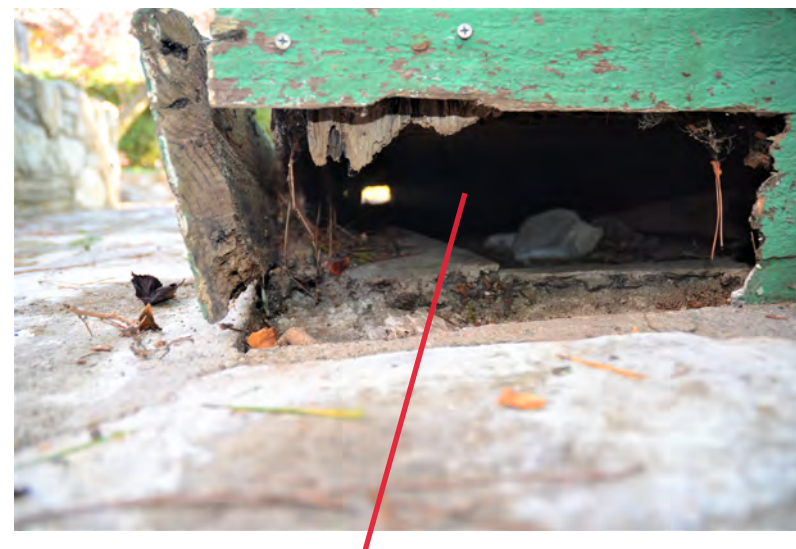
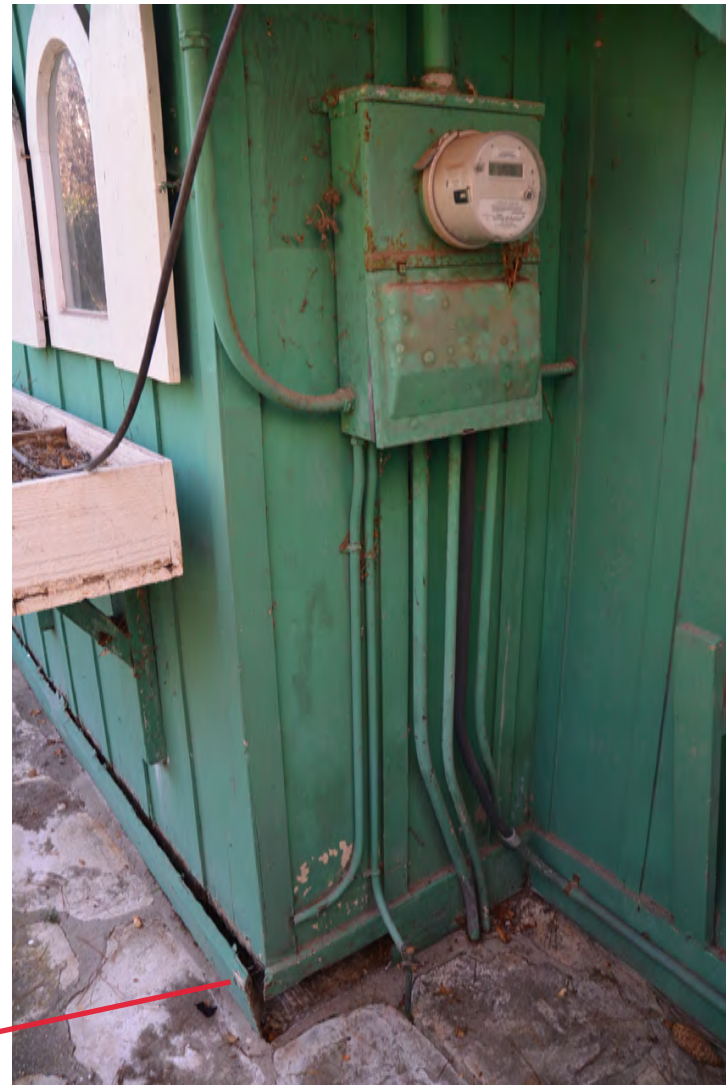
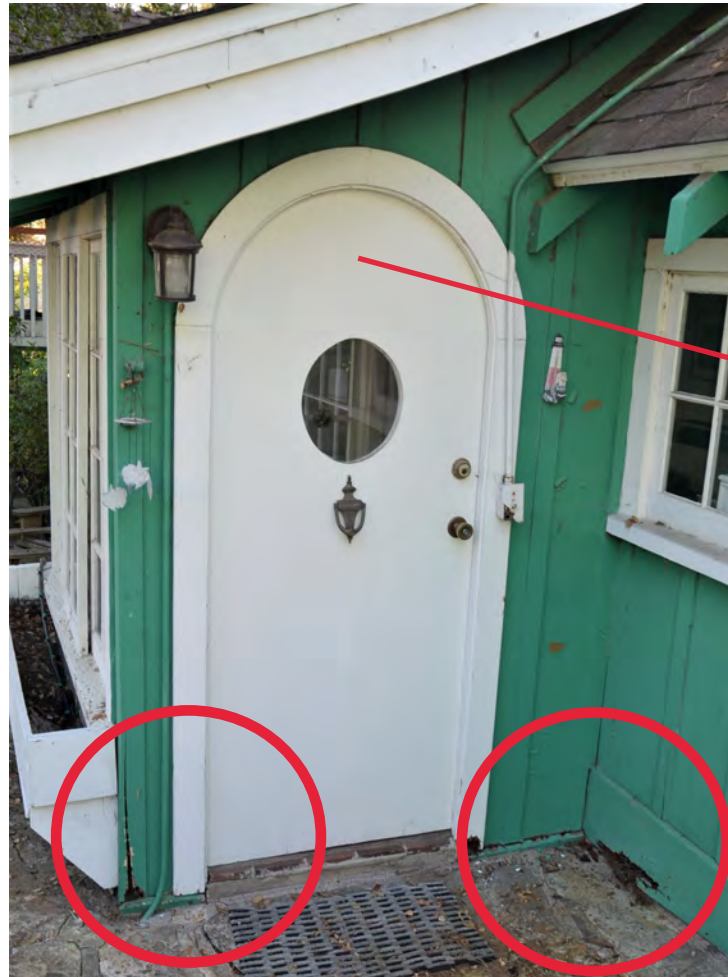
EAST ELEVATION

**SITE:**  
The flagstone stone patio surrounding the front portion of the building doesn't slope away from the foundations. Water has entered the building causing wood deterioration. This damp environment is destroying the floor framing and provide conditions for mold growth. water stains were observed in the interior of the living room.

To reduce the amount of "water and moisture intrusion" into the building, the exterior ground levels should be maintained below the bottom of the wood siding, and the top of the concrete foundation. the exterior of the building should be properly sealed and additional sub-floor vents will increase the crawl spaces ventilation and reduce moisture. At ground level, properly installed french drains along eaves will re-direct running water away from foundations.

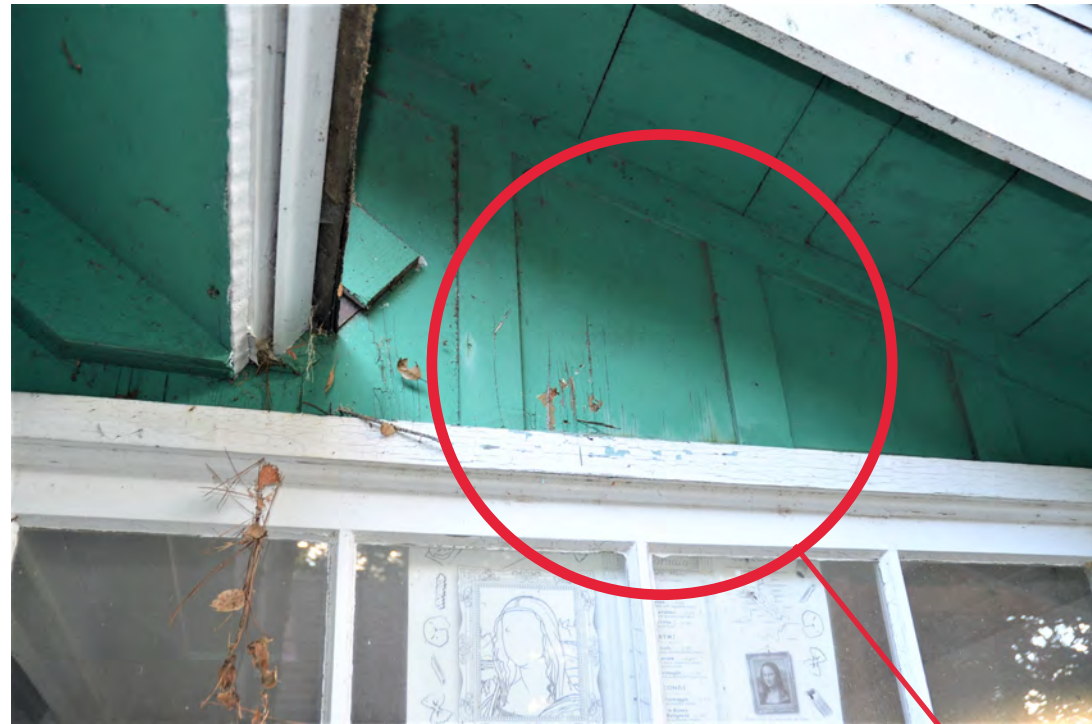
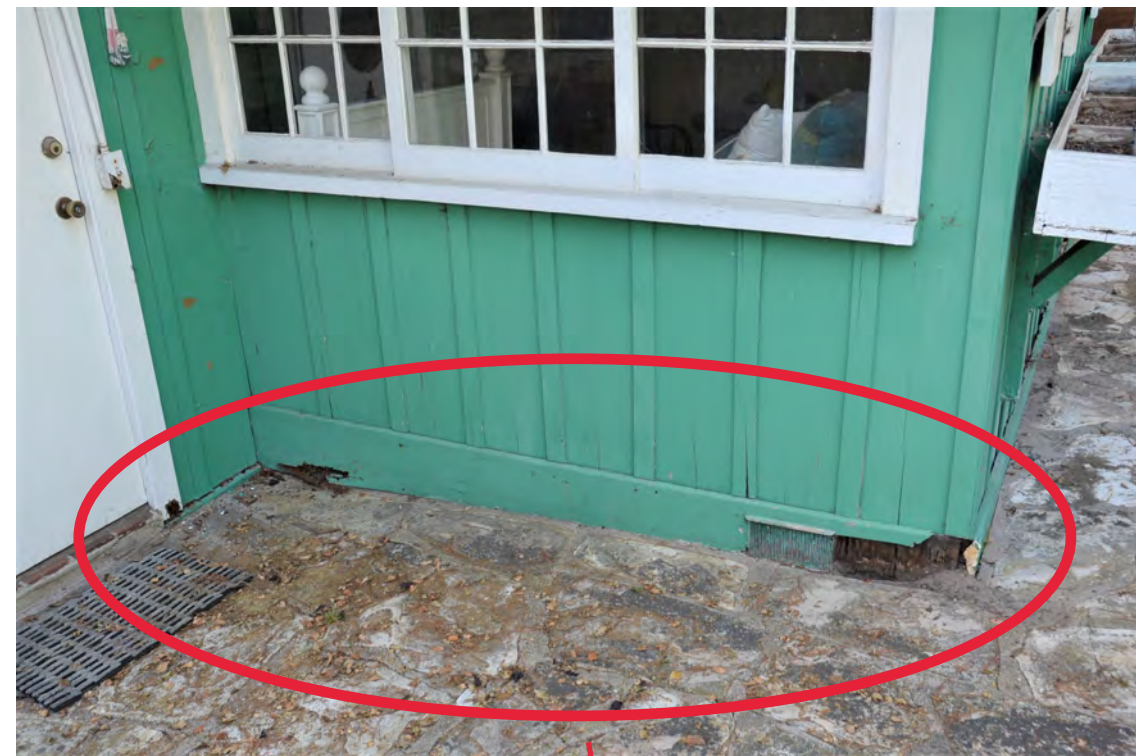
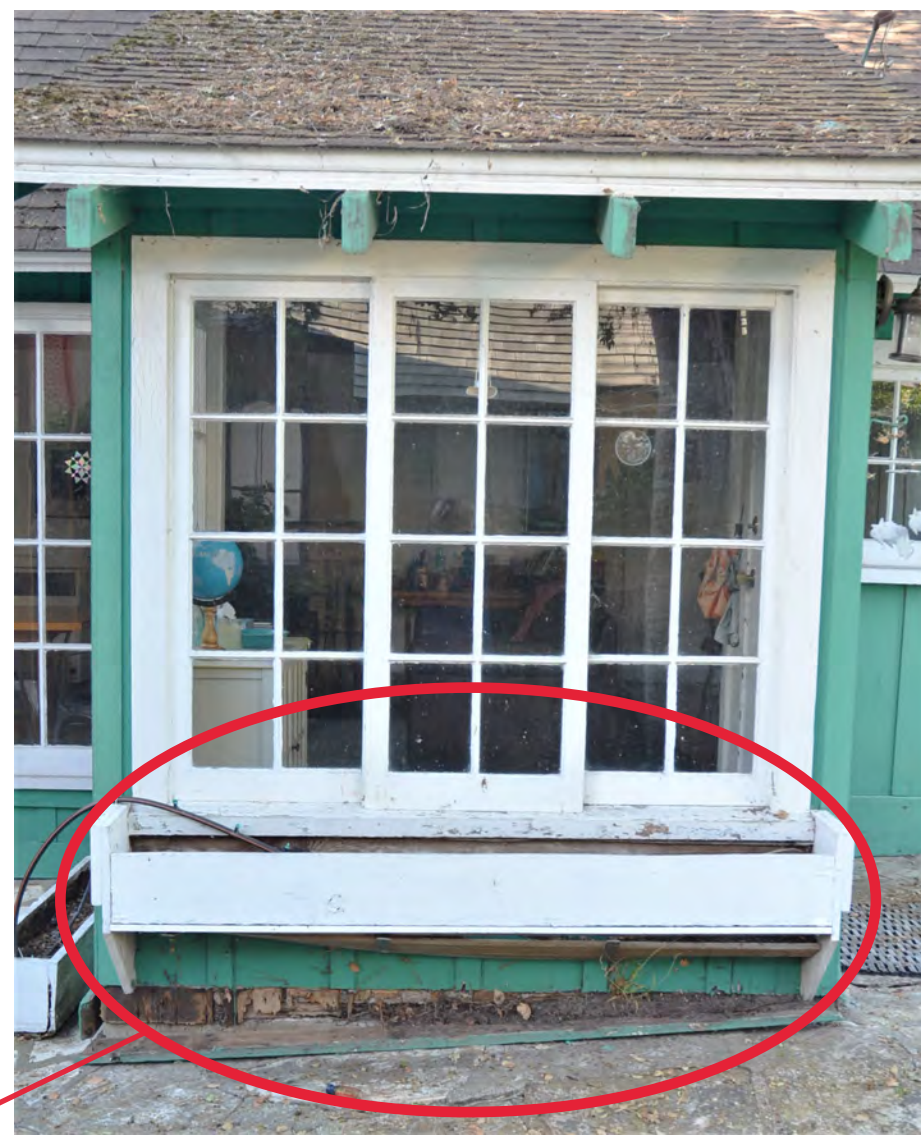
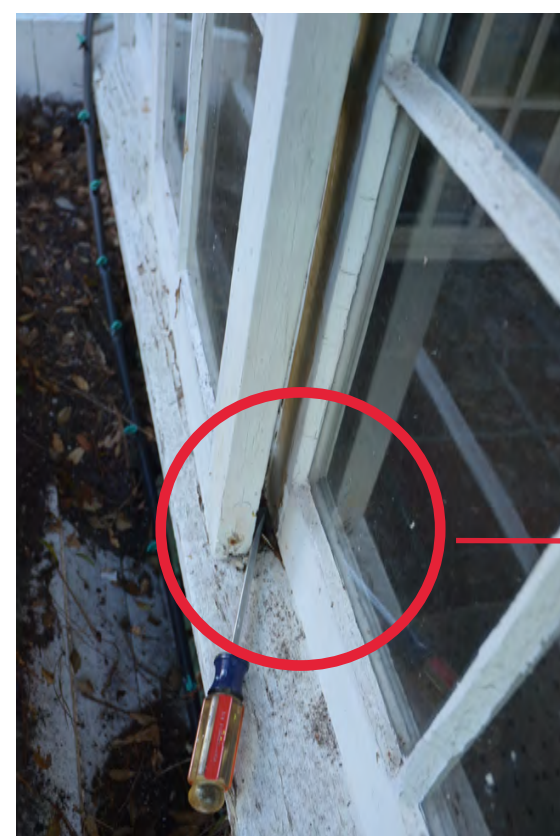
SOUTH ELEVATION

The structure shows some moderate to serious exterior wall maintenance deficiencies. Paint peeling and rotted wood can be found mostly in the lower portion of the walls due to splashing rain water and moisture absorption from siding in direct contact with the ground.

Rotted boards and trims will require to be replaced "like for like" using the same materials and installation methods. The vertical joints of the board and batten wall should be completely sealed and caulked, with the caulk being pliable without gaps or voids. A good weather protective paint or varnish finish should be maintained on exterior wood.
