## CITY OF CARMEL-BY-THE-SEA HISTORIC RESOURCES BOARD Staff Report

**SUBJECT:** **DR 21-114 (The Conservatory)** Consideration of a Determination of Consistency with the Secretary of Interior's Standards for a Design Review Application (DR 21-114, The Conservatory) for a remodel and structural seismic retrofit of an historic structure, known as the China Arts Building, which includes new acoustic infrastructure, as well as new elevator and stairway additions, a new skylight, and exterior windows located on Dolores Street 2 northwest of 7th Avenue in the Central Commercial (CC) Zoning District and Downtown Conservation District (CD) Overlay (APN: 010-147-006; Block 91, lots 6, 8, 10).

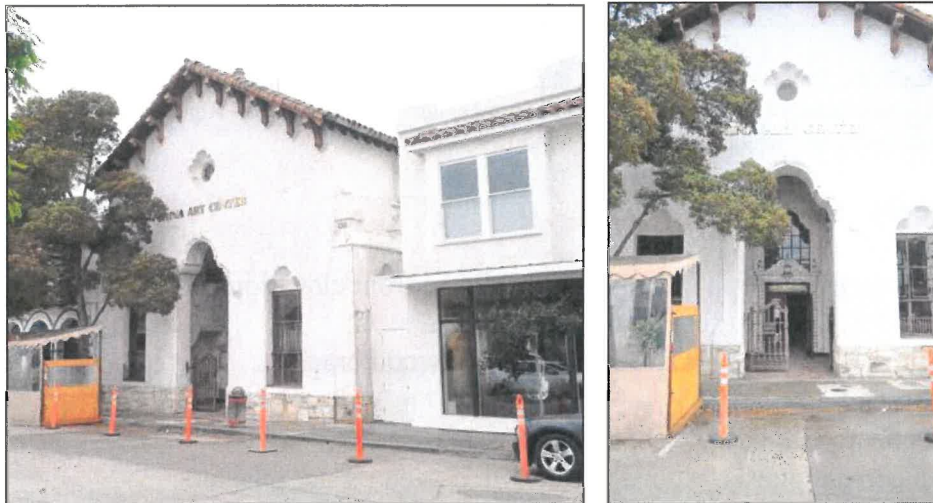
**Figures 1 and 2.** Left image shows the Dolores Street (east) elevation. Right image details the arched entrance, with character-defining cement plaster details, Carmel-stone base course and wood entry gates in front of the vestibule.

The subject property contains the China Art Center, a multi-story commercial building constructed in the Mission Revival style (Figures 1 - 4).

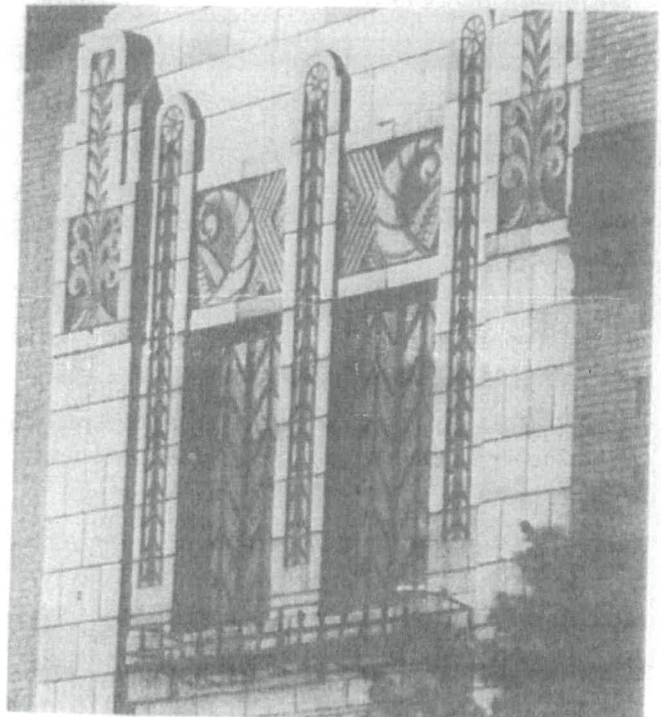
Fig. 1 Often highly distinctive in design and craftsmanship, rolled steel windows play an important role in defining the architectural character of many later nineteenth and early twentieth century buildings. Art Deco, Art Moderne, the International Style, and Post World War II Modernism depended on the slim profiles and streamlined appearance of metal windows for much of their impact. Photo: William G. Johnson.

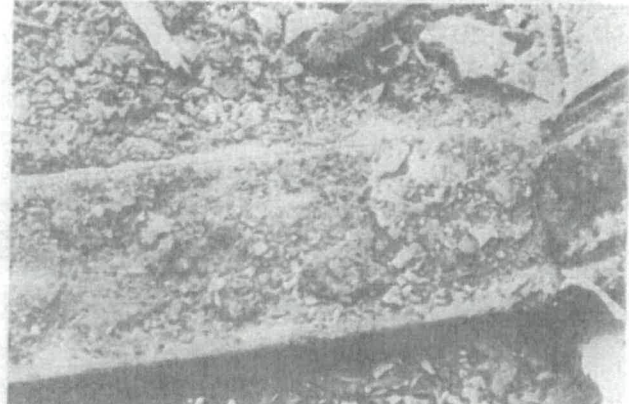
Fig. 6 d. View looking down towards the sill. The subframes appeared very rusted, but were in good condition once debris was vacuumed and surface rust was removed, in place, with chemical compounds. Where necessary, epoxy and steel filler was used to patch depressions in order to make the subframe serviceable again.

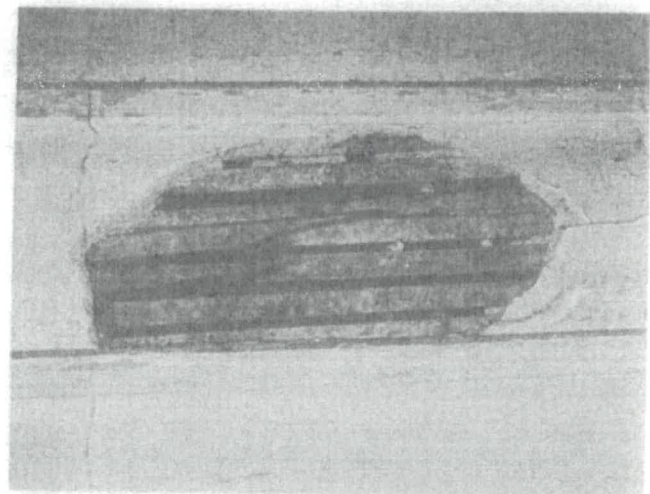
Fig. 13. This beaded ceiling in one of the bedrooms of the 1847 Lockwood House, Harpers Ferry, West Virginia, is missing portions of plaster due to broken keys. This is attributable, in part, to deterioration of the wood lath. Photo: Kaye Ellen Simonson.

Hairline cracks and holes may be unsightly, but when portions of the ceiling come loose, a more serious problem exists (Fig. 13). The keys holding the plaster to the ceiling have probably broken. First, the plaster around the loose plaster should be examined. Keys may have deteriorated because of a localized moisture problem, poor quality plaster, or structural overloading; yet, the surrounding system may be intact. If the areas surrounding the loose area are in reasonably good condition, the loose plaster can be reattached to the lath using flat-head wood screws and plaster washers (Fig. 14). To patch a hole in the ceiling plaster, metal lath is fastened over the wood lath; then the hole is filled with successive layers of plaster, as described above.

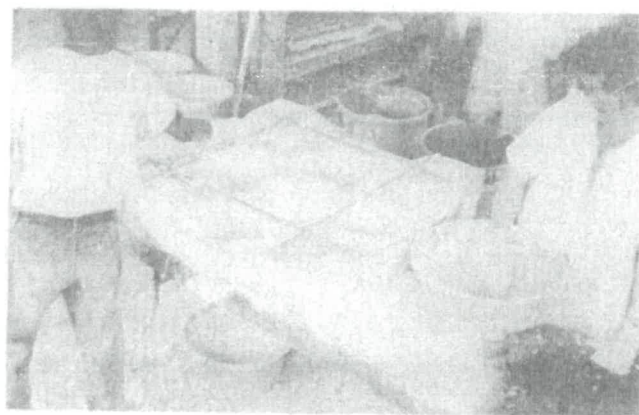
Fig. 8. Casting a Coffering Unit. Ceiling coffers are made the same way today except, historically, a hide glue mold was poured over an ornamental model whereas today urethane molding rubber is used. Now, as then, the plaster casts are made with steel channel irons embedded on the back of each panel. The coffers are hung from carrying irons fixed to the ceiling above by means of twisting wires to level each coffer to its neighbor. Afterward, the panels are fastened together and the joints pointed with plaster. Photo: David Flaharty.

Yet another significant decorative form is the **coffered ceiling**. Coffering units were cast in the shop or onsite, then installed with hanging wires to form the ceiling (see Fig 8). Ceiling design varied from period to period as to depth, panel shape, and ornamental complexity. Not always flat, coffering is seen inside domes, within barrel vaults and groin ceilings, along overhead ribs and soffits. Rosettes are usually centered in the panels and often enrich the intersections of elaborate stiles bordering the panels. Flat ceiling coffers are generally

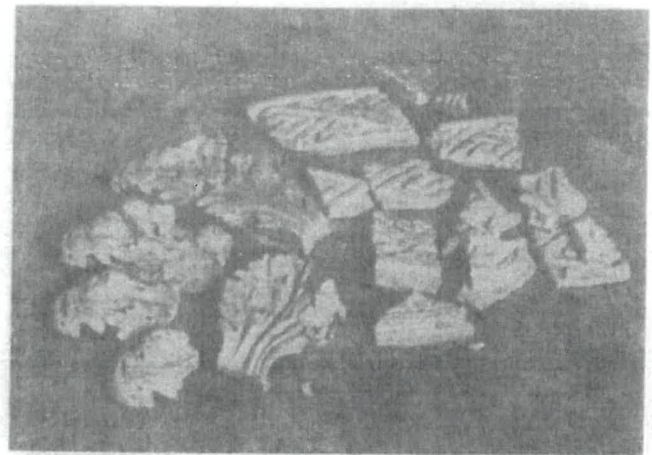
Fig. 19. Ceiling medallions may need repair or replacement. The ornamental plasterer takes impressions of the existing plaster, then casts new plaster elements. Adhesive plaster is used to reattach the new pieces. Left: Damaged elliptical medallion from Rockland, Fairmount Park, Philadelphia, Pennsylvania. Photo: David Flaharty. Right: Fragments of a medallion from the Bennett House, Charleston, South Carolina. The fragments serve as documentation for the replacement medallion. Photo: Peter Sanders.

Damaged ceiling medallions (see Fig. 19a) can be repaired by carefully removing representative plaster ornamentation, molding and recasting in the shop (see Fig. 20) and replacing the new enrichments so that they align perfectly with the original pattern. Polyvinyl acetate bonding agents are applied to the background and ornament so that the adhesive plaster grips tightly. Alternatively, a severely damaged medallion (see 19b) can be replaced using the fragments as physical documentation to cast a visually accurate replacement.

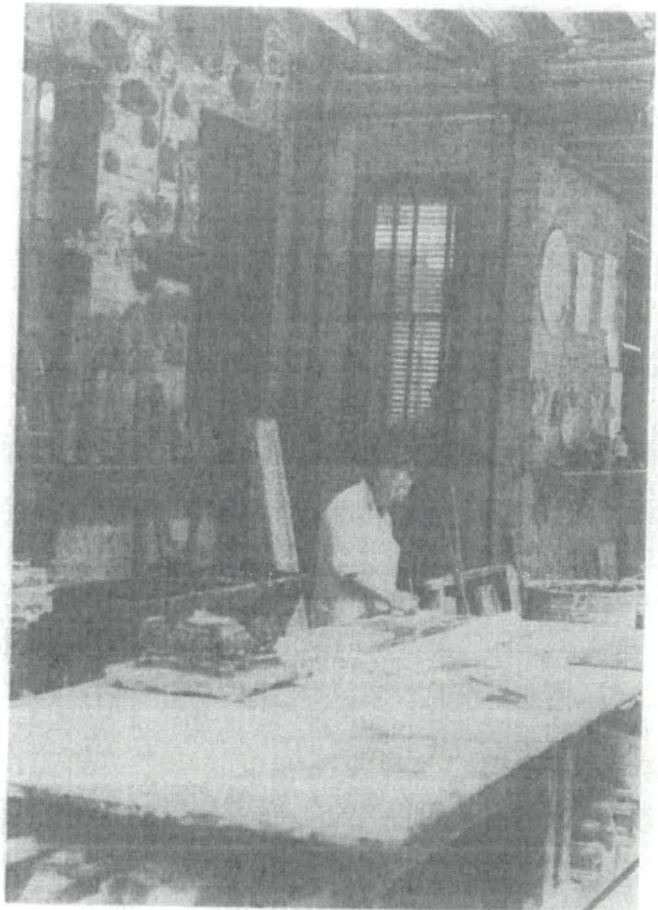
Fig. 24. This plaster studio is well organized, with ample work space. Note the plaster casts hanging neatly on the wall. Photo: Berry and Homer, Philadelphia.

or developer should secure the services of a reputable restoration contractor before proceeding further. It is clear as more and more projects are undertaken, that there is a wide disparity of skills within the trade today. This is partly due to the introduction of gypsum board as a substitute for traditional plastering. As gypsum board became popular after World War II, plasterers saw the demand for their skills decline. Plastering techniques were forgotten because they were often not passed down within shops and families. However, ornamental plaster studios have seen a resurgence in demand for their services in the last decade, particularly as more historic buildings are rehabilitated (see Fig. 24).
