Historic Evaluation

Addendum

**Addendum to Evaluation of Historical Significance for 7th & Dolores
(formerly the Palo Alto-Salinas Savings and Loan Complex)
APN 010-145-020, Carmel-by-the-Sea, CA.**

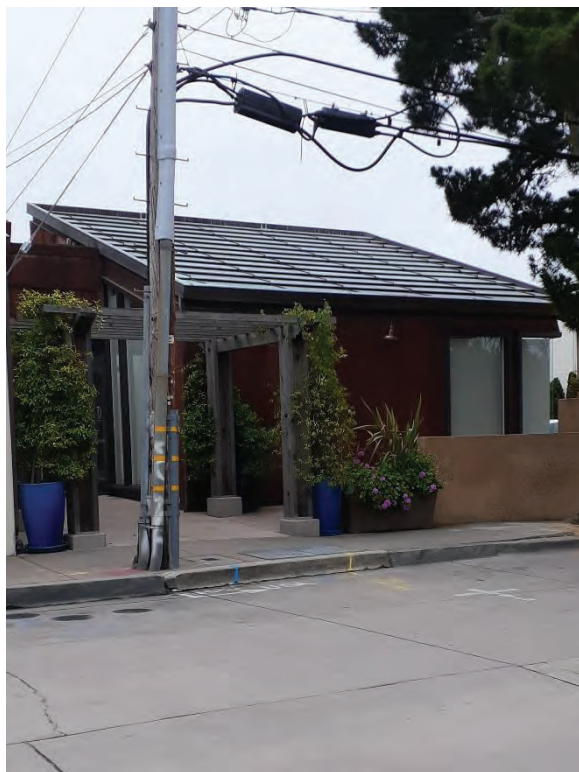
Front Elevation Facing Dolores Street, 2020

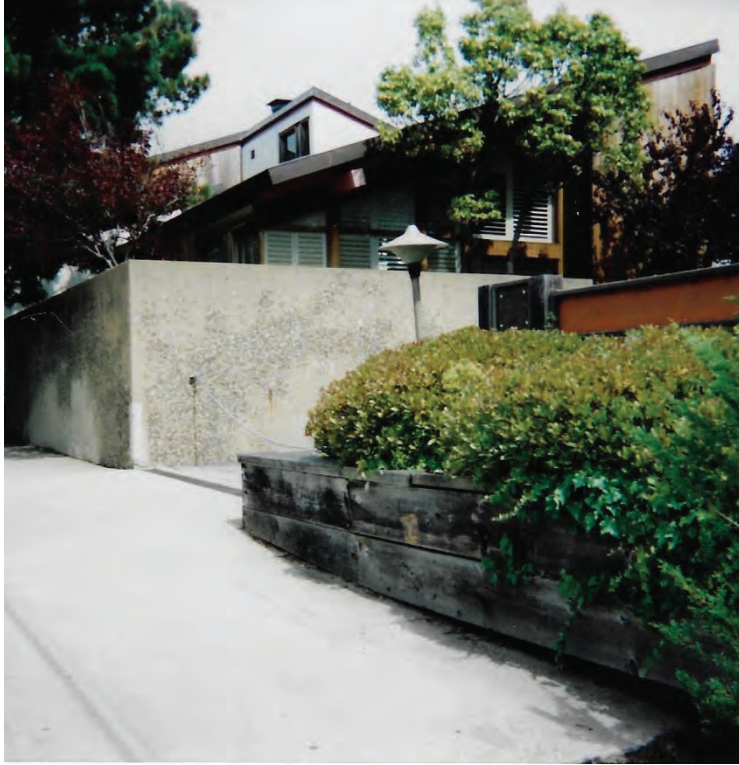
Views showing original window design, 1999.

The first remodel of the building took place in 1978³ and included the removal of the interior chair rails to accommodate plantation blinds. Eventually the exterior rails were removed from the upper and lower windows on the west and south elevations. Single panes of plate glass replaced the original windows. The wall surrounding the community room obscured much of the building but in 2013 a portion of the wall on the south elevation was removed and the entire wall was shortened by twelve inches. That same year new pergolas were added to the front and rear of the walkway.

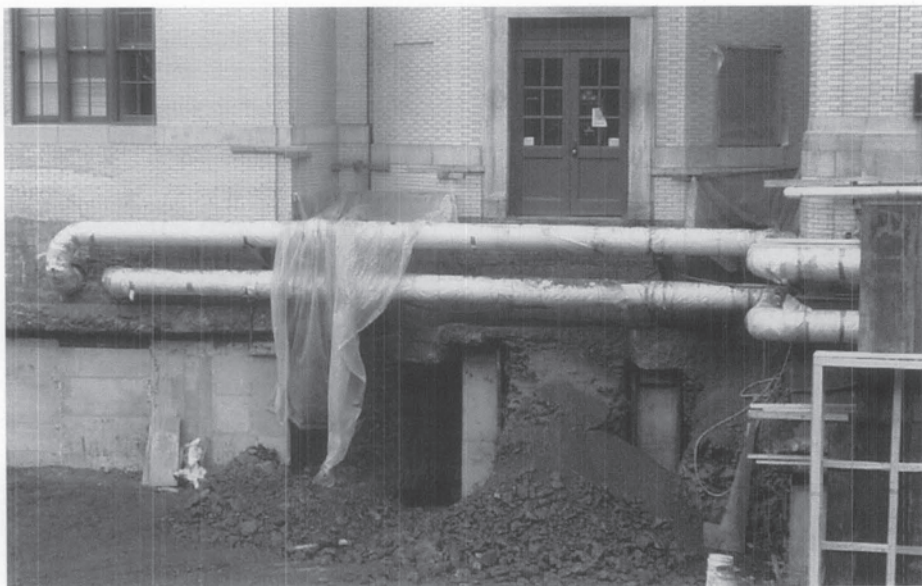
Figure 3. Concrete pier underpinning to an existing building may be necessary when adjacent construction occurs. In this example, pits are hand dug beneath the foundation of the historic building to provide space for wood forms. After concrete is poured into the forms, the space between the top of the pier and the bottom of the original foundation is packed with a quicksetting grout. The historic building owner should retain an independent engineer to ensure that the underpinning plan adequately protects the historic structure. Photo: Professor Arpad Horvath, Department of Civil and Environmental Engineering, University of California, Berkeley.

Efforts to control movement should begin during the consultation phase. Whether the developer's engineer selects underpinning or strengthened excavation walls with tie backs as the means to resist movement of the adjacent structure, the historic building team should retain its own engineer to review the plans (*see figure 3*). The consulting engineer should ensure that the selected approach addresses the unique characteristics and vulnerabilities of the historic structure and that even incidental movement is restricted.

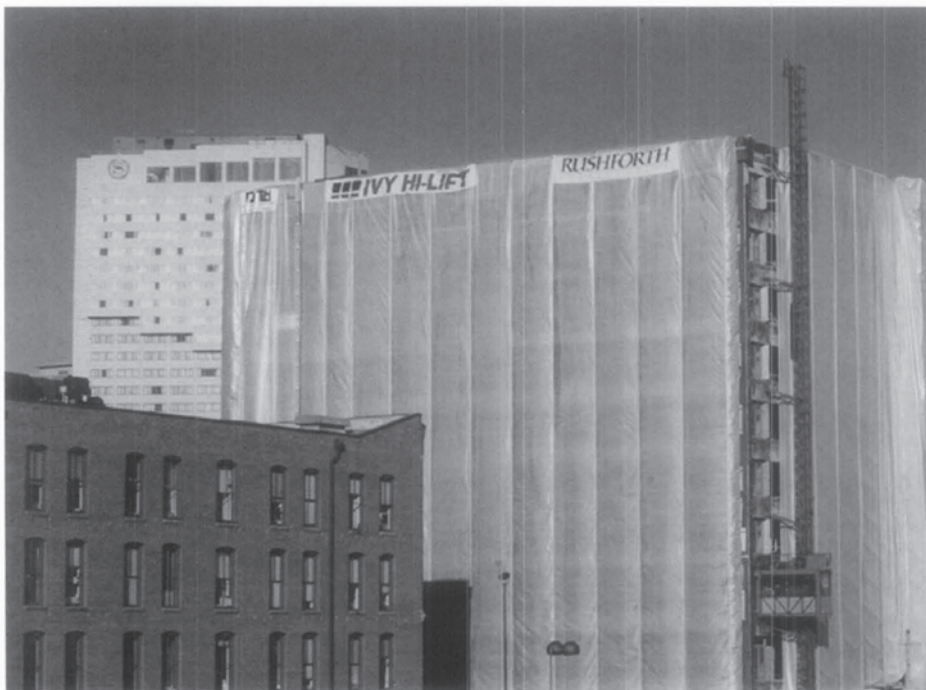
Figure 5. The historic building on the left is partially protected from debris and dust generated by the renovation of the structure to the right. Such temporary enclosure systems consist of a polyethylene or other fabric shell stretched between an aluminum frame. Photo: Walton Technology, Inc.

Other byproducts of new construction and demolition, such as dirt and dust, can also pose threats to an adjacent historic structure. Dust suppression measures including the installation of fabric enclosure systems should first be employed at the building site (*see figure 5*). Despite these efforts, historic building owners will undoubtedly have to deal with raised levels of dust infiltration. Accordingly, vulnerable interi-

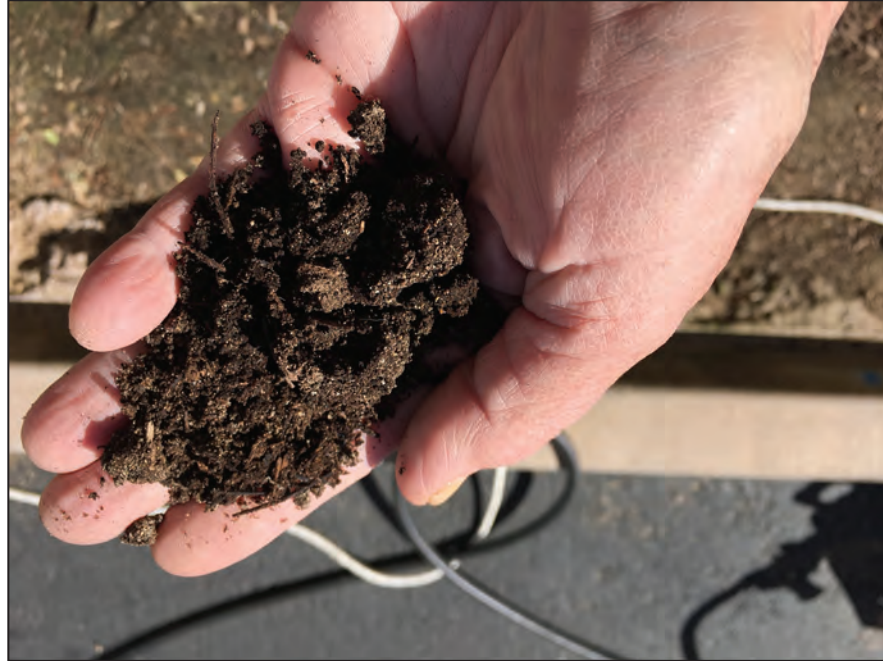
Figure 7: Soils along the eastern perimeter of the parking lot are sandy loam with no cultural materials observed.

The soils of the project parcel are exposed in numerous locations around the parcel. **Figure 7** is a close up of a handful of soils from the northern parcel, APN 010-145-023. The USDA Web Soil Survey classifies soils in this neighborhood as OaD--Oceano loamy sand, 2 to 15 percent slopes. Oceano loamy sands are stabilized eolian soils (<https://websoilsurvey.sc.egov.usda.gov>). These soils are found on marine terraces. The soil of the project parcel is dark brown to dark yellowish brown, 10YR 3/3 to 3/4, sandy loam, darkened by recent rains. There are no marine shell fragments, there are no cobbles or cobble fragments (burnt or unburnt), bone or flaked stone on the project parcel that would indicate a prehistoric site, nor are there traces of these materials. There are no fragments of old glass, or ceramics, or metal that would represent an historic site.

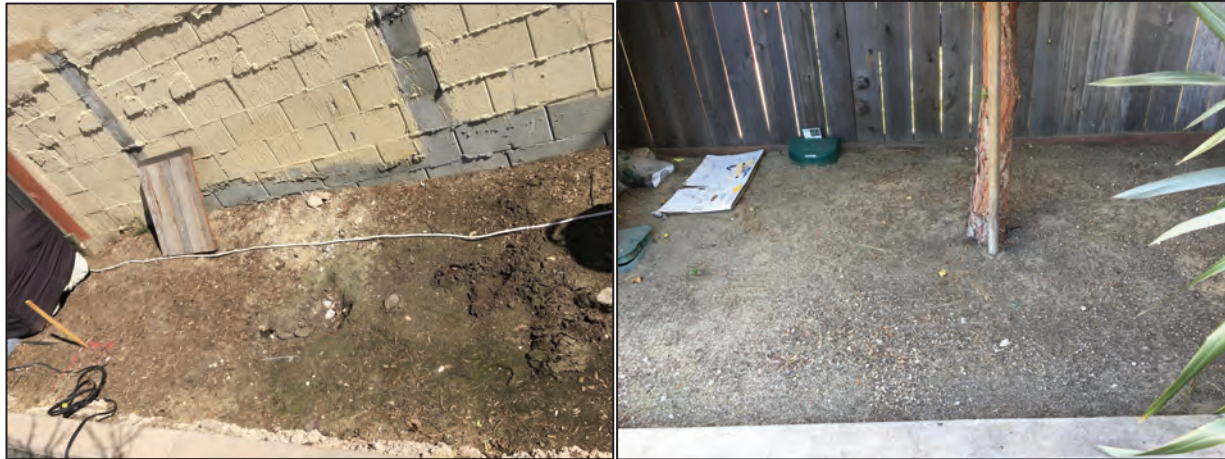
Figure 8: Soils near the eastern margins of the project parcels are exposed. The photo on the left is the northern parcel APN 010-145-023. The photo on the right is the southern of the two parcels, APN 010-145-023.

Figure 8 shows the eastern margin of the both parcels. On all three sides of these two parcels the soils are clearly exposed and more than adequate for determining the presence of cultural materials. **Figure 9** shows the soils exposed along the south margin of APN 010-145-024.

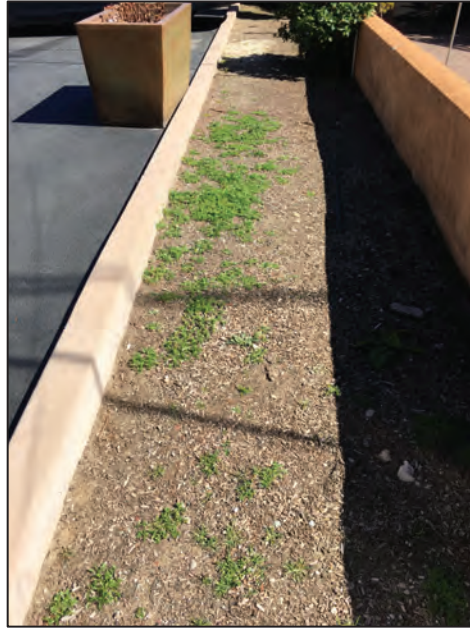
Figure 9: Soils exposed on the south side of the project parcel APN 010-145-024.

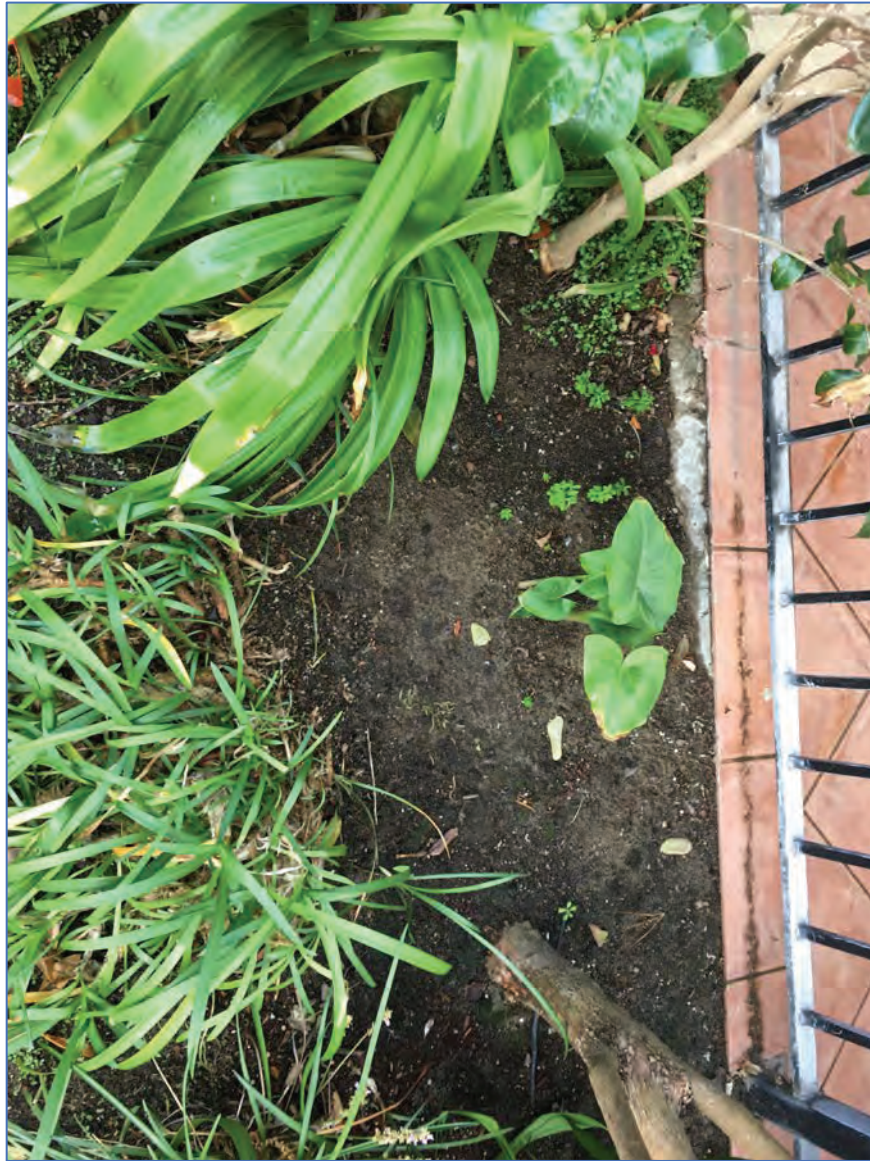
Figure 6: Soils of the central courtyard are exposed.

The soils of the project parcel are exposed in numerous locations around the parcel. **Figure 6** is a photo of the central courtyard, **Figure 7** is the west, or street side. The USDA Web Soil Survey classifies soils in this neighborhood as OaD--Oceano loamy sand, 2 to 15 percent slopes. Oceano loamy sands are stabilized eolian soils

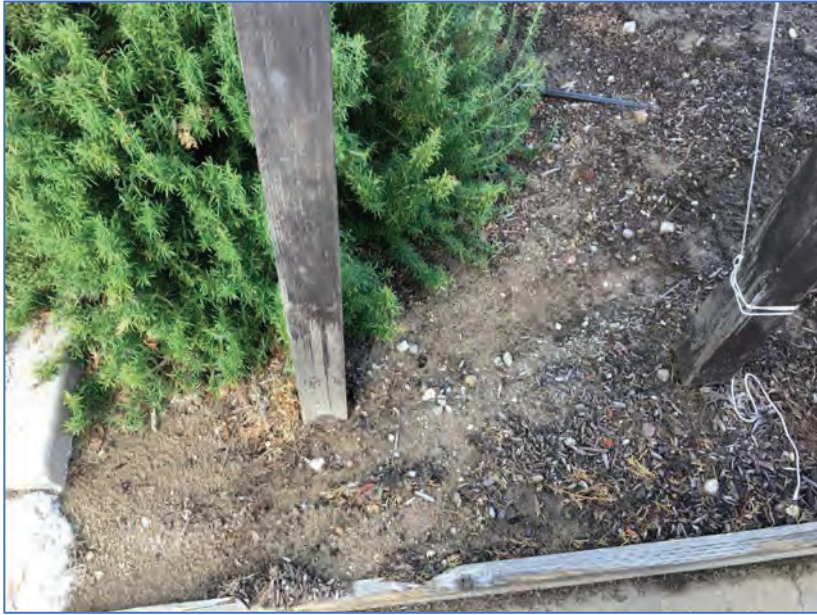
Figure 7: Soils near the west edge of the project parcel on Dolores are exposed and contain no cultural resources.

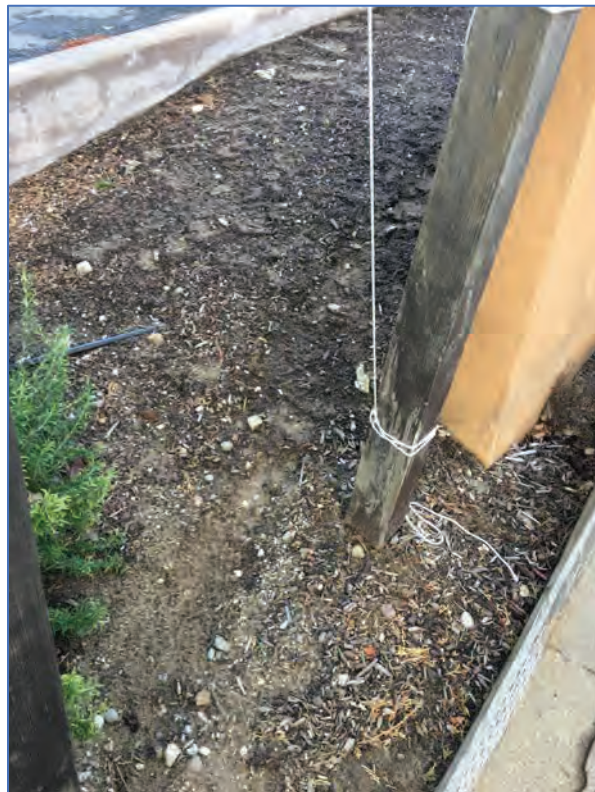
Figure 8: Soils exposed on the northwest corner of the project parcel.

There is little vegetation on the project parcel other than a few ornamentals. Although visual inspection of the soils on the project parcel is obscured by the structures and the brick patio, soils are adequately exposed at the margins of the parcel and in the center of the courtyard (**Figures 6, 7, & 8**).
