SCOPE OF WORK: DEMOLITION OF EXISTING SINGLE FAMILY DWELLING; AND CONSTRUCTION OF NEW TWO-STORY RESIDENCE.

21 EKEN RESIDENCENTA FE STREET 4 S/E 2ND AVENUE CARMEL, CALIFORNIA 93921

TITLE SHEET

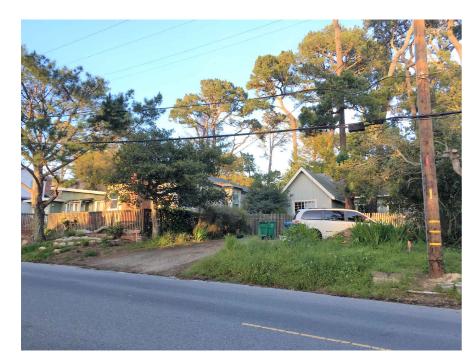
EXISTING SITE PHOTOGRAPHS

EXISTING FRONT ELEVATION

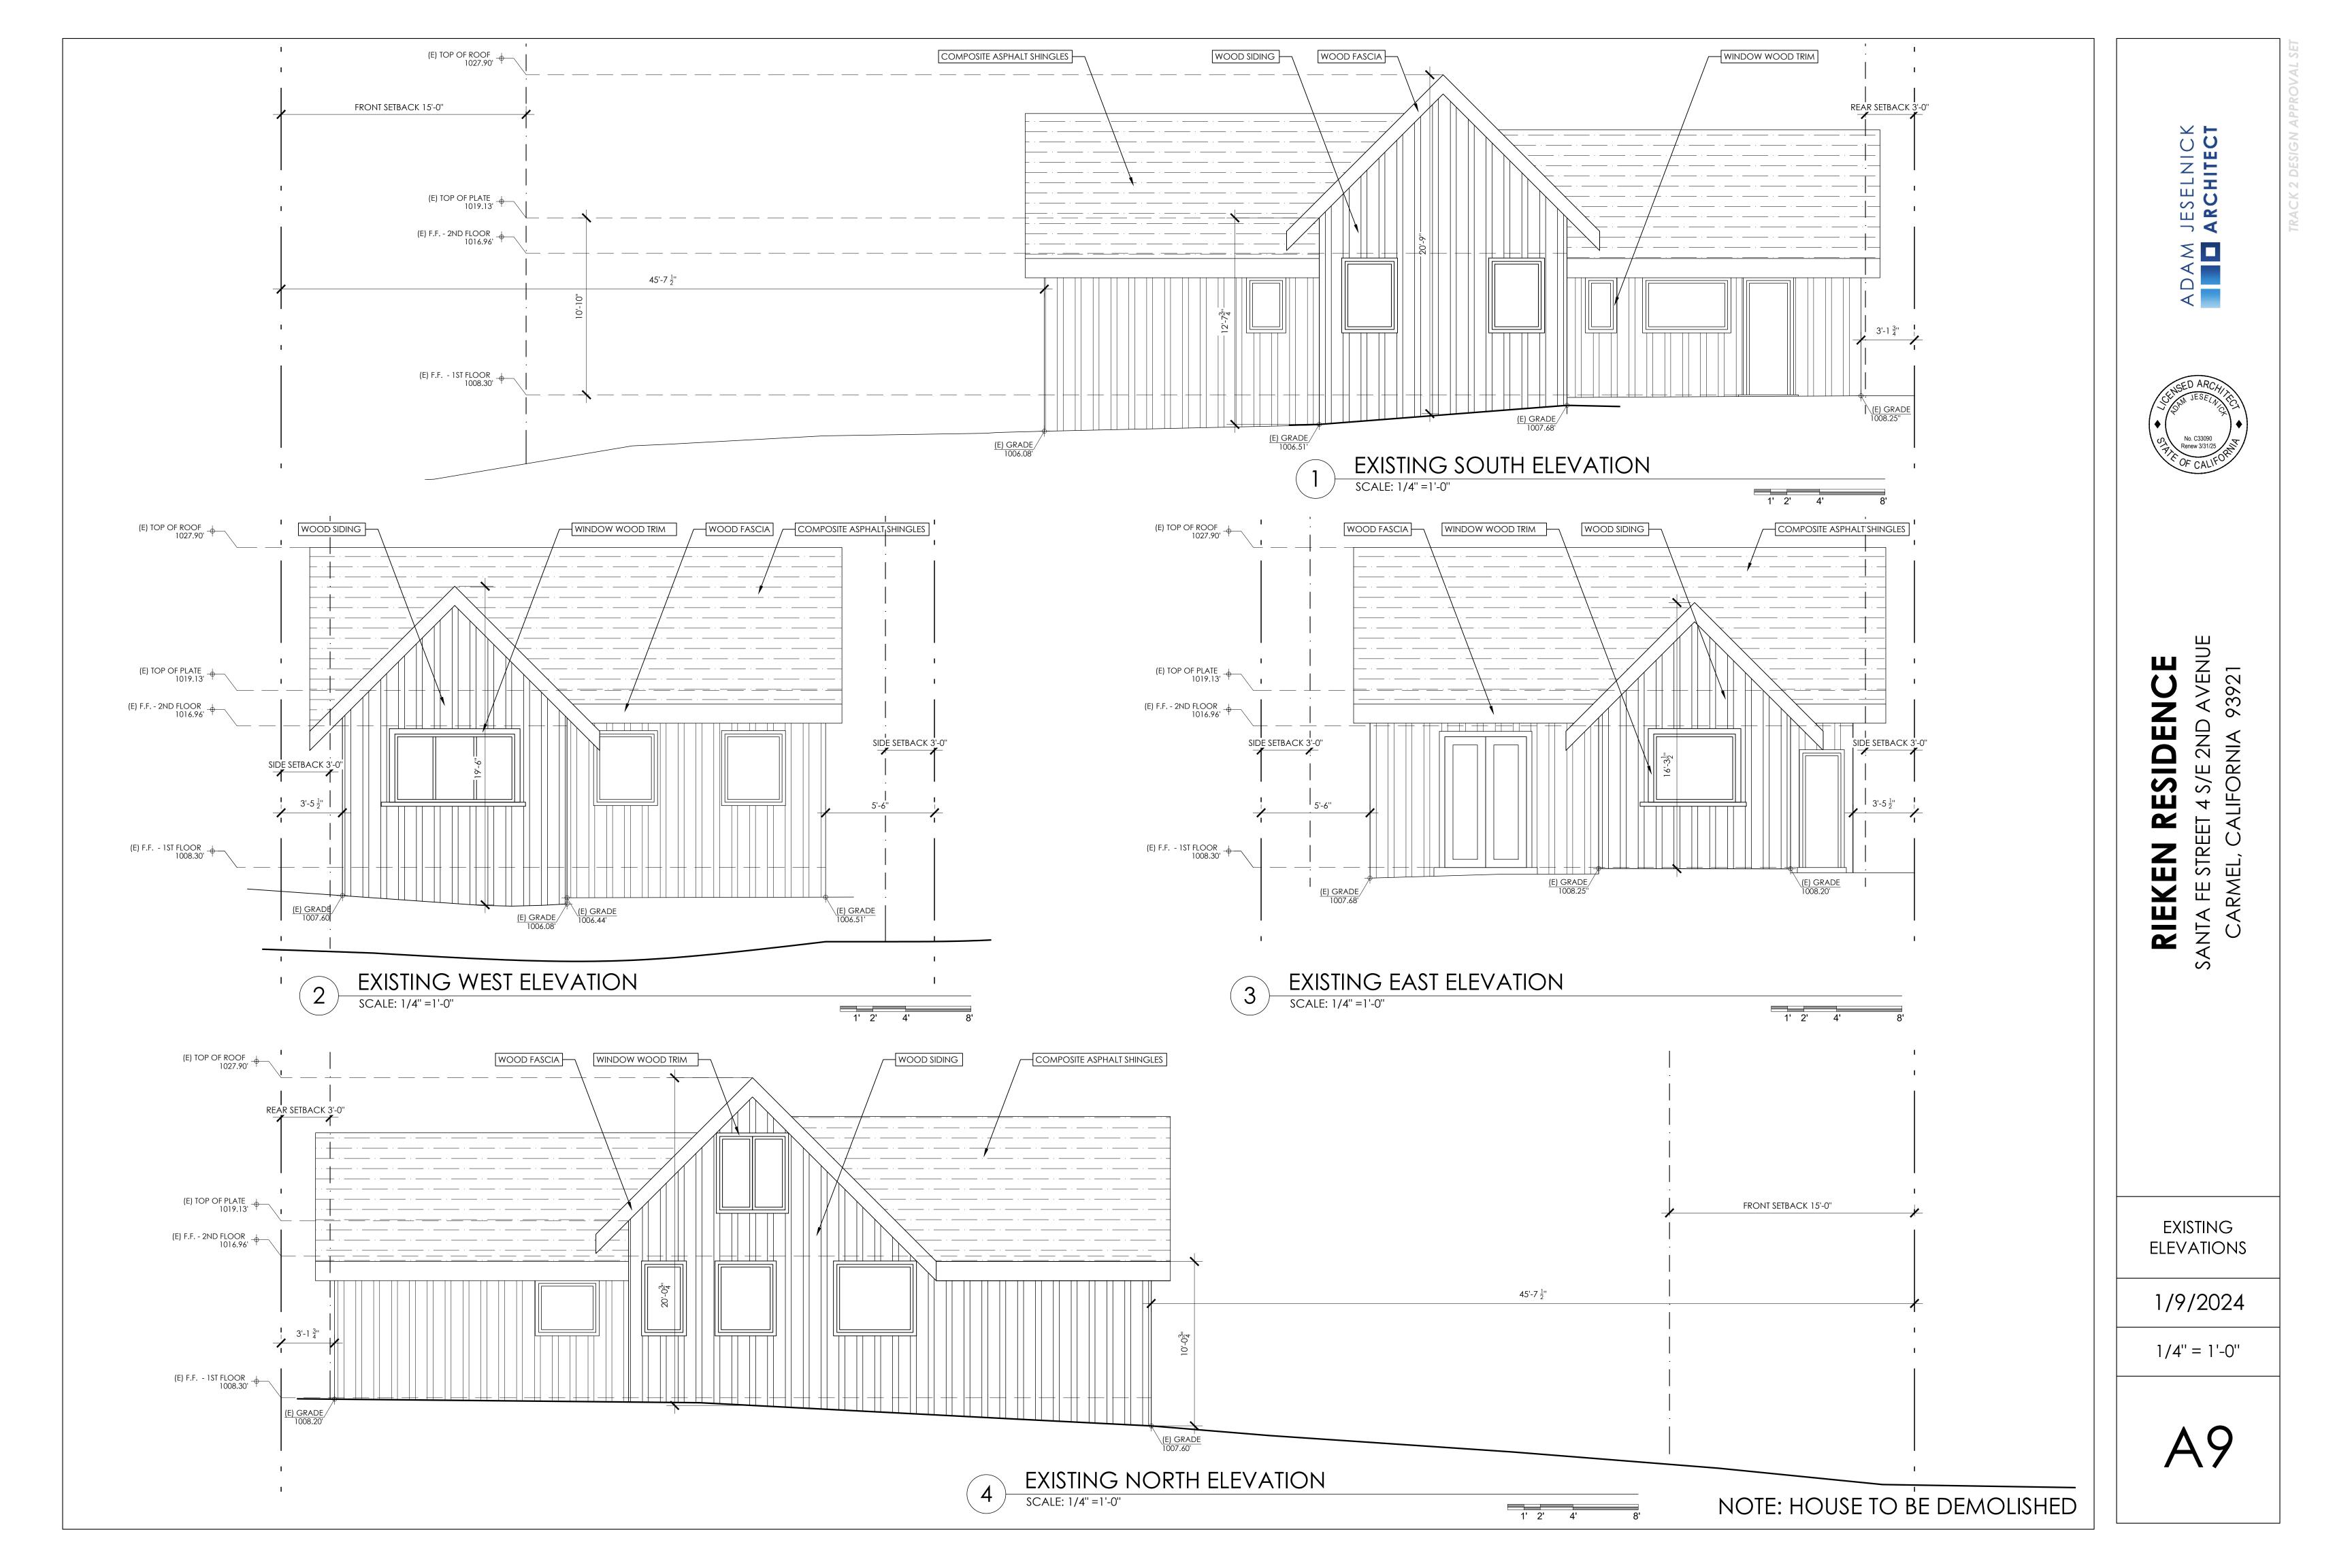
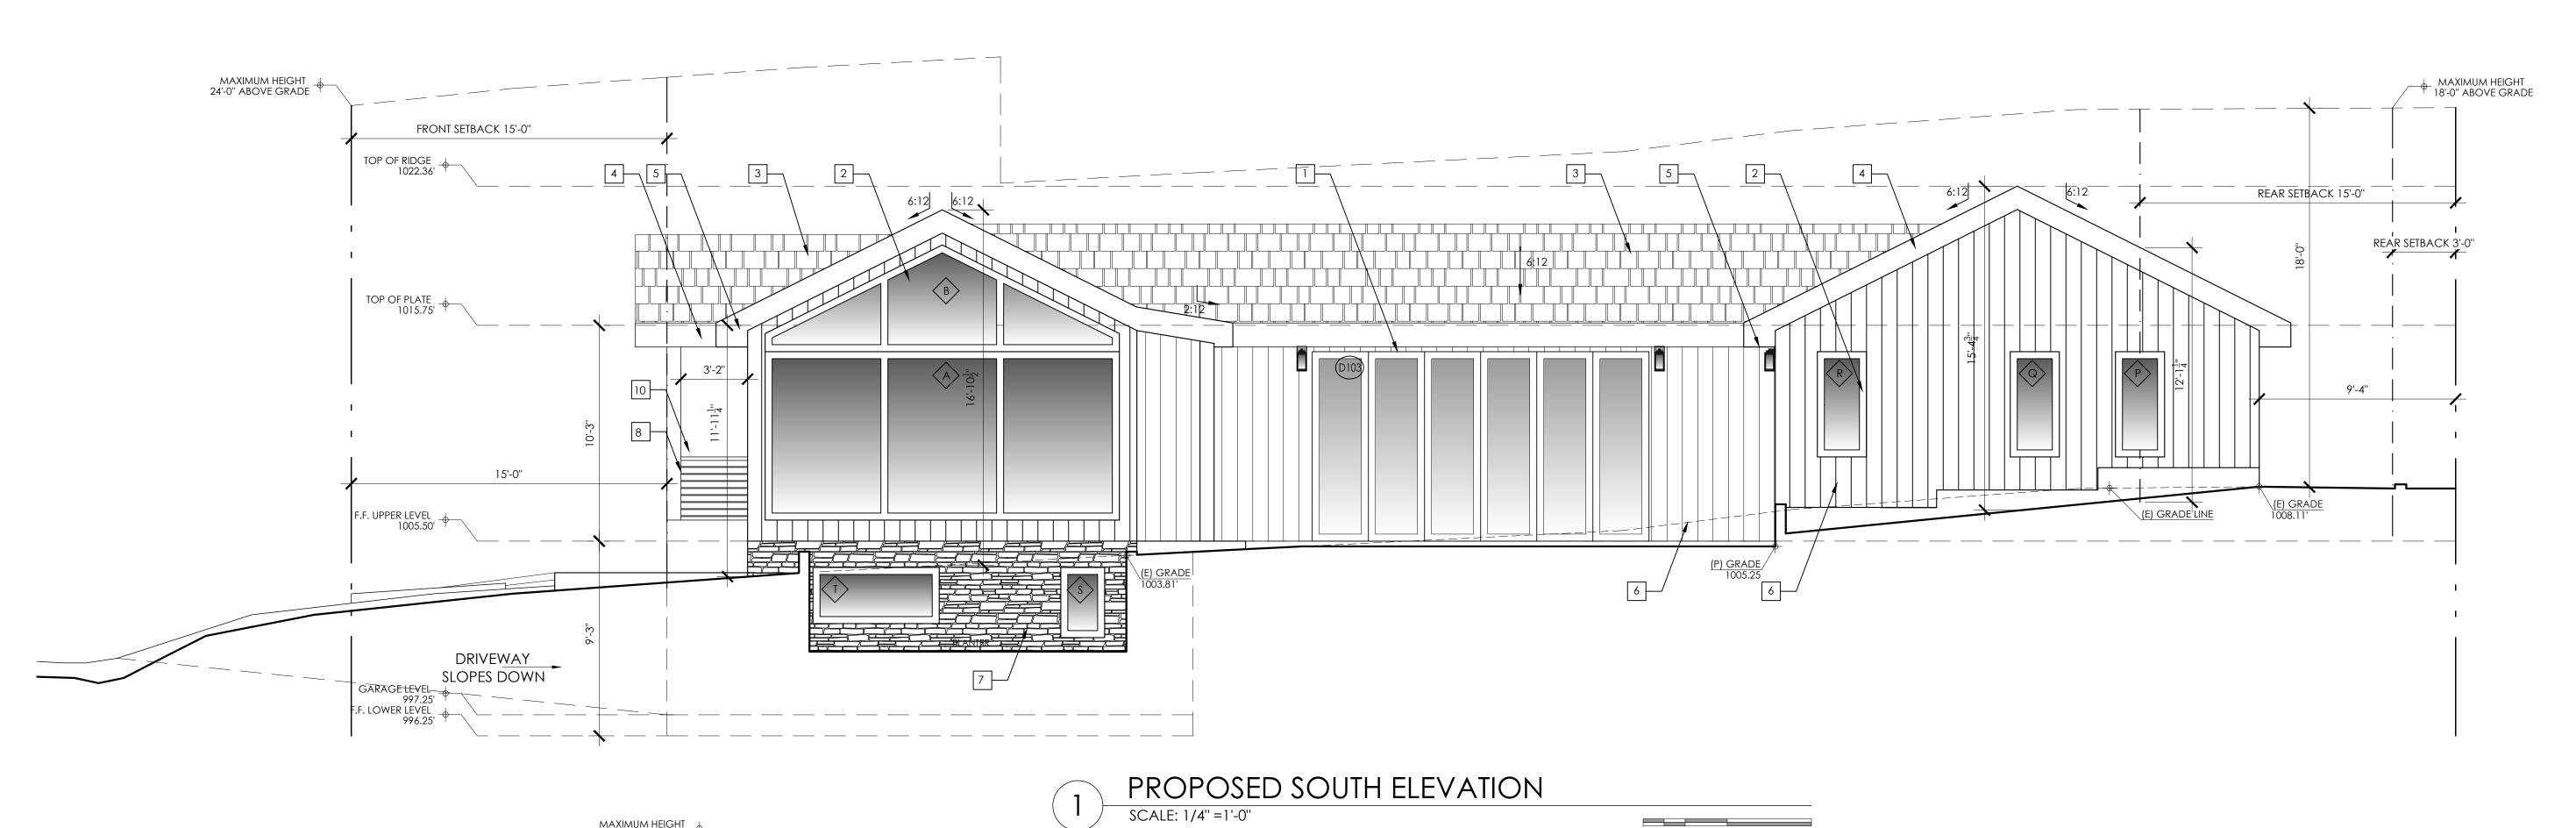
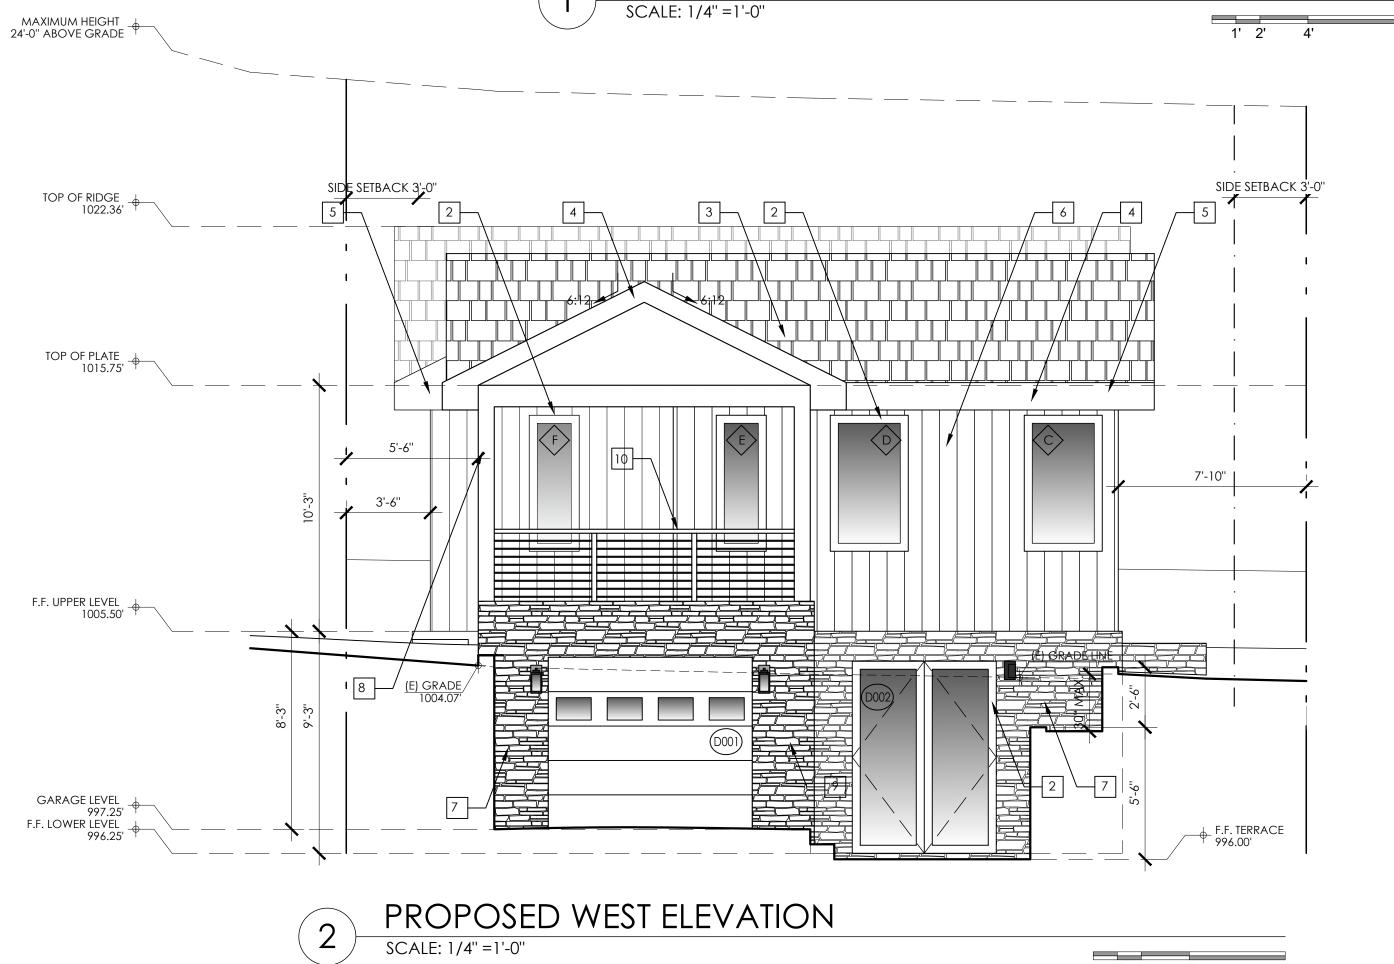
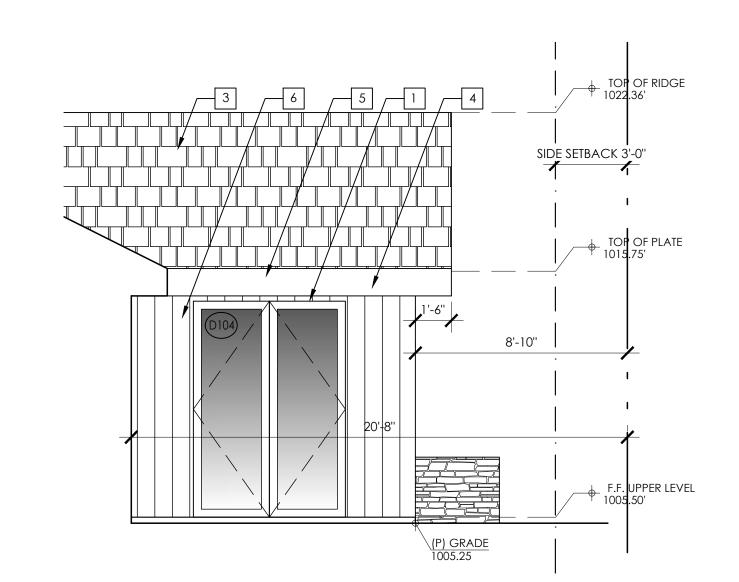
PROPOSED **ELEVATIONS**

KEYNOTES
1	ALUMINUM-CLAD WOOD DOORS. KOLBE. COLOR: BASIL
2	ALUMINUM-CLAD WOOD WINDOWS. KOLBE. COLOR: BASIL
3	SLATE ROOF. CALIFORNIA SLATE COMPANY - BURGUNDY SLATE
4	PAINTED WOOD FASCIA
5	METAL GUTTERS AND DOWNSPOUTS. ALUMINUM - PAINT TO MATCH TRIM.
6	WOOD SIDING. VERTICAL T:G. RESAWN TIMBER CO. ABODO VULCAN CLADDING TEAK
7	THIN VENEER NATURAL STONE. SBI MATERIALS - BUFF LUEDERS LEDGESTONE.
8	WOOD TRIM COLOR: PAINTED TO MATCH WINDOWS TRIM.
9	BOARD-FORMED CONCRETE
10	PAINTED METAL RAILING

PROPOSED COURTYARD WEST ELEVATION

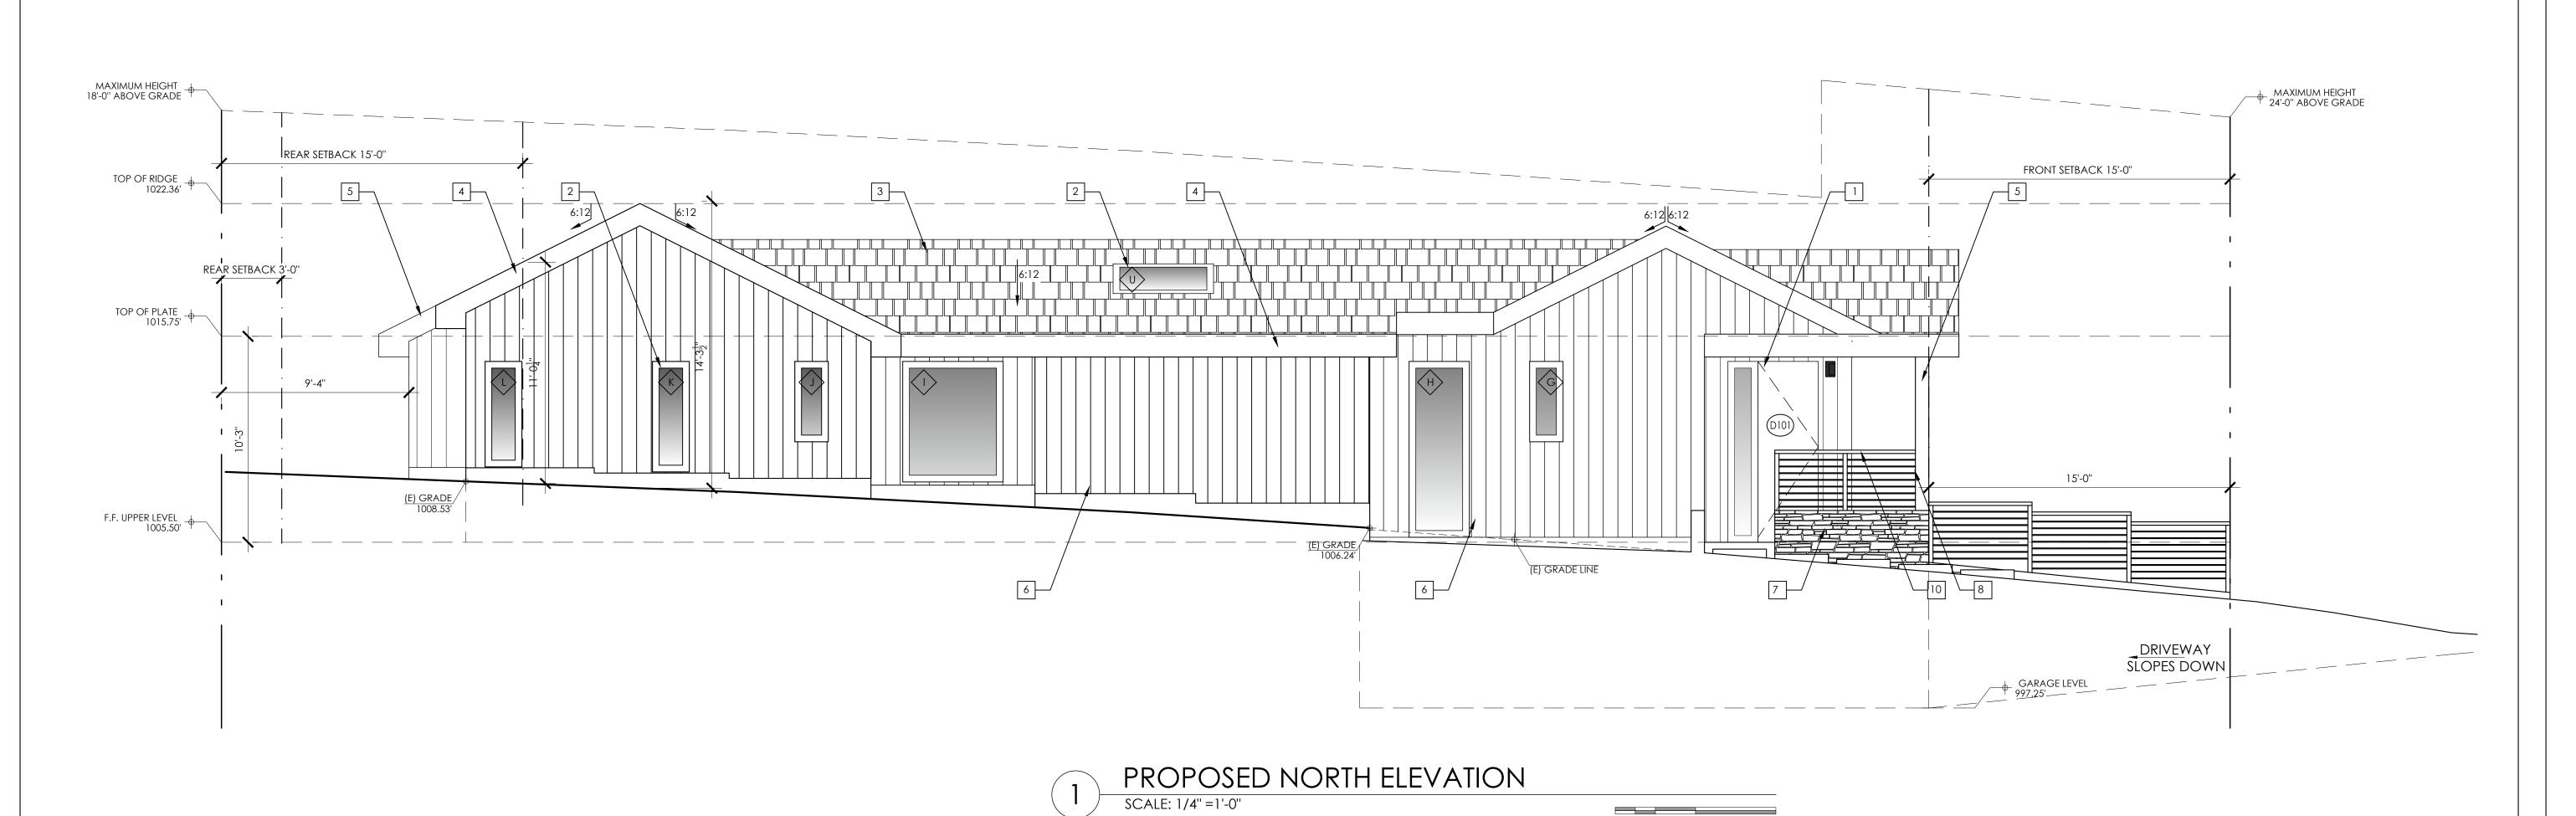
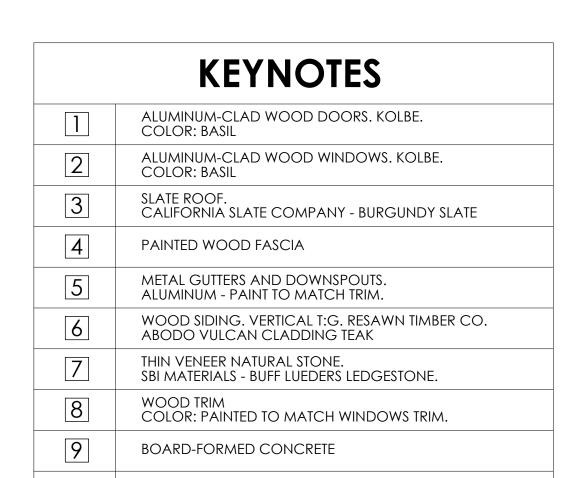
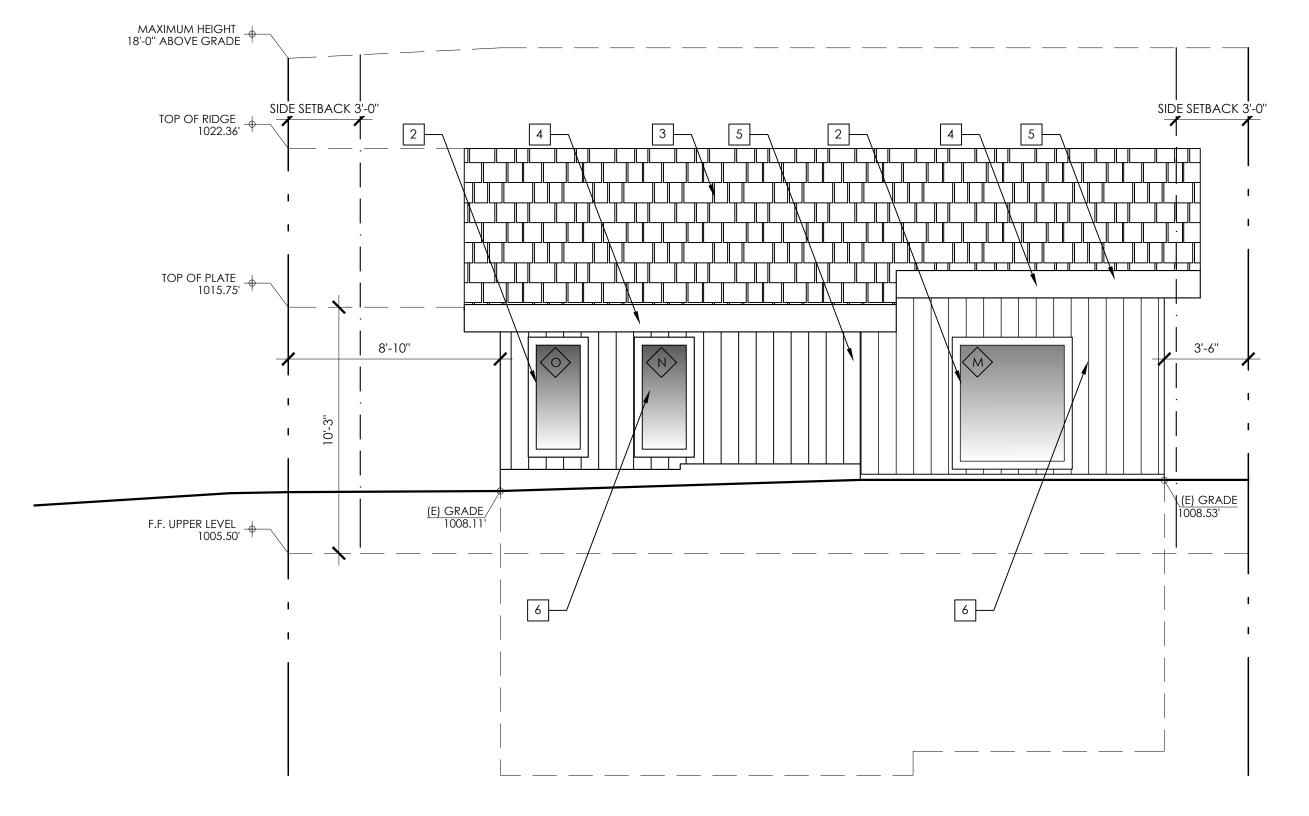
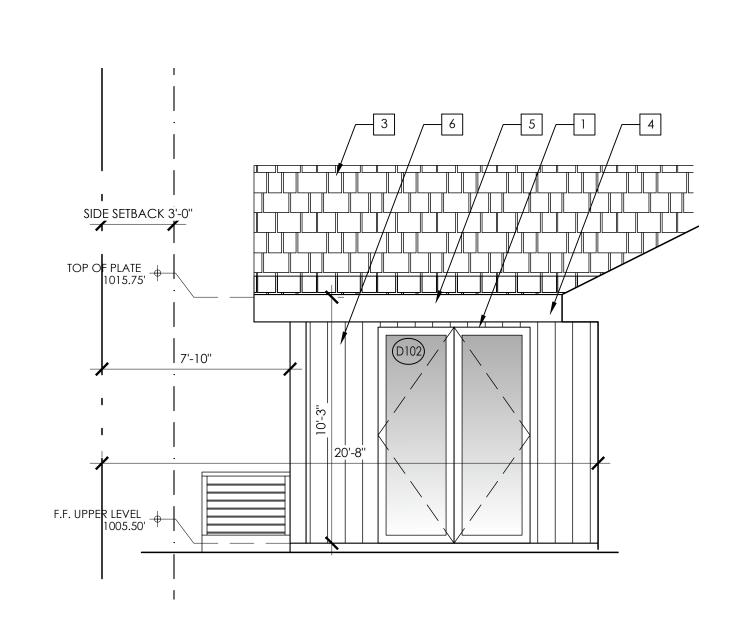
PROPOSED ELEVATIONS

PAINTED METAL RAILING

PROPOSED EAST ELEVATION

PROPOSED COURTYARD EAST ELEVATION

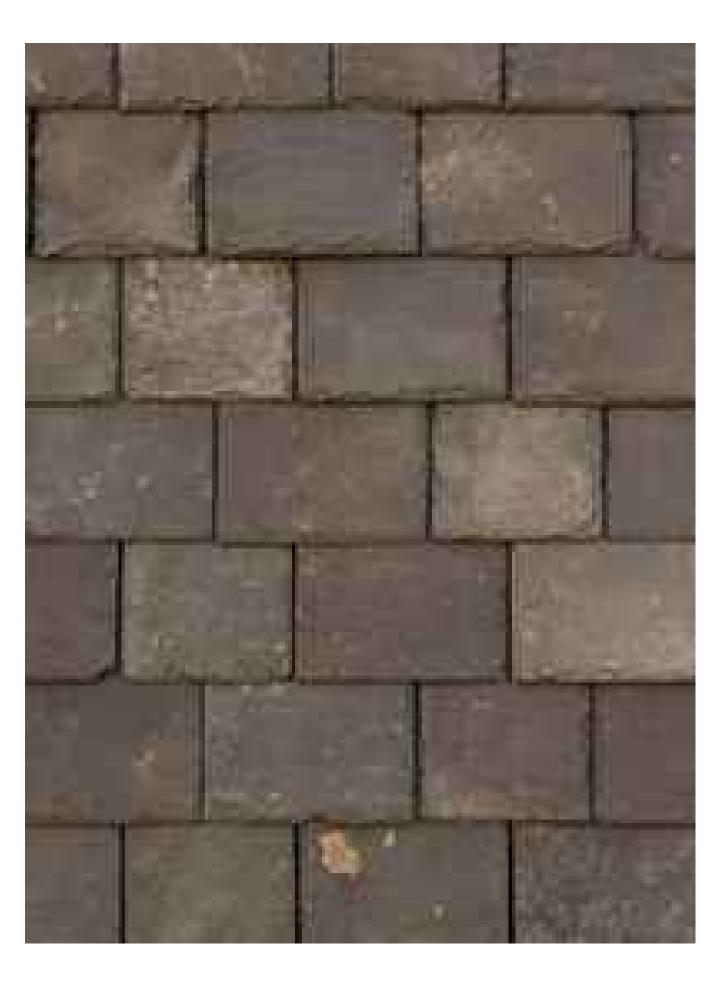
CALIFORNIA SLATE COMPANY - BURGUNDY SLATE

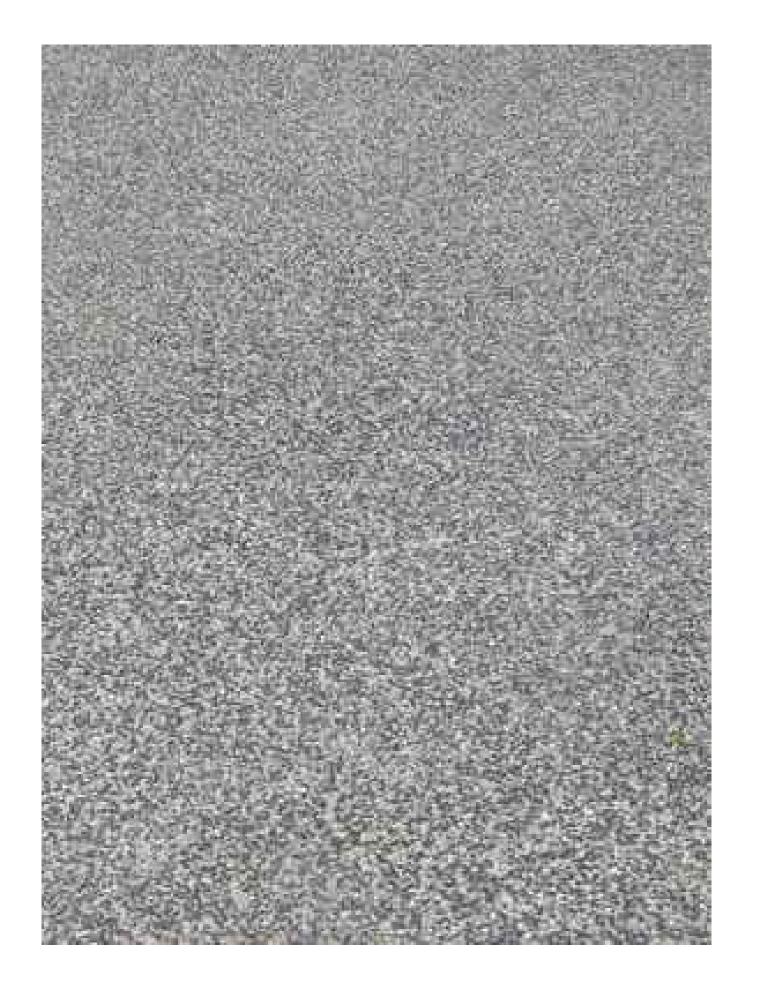
DRIVEWAY AND PATIOS
AGGREGATE CONCRETE

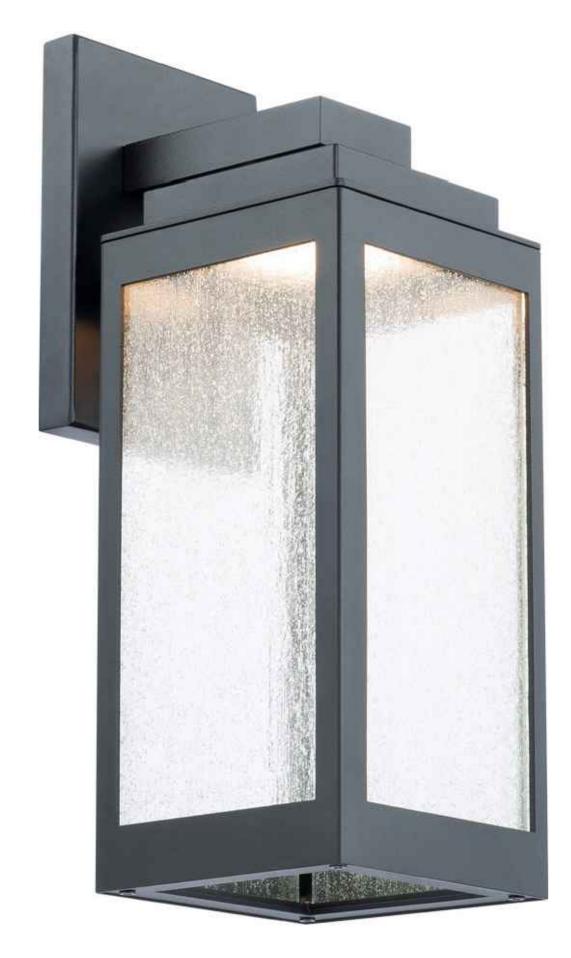
OUTDOOR WALL SCONCE
WAC LIGHTING - AMHERST 14". COLOR: BLACK.

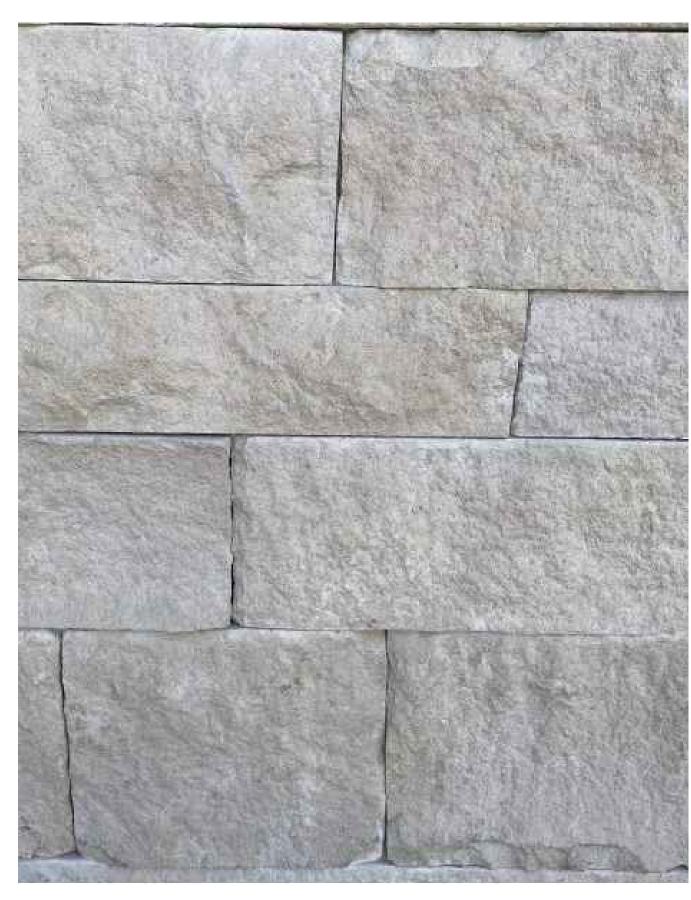
STONE
SBI MATERIALS - BUFF LUEDERS LEDGESTONE

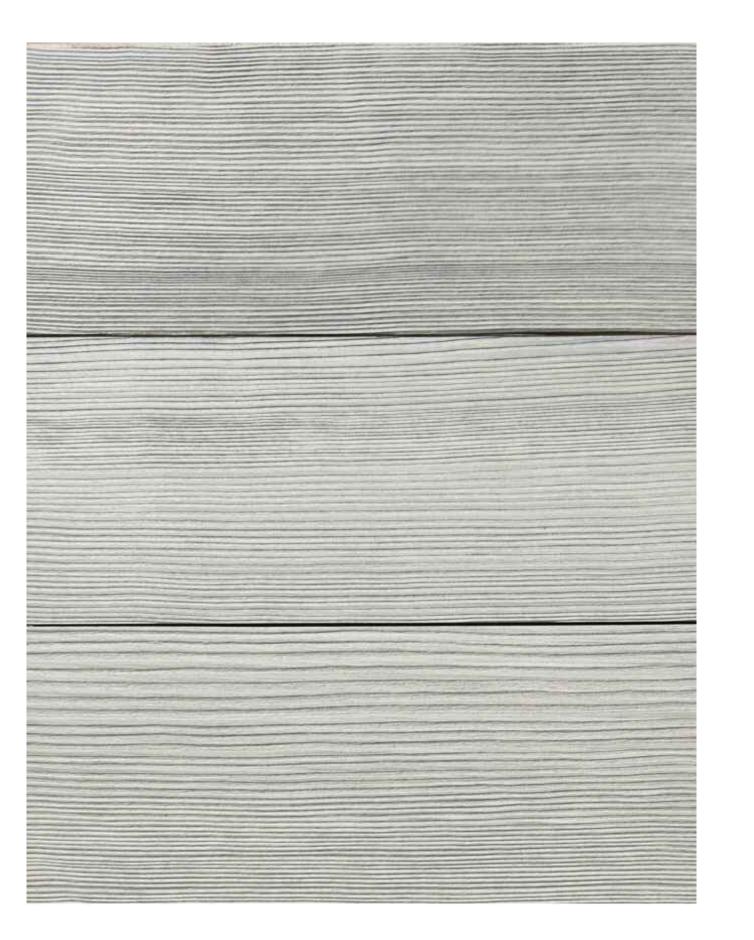
SOFFIT DELTA WOODWORKS - MOJAVE THERMAL DOUGLAS FIR VG SMOOTH MATAGORDA

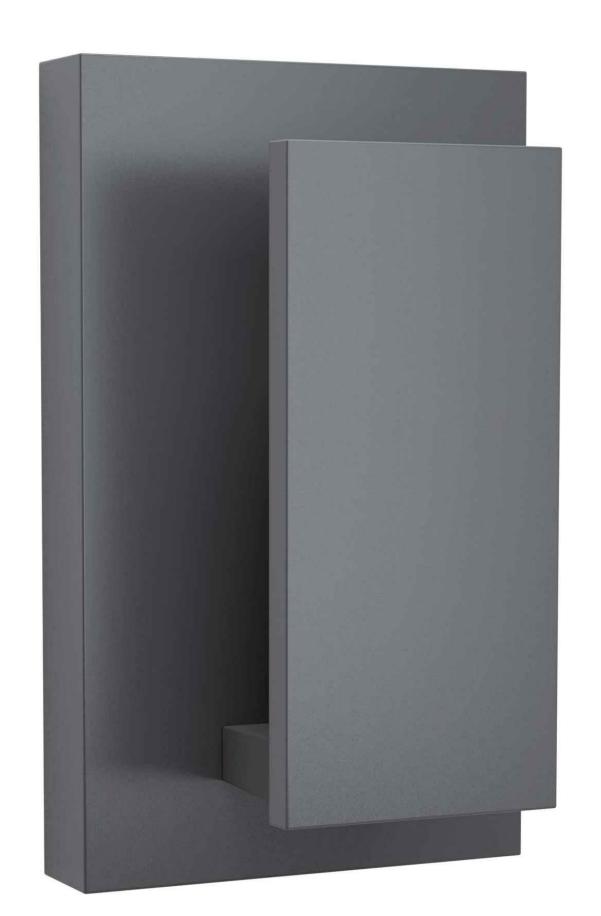
OUTDOOR WALL LIGHT
VISUAL COMFORT MODERN - NATE 9.1". COLOR: GRAPHITE
